**MONKEY ROCK SPEED RUN MONITORING REPORT:
AUGUST 2018**

REPORT No. CENRM149 (2018)

**Prepared for:
The Shire of Denmark**

**Prepared by:
The Centre of Excellence in Natural Resource Management**

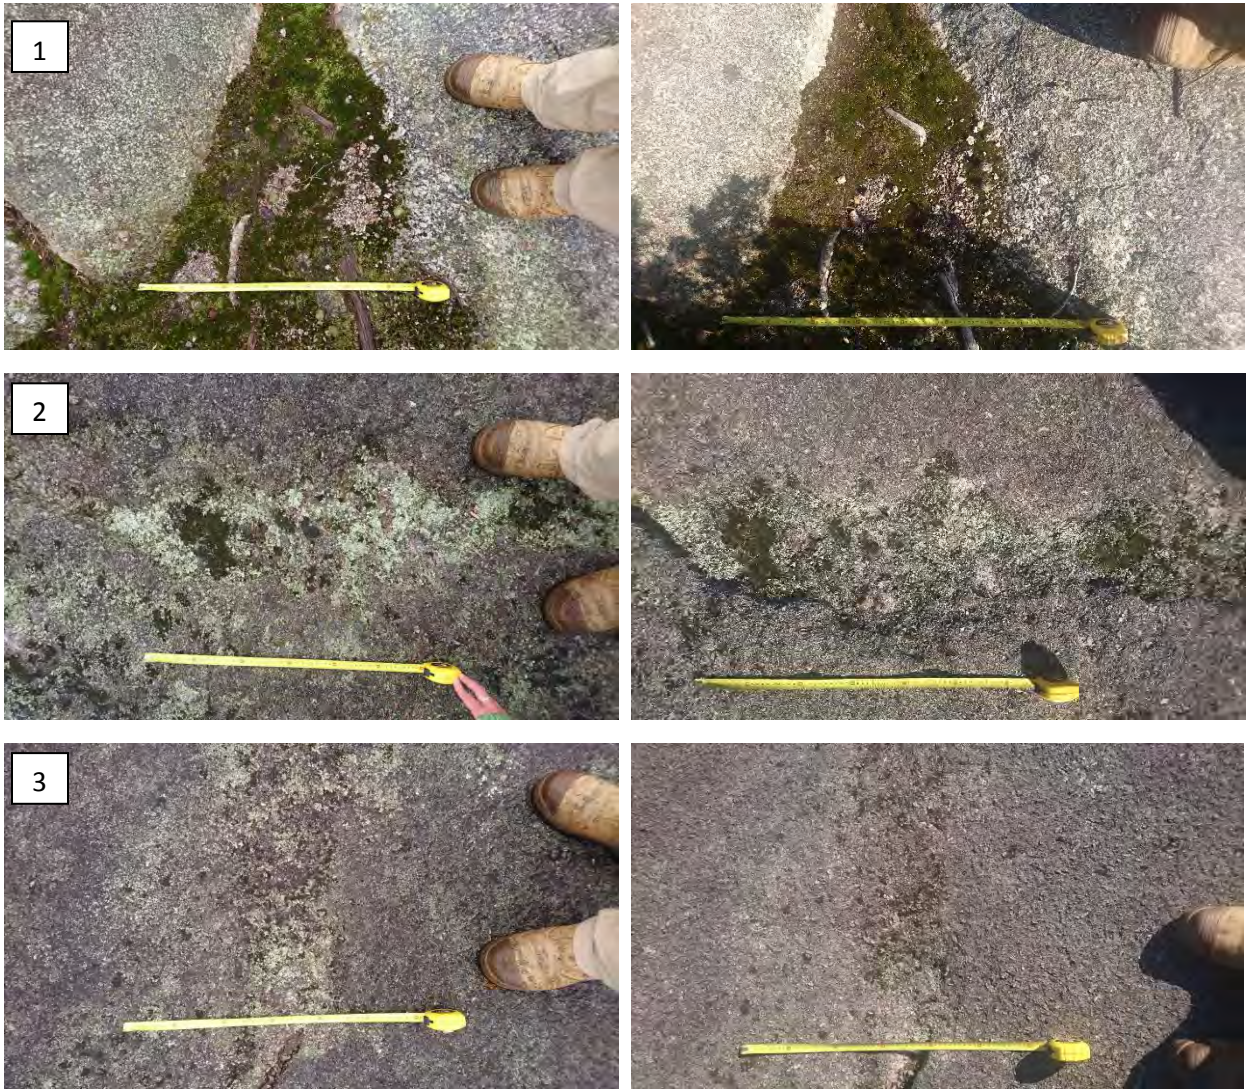
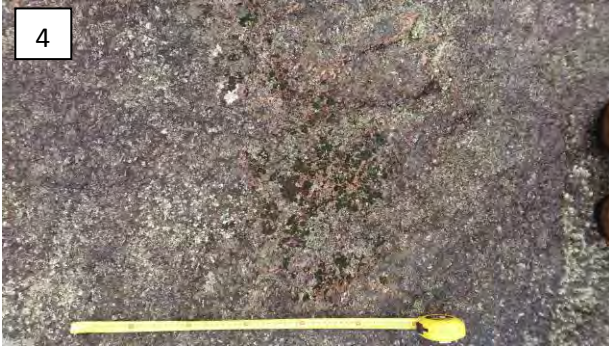
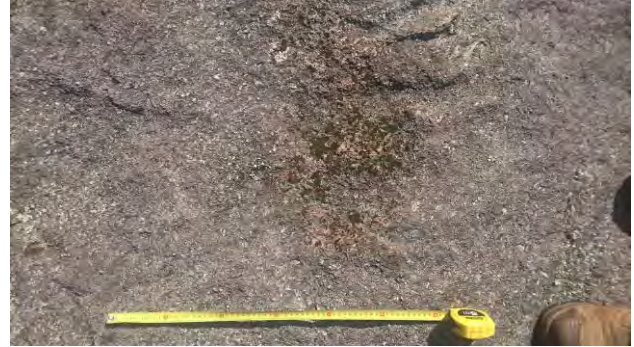
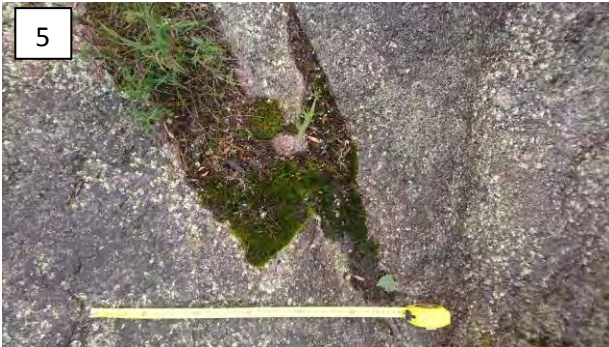
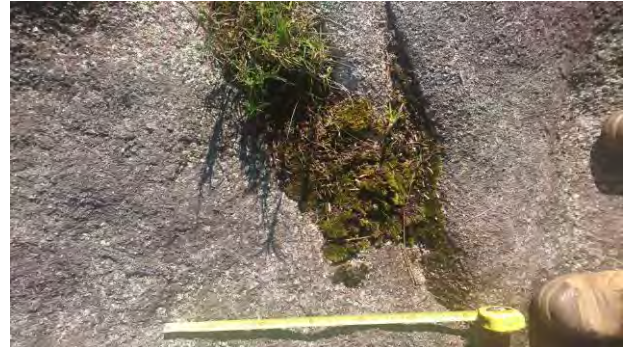
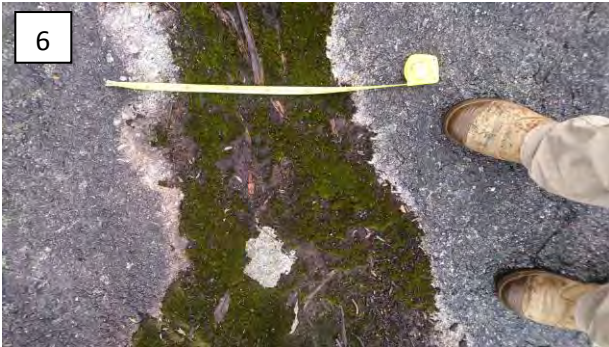
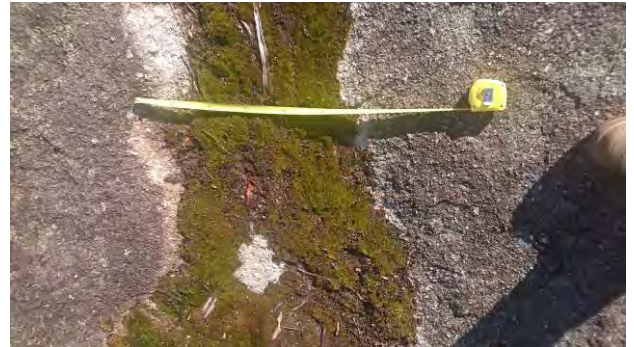
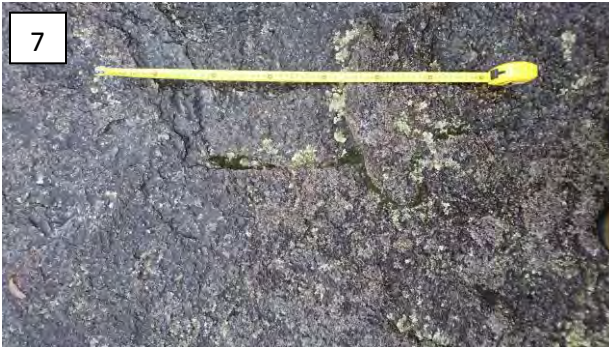
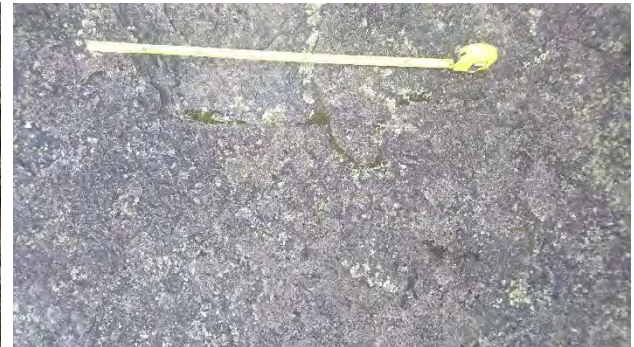
Granite: There was no evidence of any impact from bikes in any of the photo quadrats (Figure 1). The only obvious damage to moss was from kangaroo tracks near location six (Figure 2a). A faint trail of dirt from tyre-tracks was still evident in places, which highlighted that the course generally avoided mossy areas. Where the course crossed such areas, the small bridges that were implemented on the day prevented contact from the bike-tyres (evident in Figure 2b).

Figure 1: Photo-quadrats at locations 1-7 showing moss/lichen condition on Monkey Rock before (left) and after (right) the Speed Run (continued next page).

The results of this survey indicate that the Speed Run had minimal impact on the Monkey Rock area. The sample locations on the granite outcrop generally fell within the course-boundary (which was laid out after baseline sampling) and there was no observable damage to the mosses and lichens in those areas (Figure 1). The course avoided or bridged gullies and incisions where mosses and lichens were most prevalent, following a similar path to that used by site-seers year round. While this path likely had greater coverage of mosses and lichens historically, the bikes have had little to no impact on the area in its current state. The only obvious disturbance to the moss was caused by a kangaroo or wallaby, indicated by a footprint (Figure 2a). The course did pass over a narrow patch of lichen approximately 1m south of quadrat two; this area was not part of the initial quadrat collection so there is no before-photo for comparison, but there did not appear to be any damage. If future monitoring is undertaken for subsequent events, this site should be included in the photo-quadrat collection.

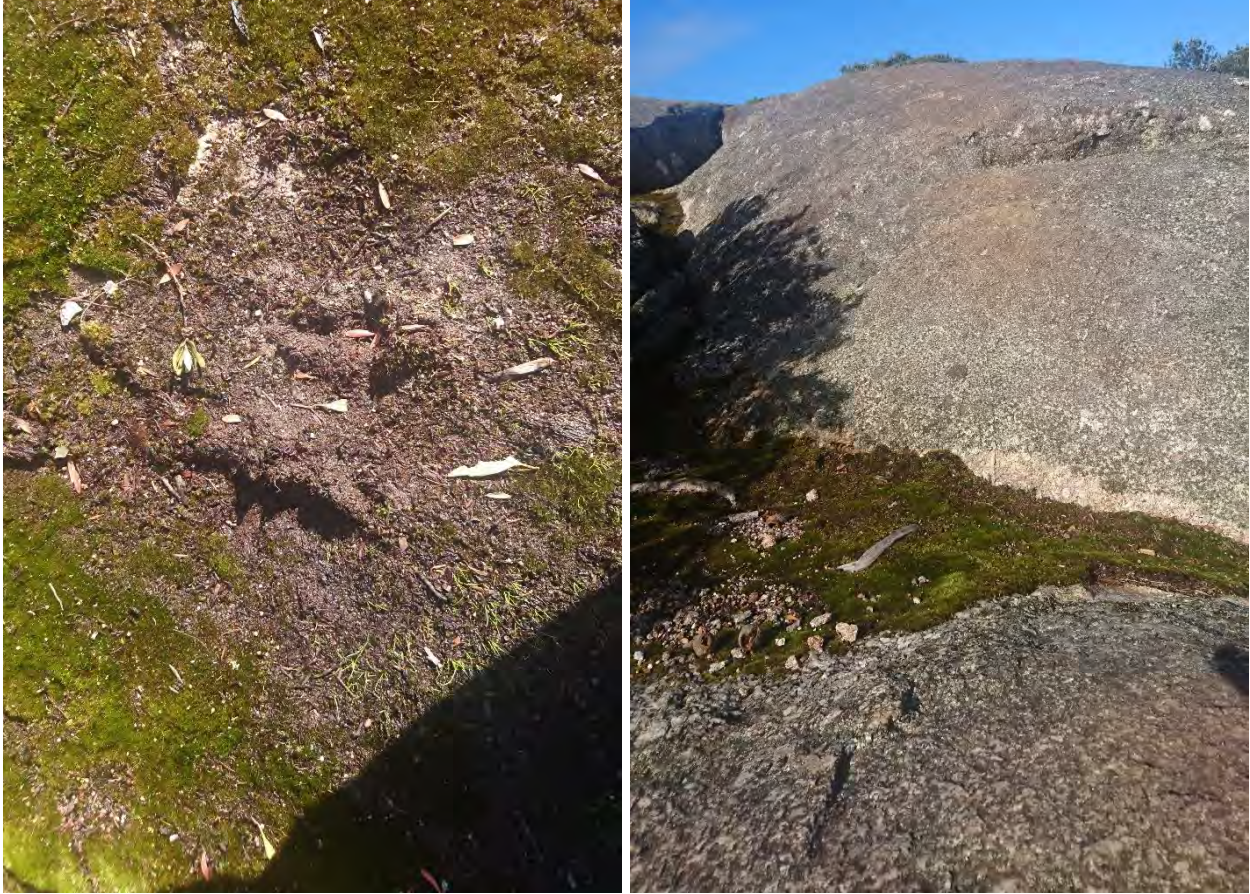
Figure 2: (a) Disturbance from kangaroo tracks. (b) Gaps were bridged during the event, preventing damage to moss. This is evident from the faint tyre-tracks on the upper and lower rocks.

A faint trail of dirt from bike-tyres was still evident on the outcrop four days after the event, despite heavy rain (Figure 2b). This will likely be washed away shortly, but it does highlight the potential spread of soils and soil-borne pathogens (i.e. dieback) by the bikes and spectators. Anti-dieback measures taken by the event organisers (see introduction) have mitigated this concern, and should be continued if the event is held again.

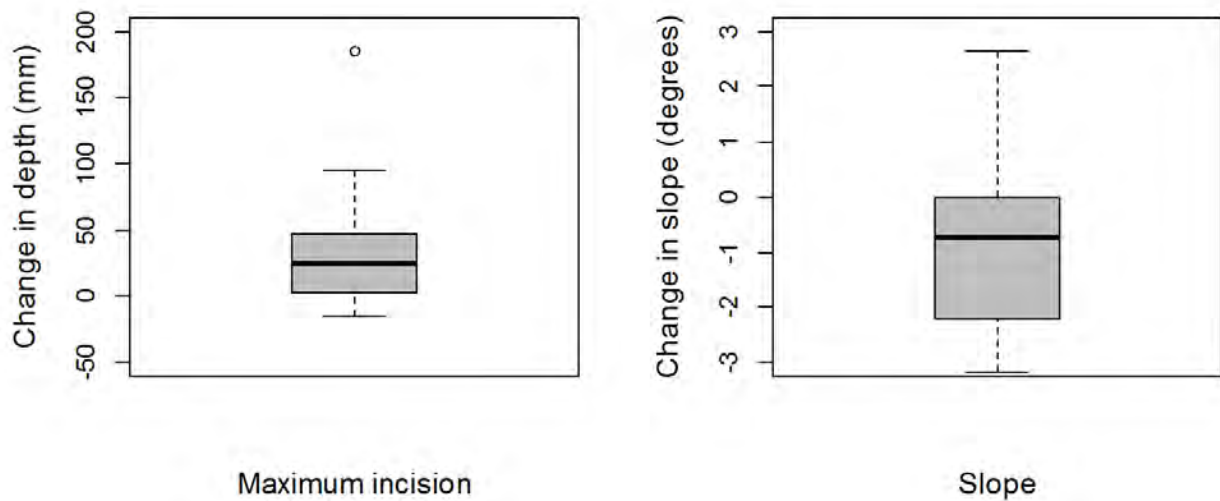
Firebreak: There was a significant change in incision depth ($P < 0.05$) and slope ($P < 0.05$) (Figure 3), however there was almost no evidence of incisions from bike-tyres, with car-tyres tracks being more obvious (although only minimal). Erosion from runoff was far more obvious than effects from either bikes or cars, and caused obvious changes in slope including build up from sedimentation in some places (Figure 4 a-c).

Figure 3: Change in maximum trail incision and slope of the firebreak after the Monkey Rock Speed Run (NB: Changes were caused erosion from runoff rather than bikes).

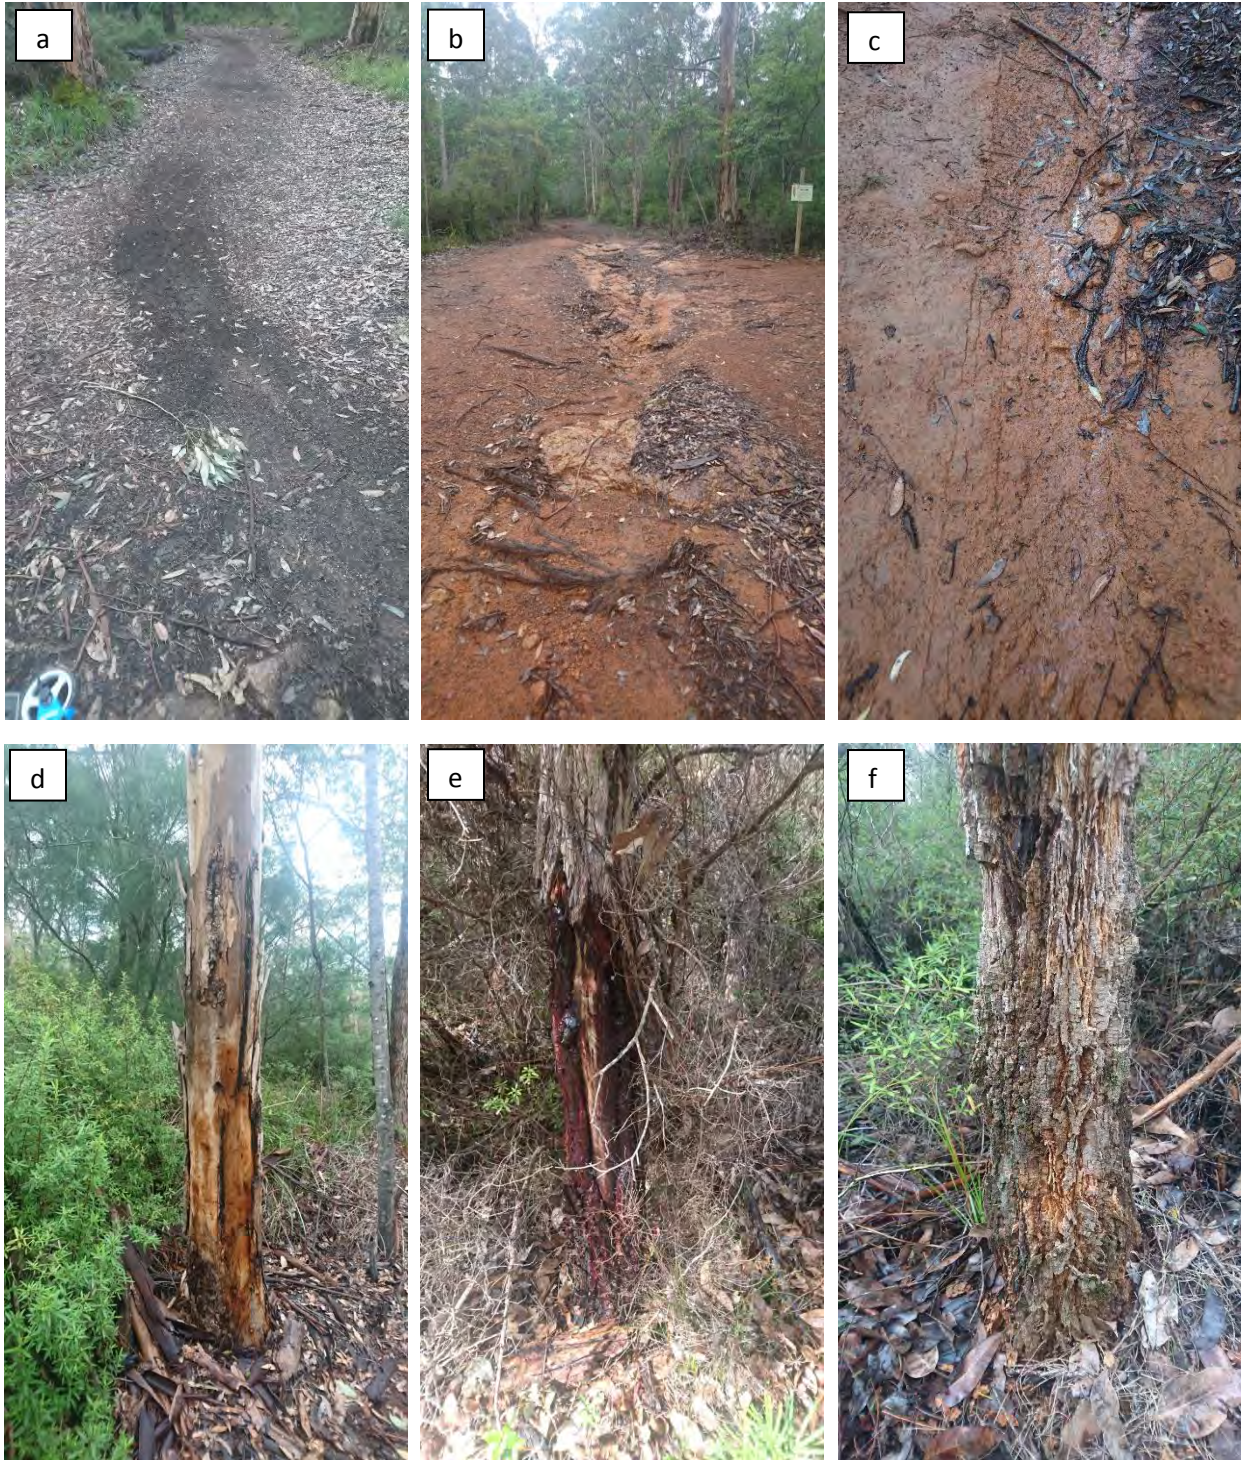
There were few trees within 1m of the firebreak (mean = 1.3/transect), and there was no evidence of tree-scarring from bikes (data not presented). Bark was missing from a few trees along the course, however this may have been from natural weathering. These trees were not within our sampling areas so there were no pre-race photos for comparison, and they may have been in similar condition during baseline sampling (Figure 4 d-f). There was no evidence of trampling in the vegetation adjacent to the firebreak. Debris that had been cleared from the firebreak for the event was piled up in some places, but this only impacted vegetation which was clearly within the firebreak.

Figure 4: (a) Incisions from bikes were minimal, and restricted to the firebreak rather than the adjacent Bibbulmun track. (b) Erosion and sedimentation from rainfall runoff was far more evident than bike incisions. (c) Vehicle tracks were also evident. (d-f) Some trees along the course had recently lost bark, although the cause is unknown.
