11<sup>th</sup> October 2016

RE: Arborist Report – Riverbend Lane, Denmark WA

## Arborist Report – Riverbend Lane, Denmark WA

Prepared for LandCorp

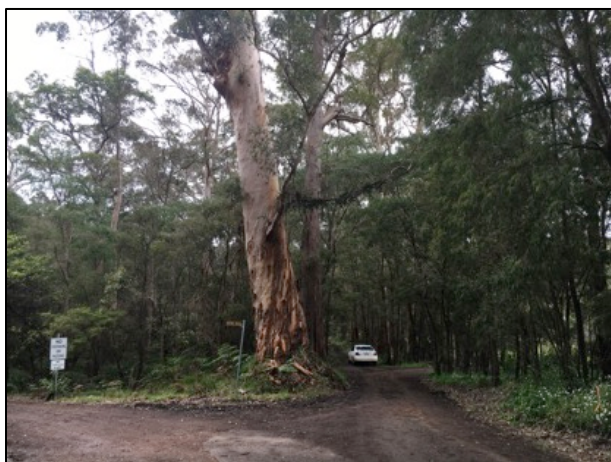
The tree has a lean to the north over the bridge on Riche Rd. A mature Marri tree (*Corymbia calophylla*) arises near the base of the subject tree and leans away to the east.

**Image 1:** Looking east towards the tree.

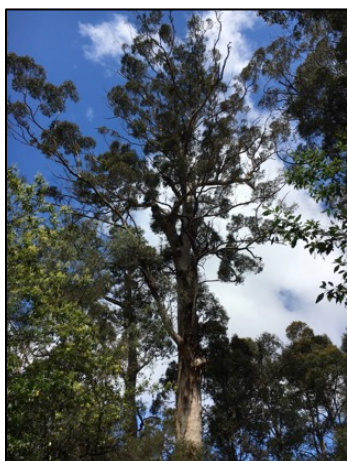
- 4.2 It is evident from the crown structure that the tree is over-mature.

The upper canopy is undergoing a natural retrenchment and the internal and lower canopy are well developed. There are many large dead limbs in the upper crown to approximately 600mm diameter.

**Image 2:** The crown is undergoing a natural retrenchment with many large 1<sup>st</sup> order limbs having failed or died-back and a secondary internal crown structure having developed.

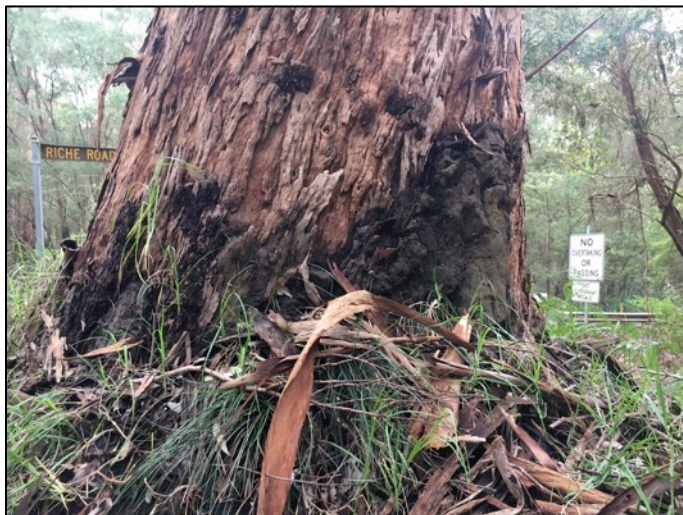
- 4.3** There are multiple large hollows visible in the stubs from broken limbs. A local resident reported seeing both ducks and Cockatoos nesting in these hollows.
- 4.4** Soil is mounded around the lower trunk to a height of 1m above the surrounding ground level and there are large mounds of termite mud around the base of the tree.

**Image 3:** The base of the tree with termite mud encircling the trunk.

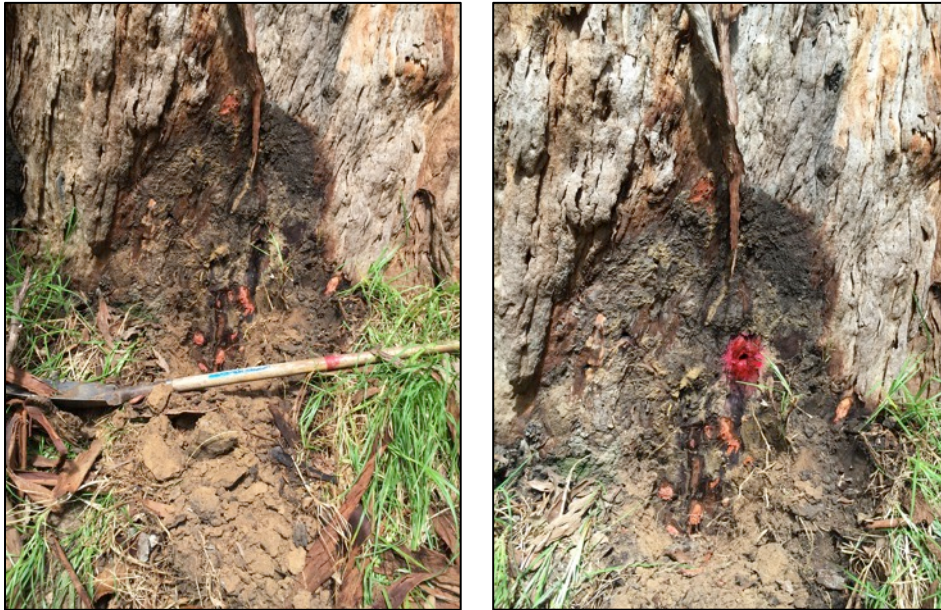
- 6.1 In order to investigate the extent of any damage from termites I used a shovel to remove the soil and termite mud from around the base of the tree. During this process I was able to confirm the termites are still active.
- 6.2 Following the removal of the mud a number of entry-points for the termites were evident on the trunk. I plotted these entry-points on a diagram and used spray-paint to highlight them so they can be located in photographs.

**Images 4 & 5: With the termite mud removed the entry-points for the termites were visible.**

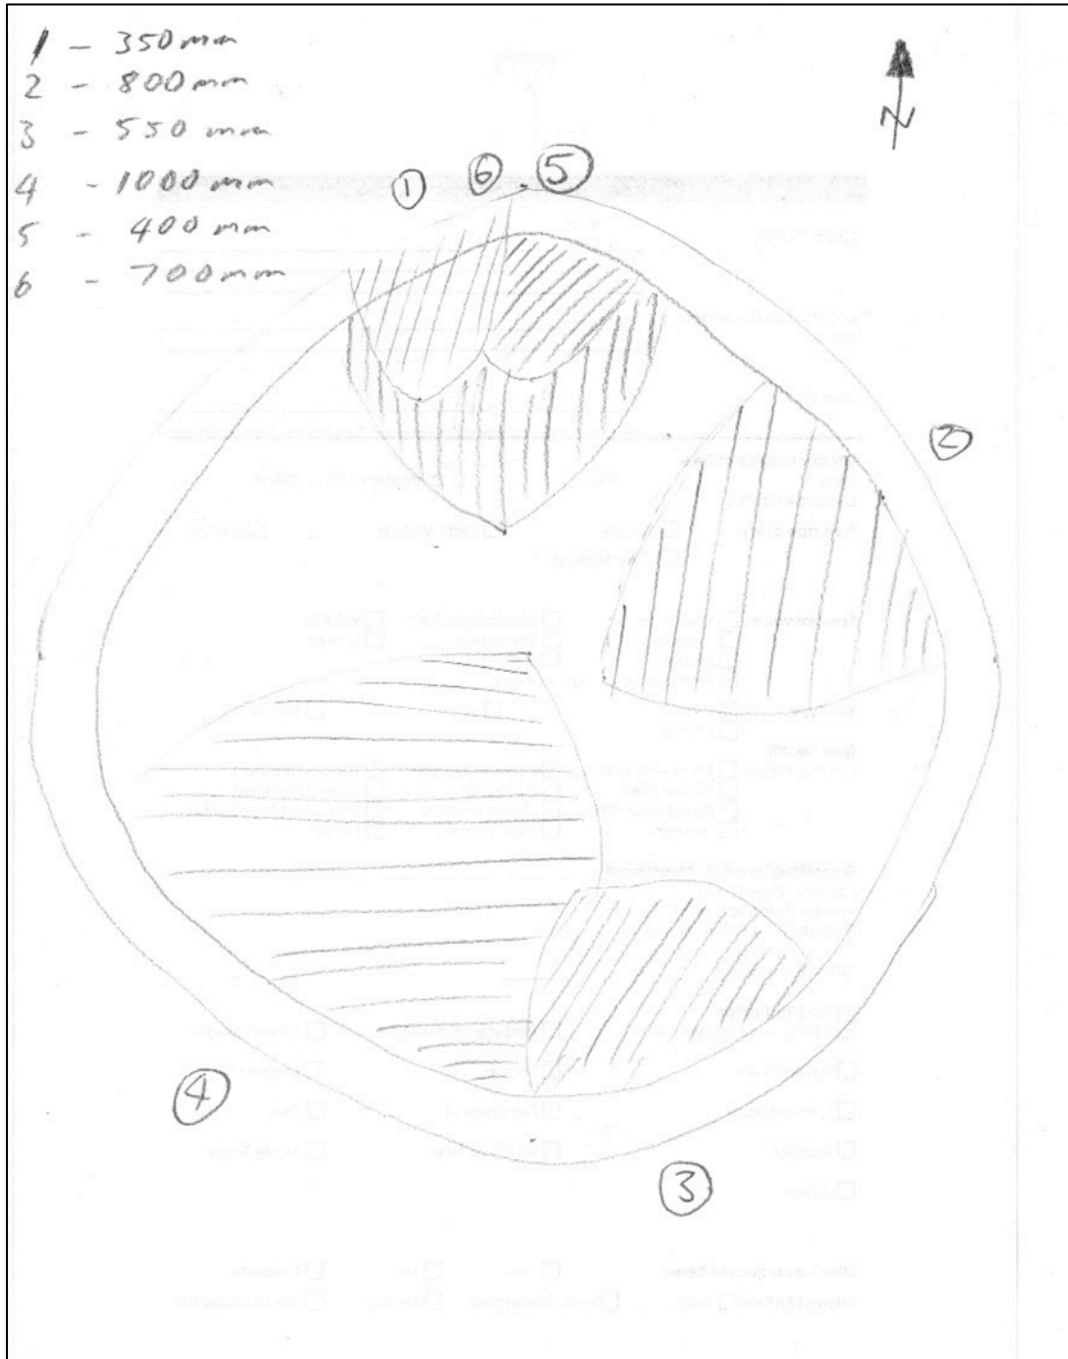
**Image 6:** Diagram of probe locations.

**6.3** In all I uncovered 6 entry-points and using a 10mm diameter steel probe I was able to gauge the extent of the damage to the lower trunk.

The diagram below shows the location and depth (mm) that I was able to insert the probe by hand. The shaded areas represent my interpretation of the extent of the defective wood.

**7.4** The termite damage and associated decay in the lower trunk is extensive. Even allowing for the healthy reaction-wood that encircles the decayed area, the area affected by termites and decay is proportionally large.

This degraded wood constitutes such a large percentage of the cross-section of the lower trunk that the tree is not structurally viable.

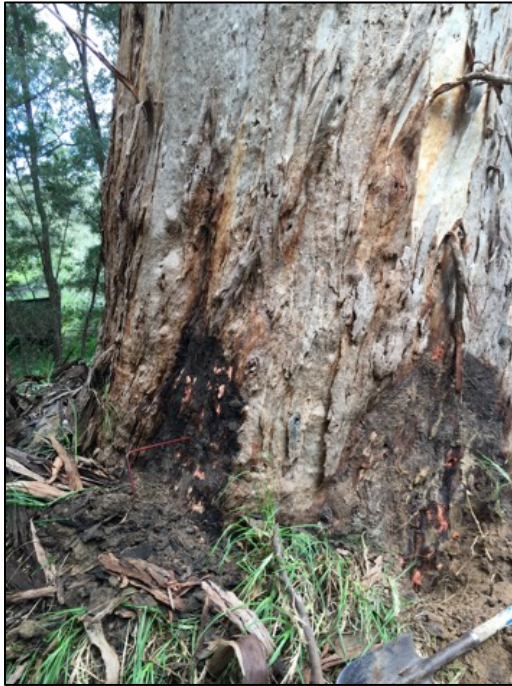
**Image 7:** Probe location no.6 – The handle of the 1100mm probe is visible protruding from the trunk.

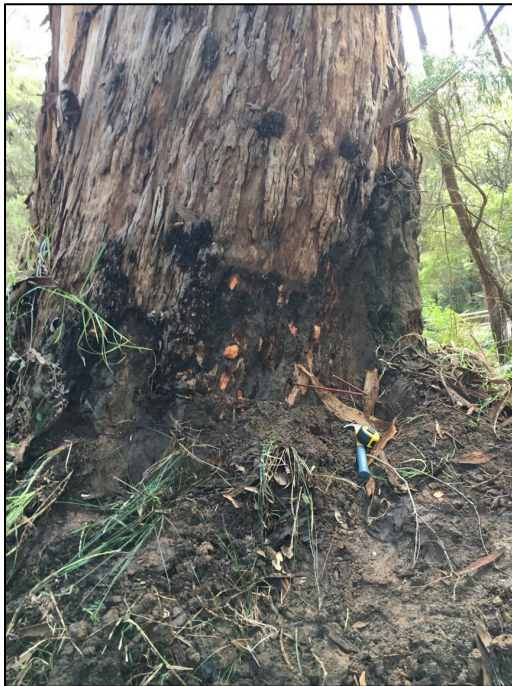
**Image 8:** Probe location no. 4. The probe was able to be inserted 1000mm into the trunk on the tension side of the trees lean.

**7.5** If left to senesce naturally, it is my opinion that the tree will fail due to fracture of the lower trunk well before the upper crown degrades to a point where the load on the weakened trunk is sustainable.

If the proposed road alignment is to pass within the fall zone to the north of the tree then the removal of the tree or shortening it to a height that it could not strike infrastructure would be the only feasible option.
