Strategic Asset Management Report - Buildings

PROPERTY INSPECTION REPORT

CONSTRUCTION DEFECTS & MAINTENANCE SCHEDULE

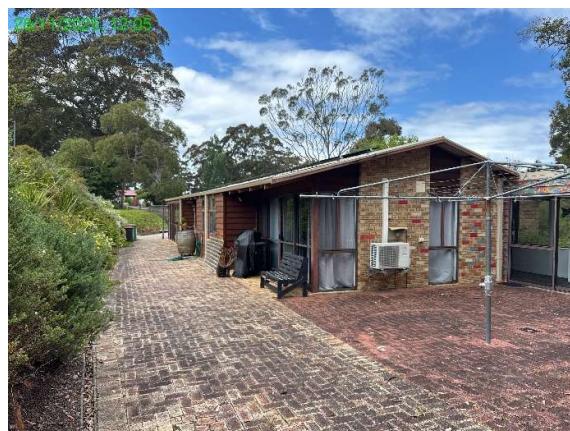
along the north side of the building. Refer photo 13.3.1 that shows the concrete lid at the far end of the building.

Photo 13.3.1 Note DP directly behind the R/hoist to be connected to the sump to the right/middle of C/yard.

A downpipe in the intermediate courtyard (photo 13.3.1) discharges near the door and the ground/pavement are at the same level. This DP need to be connected to the SW pit in the centre of the Courtyard and via a sump at the base of the DP as explained above. The existing configuration has caused water to enter the building and rot of the timber door frame has occurred. Moisture from the above Box gutters has also contributed.

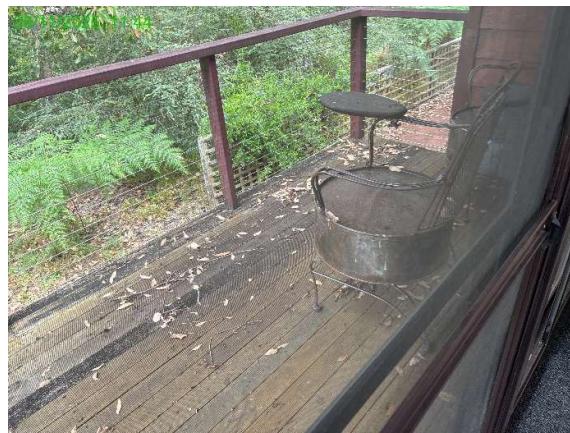
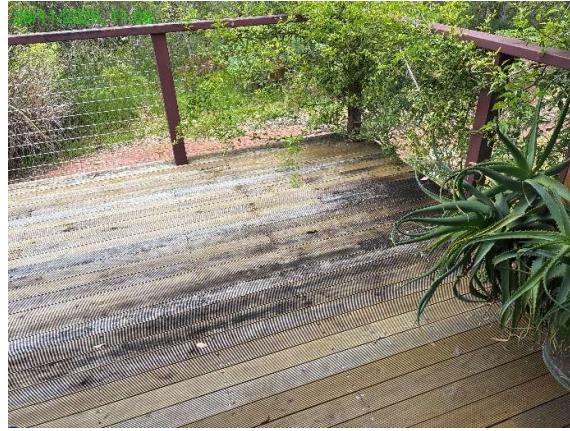
Located on the south side of the building, constructed in timber with reeded pine decking. Handrails of stainless-steel wire with timber posts and top rail. The reeded decking on Balcony and Ramp are in a poor condition. Refer Photo's 13.4.1.

Photo 13.4.1 Decking

Clean down decking and repaint. Replace, any rotted timber. Check gradients of ramp to comply with regulations. Note handrails must be 1000mm above deck

level. If disable access required, side rails at ramp edges are necessary. Refer to Building Code.

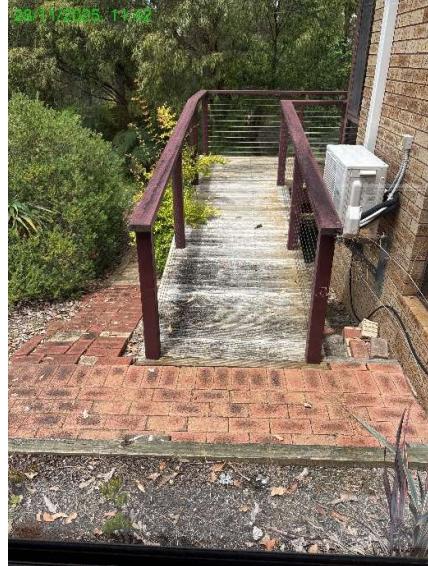
Photo 13.4.1. Ramp

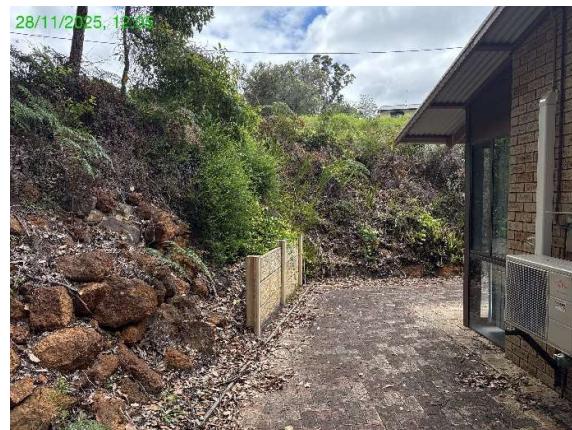
13.4 Boundary walls, Fencing & Gates: There are no boundary walls or gates. A dolerite pitched wall is landscaped and is a satisfactory solution to retaining the cut into the hillside. Some safety measure may be required at the top of the wall. Eg security fencing. Handrails on the south side of the carparking area and the Entry forecourt do not meet regulation standard for height and prevention of fall. (Refer photo 13.4.1).

Photo: 13.4.1 No safety fence at top of embankment.

Replace fencing/handrail on south side of Entry forecourt/parking area.
Check safety requirements at top of dolerite wall.

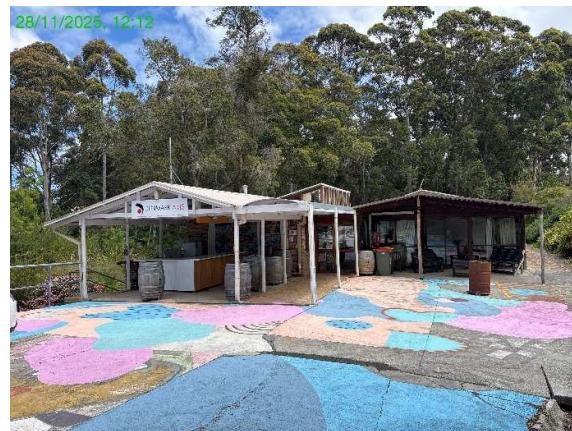
Photo: 13.4.1 Metal balustrade and timber balustrade in Entry area LHS of photo.

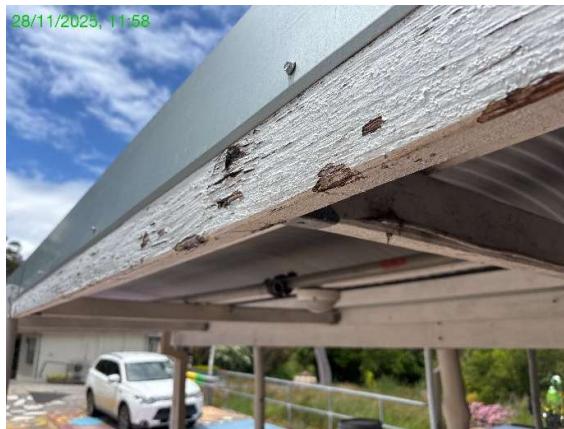
Photo 13.6.1 Timber rot and metal balustrade in the background.

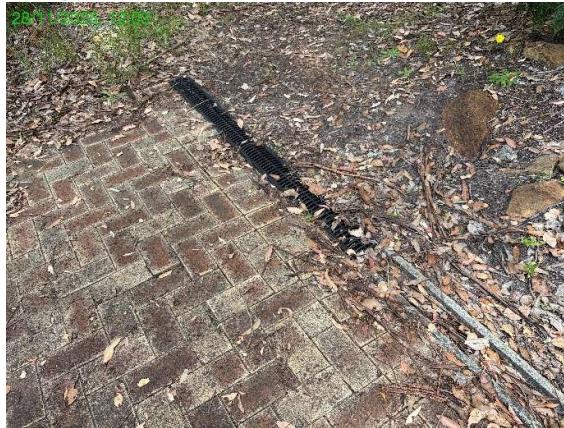
Photo 13.6.1 Grate and spoon drain to be maintained.

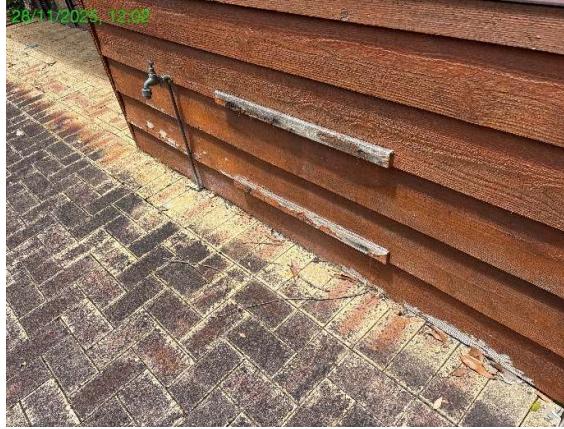
Photo 13.6.1 Discoloured paving.

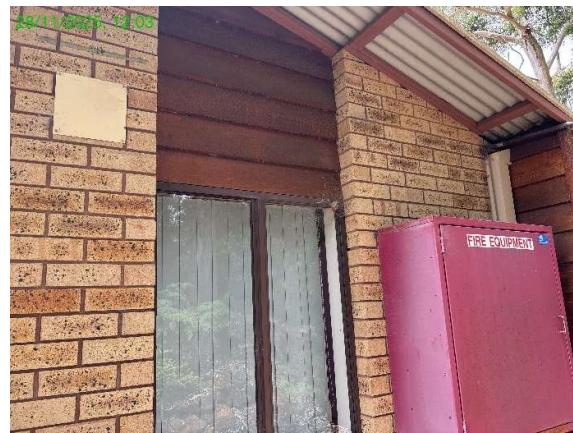
Not inspected. Given the proximity of the Fire Station the response time would be relatively short albeit a Volunteer Station. Internal fire protection is adequate Refer photo 13.7.1 Exit signs and Extinguishers provided. Standard Hose reel cabinet Photo 13.7.1.has faded paint finish.

Photo 13.7.1 External Fire Hose Reel Cabinet (paint required)

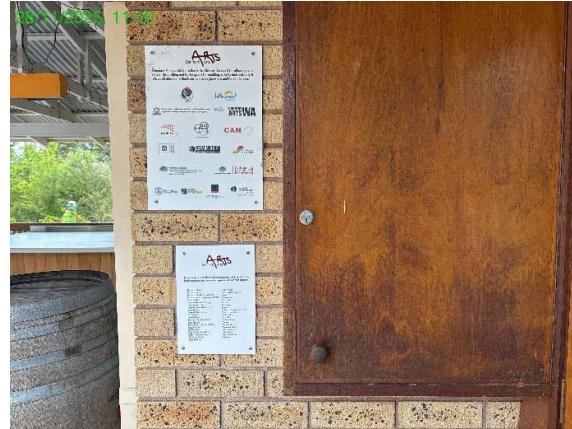
13.11 External Electrical:**No inspected. Meter/Power board locked. Refer Photo****13.11.1.**

**Clean and paint.
Electrician to check.**

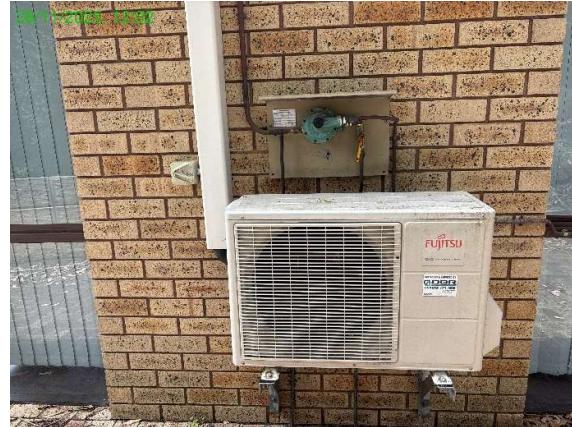
13.12 Air Conditioning:**Provided to most areas. Extent of effectiveness unknown.**

**Photo 13.12.1 West end of building.****Recommendation:**

A maintenance contract for all Air conditioning should be in place, to ensure the system meets health and safety requirements especially in the event of a claim by the public/staff.

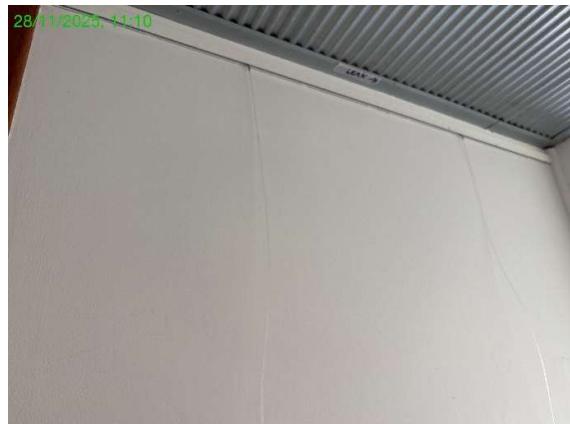
Are satisfactory, however water damage has occurred to walls in the passage. Refer Photo 13.14.1 This damage due to overflowing box gutters and external storm/surface water not being able run off to sumps/ storm water reticulation. Refer above SW recommendations. External weather boards require painting.

Photo 13.14.1 Photo is typical of water dripping down passage walls throughout the length of the passage.

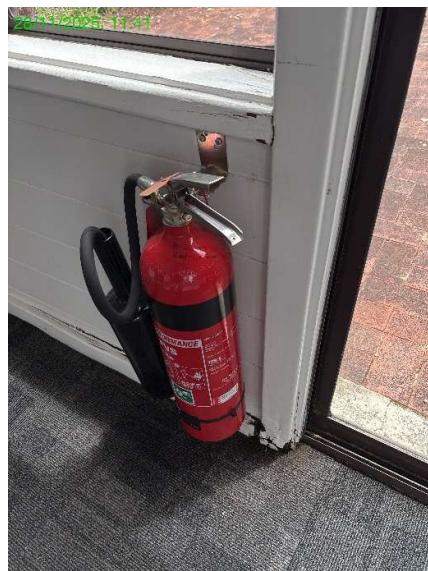
Photo 13.14.1 Skirting and timber door frame has rot. Note internal and external finishes at the same level.

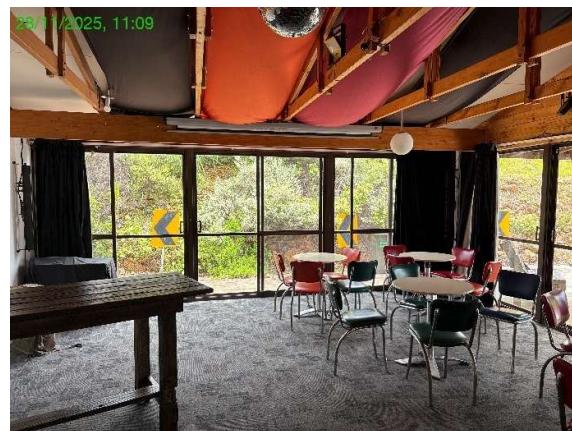
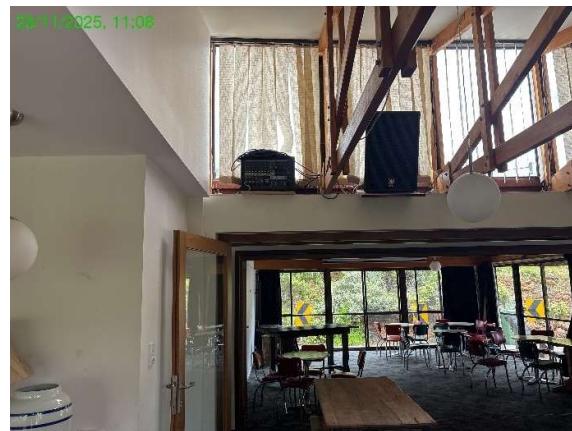
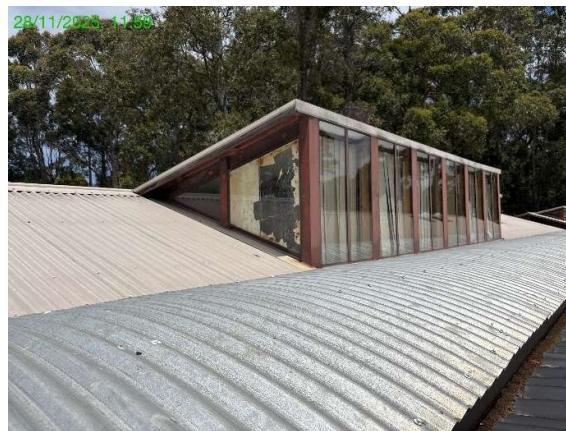
Are at the end of their working life and are a type usually used in domestic construction. The Powder coated finish has deteriorated and the operation of the windows in some places is poor. Cover plate rivets have failed. Flyscreen replacement may be required. Security and thermal design together with a Bush fire Alert Level (BAL) are unlikely to comply with current regulations and may be an unacceptable risk for a public occupied building. We assume the building is classified as a 9b determined by the purpose for which it is designed, constructed, or adapted to be used.

Photo 13.15.1 The same sliding door/window frame configuration has been used to all large opening.

Photo 13.15.1 North light windows were not inspected in detail, but they aluminium domestic type and aged.

Photo 13.15.1 Aluminium domestic type south light windows

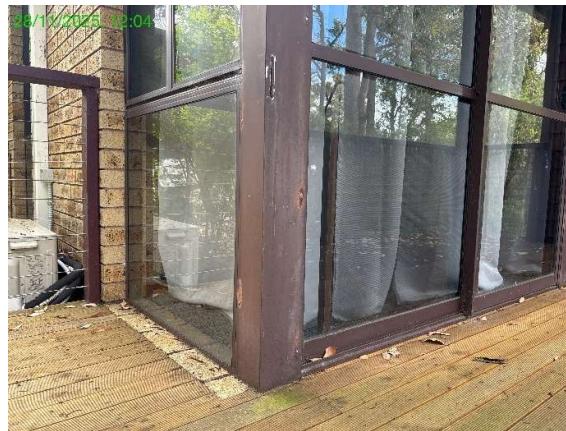
Photo 13.15.1 Aluminium cover rivets have failed on several windows.

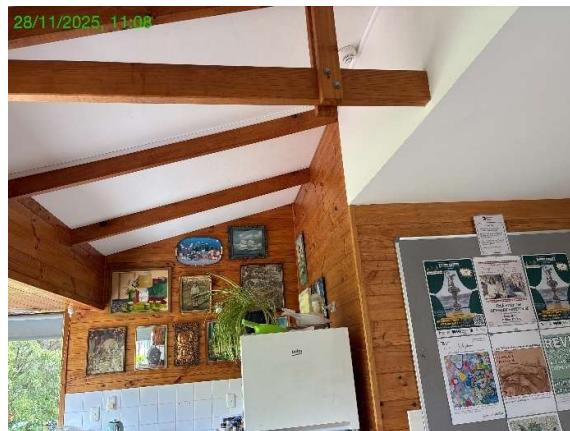
Photo 13.16.1

Cathedral ceiling (refer photo 13.16.1) by their nature are constructed with very narrow voids that under recent regulations do not support the level of insulation now required.

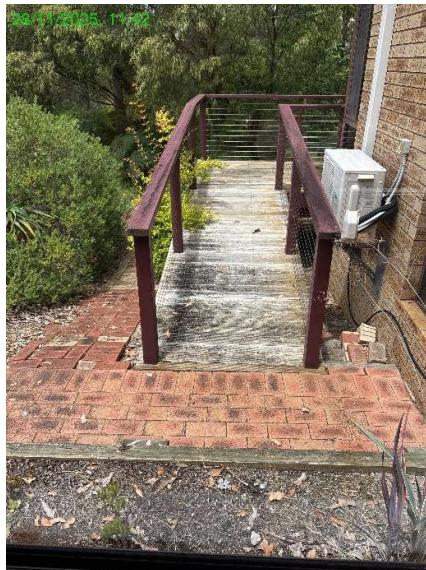
Photo 13.19.1

Steps /Stairs/Ramps/Handrails are located at the rear of the building and may form part of the escape route. The ramp grade, riser and going to steps and location and height of handrails are all well defined in the building code. It is important that compliance is achieved as often it become an issue in the event of an accident that is a result of the Universal Access not meeting the code.

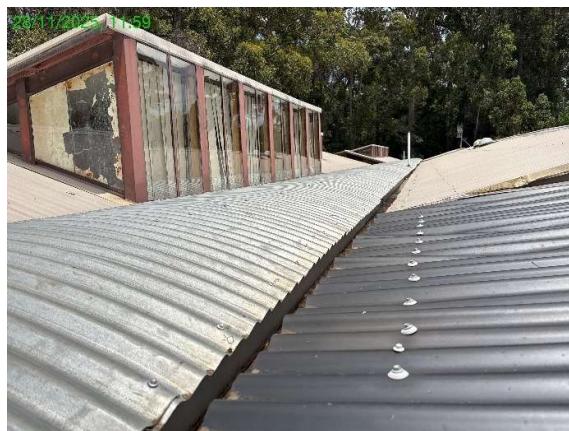
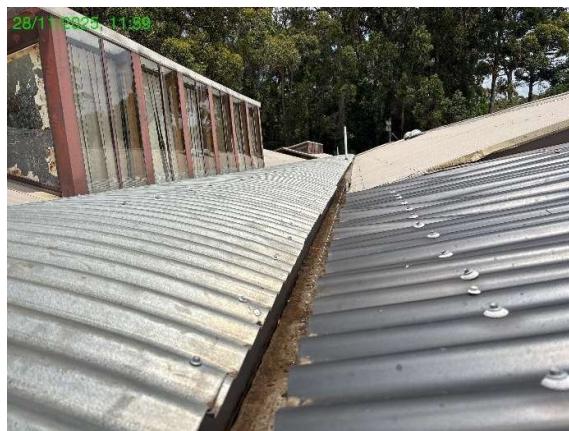
Photo 13.20.1

There are two box gutters either side of the passageway connected by a corrugated barrel roof sheeting. The box gutters extend for the whole length of the building. This does not meet SCIRO's recommendation for box gutter flows and discharge to Downpipes. For example, there is no allowance for expansion and contraction of the metal over its entire length. Refer photo 13.20.1.

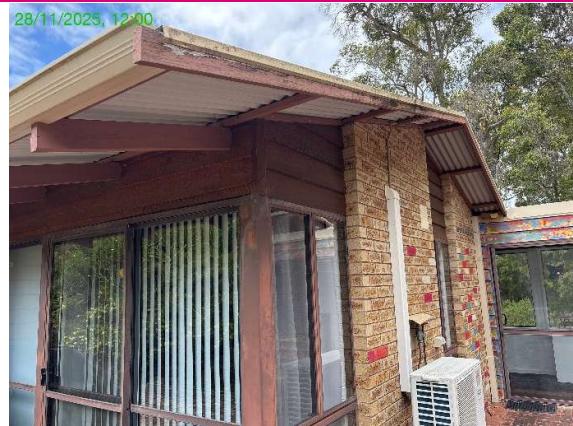
The fascia board and tails of fascia boards to gabled ends and elsewhere require painting. As rot occurs most often to the tail an extended metal flashing that wraps over to protects the tail is recommended.

Photo 13.20.1 Paint fascia board and seal tails.

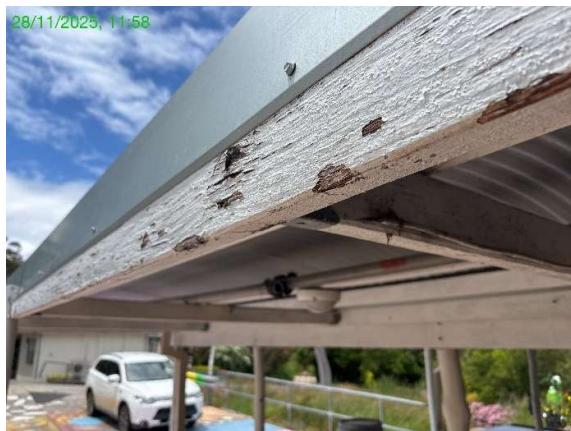
There are posts and beams supporting the front Entry Area Of trusses etc that form an area originally used as a vehicle shelter. The post are connected to the concrete floor with bolts that are rusting, and the post support beams that in turn support trusses. The beam has rot and should be replaced in the short term. Refer Photo 13.21.1

Photo 13.21.1 Entry beam with timber rot.

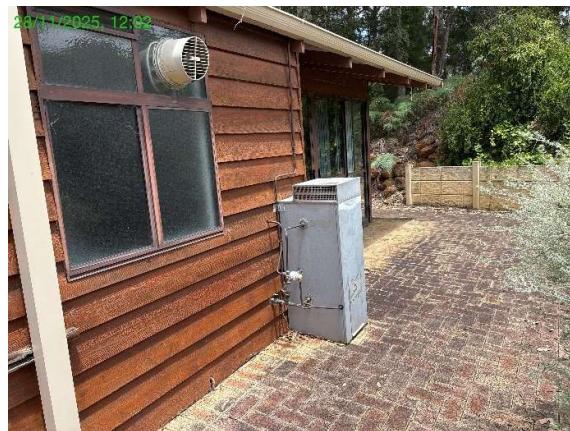
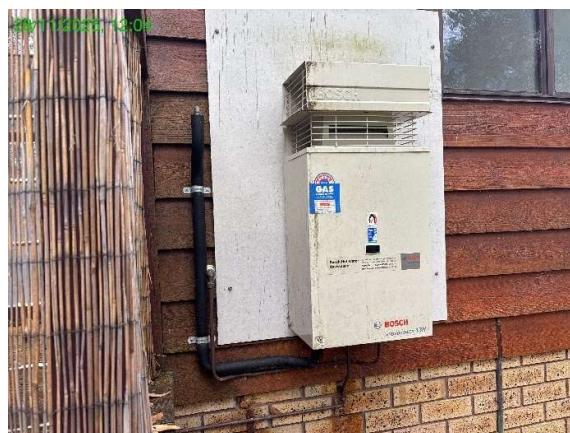
Untested: Plumber/Electrician to check. Refer Photo 13.24.1

We recommend a gas/or electrical licenced trade inspect and advise their condition. Inspection dates to be recorded.
