# PEACEFUL BAY HERITAGE PRECINCT

## CONSERVATION PLAN

PREPARED BY DAVID HEAVER AND ASSOCIATES ARCHITECTS  
FOR THE SHIRE OF DENMARK

DECEMBER 2003

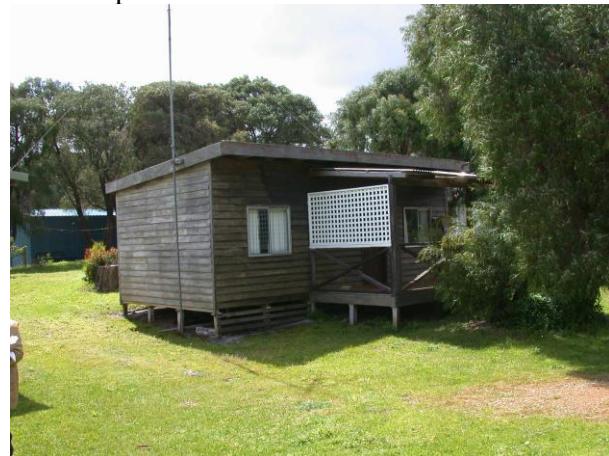
**Photo 8** Timber clad skillion

The lattice work to the verandah addition is not an authentic detail.

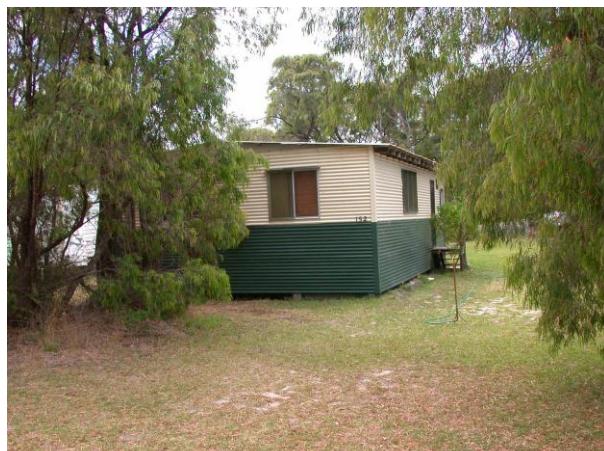
**Photo 19** Authentic cladding has been replaced with colorbonded corrugated steel

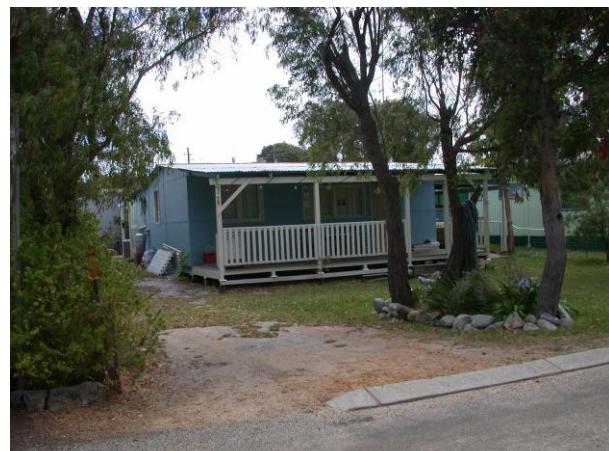
**Photo 20** Balustrading is a decorative element that is not authentic to the precinct

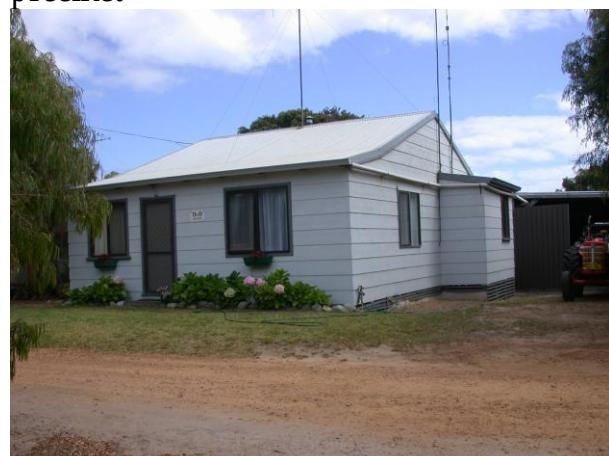
**Photo 22** Wide profile cement sheet boarding is not authentic

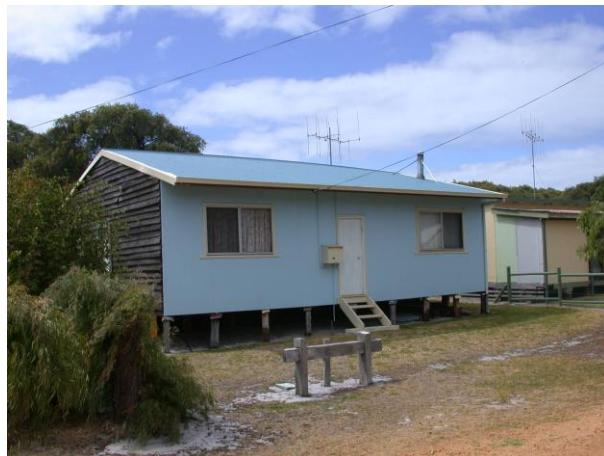
**Photo 23** The timber boarding to the front of this cottage has been replaced with flat cement sheet

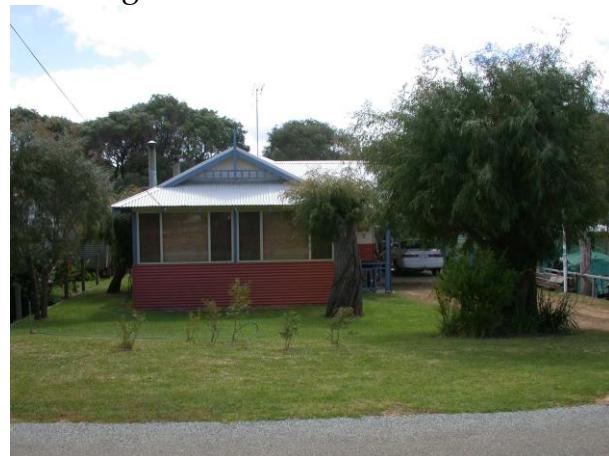
**Photo 24** House has recently been extended and reclad with corrugated customorb

Decorative elements such as that on the gable are not authentic to the place, neither is the hipped carport.

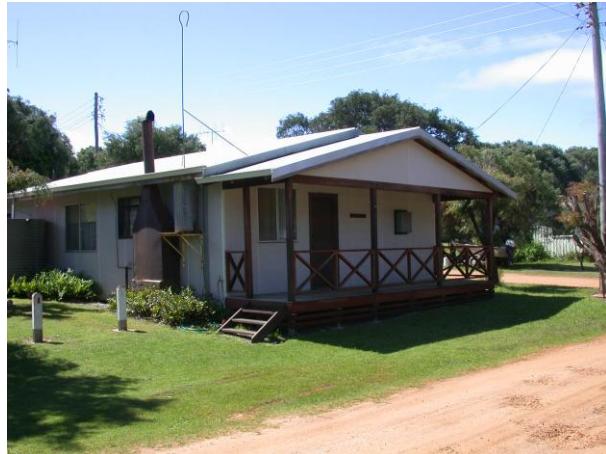
**Photo 28** New verandah  
New verandahs are starting to be added. Decorative elements such as crossed balustrading are not authentic to the precinct.

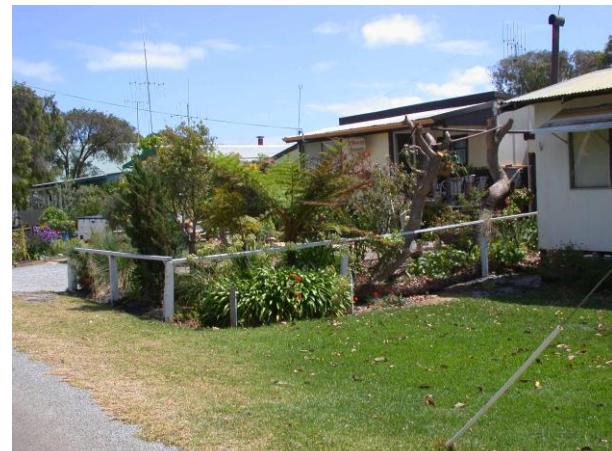
**Photo 42** Exotic Planting

Planting of exotic species is not authentic, but because of the increase in permanent population is becoming more frequent.

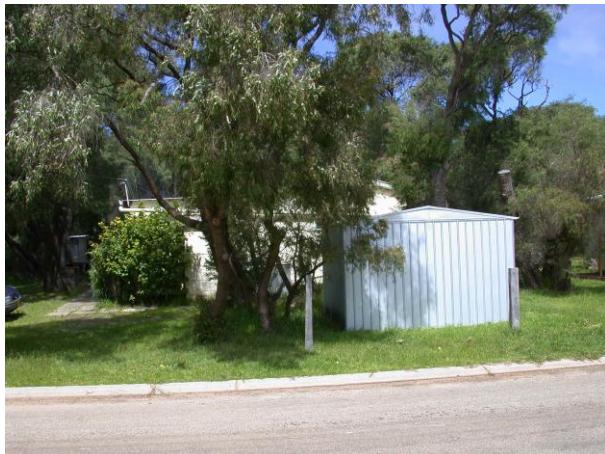
**Photo 43** Steel garage built close to the front boundary is an intrusive element

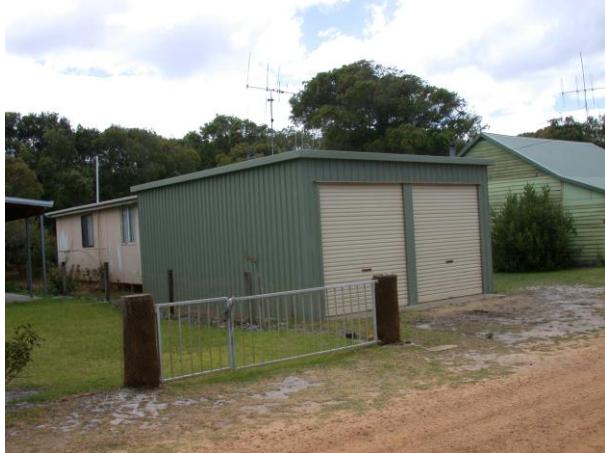
**Photo 45** Large steel shed constructed close to the front boundary

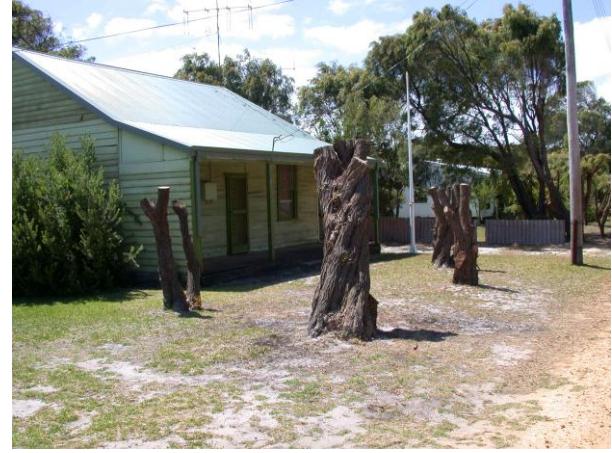
**Photo 46** Peppermints have been lopped to stumps

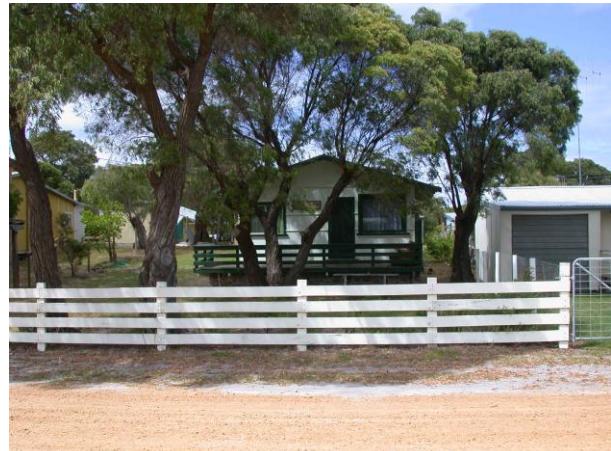
**Photo 48** Wide post and rail fence is visually intrusive

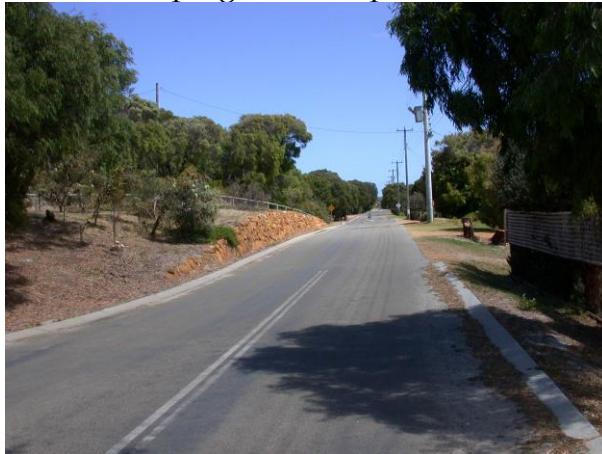
**Photo 61** First Avenue at the entrance to the precinct

Bitumen, kerbing and linework are not in keeping with the precinct.

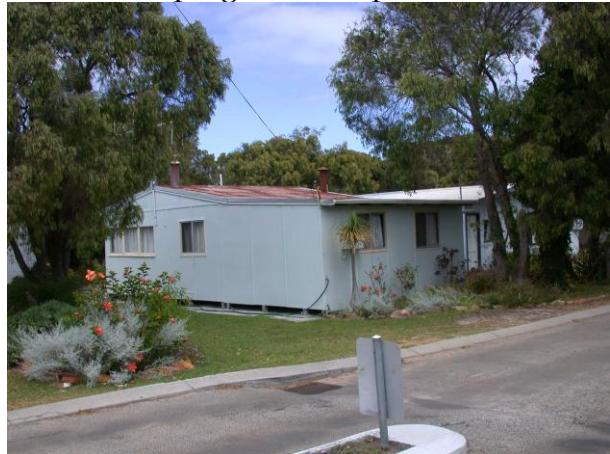
**Photo 62** Traffic Island to First Avenue

This is not considered appropriate to the character of the precinct

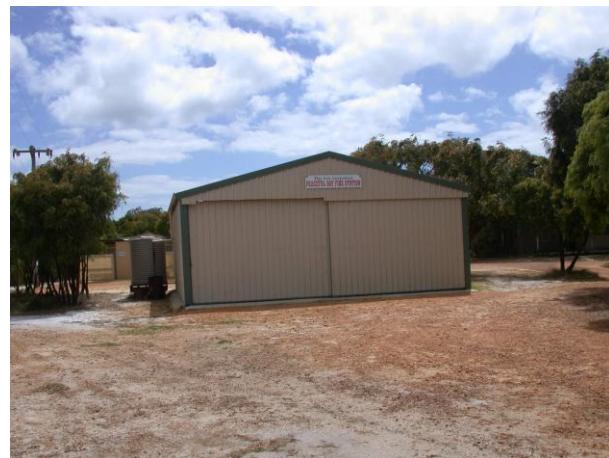
**Photo 66** Fire Brigade building on West Avenue

This is a large steel building standing alone in a large area of gravel
