Wilson Inlet Foreshore Flora Survey- *Revisit to Vegetation Monitoring Sites established in March 2011*

September 2016

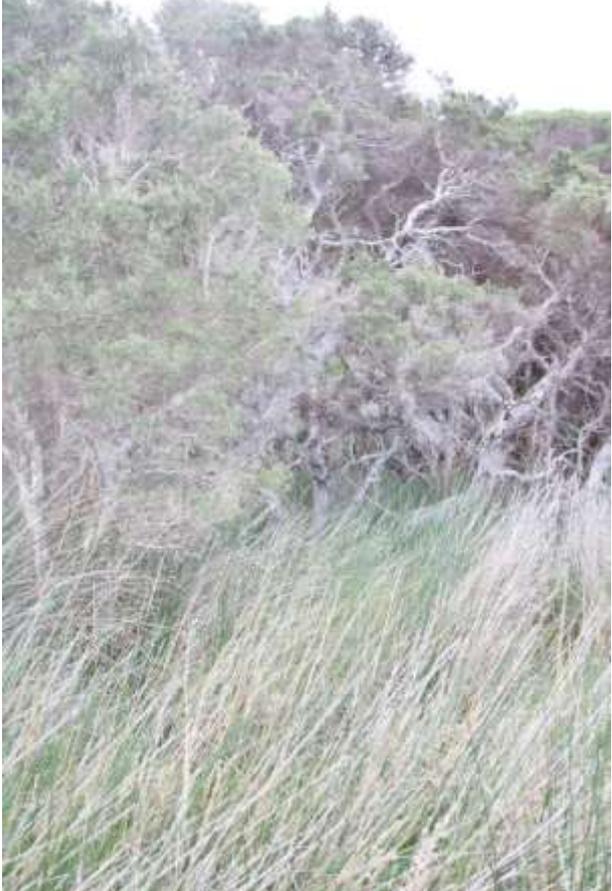
Juncus krausii on the shore are inundated and looking stressed as is the samphire

The *Juncus krausii* beneath the paperparks at the land end are stressed (very brown)

Native plants are stressed but recovering. Weeds are persisting.

Overall vegetation condition has declined.

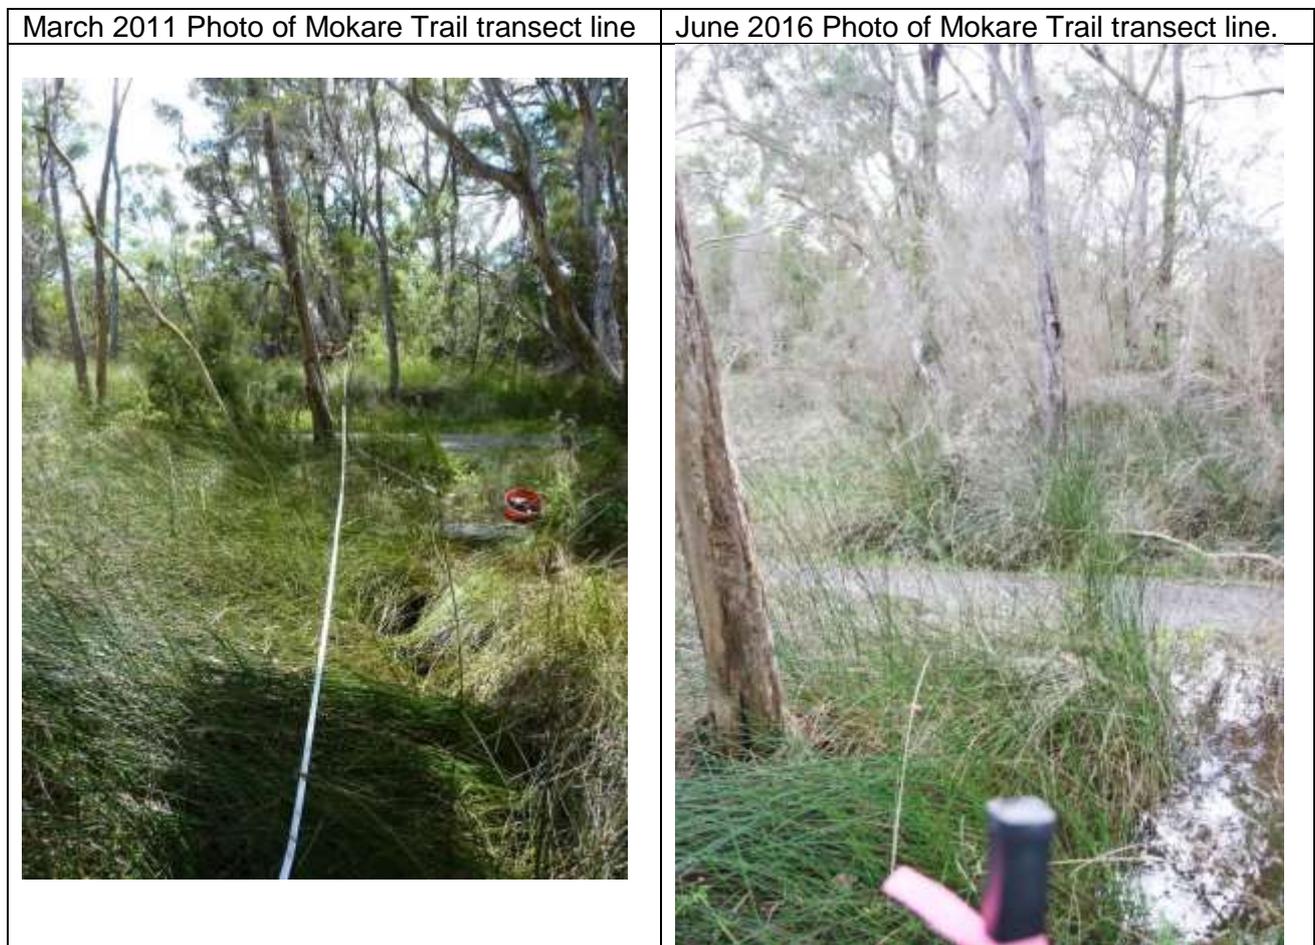
Many dead saplings along the walk trail.

Rushes have declined and are stressed

While many of the tree deaths may have occurred prior to the 2011 survey it is clear from comparing the photo in the 2011 report to the same area at present that the vegetation condition has declined.

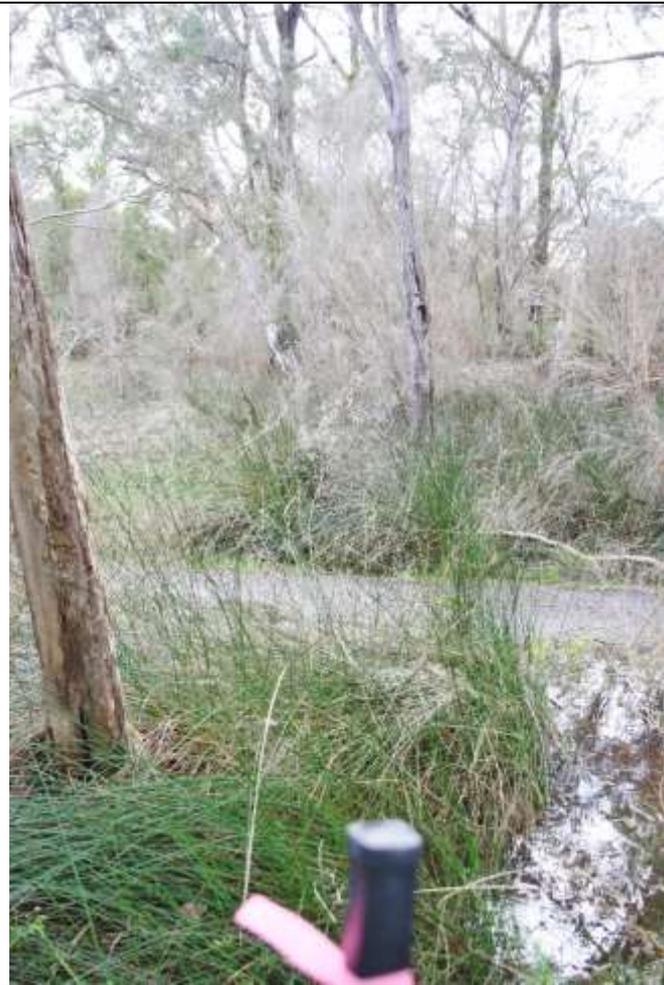
Photo 2 /101.6850
Taken from river peg
looking towards land
peg (compare to
2011 survey report
photo)

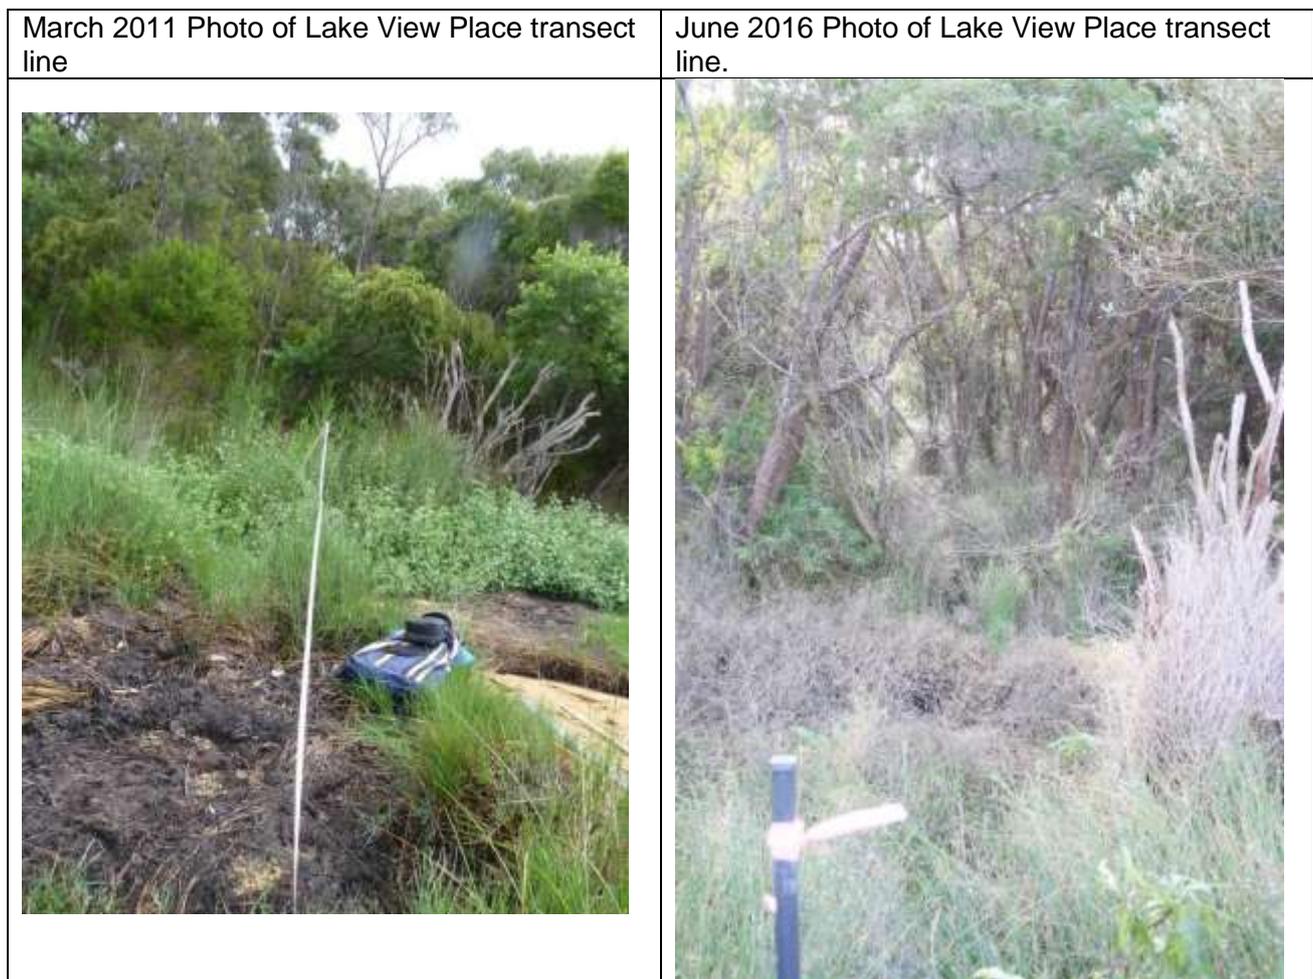
Melaleuca densa varies from only the branch tips being green to some very healthy specimens.

There is a distinct transition line from the very degraded shore to good bushinland.

Vegetation has declined since 2011 in terms of quantity and condition

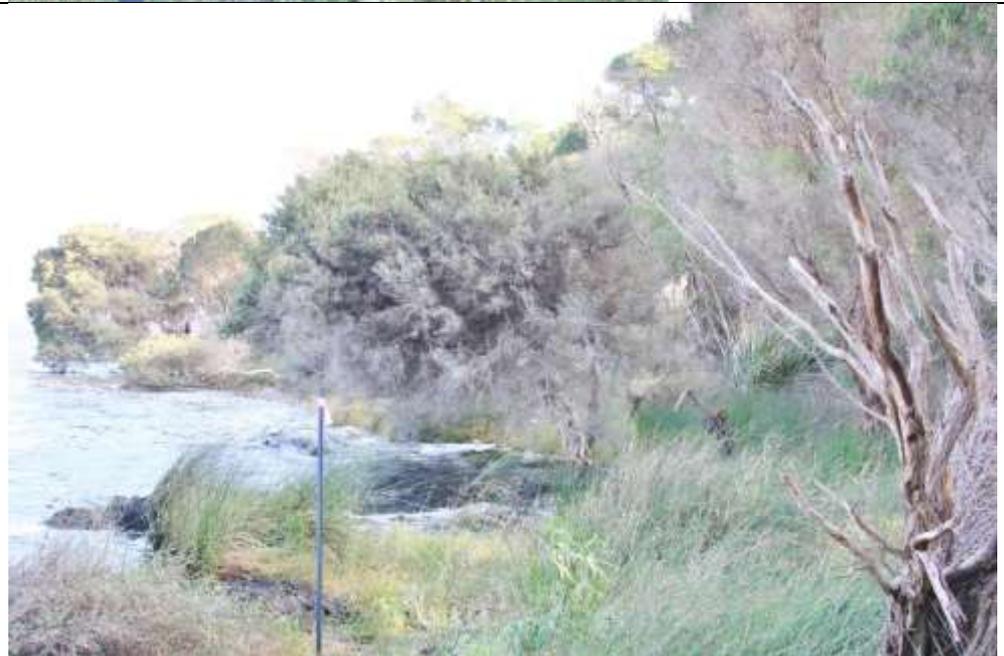
Photo 3/ 101.6848
Taken looking west
to inlet peg and
dead Melaleuca
densa

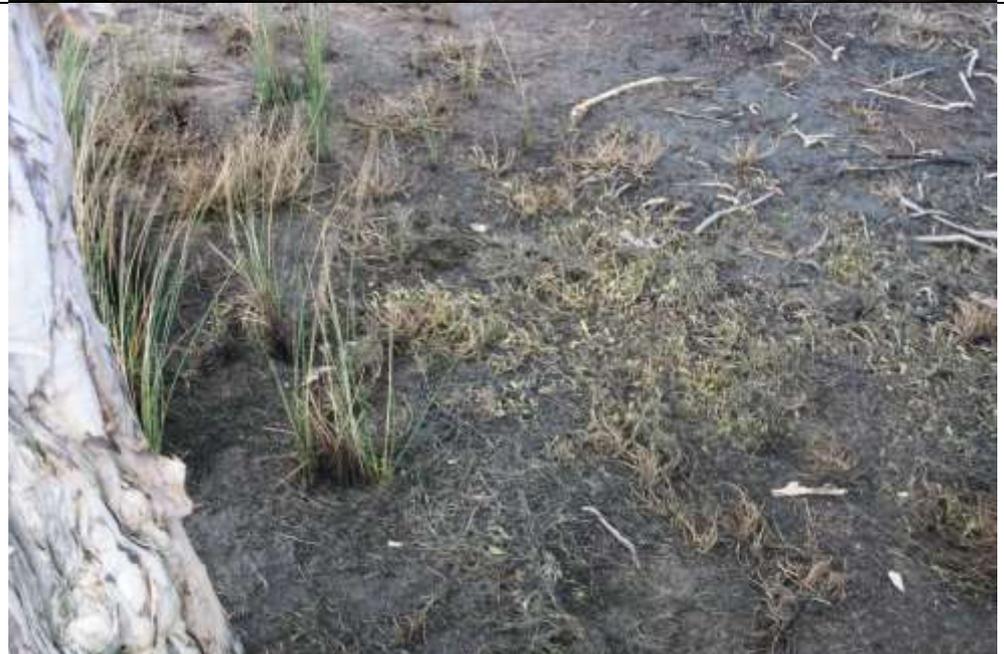
Crusoe Beach
Photo8 / 101.6893
Selliera radicans at
base of Melaleuca
cuticularis on
transect looking
stressed but alive

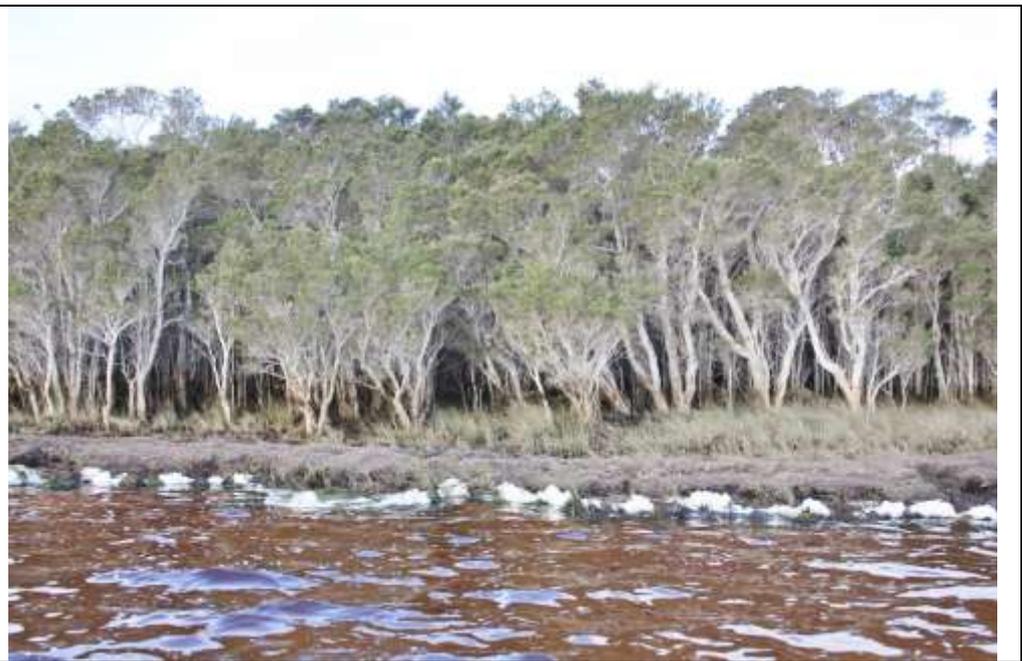
Photo5/ 101.6895

Melaleuca cuticularis look healthy, however photo 101.6895 shows change.

Dramatic decline of *Juncus kraussii*

Taken from inlet at the same location as 2011 report photo. It clearly shows decline of rushes and tree canopy thinning.

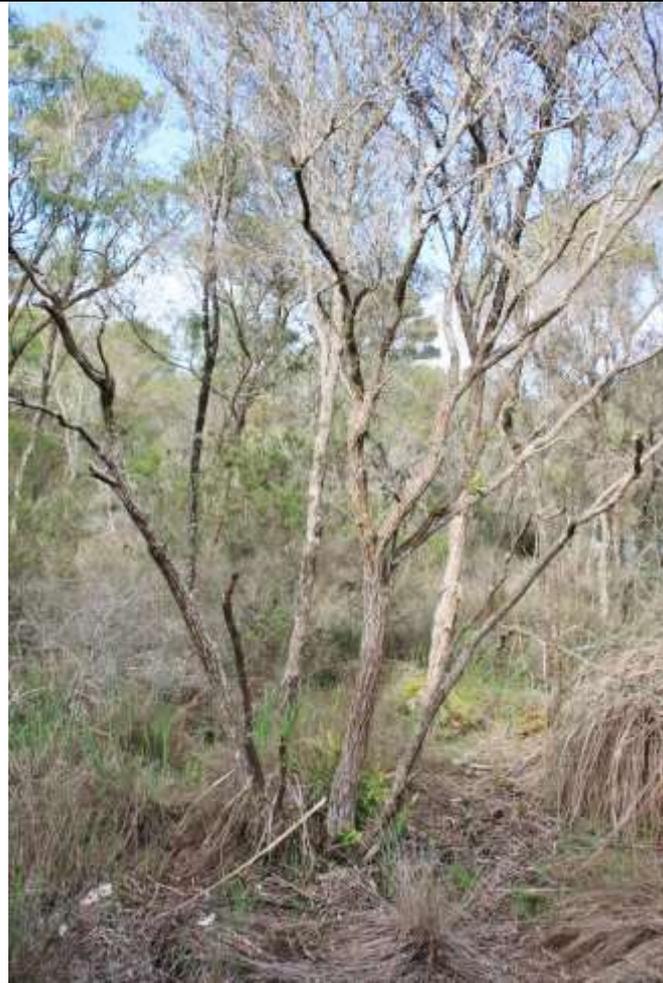
Photo4 / 101.6824
Taken South East of
land peg looking
South from GPS
location
S35.01484
E117.46542
showing recovering
Agonis flexuosa on
high water mark with
Gladiolus undulatus
and *Watsonia*
amongst it

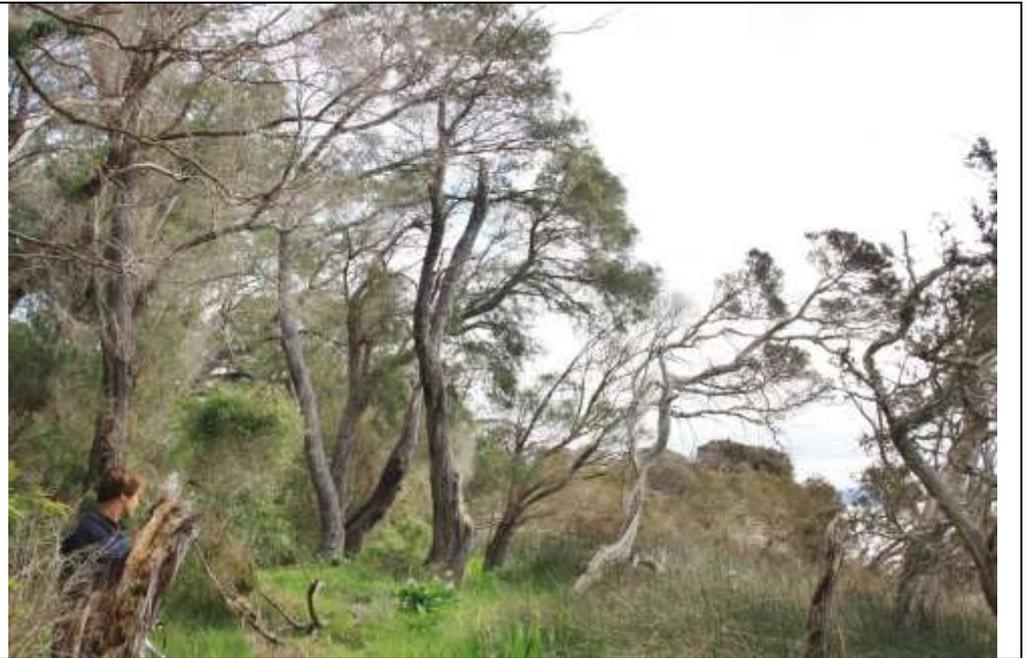
Photo3 / 101.6827
Looking West along
Bibbulman Track
across transect to
show dead
Peppermint on
transect line, live
Peppermints behind
