Ocean Beach and Peaceful Bay Shire of Denmark

Coastal Hazard Risk Management and Adaptation Plan

Seashore Engineering Pty Ltd November 2017

Report SE050-01-RevB

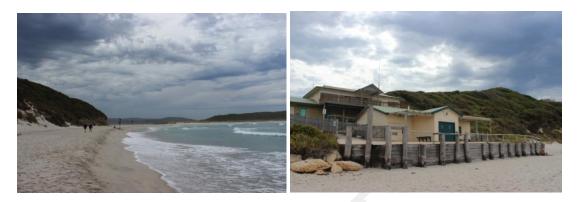
Figure 1.2 Ocean Beach (March 2017)

Ocean Beach is an east facing high-energy sandy beach popular for swimming and surfing and subject to coastal erosion most recently in the late 1990's, 2013 and 2016. Coastal infrastructure and beach access is provided along a 400m section at the southern end of the beach between granite rock outcrops and the entrance to the seasonally open Wilson Inlet. This is the main recreational ocean beach for Denmark and is used for commercial and club based activities.

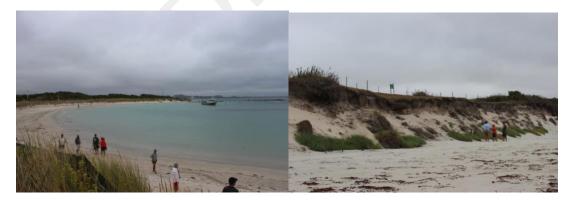
Figure 1.3 Peaceful Bay (March 2016)

Peaceful Bay is a smaller settlement further west. It has a lower energy sandy beach, with a small sheltered pocket beach providing a relatively calm swimming beach and beach launching for recreational vessels, and a longer eroding sandy beach to the north. The coastline north of the Peaceful Bay jetty has eroded approximately 15 m between 2002 and 2014, resulting in the retreat of sheds from a Fisherman's lease area. The Shire is concerned about future threats to Peaceful Bay Road, the only means of access to the townsite, if the current rate of coastal erosion continues.

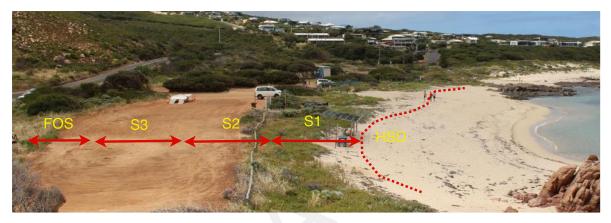
Figure 2.1 Representing Allowance for Erosion on Sandy Coast (incl HSD) S1 + S2 + S3 + FOS

Note: HSD – Horizontal Setback Datum, S1 – Allowance for Current Risk of Storm Erosion, S2 – Allowance for Historic Shoreline Movement Trends, S3 – Allowance for Erosion Caused by Future Sea Level Rise, FoS – Factor of Safety (Allowance for Uncertainty)

The assumption underlying the mapping for the 10, 50 & 100 year are provided in Attachment B. The method and assumed coastal processes allowances for sandy coasts (S1 + S2 + S3) for the 10, 50 and 100 year planning periods for the project sites are shown in Figure 2.1 and detailed below.

For sandy coastlines, SPP2.6 specifies allowance for erosion on sandy coastlines as outlined in Figure 2.1. For rocky coastlines, SPP2.6 recommends a geotechnical stability assessment be completed for assessing erosion risk, which is not within the scope of the current report, however, allowances have been made for slumping of vertical erosion scarps.

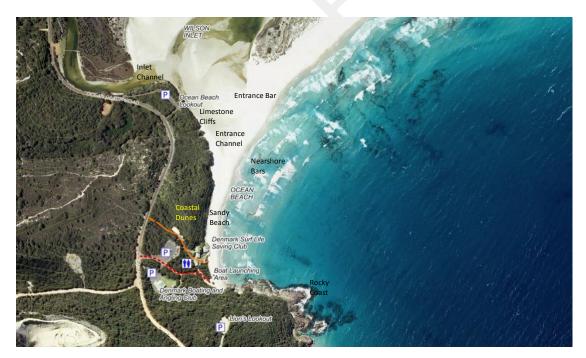
Figure 2.2 Ocean Beach Coastal Landforms

- Sandy beach with a relatively wide flat berm of moderate grade, medium to fine white marine sand with median diameter of 0.35mm (see Figure 2.4) and orientated to the east but exposed to high-energy wave conditions.
- Rocky coast to the south (Wilson Head) that provides a local control and influences the wider platform of the sandy beach.
- Coastal dunes including incipient foredunes subject to cycles of erosion and recovery, and larger primary dunes up to 30m in height. This is the coastal landform south of the inlet entrance where the majority of the coastal infrastructure at Ocean Beach is located.
- Limestone cliffs that control and define the western margin of the entrance channel to Wilson Inlet.
- The entrance bar, channel and associated features of Wilson Inlet. This is a large seasonally open south coast inlet. The Shire open the inlet seasonally to control inland flooding.

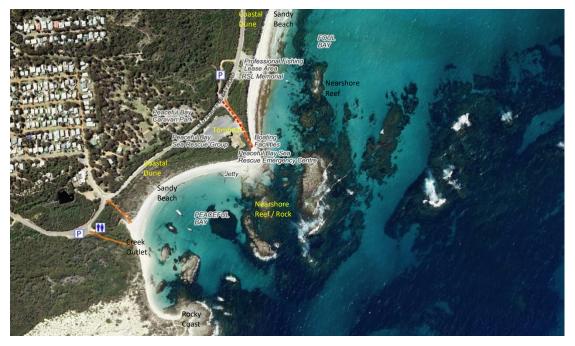
Figure 2.3 Peaceful Bay Coastal Landforms

- Sandy beach of Peaceful Bay, with a crescent shaped planform. Sand at Peaceful Bay and Foul Bay is predominantly fine white marine sand with a median grain diameter of 0.2mm (see Figure 2.4).
- Rocky coastline to the south, which provides a local control.
- Coastal dunes including:
 - Incipient foredunes along Peaceful Bay subject to cycles of erosion and recovery, and primary dunes up to 5m in height.
 - Eroding primary dune along Foul Bay. The height of the dunes is ~6m AHD, which is 4m above the level of the beach.
- Nearshore rock and reef and an associated large salient or tombolo¹ in the vicinity of the boating facilities, which separates Peaceful and Foul Bays.
- Nearshore reefs which provide sheltering and localised wave refraction, including the shoreline planform locally.

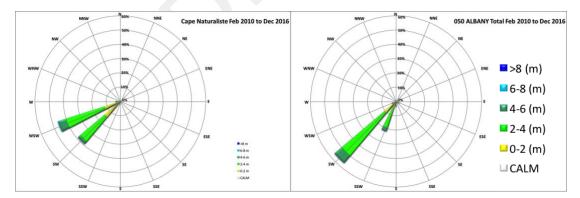
Figure 2.6 Comparison of Wave Roses for Cape Naturaliste (left) and Albany (right) -Annual Wave Climate.

Offshore wave conditions are recorded at Albany in 60m water depths (Figure 2.5). Nondirectional records are available since June 2005 with directional data available since September 2008. Comparison with the Cape Naturalise wave buoy from the west coast (Figure 2.6) shows a mean wave direction from the southwest, with swells also observed from the south-southwest. This is different to the west coast where the west-southwest swell direction dominates. The Albany data is considered to be representative of offshore wave conditions along the Shire of Denmark coast.

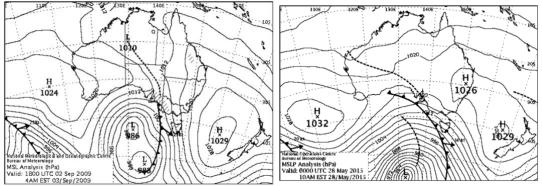
Figure 2.7 Synoptic Charts for Highest Wave Events 2nd September 2009 (left) and 28th May 2015 (right)

These events were produced by the storm systems, as represented in Figure 2.7. It is noted that larger wave events along the south coast, generated by low pressure systems tracking a long way offshore, may not necessarily coincide with locally high water levels (storm surges). Beaches may be more vulnerable to less intense low pressure systems that track closer to the coast and result in coincident high water levels and waves.

These two events were then used to assess the influence of offshore wave height for modelling during the risk identification phase, with adjusted water levels. Notably, high water levels were not observed to be coincident with the wave events mentioned above, which were 1m AHD in 2009 and 0.68m AHD in 2015.

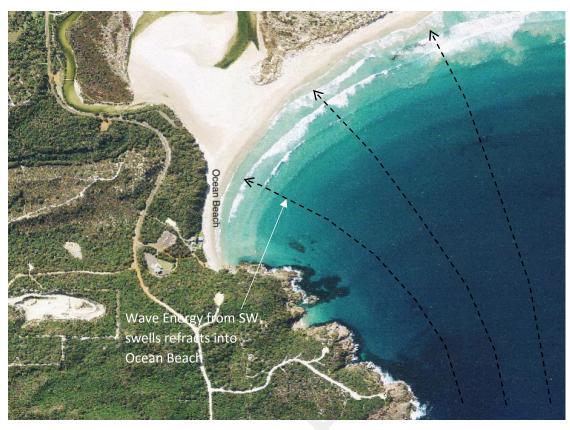
Figure 2.9 Refraction of Waves into Ocean Beach (September 2010)

Ocean Beach is an east facing beach at the western end of an exposed high wave energy beach. Some sheltering is afforded Ocean Beach through dissipation of wave energy from SW and SSW swell energy as it refracts around Wilson Head, which was illustrated by modelling undertaken for the Ocean Beach Alternate Boat Launching Facility Study [7]. However, the beach is exposed to sea waves produced by local winds from the E to S. Figure 2.9 Illustrates the refraction of waves into Ocean Beach.

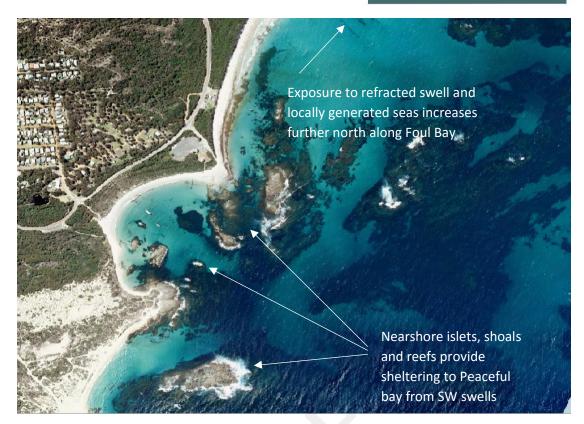
Figure 2.10 Illustration of Sheltering at Peaceful Bay

Peaceful Bay is protected from the largest of swell waves by a series of nearshore shoals and reefs, which break up the wave energy before it can make landfall. The southern part of Foul Bay is also largely protected by nearshore islets, shoals and reefs. However, further north along the beach is more exposed to refracted swell energy and locally generated seas from the east. Figure 2.10 highlights the nearshore features at Peaceful Bay that provide sheltering from large SW swells and the relative increase in exposure to locally generated easterly seas further north along Foul Bay.

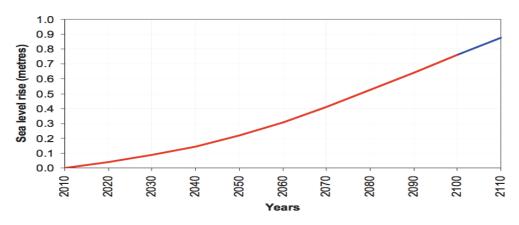
Figure 2.11 Recommended Allowance for Sea Level Rise in Coastal Planning for WA

Coastal adaptation planning requires consideration of the potential impact of Sea Level Rise (SLR) on the coast. Figure 2.11 shows the recommended allowance when planning for Sea Level Rise in Western Australia based on the report on Sea Level Change in Western Australia - Application to Planning. SPP2.6 Schedule 1 [8]. Section 2.3.3 and 2.4.3 provides a horizontal allowance for Sea Level Rise (SLR) as a component of the coastal setbacks for Ocean Beach and Peaceful Bay respectively.

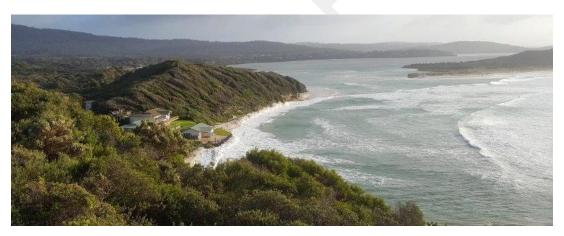
Figure 2.12 Ocean Beach During Storm (Sep 2016) – Supplied by Shire of Denmark.

The focus of the coastal hazard assessment at Ocean Beach is on the 400m stretch of coastline between the granite rock outcrops and the entrance to the seasonally open Wilson Inlet where the majority of the coastal assets are located. As outlined in Section 2.2.1.2 this section of Ocean Beach is east facing and is exposed to locally generated easterly seas and refracted swell energy, which is predominantly from the SW and SSW. This makes this stretch of beach vulnerable to periodic erosion events associated with large storms, as was the case in the late 1990's, 2013 and 2016.

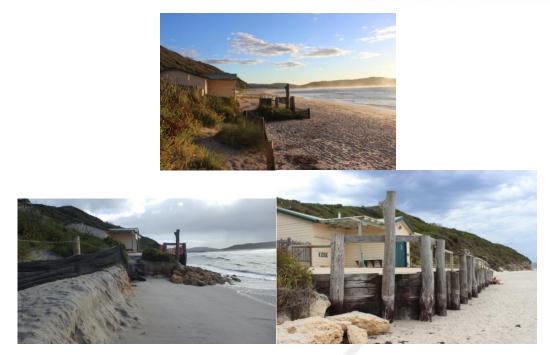
Figure 2.13 Erosion Event at Ocean Beach Timber Retaining Wall Pre (SE top June 2016) During (SoD left August 2016) and Recovered (SE right March 2017)

The Shire provided site photos from a storm erosion event in August 2016 that damaged beach access ramps and stairs. Meteorological records indicate the storm was associated with a low-pressure system passing directly over the site. Storm erosion of beaches often occurs during elevated water levels (high tide coincident with storm surge). Water level records from Albany identified a moderate storm surge that may have coincided with high tide as it passed over Denmark. Wave heights and directions were not recorded in this event. Based on site photos, near vertical erosion scarps larger than 2 meters in height were observed (Figure 2.13). This provided some local context to the modelling of the current risk of storm erosion, although survey was not available to verify the model for this event.

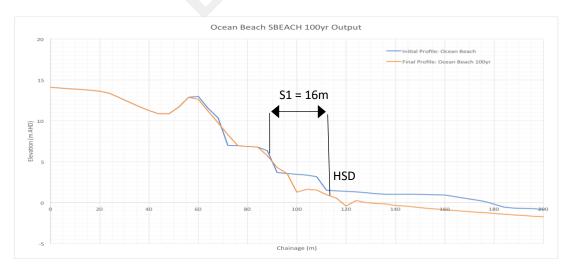
Figure 2.14 Ocean Beach SBEACH Erosion Modelling for 100yrARI erosion event (modelling assumes retaining wall not present)

SPP2.6 [2] requires the S1 Allowance for Current Risk of Storm Erosion to be based on consideration of a 100yr ARI storm event in the region. Available wave and water level data from Albany, the best available regional data, was analysed to develop a data set suitable for modelling storm erosion using the SBEACH software package. The highest recorded water level since monitoring began in 1986 was 1.02m AHD in a storm in 2007. Time series wave and water level data is available for this storm. The time series data from the 2007 storm was modified to provide appropriate input to model the 100yr ARI storm at Ocean Beach. Three runs of the storm event were used to assess the erosion associated with a nominal '100-year' erosion event, and one run for nominal '10 year' event.

A key consideration in the assessment of coastal hazards at Ocean Beach is the slope stability of high vertical erosion scarps at the relatively steep (1:4) and elevated site. An allowance has been made in the modelling for near vertical erosion scarps to slump to a 30 degrees angle of repose. This requires further consideration in the assessment of adaptation options for assets at this site.

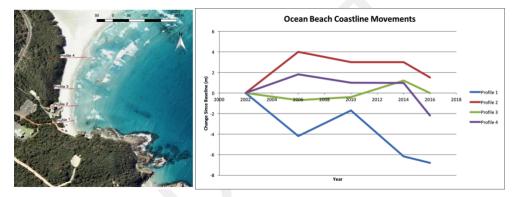
Figure 2.15 Ocean Beach – Historic Shoreline Movement Trends

The historic shoreline movement trends have been assessed based on aerial imagery provided by the Shire from 2002, 2006, 2010, 2014 & 2016. The following was noted based on the assessment of 4 profiles:

- The vegetation line has eroded about 7 meters in the profile south of the surf club since 2002. The nature of this erosion appears to be episodic, and there is capacity for the dunes to recover between events, however historically this represents a net erosion trend in the order of 0.5m/year.
- Net erosion has not occurred at the surf club due to the timber retaining wall.
- The beach to the north near the inlet entrance has been relatively stable due to rock controls along the back of the beach limiting the landward extent of erosion.

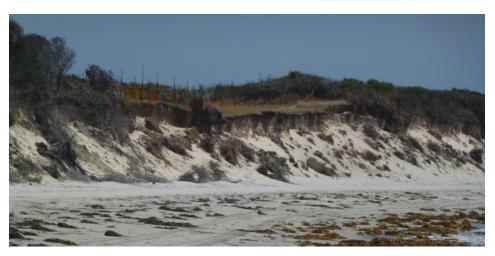
Figure 2.16 Peaceful Bay (Foul Bay) – Erosion Near Fisherman's Lease Area (SoD)

Peaceful Bay is a small coastal settlement in the west of the Shire. A small sheltered pocket beach provides a relatively calm swimming beach and beach launching for recreational vessels, and there is a longer eroding sandy beach to the north. There appears to be significant gaps between erosion events as incipient vegetation is evident at the toe of the dune in many site photos.

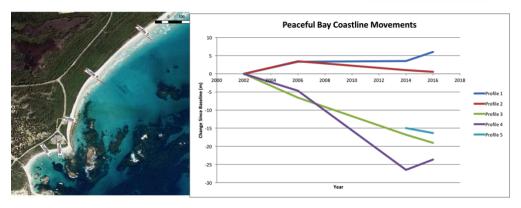
Figure 2.17 Peaceful Bay – Historic Shoreline Movement Trends

The historic shoreline movement trends have been assessed based on aerial imagery provided by the Shire from 2002, 2006, 2014 & 2016. The following was noted based on the assessment of 5 profiles:

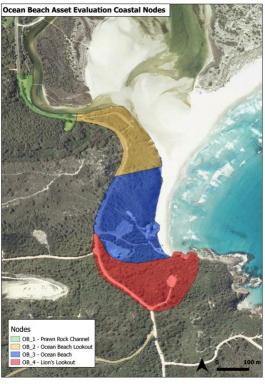
Figure 3.1 Ocean Beach Coastal Nodes

Four coastal nodes were identified at Ocean Beach based on coastal type and the location of public infrastructure. These coastal nodes are Prawn Rock in the north, Ocean Beach Lookout, Ocean Beach and Lion's Lookout In the south. The delineation of the coastal nodes is shown in Figure 3.1.

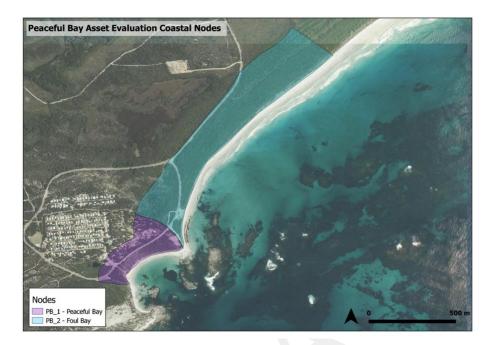
Figure 3.2 Peaceful Bay Coastal Nodes (Note: northern extent of PB_2 is the reserve boundary, not limit of coastal exposure)

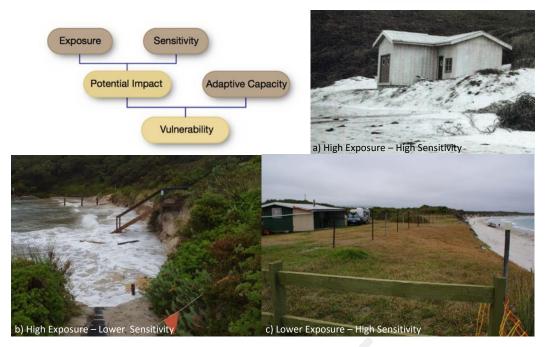
Figure 4.2 Potential Impact based on Exposure and Sensitivity for Old Boat Shed at Ocean Beach (a), Beach Access Stair (b) and Leasehold Buildings at Foul Bay (c)

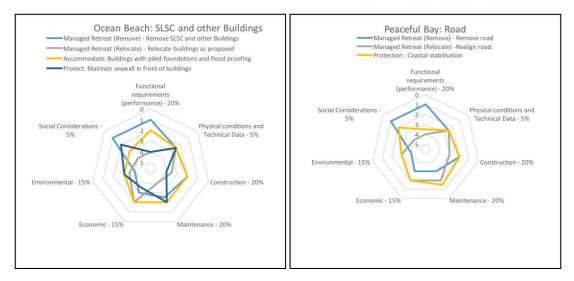
Figure 5.2 Multi-Criteria Analysis for Ocean Beach SLSC and Buildings (left) and Peaceful Bay Road (right)

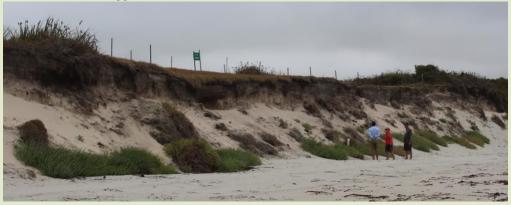
Example: The Fisherman's Lease site in Peaceful Bay is within the area with high exposure to coastal processes. Aerial photographs have identified that the dunes adjacent to the sites are eroding at about 1.4m/yr. Beach profile monitoring would better define the rate of erosion, improve understanding of potential causes (i.e. realignment of wider beach planform, limited sediment for post storm recovery) and would highlight the timeframes for implementation of coastal adaptation options (i.e. when a management action would be triggered).

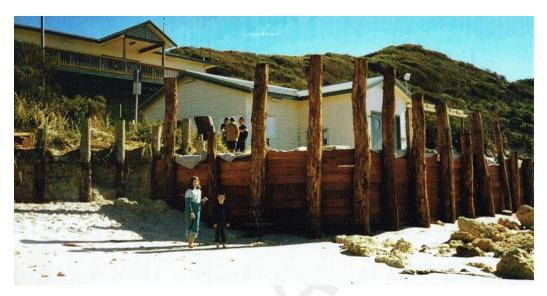
Figure 5.3 Timber Retaining Wall in front of the Ocean Beach SLSC Buildings (date unknown, courtesy of the Denmark SLSC)

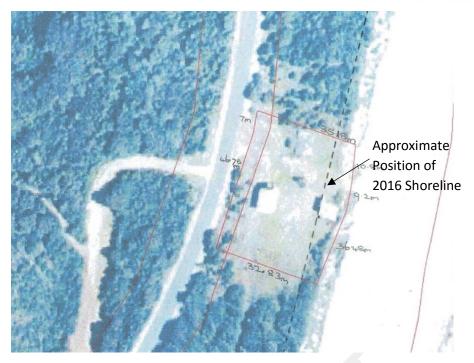
Figure 5.4 Schematic of Fisherman's Lease Boundary with Approximate Position of Shoreline in 2016

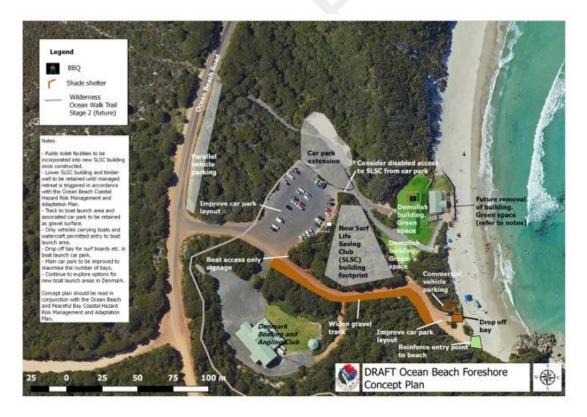
Figure 5.5 Ocean Beach 10 year Foreshore Concept Plan

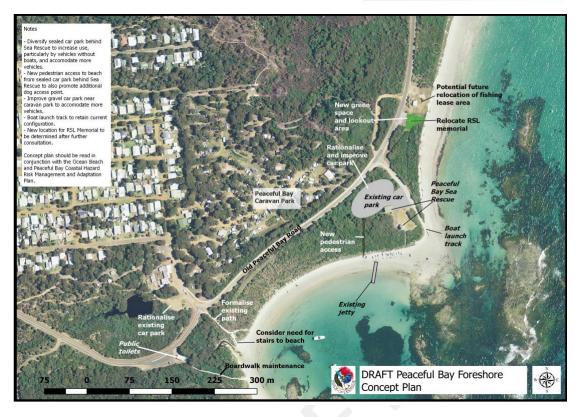
Figure 5.6 Peaceful Bay 10 year Foreshore Concept Plan

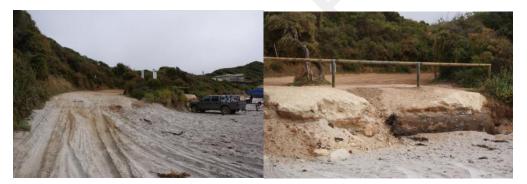
Figure 5.7 Vehicle Access and Adjacent Turn Around Area at Ocean Beach

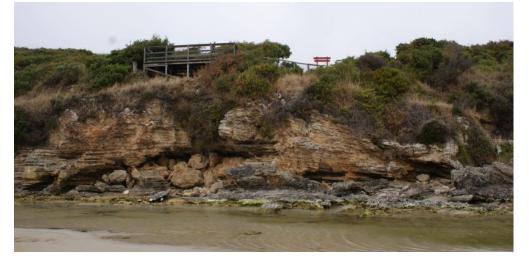
Figure 5.8 Weakly Lithified Sedimentary Rock Coast adjacent to Ocean Beach Lookout

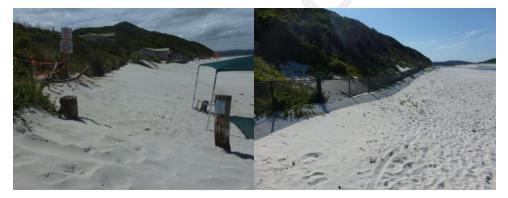
Figure 5.9 Coastal Adaptation Responses including Sand Nourishment and Dune Rehabilitation

There are also a range of short-term adaptation options that can be considered by the Shire. These include beach nourishment as has occurred previously at Ocean Beach to reinstate foredunes at the back of the beach. Management of pedestrian access of coastal dunes also ensures existing dune buffers are maintained or enhanced prior to coastal storms.

- Improvements to gravel car park layout and provision of drop-off and commercial parking – the extent of the parking and drop-off zones will need to carefully consider their proximity to the coast and potential to relocate in the future in line with coastline recession. Reinstatement of the foredune buffer between the vehicle beach access point and the surf club would be preferable, provided turning circles and amenity can be maintained. For example, we understand the dune in this area has previously been reinstated by sand nourishment (refer Figure 5.9).

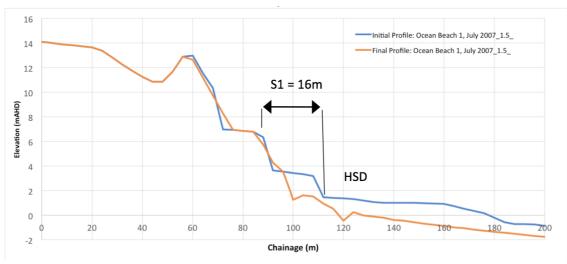
Figure 3: SBEACH erosion model for 100-year average return interval storm. Note: HSD = Horizontal Setback Datum

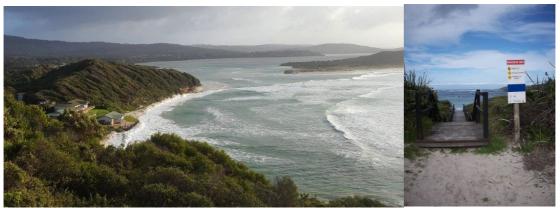
Figure 4: Ocean Beach during a storm in September 2016 and Peaceful Bay Beach Access Stairs

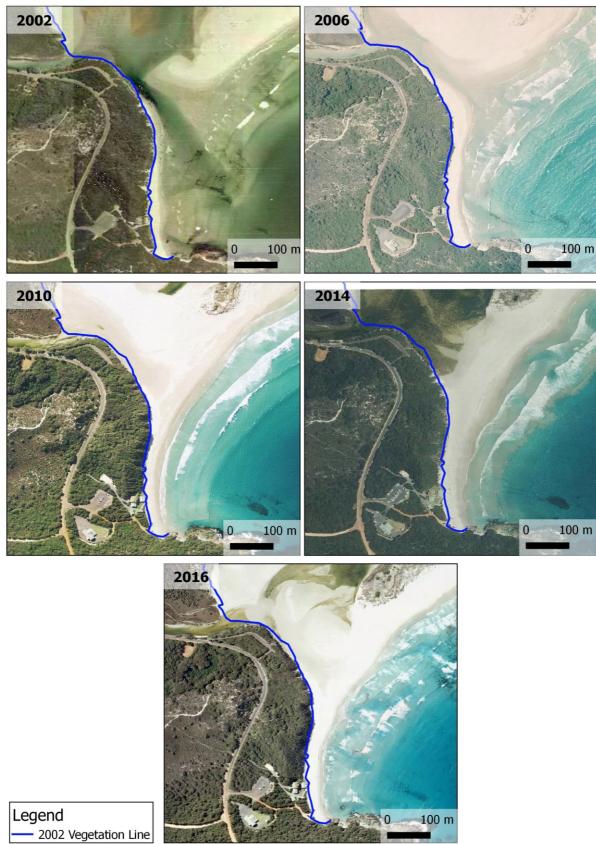
Figure 5: Historic Aerial Imagery for Ocean Beach

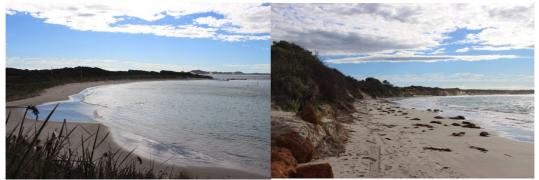
The coastline north of the Peaceful Bay boat launching area, in Foul Bay, has eroded approximately 15 m between 2002 and 2014, resulting in the retreat of sheds from a Fishermen's lease area. If the current rate of erosion continues, the Shire is concerned about future threats to Peaceful Bay Road, which is an access route for the townsite.

Figure 6: Sandy Beaches at Peaceful Bay (L) and Foul Bay to the North of the Boat Launching Area (R) During Reconnaissance Site Inspection (June 2016)

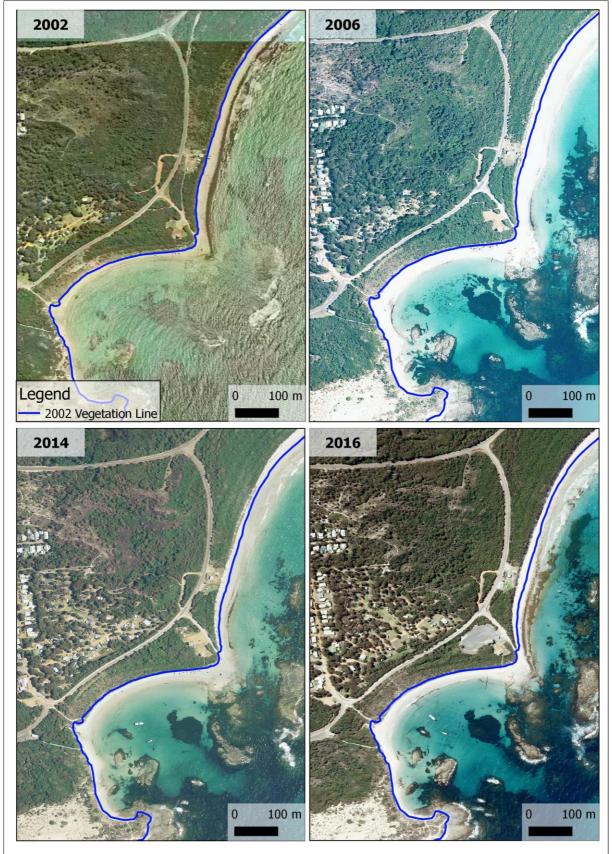
Figure 8 Peaceful Bay Aerial Imagery
