**Lot 150
South Coast Highway
Nornalup WA**

Land Capability & Environmental Assessment Report

30/09/2015

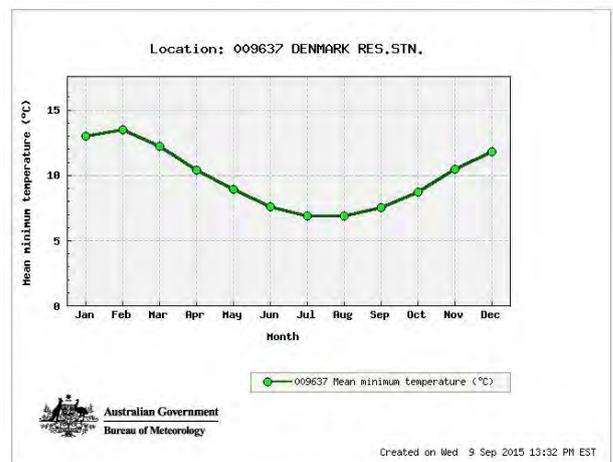
Figure 4 –Mean Minimum Temperatures Denmark Station (BOM, 2015)

Winter daily maximum temperatures average approximately 16.1°C, while the average minimum is approximately 6.9°C in July and August. Daily minimum temperatures below 5°C can be expected about once or twice a month in winter, but Denmark daily temperature records between 1907 and 1965 show no occasion where the temperature fell to zero. Please refer to Figure 3 and Figure 4 below illustrating Average Temperatures Denmark (BOM 2015).

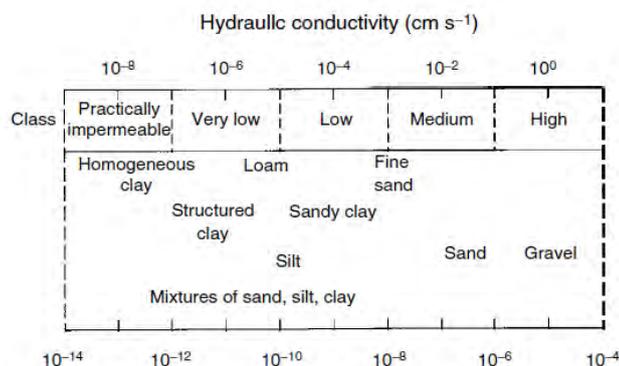
Figure 7 – Generalised Permeability (Hydraulic Conductivity of Soil Types)

and loam in the samples also accounts for the low permeability. Loamy soils are generally of very low permeability and clay soils are generally of an impermeable nature (Figure 7 and 8).

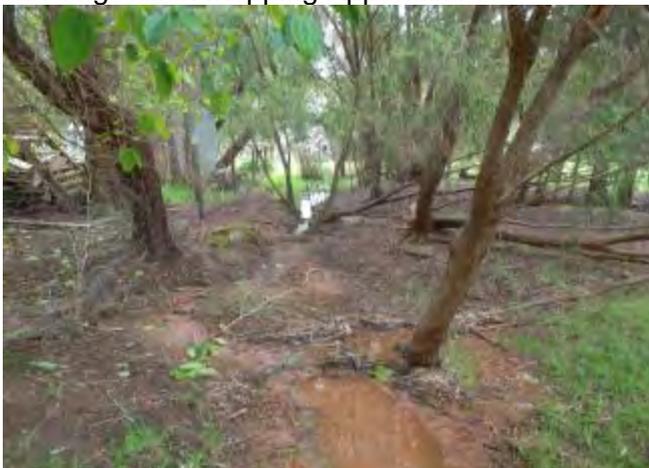
Photograph 9 – View of Low Open Peppermint Woodland over drainage swales along eastern boundary of lot A.

This vegetation type forms approximately <2% of the subject site. This vegetation type is represented in the southern boundary of Lot A along the open drain. This vegetation type has dominant tree species of Peppermint (*Agonis flexuosa*) with a cleared/disturbed understorey of introduced grasses such as Kikuyu, Water Couch and Arum Lilly (refer to Section 4.5 for more detail on weed species). Small patches of *Baumea juncea* occur along drainage swales and in the paddock to the north of the Peppermint Open Woodlands. Refer to Photographs 9 and 10 below and Vegetation Mapping Appendix F.

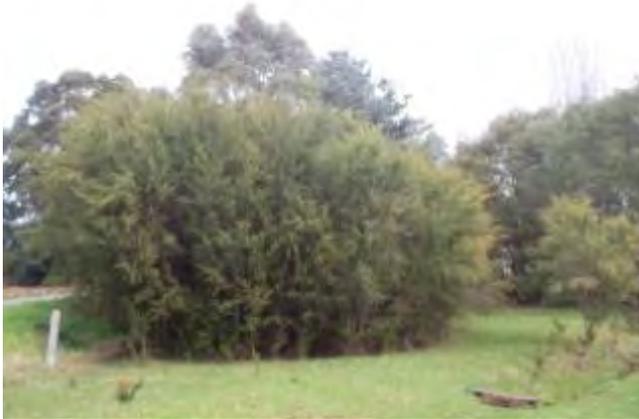
Photograph 11 – View of *Taxandria* Scrub located along the eastern boundary.

This vegetation type forms approximately less than 1% of the subject site, and is represented in the eastern boundary of the subject site. As previously discussed, it is possible that this vegetation type is regrowth having been previously cleared, with the 2007 aerial photograph used for the project not reflecting this vegetation being present on the site. The vegetation is dense, and consists only of *Taxandria linearifolia* (Karri tea tree) with no other vegetation structure. Refer to Photograph 11 and Vegetation Mapping Appendix F.

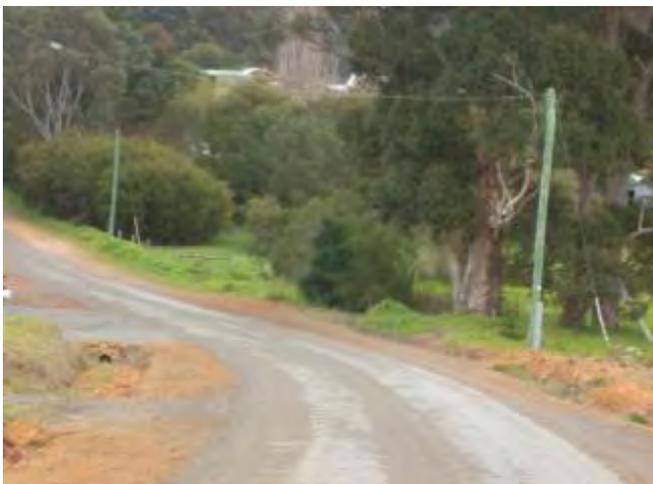
Photograph 13 – View from the north east towards the subject site along McPherson Drive. Most of the stormwater from uphill is being directed into the subject site. (mid-RHS of photograph)

A series of surface cut-off swale drains occur across the eastern extent of lot A and Lot B. The water is predominantly from the adjacent Macpherson Drive road reserve. Two cut off drains (open swales) enter from the eastern boundary of lot and are retained in a small seasonal pond. Overflow from this is then dispersed into a below ground sump. The Department of Health recommend a 6m setback from any drain or subsurface drain (DoH, 2011), therefore this is applied from any – on-site effluent disposal field.

Consideration from the Shire of Denmark should be given to the directional flows of the stormwater off Macpherson Drive and away from the subject site to the stormwater system along South Coast Highway or into the POS area to the north. The current arrangement of directing water (from uphill road and infrastructure) into the subject site is not a sound long term solution and investigations could be made into the POS area to the north of the subject site or the highway stormwater system as a possible location for any stormwater treatments from the subdivision uphill. Refer to Photographs 13 and 14 below.

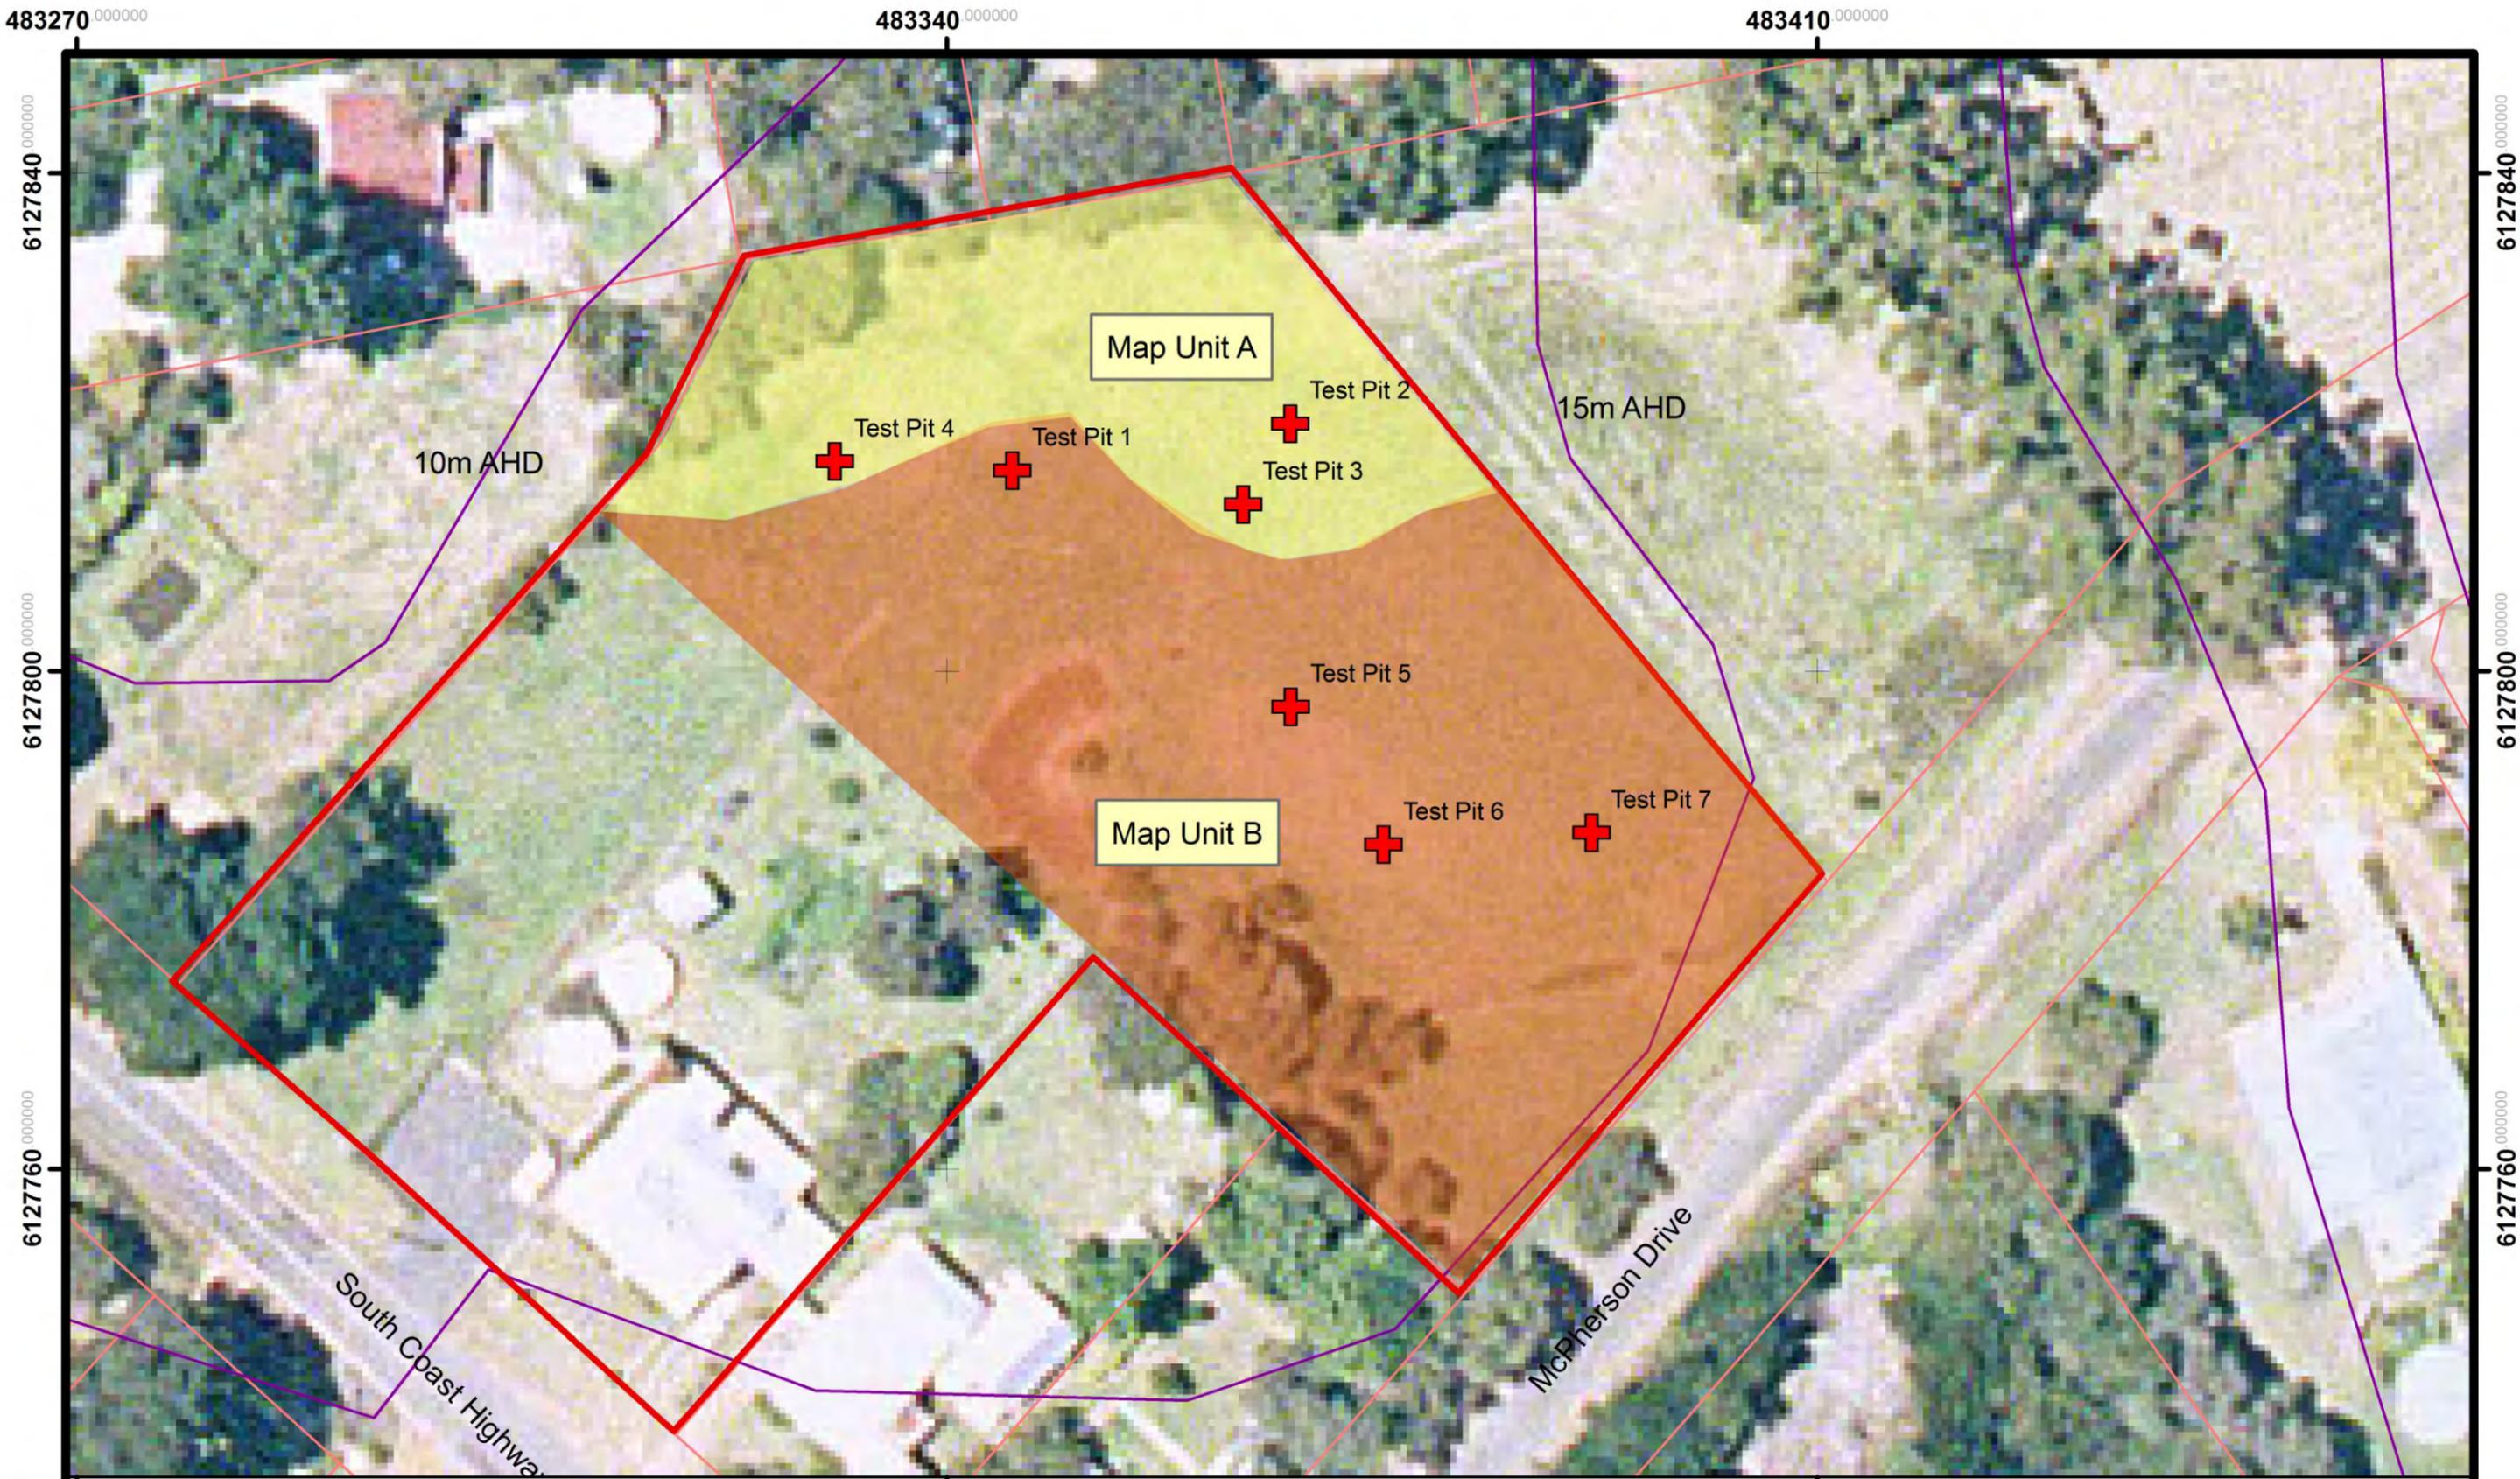
(Test Pits 1, 5, 6, and 7)

- Map Unit A – areas with a High capability (Land Capability Class II) of supporting the land use and limitations can be overcome by design and management inputs.
- Map Unit B – areas with a Very high capability (Land Capability Class I) of supporting the land use, there are very few physical limitations to the specified use are present or else they are easily overcome. Risk of land degradation under the proposed use is negligible.

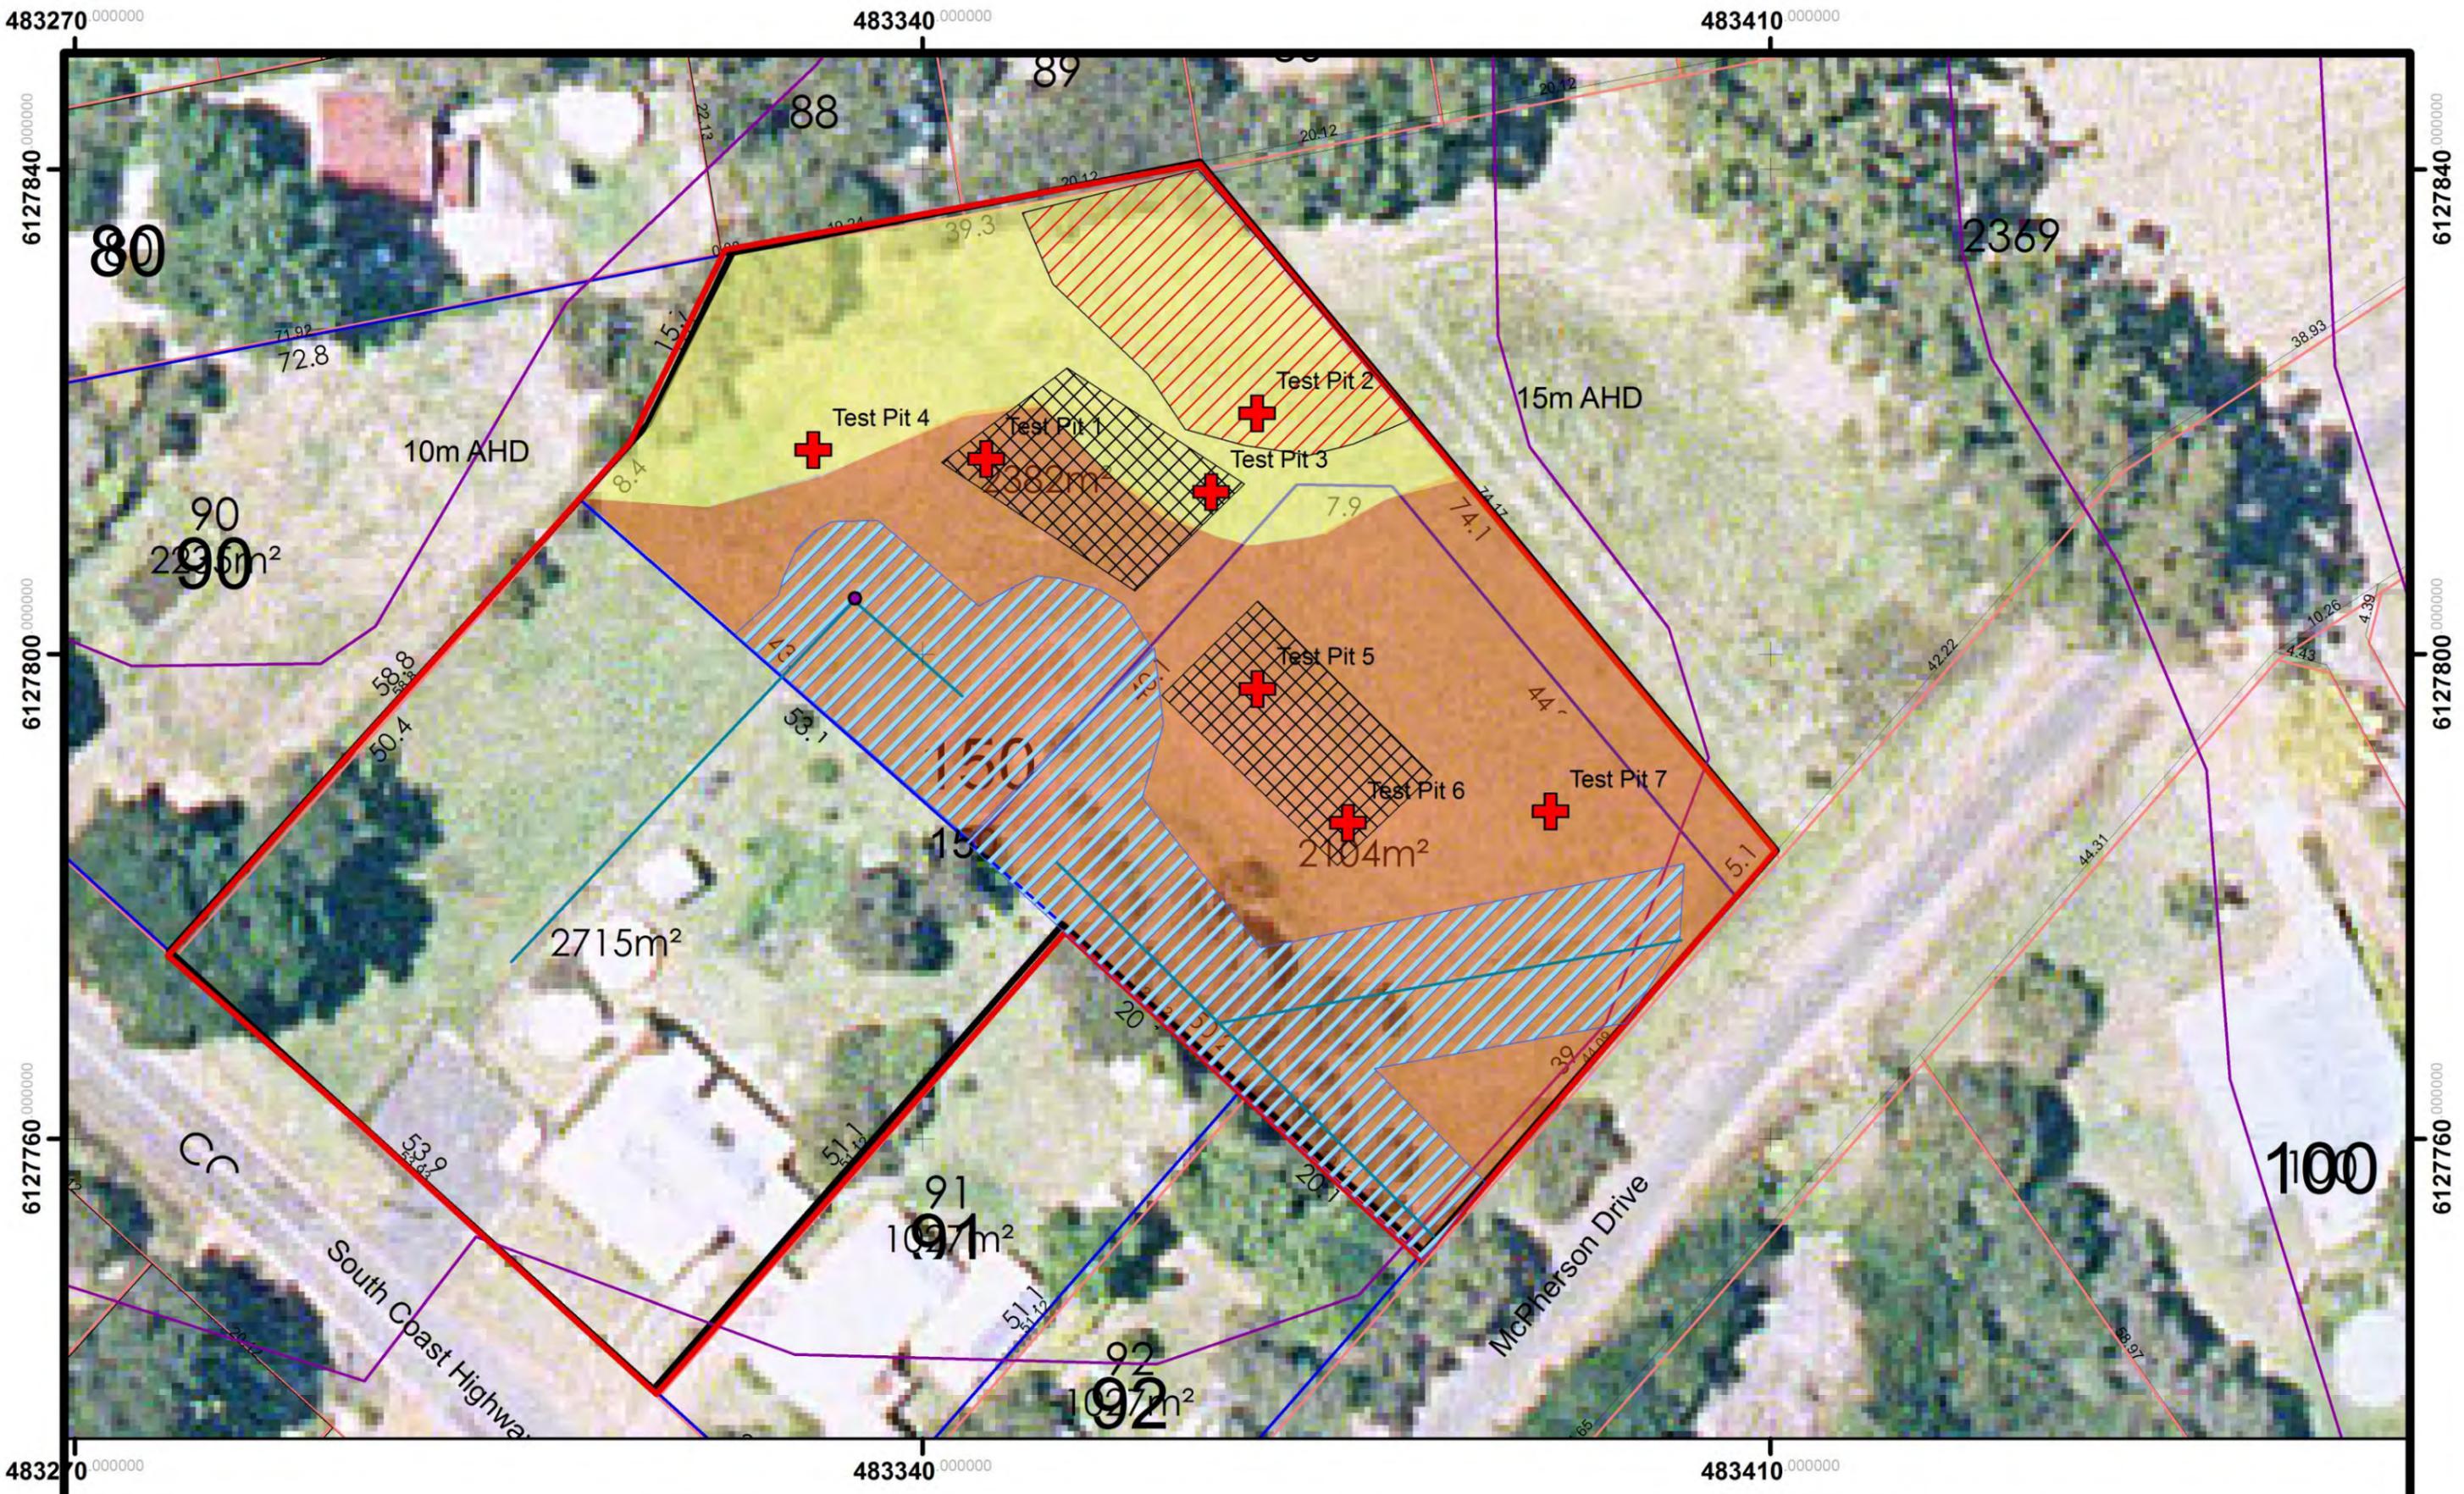
Please refer to Limitations Mapping over the page.

Map Unit B – areas with a Very high capability (Land Capability Class I) of supporting the land use, there are very few physical limitations to the specified use are present or else they are easily overcome. Risk of land degradation under the proposed use is negligible.

- Legend**
- Cadastral
 - Map unit A
 - Map Unit B
 - Subject site
 - Land Application Area
 - Waterlogging
 - Drain setback
 - Sump
 - Test Pits
 - Drains

- Residences will need to be a minimum setback of 6m from any drain, drainage channel or sub-surface drain;
- Recommended on-site effluent is via traditional effluent disposal systems with a possible site plan for each lot in Appendix E; and
- Effluent disposal is not recommended in the north-western portion of the subject site (Test pit 2).

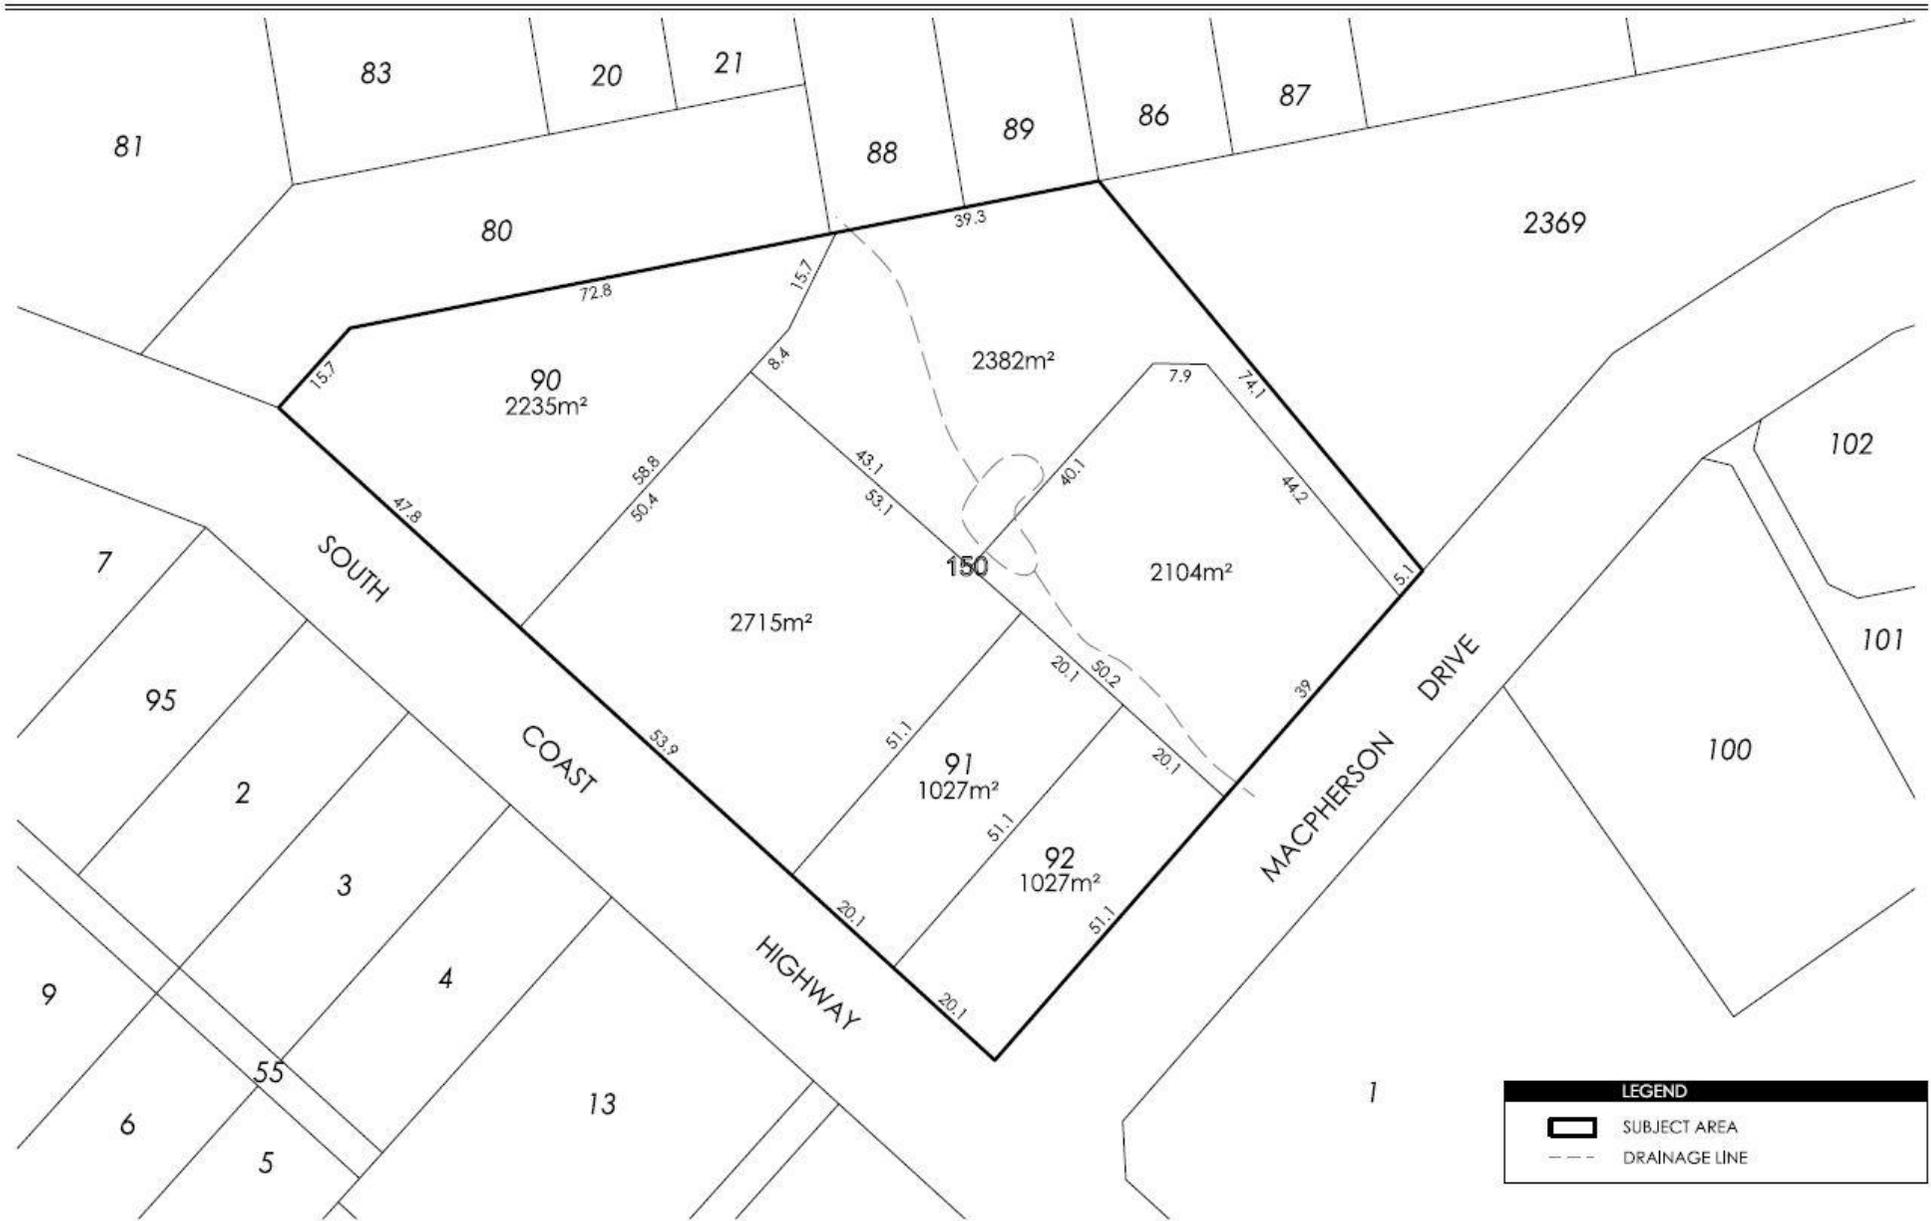
SUBDIVISION GUIDE PLAN
 LOT 150 SOUTH COAST HIGHWAY, NORNALUP

Subdivision Guide Plan

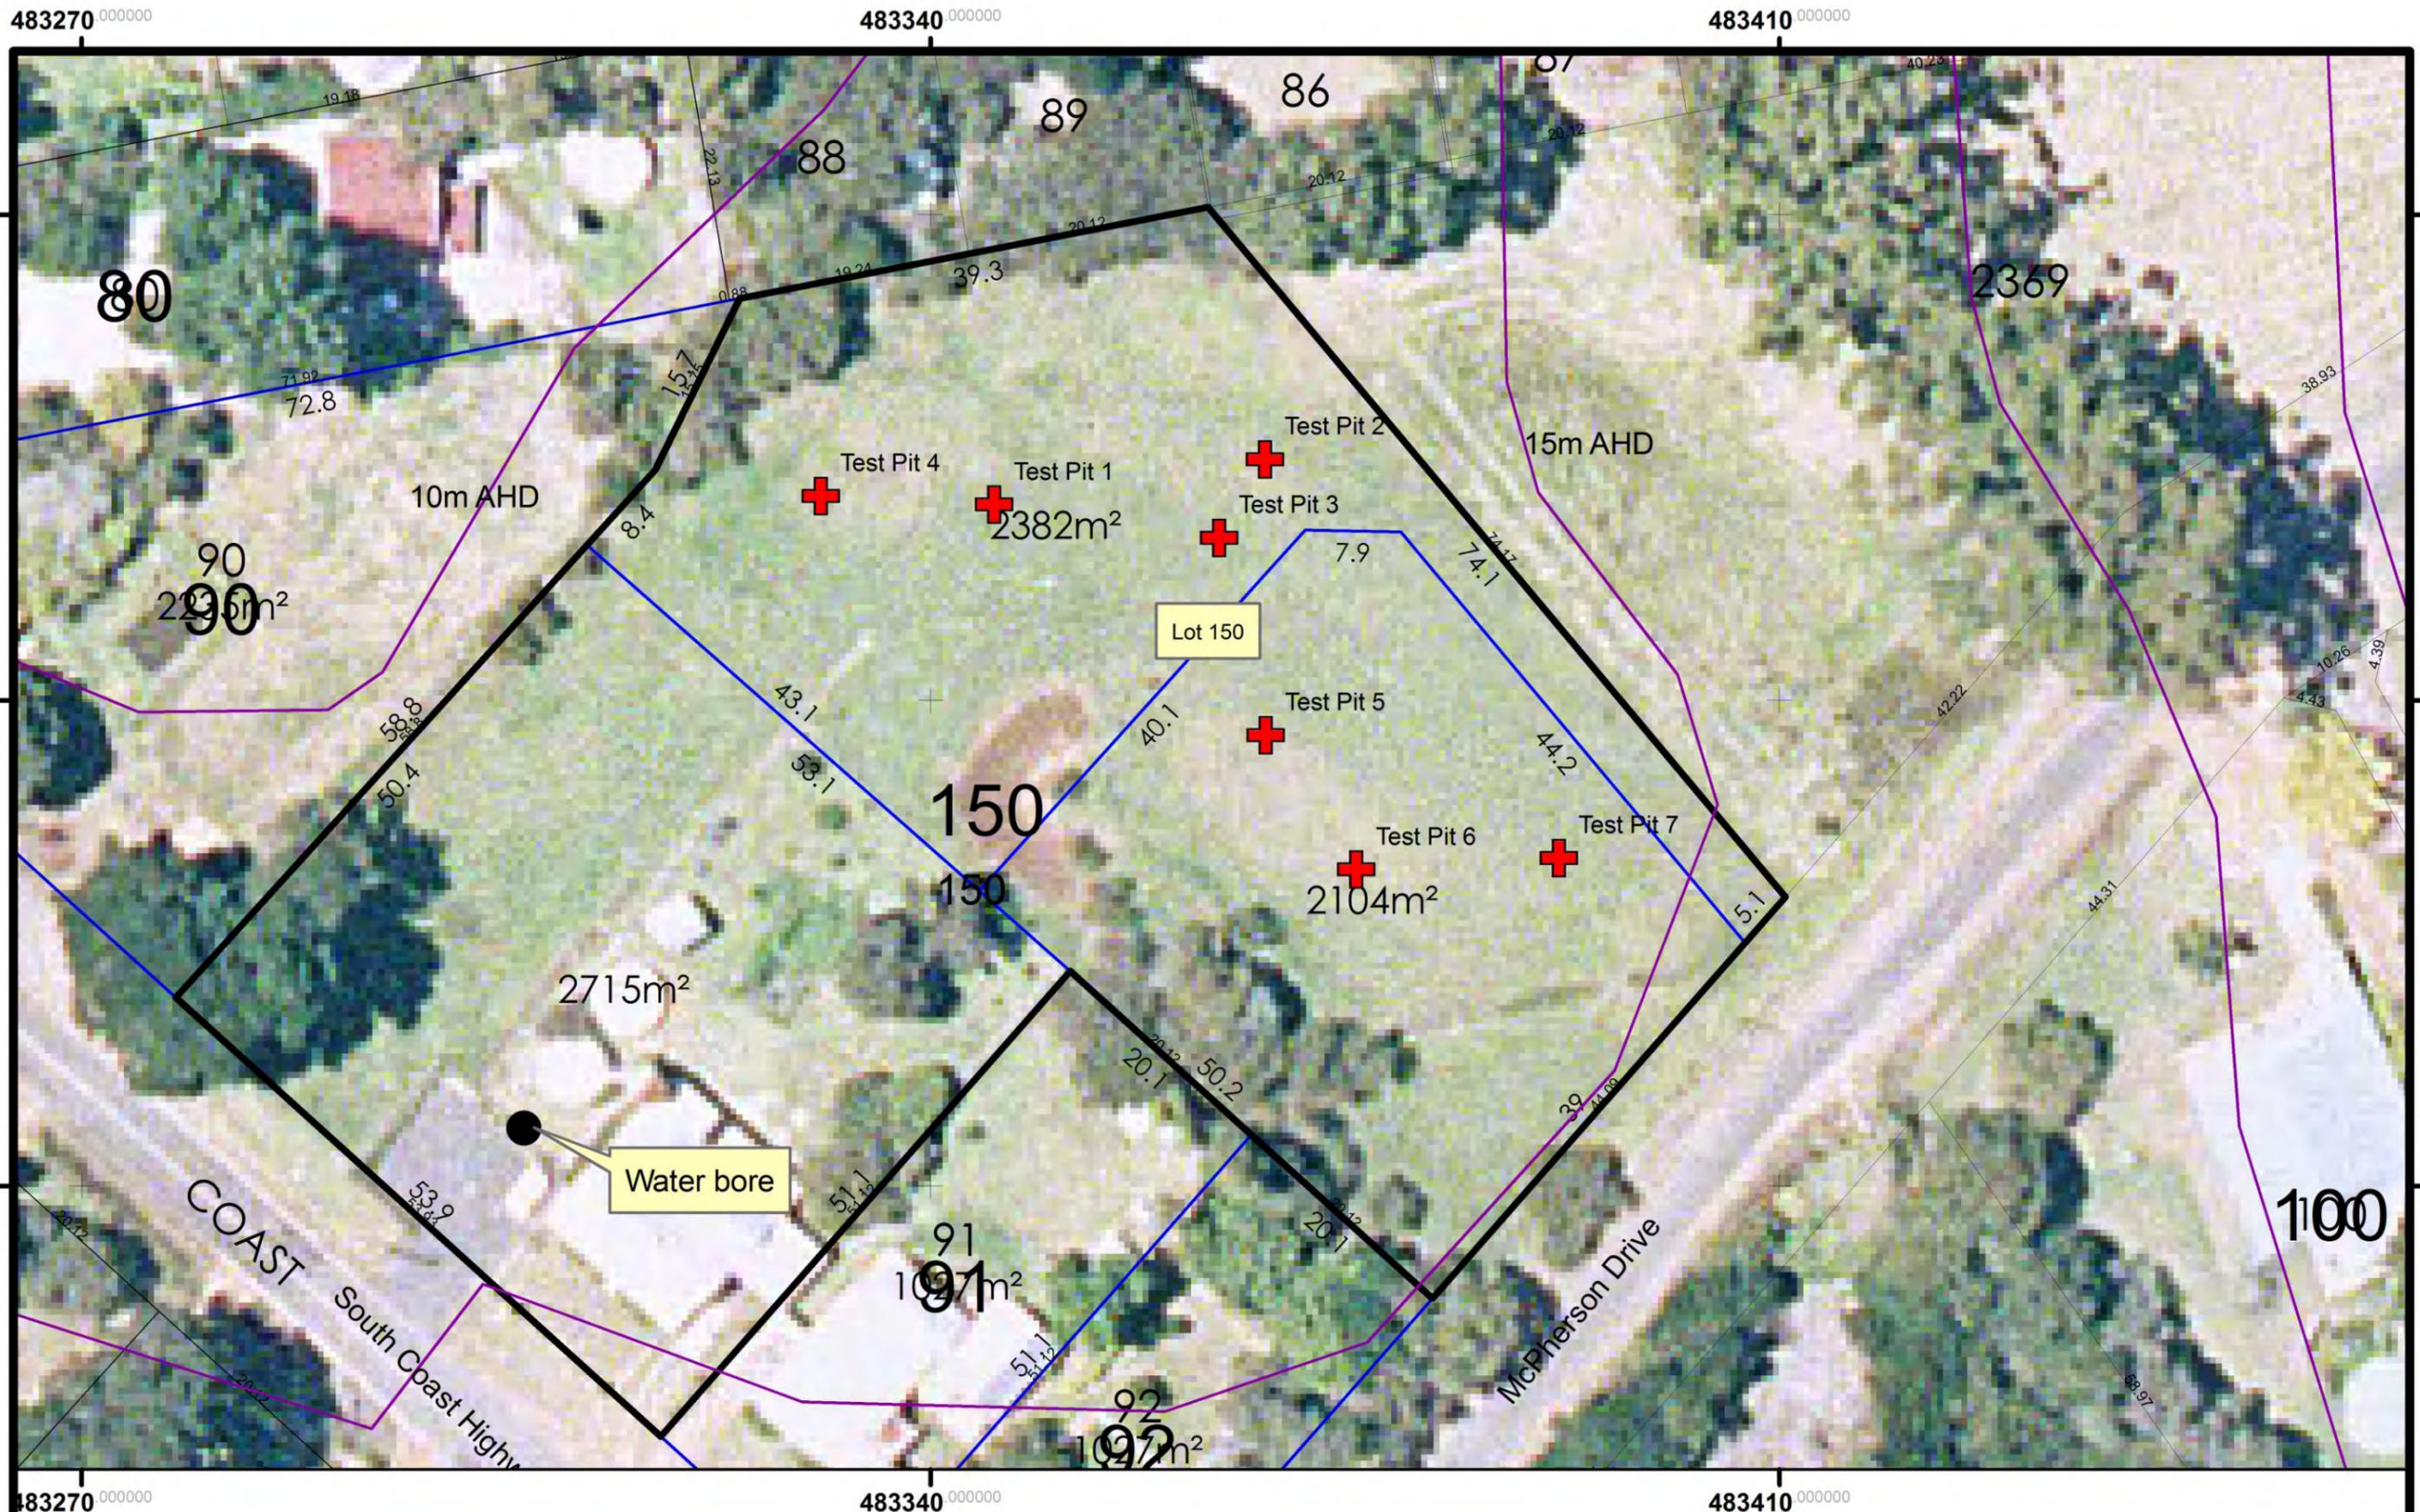
Soil Test Pit Mapping

Soil Profile Sampling Results and

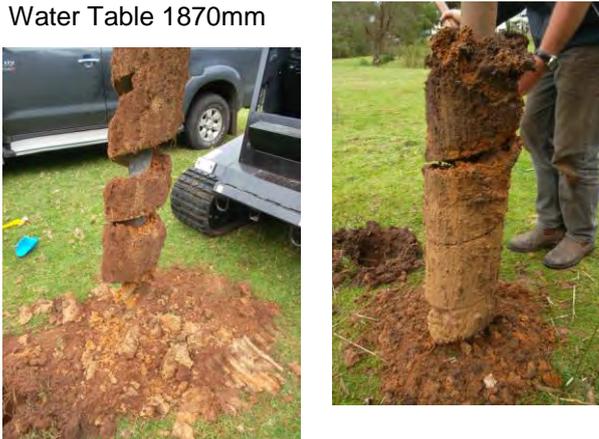
<u>Location</u>	<u>Site description</u>	<u>Depth of profile (mm)</u>	<u>Soil Description</u>	<u>Laboratory test</u>
Test Pit 1 6127816 483344	South west corner, middle lot B	0-70 70-600 600-1000 1000-1800 1800-2000	Moist dark brown sandy loam, organic matter Topsoil Moist brown clayey loamy gravel pebbles 20-30mm (gravels) Moist light brown clayey loam 10-20mm pebbles (gravels) Slightly moist mottled orange/grey/brown clay pebbles 10-30mm (gravels) Dry compacted light grey mottled red and pink clay, minor pebbles Water Table 1870mm

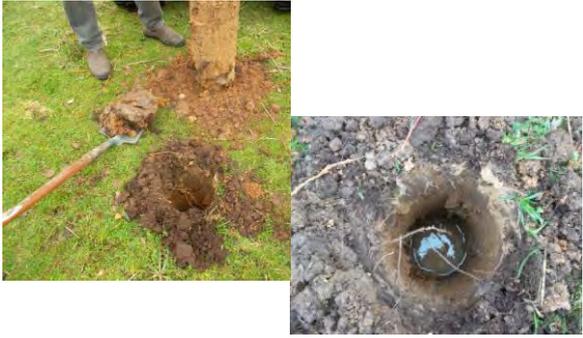
Sample 1 PRI & Permeability 0-600mm
Test Pit 2 6127820 483367	North west Corner	0-70 70-400 400-1200 1200-1700 1700-2000	Moist dark brown silty clay, organic matter Topsoil Wet brown sandy silty clay Wet light brown silty clay Moist light brown mottled red clay pebbles 20-30mm (gravel) Moist brown sandy silt with gravel Water Table 270mm

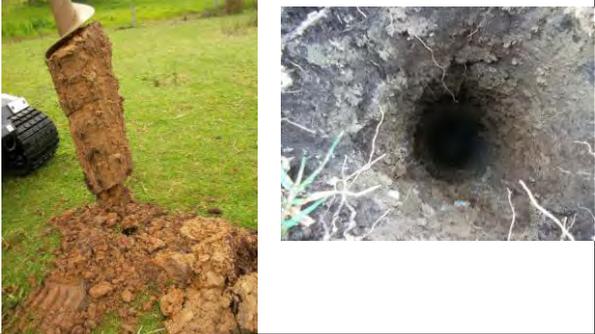
<u>Location</u>	<u>Site description</u>	<u>Depth of profile (mm)</u>	<u>Soil Description</u>	<u>Laboratory test</u>
Test Pit 3 6127813 483363	East end of lot	0-70 70-250 250-500 500-1400 1400-2000	Wet dark brown silty clay, organic matter, topsoil Wet dark brown sandy silty clay Wet light brown sandy silty clay minor pebbles 5-10mm Wet becoming dry light brown to orange clay Dry white/grey clay Water Table 730mm

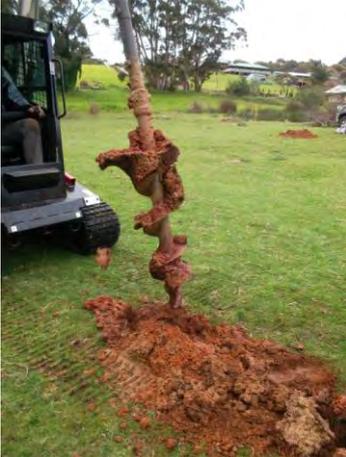
Test Pit 4 6127817 483330	Western boundary	0-50 50-250 250-1000 1000-1400 1400-2000	Moist dark brown silty clay, organic matter (topsoil) Moist dark brown sandy gravel pebbles 15-30mm (gravels) Moist light brown mottled red sandy clay Moist red loamy clay with pebbles 20-30mm (gravels) Dry grey mottled pink clay Water table 700mm

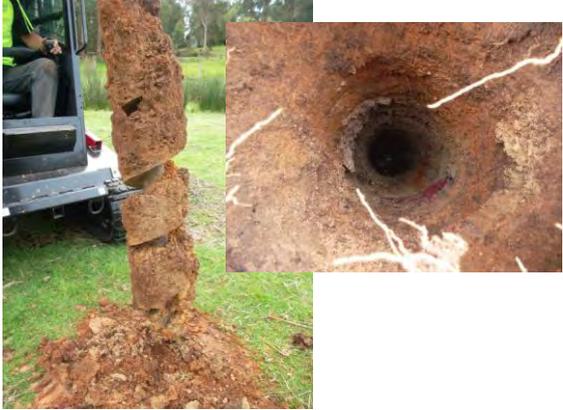
<u>Location</u>	<u>Site description</u>	<u>Depth of profile (mm)</u>	<u>Soil Description</u>	
Test Pit 5 6127797 483367	Lot a western border	0-50 50-200 200-500 500-700 700-1000 1000-1200 1200-2000	Moist dark brown sandy loam, organic matter (topsoil) Moist brown gravelly loam, pebbles 10-20mm Moist light brown sandy clayey loam pebbles 10-20mm (gravels) Moist light brown sandy clay Moist light brown sandy clay with gravels 2-30mm Moist light brown gravelly clay Slightly moist mottled red/grey/orange clay with granite granules No Water Table reached	Sample 1 PRI & Permeability 200-1000mm

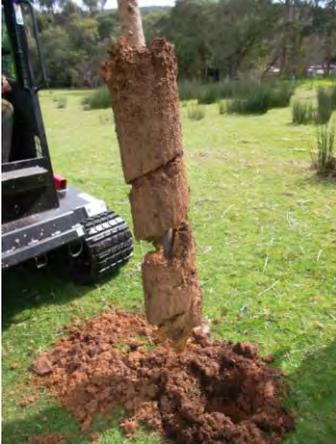
Test Pit 6 6127786 483375	Mod lot A	0-50 50-250 250-530 530-1100 1100-1700 1700-2000	Moist dark brown sandy loam, organic matter (topsoil) Moist dark brown sandy silty loam moist light brown sandy silty loam Slightly moist light brown silty clay pebbles 20-30mm Slightly moist mottled red/orange/grey clay Dry compacted red slightly mottled grey clay No Water Table reached

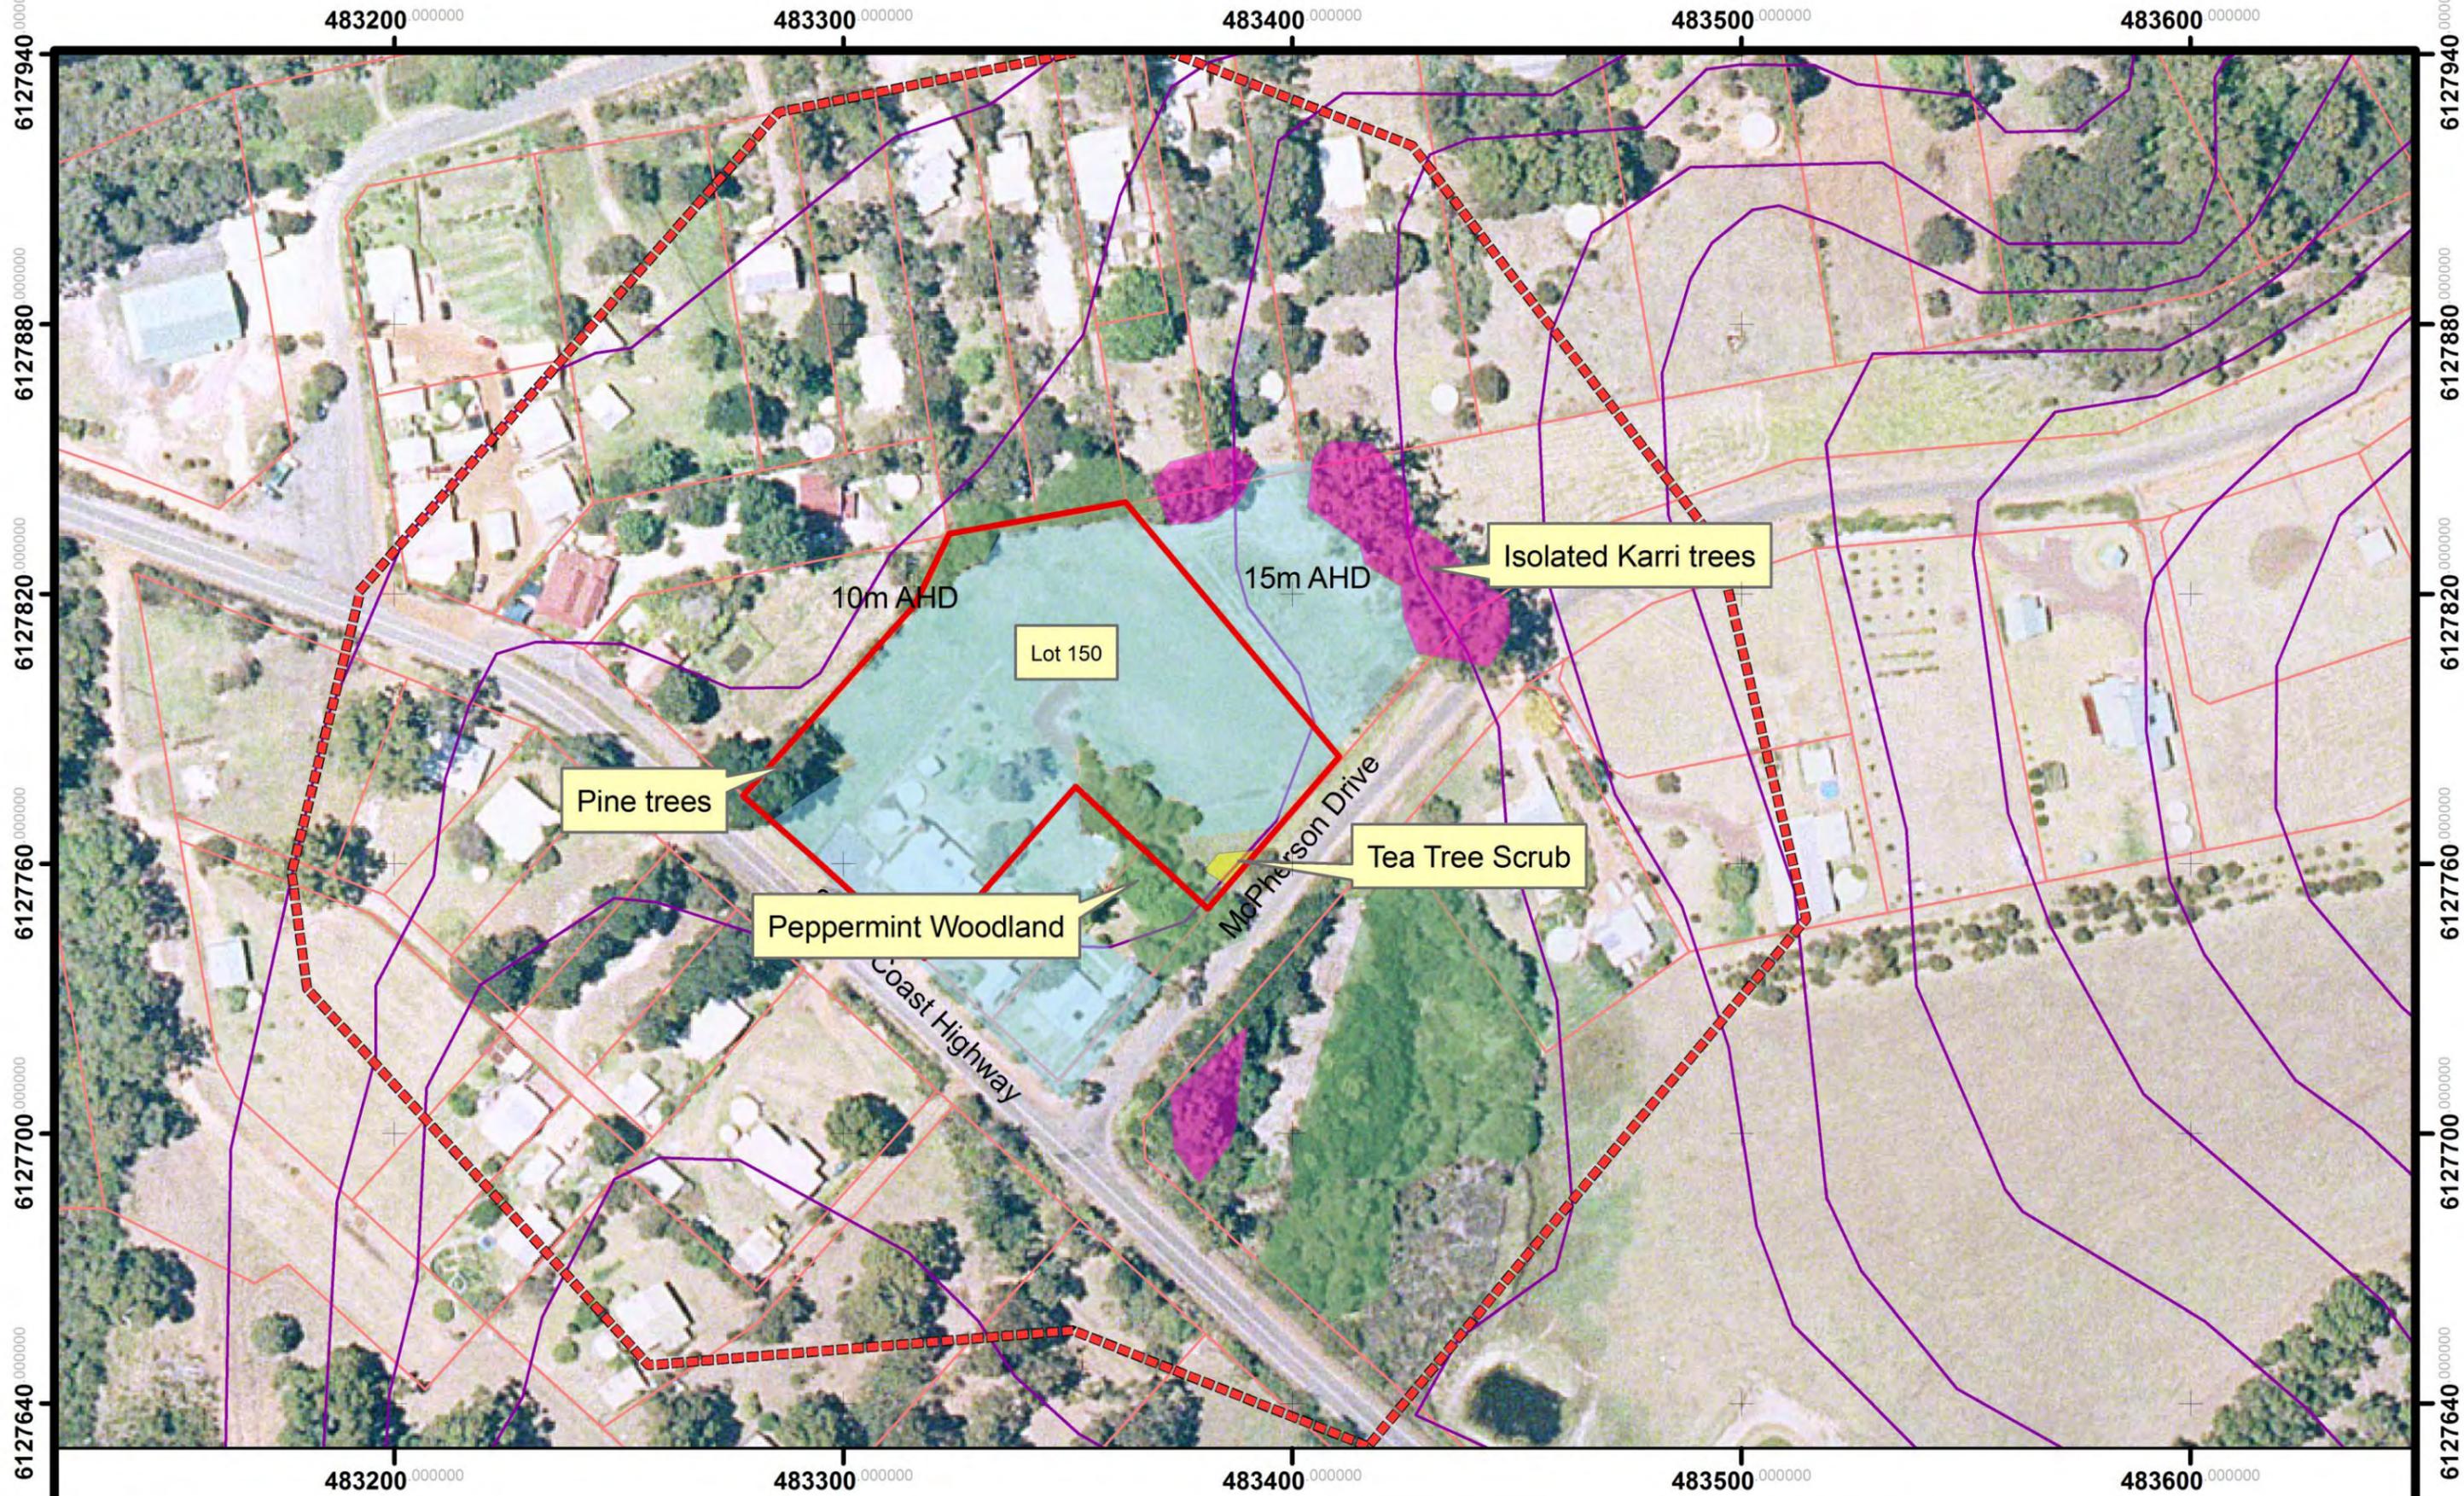
Vegetation Mapping

- 100m Bushfire Prone
- subject site
- Tea tree scrub
- Peppermint Woodland
- Isolated Karri Trees
- Cleared or bare areas
- Cadastre
