*Lot 3002 Hardy Street, Denmark*

# **Remedial Action Plan**

**On behalf of  
Shire of Denmark**

Date: September 2016  
Reference: W-04925.01  
Status: FINAL

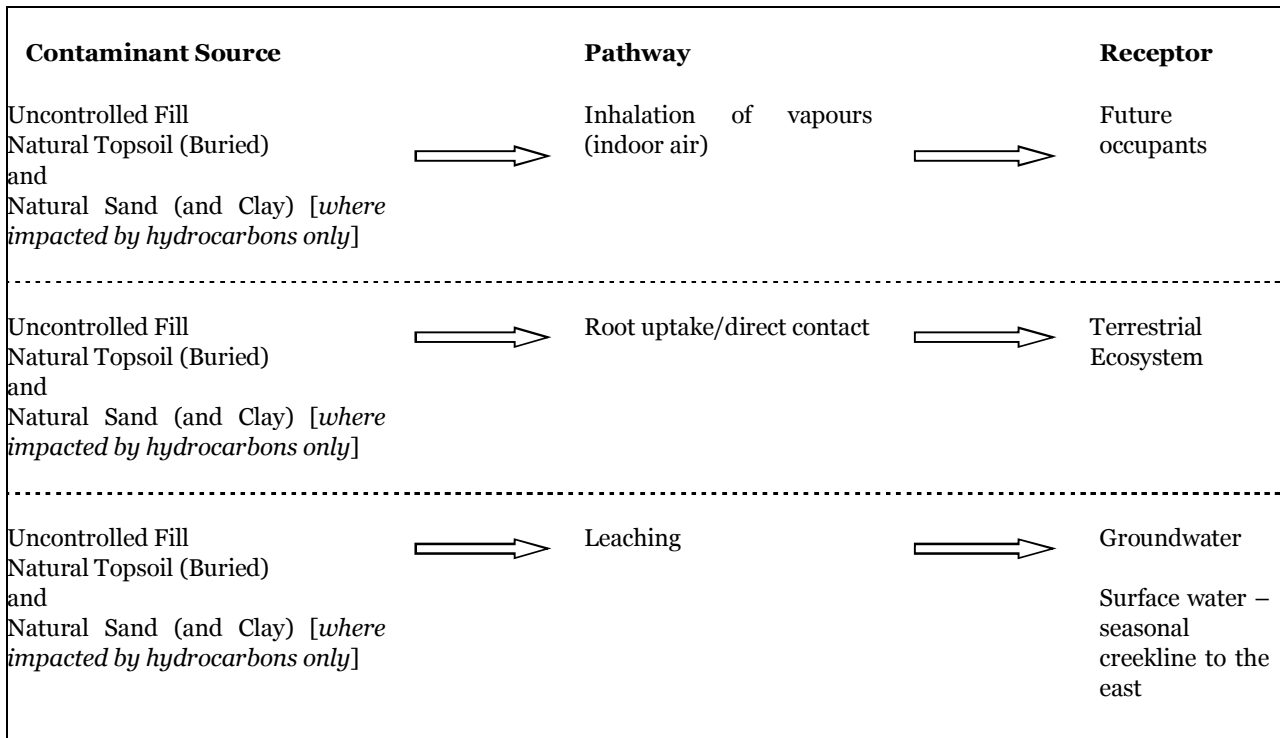
**Figure 2-2: Relevant Pollutant Linkages**

Figure 2-2 represents the contaminant source, pathway and receptors for the relevant pollutant linkages.

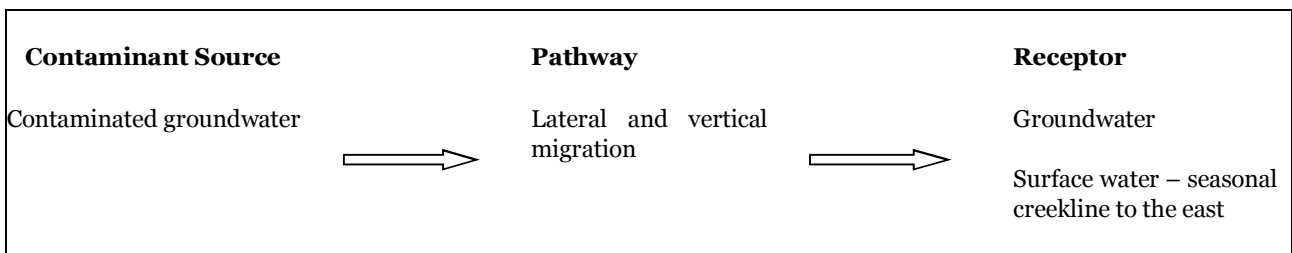
**Figure 2-3: Possible Pollutant Linkage Associated with Contaminated Groundwater**

Should visual and olfactory evidence of groundwater contamination be encountered during the removal of the unsuitable soils, then the quality of this water should be assessed and dealt with appropriately during these works. It is also considered prudent during the removal of the unsuitable soils to monitor of groundwater within the seasonal creek line (upstream and downstream of Lot 3002) located to the east of the site in Lot 3003 (Figure 2-3).

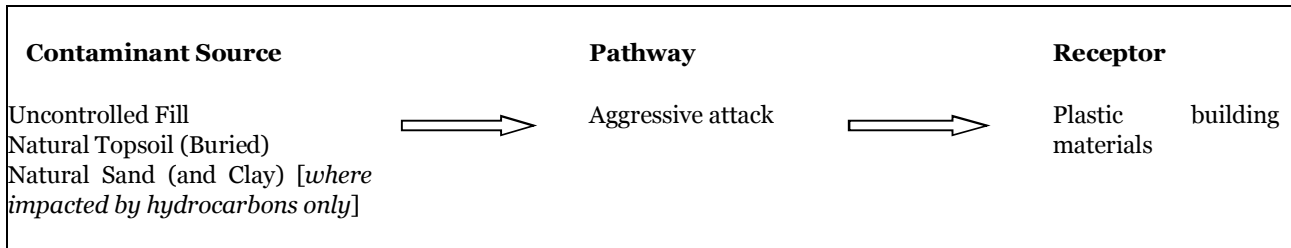
**Figure 2-5: Possible Pollutant Linkage Associated with Hydrocarbon Impacted Soils**

Certain hydrocarbons (particularly aromatic compounds) can permeate plastic water pipes and taint drinking water supplies. Other hydrocarbons can cause aggressive attack to plastic building materials (Figure 2-5).

However, the removal of the unsuitable Uncontrolled Fill, Natural Topsoil (Buried) and Natural Sand will also remove the source of hydrocarbons which could cause aggressive attack to plastic building materials.

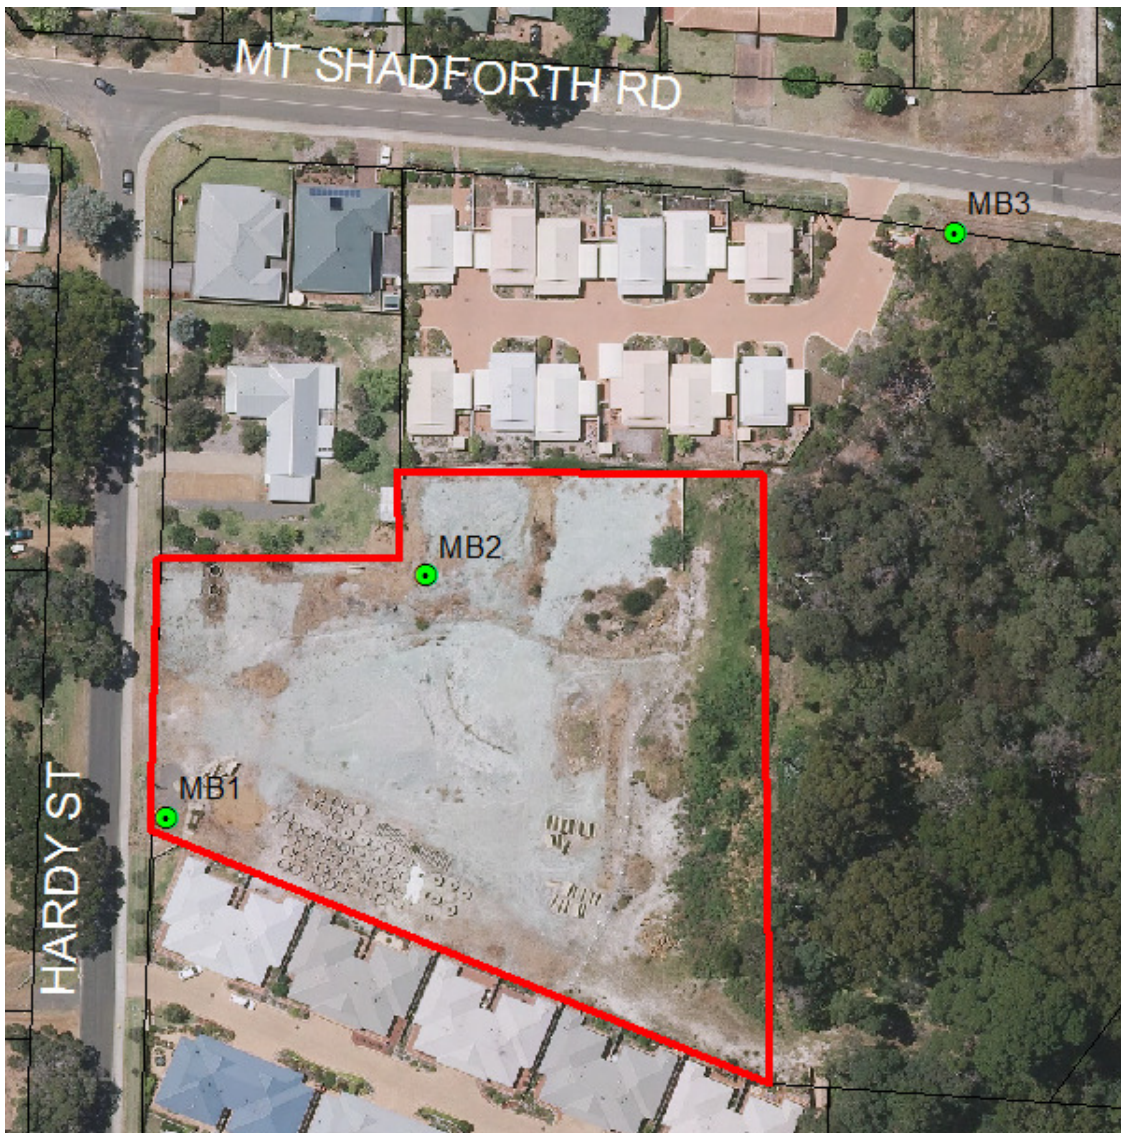
Three groundwater monitoring bores (Figure 8-1) were installed 26 April 2016. MB1 was installed upslope of the contaminated material, MB2 adjacent to previously identified contaminants and MB3 downslope of the site. Initial groundwater monitoring was undertaken by Opus, on behalf of the Shire of Denmark, on 9 May 2016 to investigate background contaminant levels.

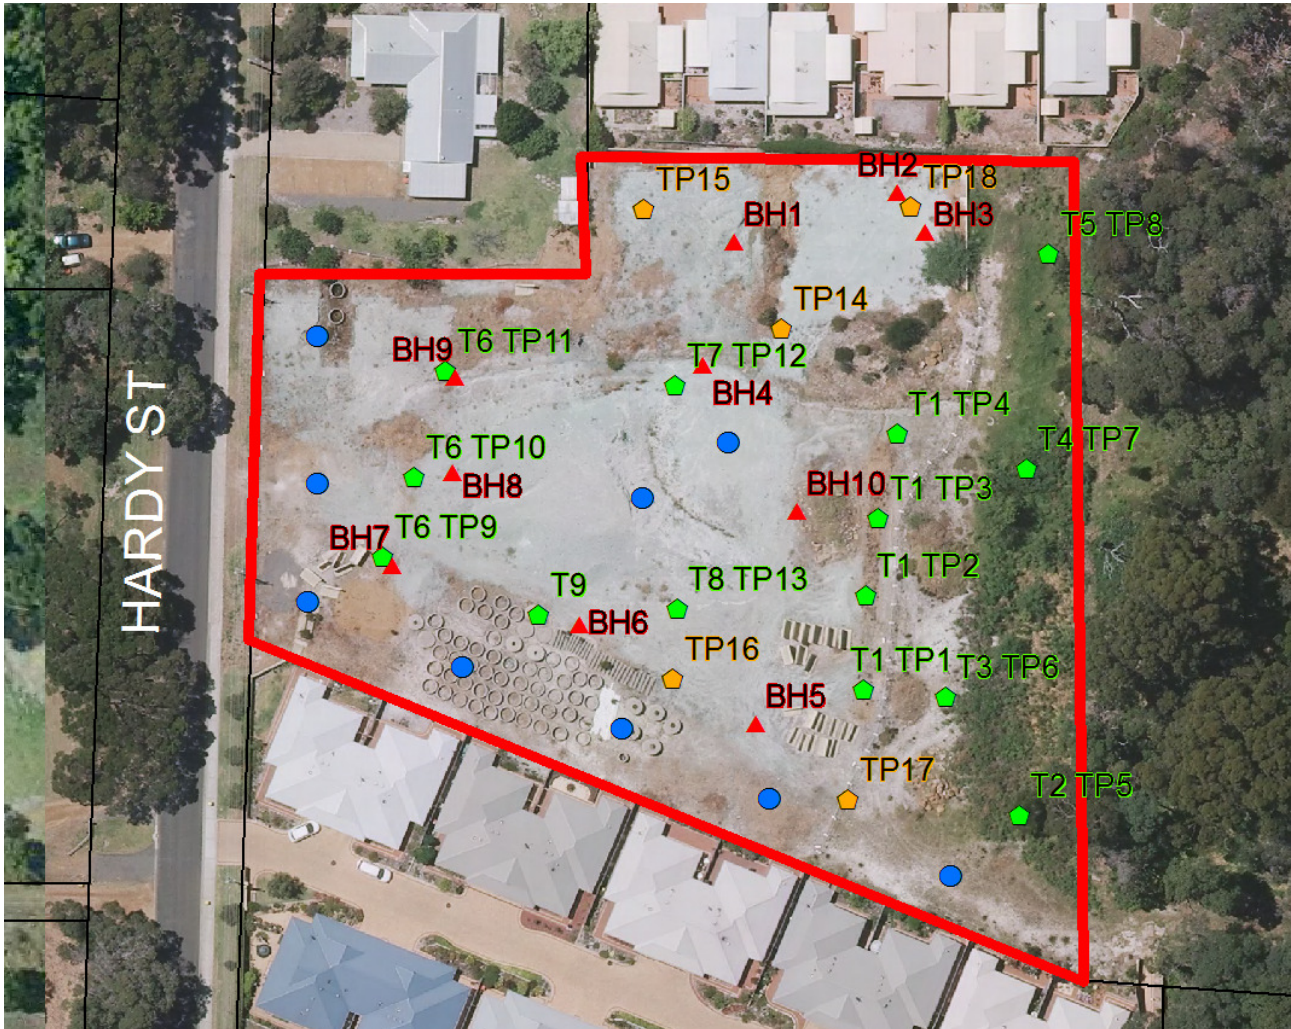
Figure E-1 below identifies locations within Lot 3002 Hardy Street previously investigated. Additional locations are proposed on the western and southern boundaries and in the centre of the site where materials being stored onsite previously obstructed investigations.

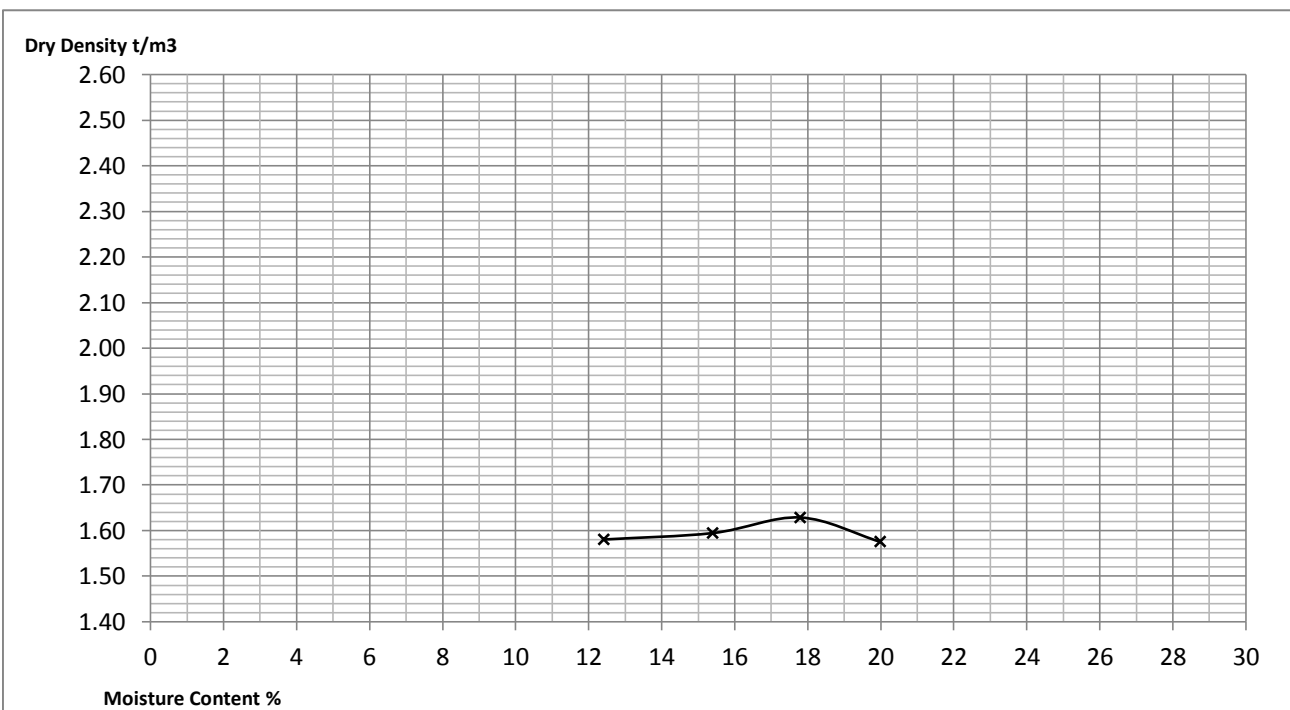
<b>Optimum Moisture Content %</b>	17.5	<b>Maximum Dry Density t/m3</b>	1.63	<b>Retained 19.0 mm sieve %</b>	0.0
<b>Corrected OMC %</b>	-	<b>Corrected MDD t/m3</b>	-	<b>Corrected 19.0 mm sieve %</b>	-

Soil Description (visual)                      Grey, SAND

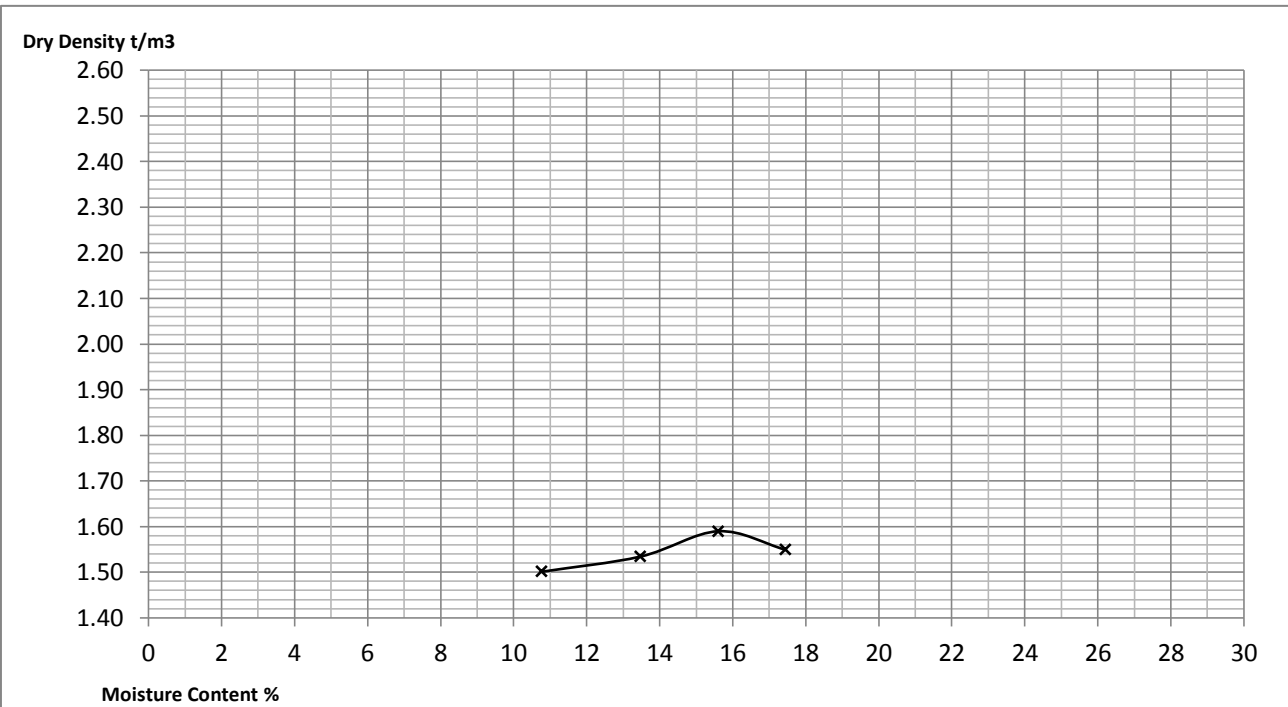
<b>Optimum Moisture Content %</b>	15.5	<b>Maximum Dry Density t/m3</b>	1.59	<b>Retained 19.0 mm sieve %</b>	0.0
<b>Corrected OMC %</b>	-	<b>Corrected MDD t/m3</b>	-	<b>Corrected 19.0 mm sieve %</b>	-

Soil Description (visual)                      White SAND

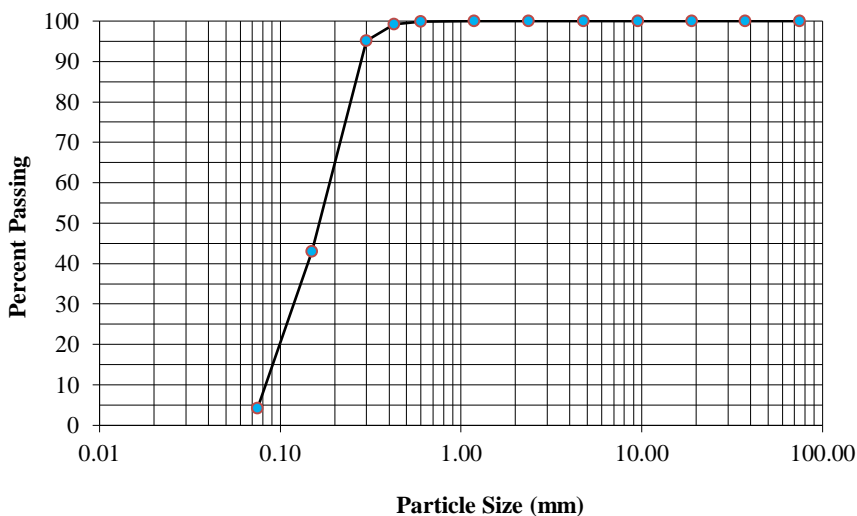
### Particle Size Distribution

Job No/Sample ID	17680/PSD-2	Test Request Number	N/a
Client	Opus International Consultants Pty Ltd		
Project	Denmark Site - Proposed Fill		
Sample Location	Sample 2		
Date & Time Tested	4/5/16 3.00pm		
Tested By	J.Gray

Sieve Size	Passing	Retained
75.0 mm	100 %	0 %
37.5 mm	100 %	0 %
19.0 mm	100 %	0 %
9.5 mm	100 %	0 %
4.75 mm	100 %	0 %
2.36 mm	100 %	0 %
1.18 mm	100 %	0 %
0.600 mm	100 %	0 %
0.425 mm	99 %	1 %
0.300 mm	95 %	5 %
0.150 mm	43 %	57 %
0.075 mm	4 %	96 %

Soil Description	White, SAND
Depth	N/a

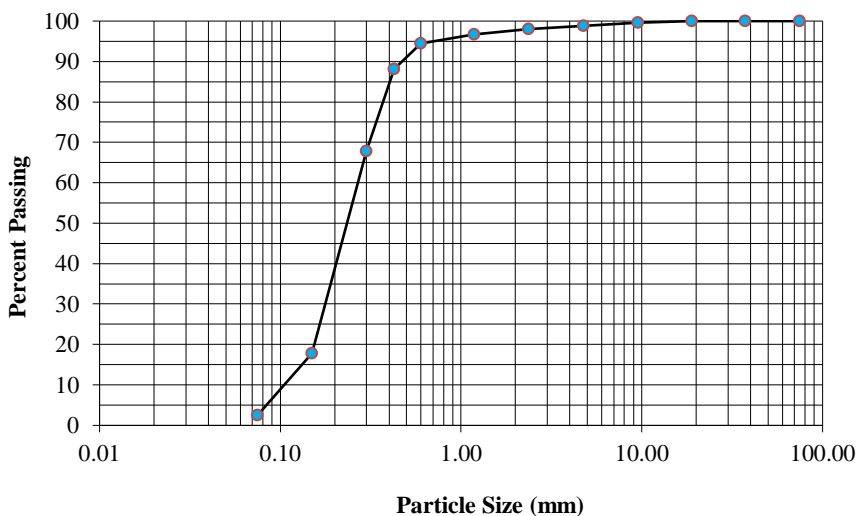
### Particle Size Distribution

Job No/Sample ID	17680/PSD-1	Test Request Number	N/a
Client	Opus International Consultants Pty Ltd		
Project	Denmark Site - Proposed Fill		
Sample Location	Sample 1		
Date & Time Tested	4/4/16 pm		
Tested By	S.Gough

Sieve Size	Passing	Retained
75.0 mm	100 %	0 %
37.5 mm	100 %	0 %
19.0 mm	100 %	0 %
9.5 mm	100 %	0 %
4.75 mm	99 %	1 %
2.36 mm	98 %	2 %
1.18 mm	97 %	3 %
0.600 mm	94 %	6 %
0.425 mm	88 %	12 %
0.300 mm	68 %	32 %
0.150 mm	18 %	82 %
0.075 mm	3 %	97 %

Soil Description	Grey, SAND
Depth	N/a
