### VISION FOR PRAWN ROCK CHANNEL

# Prawn Rock Channel Concept Plan

Adopted by Council at the Ordinary Meeting of Council held on 29 September 2015.

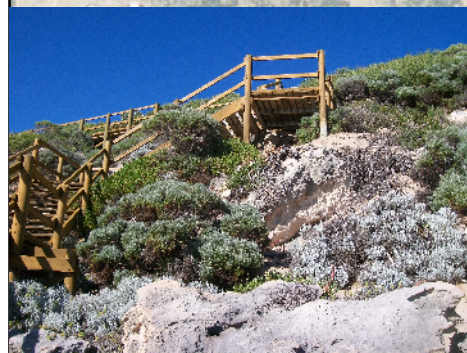
Image 5: Example staircase (Photos for illustrative purposes only).

New track and stairs to Ocean Beach. Stairs to include viewing platform. See Image 4-6.

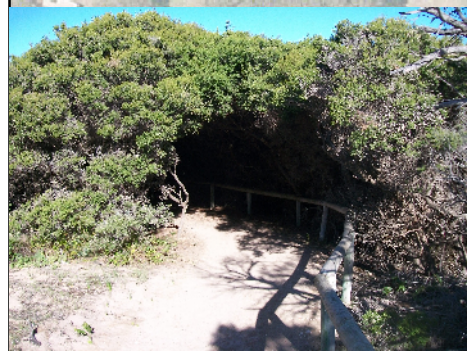
Image 6: Example coastal trail (Photos for illustrative purposes only).

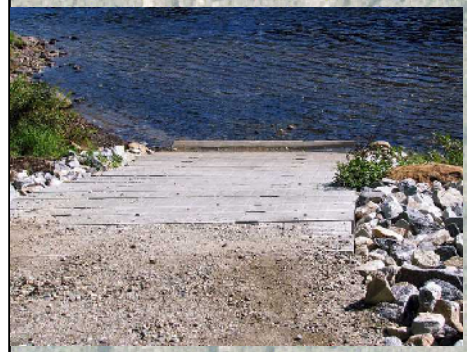
Image 7: Example disabled access to water (to include a hand rail) (Photo for illustrative purposes only).

Disabled access to water. See Image 7.

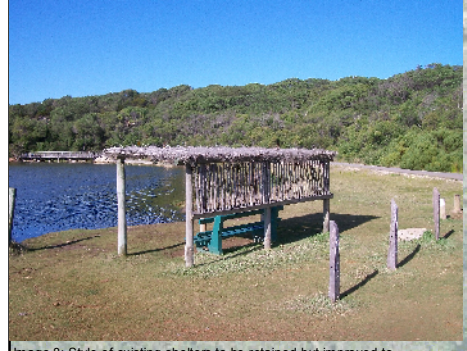
Image 8: Style of existing shelters to be retained but improved to feature fully enclosed rear wall.

Brushwood and timber shelters on mainland to be retained and include picnic table and seating. Shelters will be fully enclosed on one side. See Image 8.

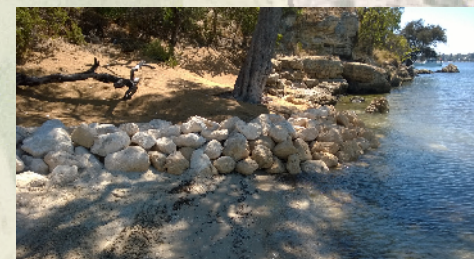
Image 1: Example bank protection works (Photos for illustrative purposes only).

Erosion control of banks. May utilise coir logs, limestone rocks, geotextiles. Locations to be determined. See Image 1.

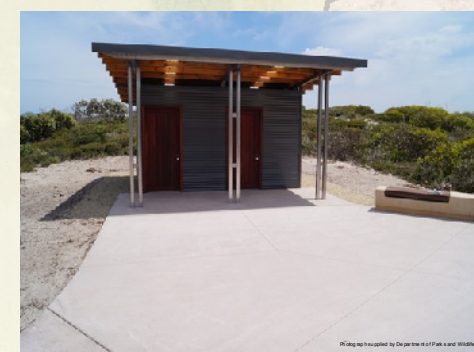
Image 3: Example educational signage hub (Photo for illustrative purposes only).

Educational and informative signage hub. See Image 3.
