Attachment A Coastal Hazard Mapping

SHIRE OF DENMARK COASTAL HAZARD RISK MANAGEMENT AND ADAPTATION PLAN PEACEFUL BAY ALLOWANCE FOR COASTAL PROCESSES

Coastal Hazards Issues Paper

OCEAN BEACH and PEACEFUL BAY Shire of Denmark

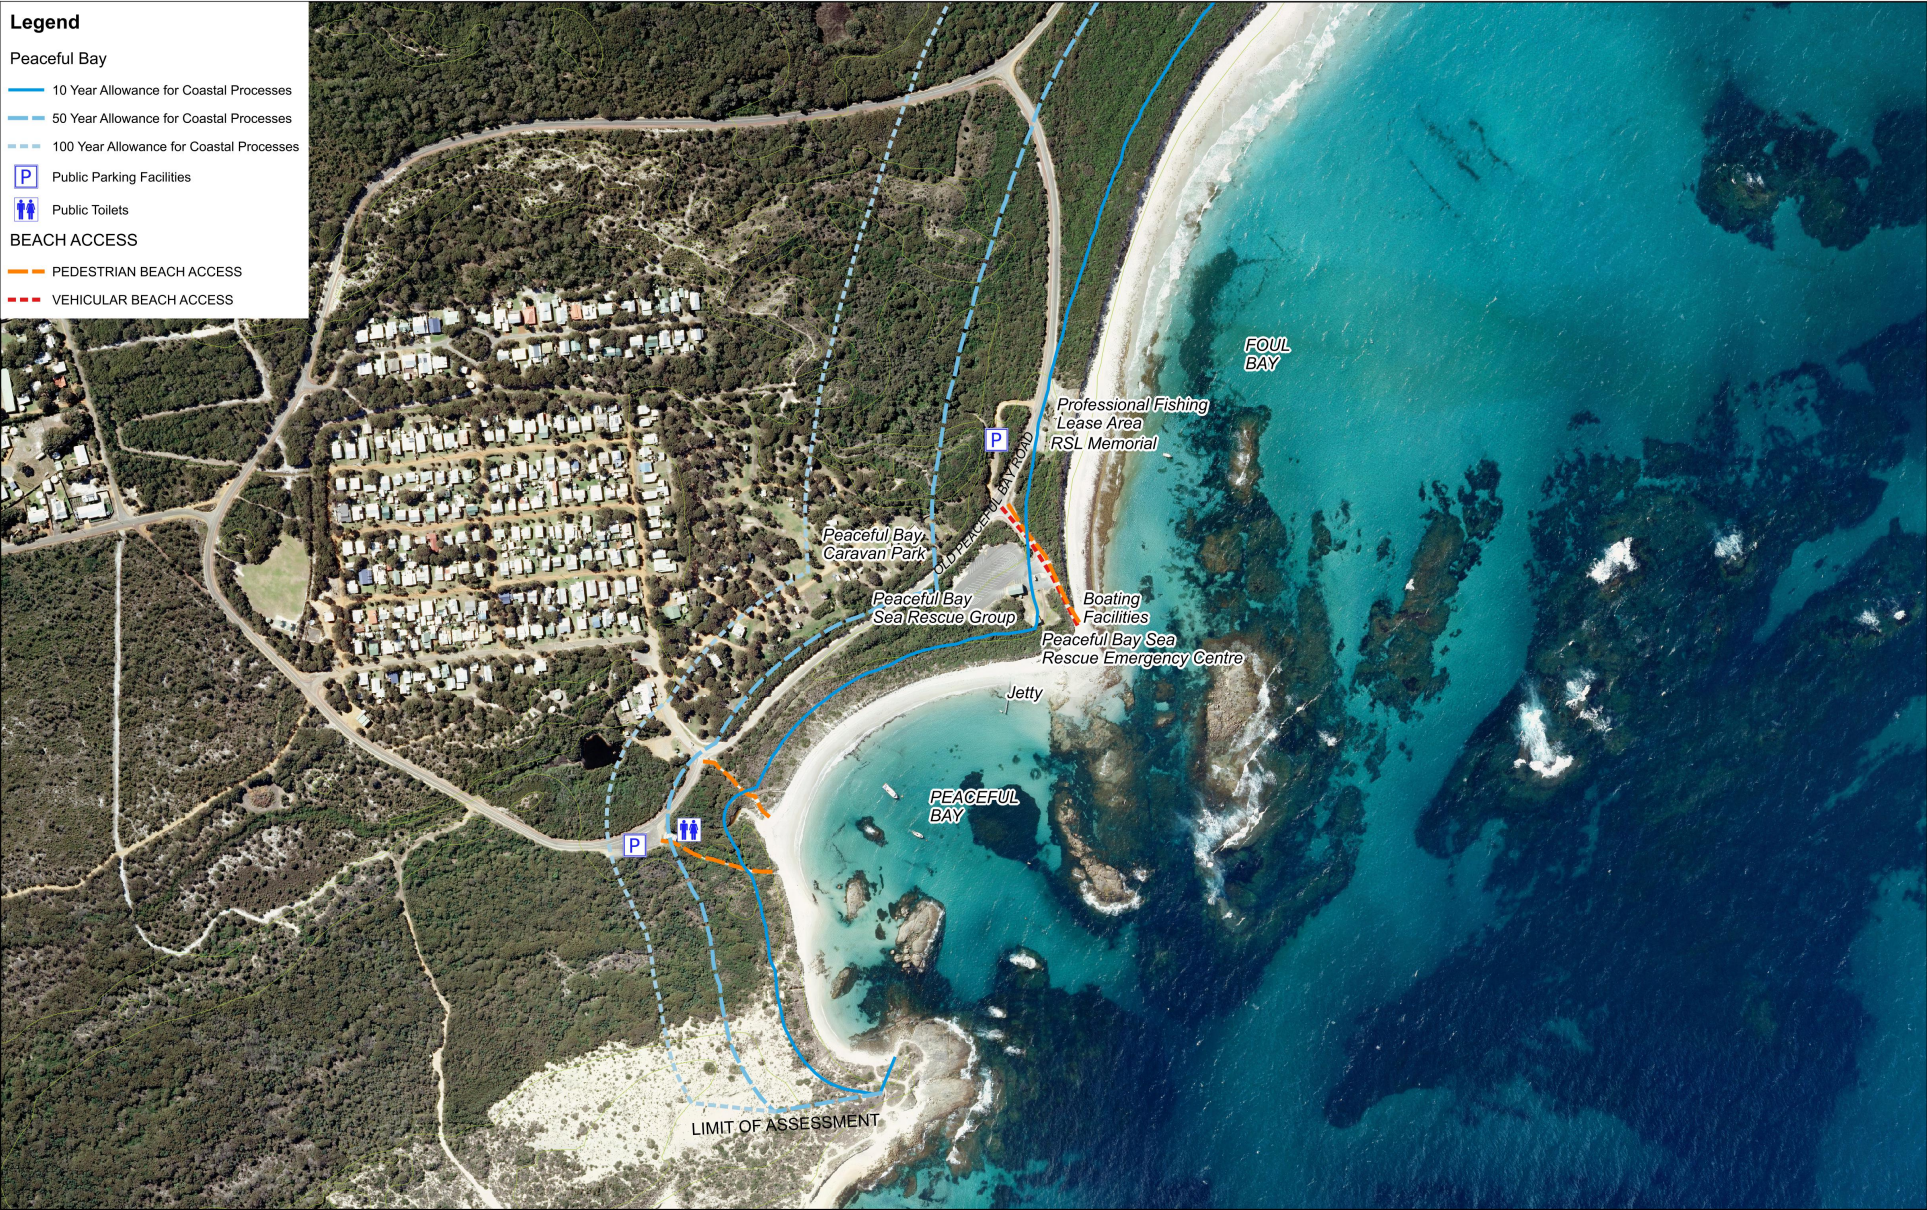
DRAWING NUMBER SE050-01-01

- 10 Year Allowance for Coastal Processes
- 50 Year Allowance for Coastal Processes
- 100 Year Allowance for Coastal Processes

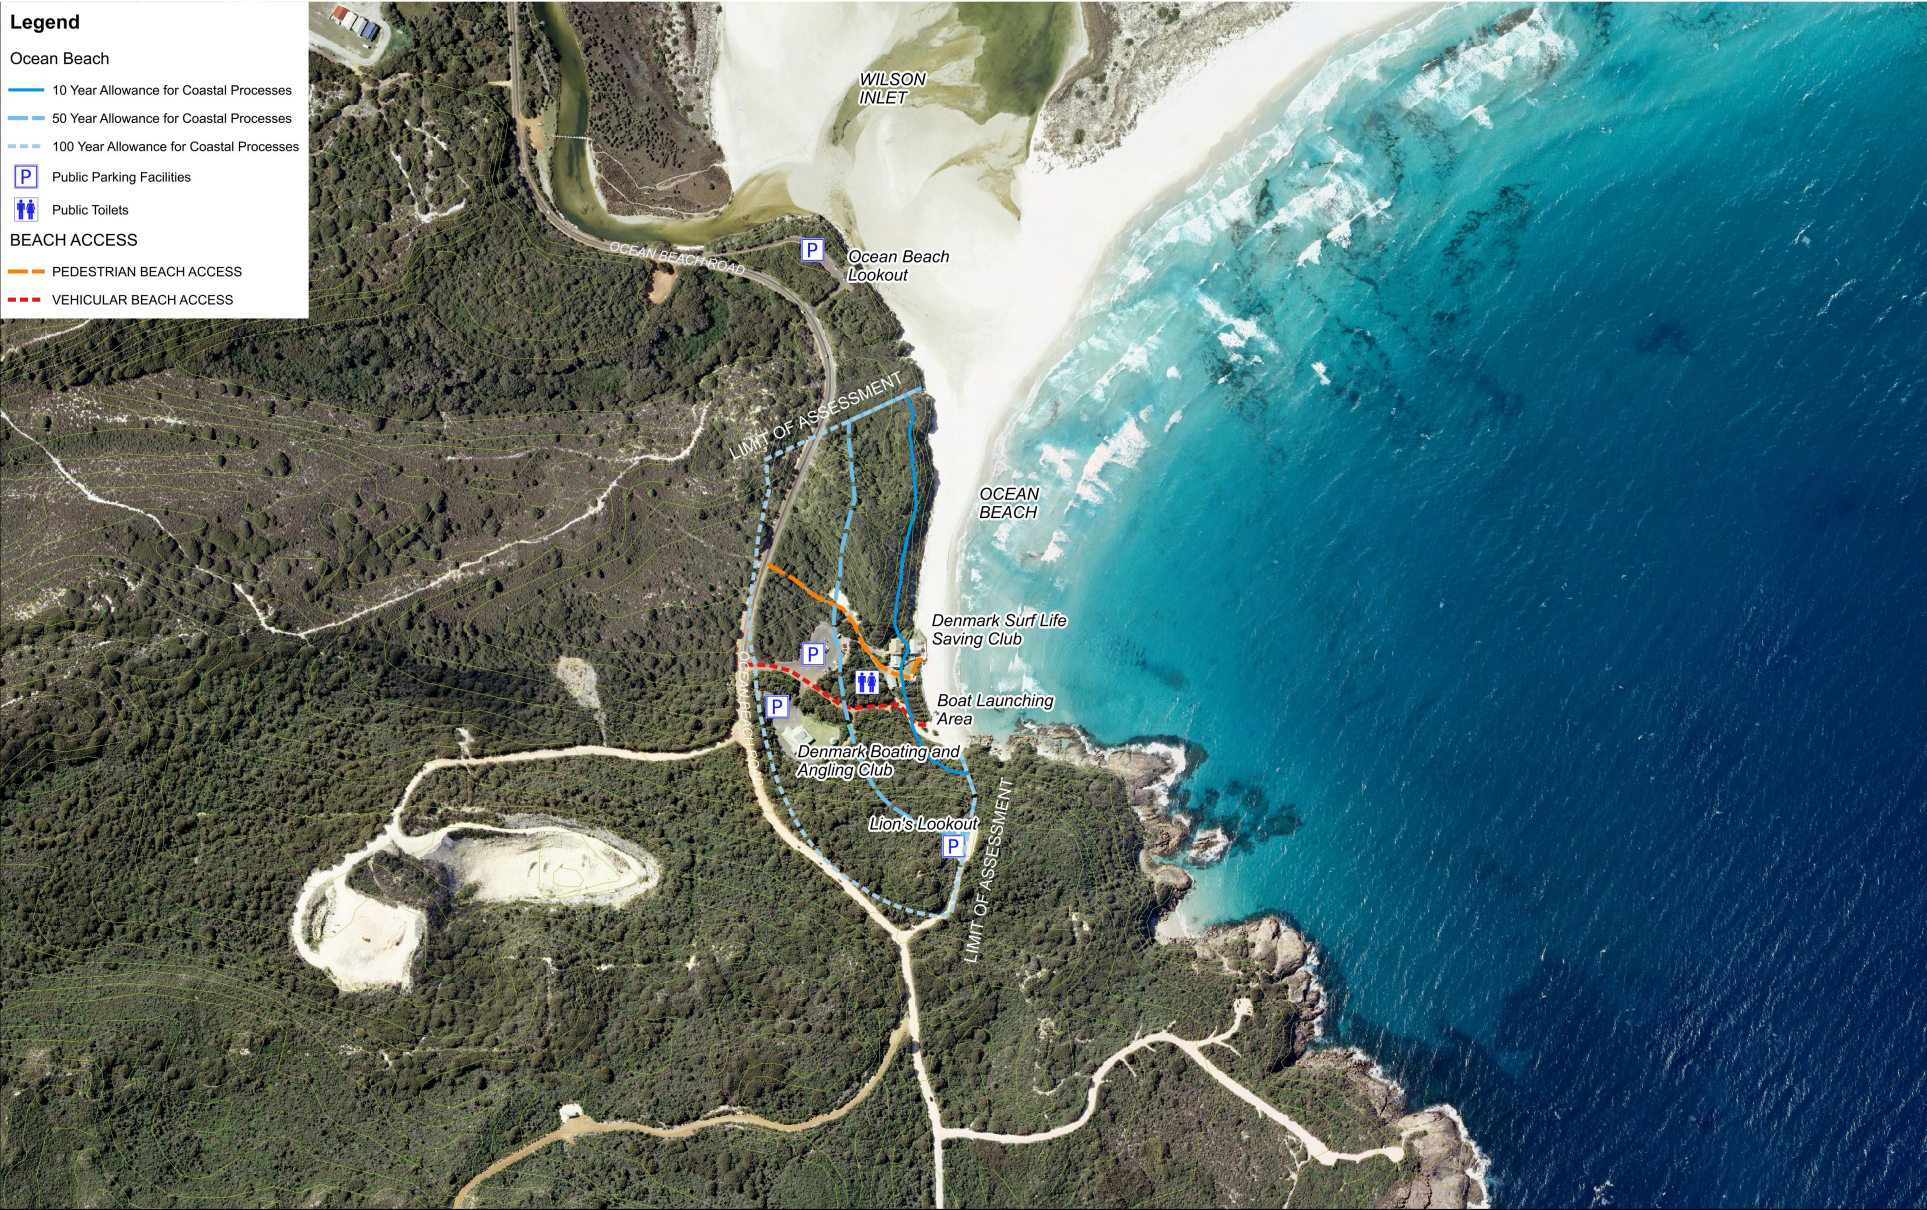
APPROVED PROJECT MANAGER				DRAWING NUMBER SE050-01-02		REV C

- 10 Year Allowance for Coastal Processes
- 50 Year Allowance for Coastal Processes
- 100 Year Allowance for Coastal Processes

SHIRE OF DENMARK COASTAL HAZARD RISK MANAGEMENT AND ADAPTATION PLAN OCEAN BEACH ALLOWANCE FOR COASTAL PROCESSES	
C	31/05/18	FINAL	OS	SB	1. AERIAL IMAGE JANUARY 2018 2. CONTOURS FROM LANDSAT 3. COASTAL EROSION ALLOWANCES HAVE BEEN DETERMINED USING METHODS OUTLINED IN SCHEDULE 1 OF SP/CA 4. ALLOWANCES ARE BASED ON AVAILABLE DATA AT THE TIME OF STUDY 5. ALLOWANCES ARE NOT A PREDICTION OF THE SHORELINE POSITION AT THE END OF THE RESPECTIVE PLANNING PERIODS 6. THESE PLANS DO NOT HAVE THE PRECISION REQUIRED TO DEFINE THE EROSION RISK TO INDIVIDUAL PROPERTIES 7. ALLOWANCES FOR COASTAL PROCESSES HAVE BEEN ROUNDED TO THE NEAREST 5 METERS AND HAVE BEEN OFFSET FROM THE HORIZONTAL SETBACK DATUM (HSD) 8. THE HSD IS DEFINED AS THE 15m AND 50m CONTOUR, WHICH IS NORMALLY THE VEGETATION LINE 9. COASTAL HAZARDS IN THE VICINITY OF LIMESTONE CLIFFS REQUIRE FURTHER ASSESSMENT BY A GEOTECHNICAL ENGINEER. UNDERLYING ROCK HAS THE POTENTIAL TO SIGNIFICANTLY AFFECT THE EXTENT OF COASTAL HAZARD.	50	0		50	100	150	200	ENGINEER	SB			22/12/16

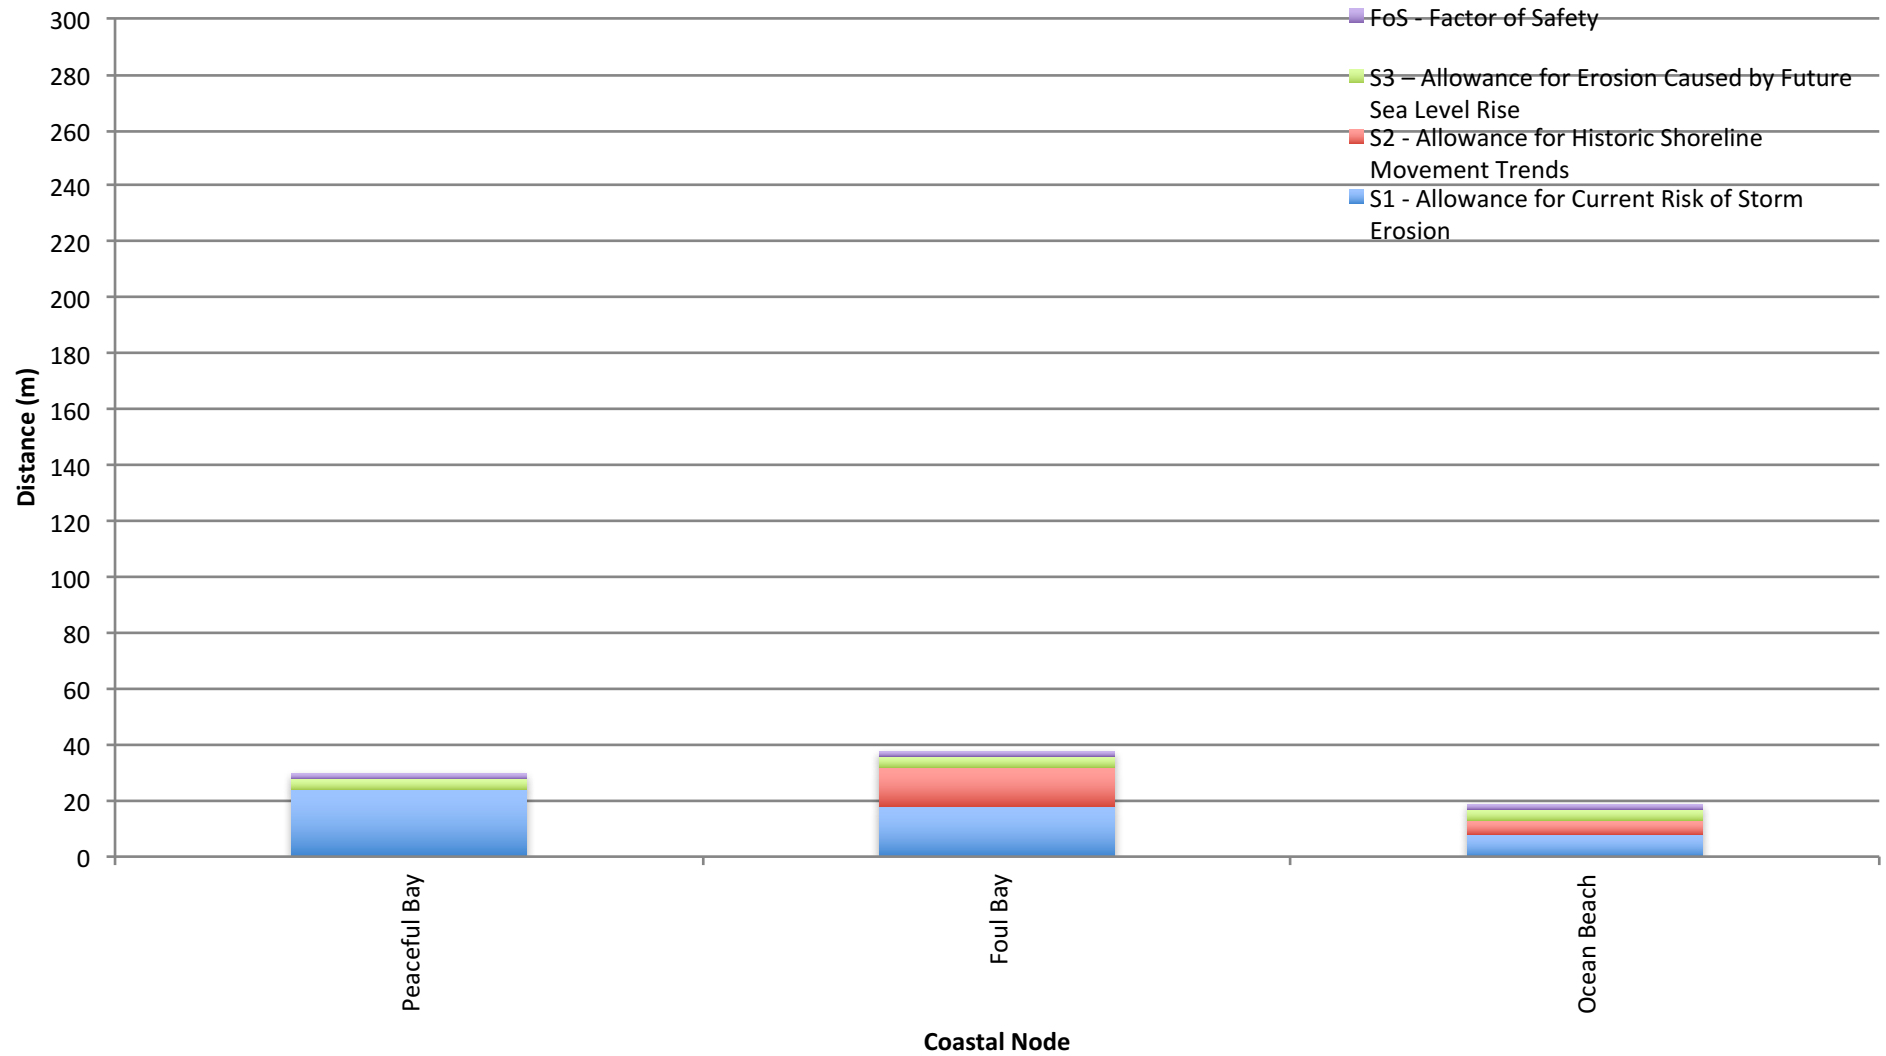
10 Year Coastal Processes Allowance from HSD

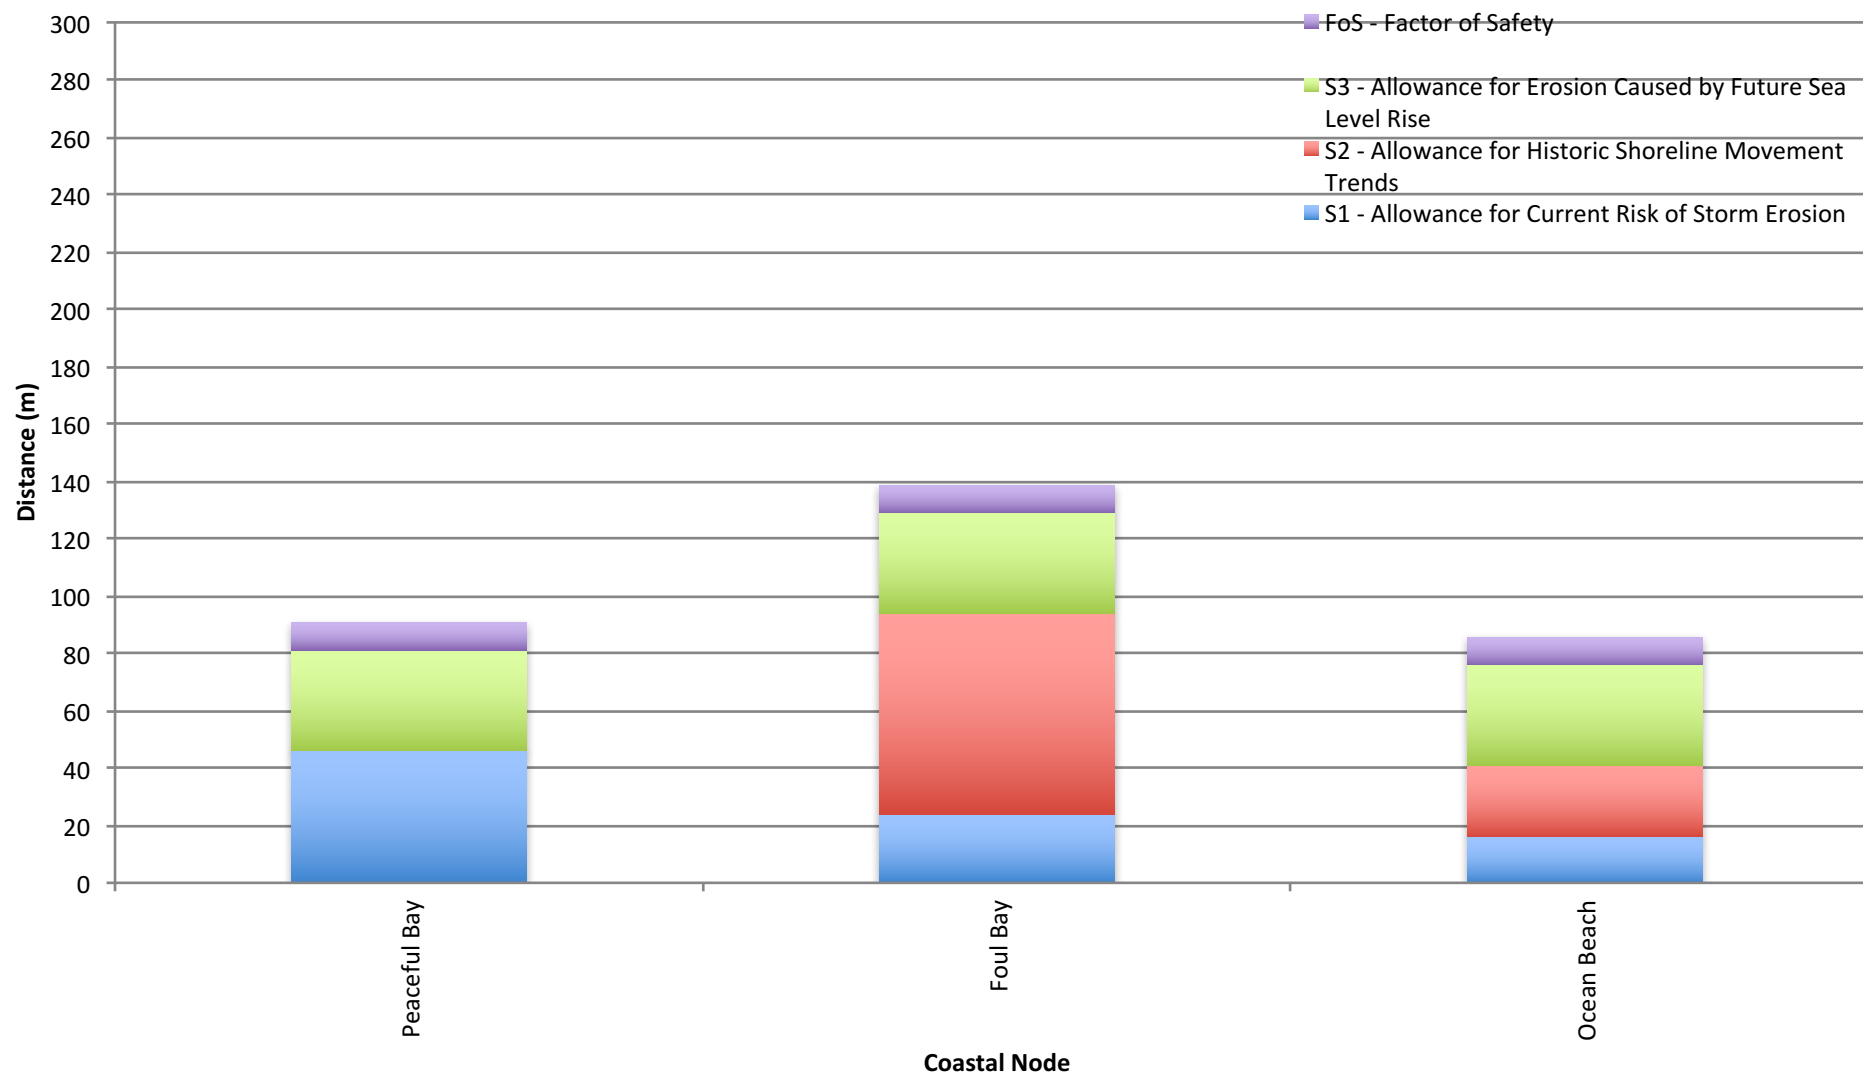
50 Year Coastal Processes Allowance from HSD

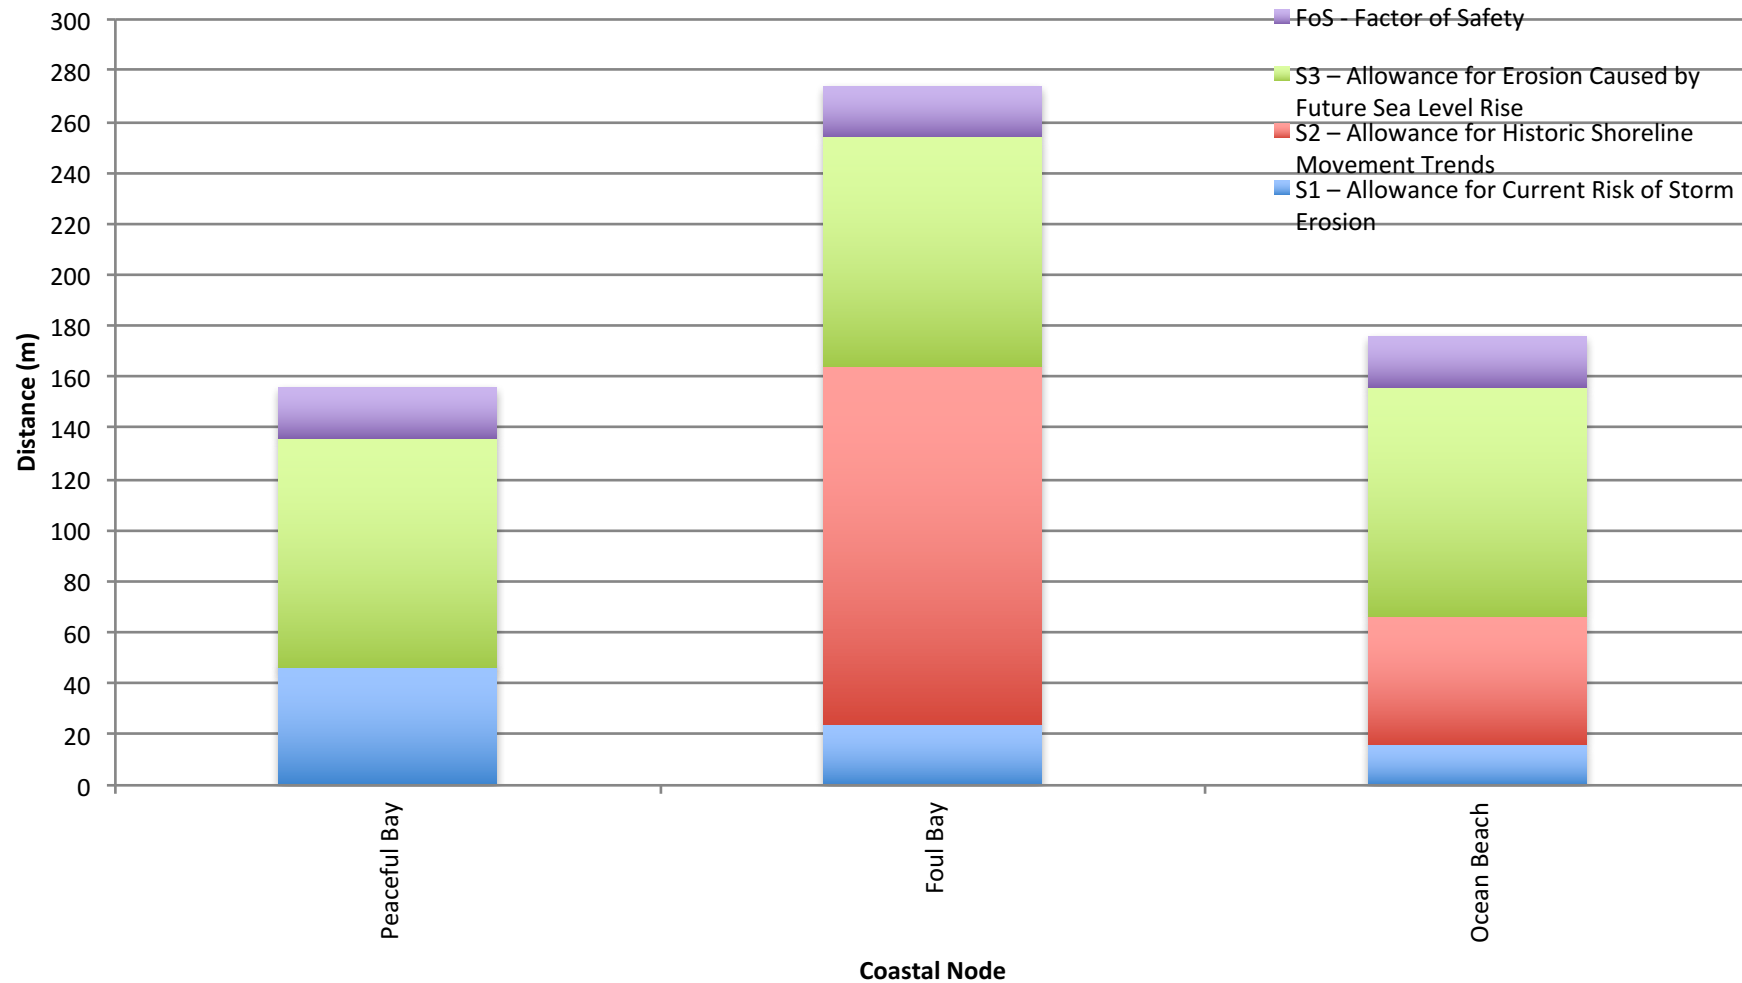
100 Year Coastal Processes Allowance from HSD

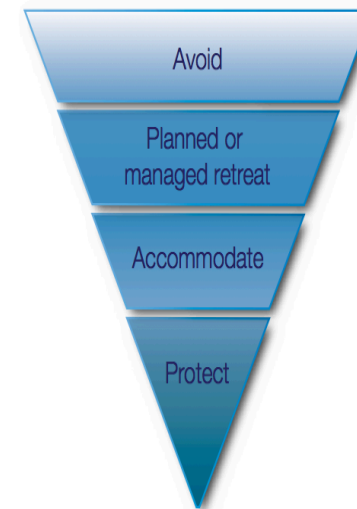
Risk Management and Adaptation Hierarchy (CHRM Guidelines)

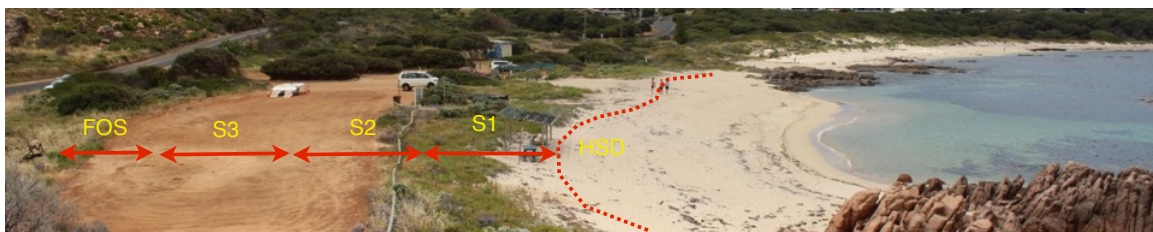
Figure 1: Concept for the assessment of coastal processes allowances under SPP2.6 as applied to Gracetown Beach for Augusta Margaret River CHRMAP.

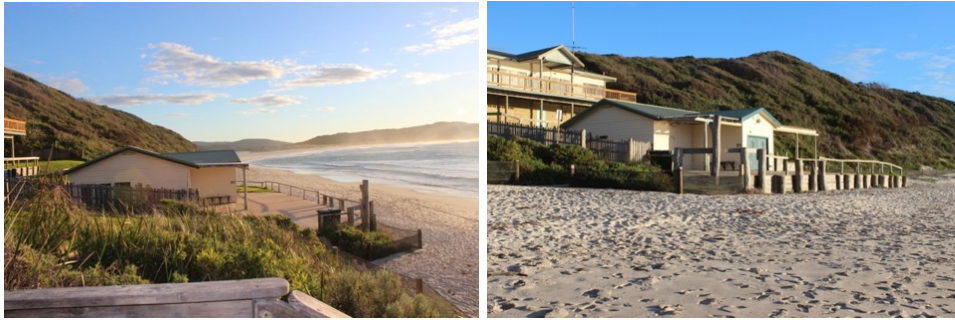
Figure 2: Ocean Beach During Reconnaissance Site Inspection (June 2016)

Ocean Beach is an east facing high-energy sandy beach popular for swimming, surfing and boating; and has been subject to coastal erosion in the late 1990's, 2013 and 2016. Coastal infrastructure and beach access is provided along a 400m section at the southern end of the beach, between the granite rock outcrops and the entrance to the seasonally open Wilson Inlet. This is the main recreational ocean beach for the Town of Denmark and is used for commercial and club based activities. Redevelopment of the Surf Life Saving Club is proposed at some time in the future.

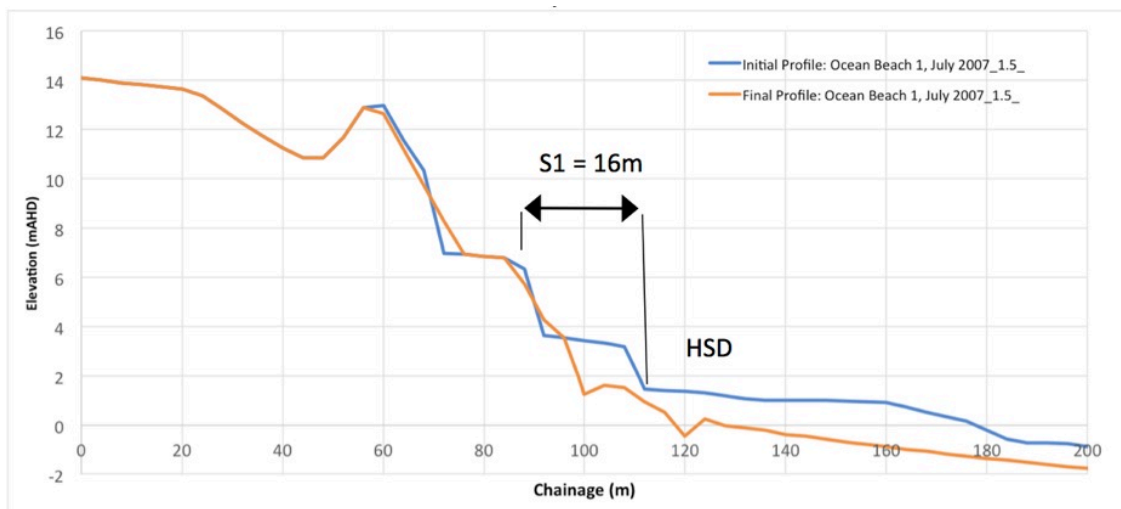
Figure 3: SBEACH erosion model for 100-year average return interval storm.

- Figure 3 – “HSD” needs defining
 - Change “surf club” to Denmark Surf Life Saving Club (can abbreviate after first mention).
 - Table 1 and 2 – would it be easier to understand if the full table from the Hazard Assessment was included? Could then delete some of the text above it.

To identify historic storms with high water levels or high waves, 11 years of wave records and 29 years of water level records were assessed from Albany, the closest available records. Cross-shore beach erosion modeling for a 1 in 100yr event was undertaken using the USACE's SBEACH one-line model at a typical beach profile along Ocean Beach. The initial (pre-storm) and final (post-storm) beach profiles output from the model are shown in Figure 3. The assumed allowance for Acute Storm Erosion (S1) was 16 meters.

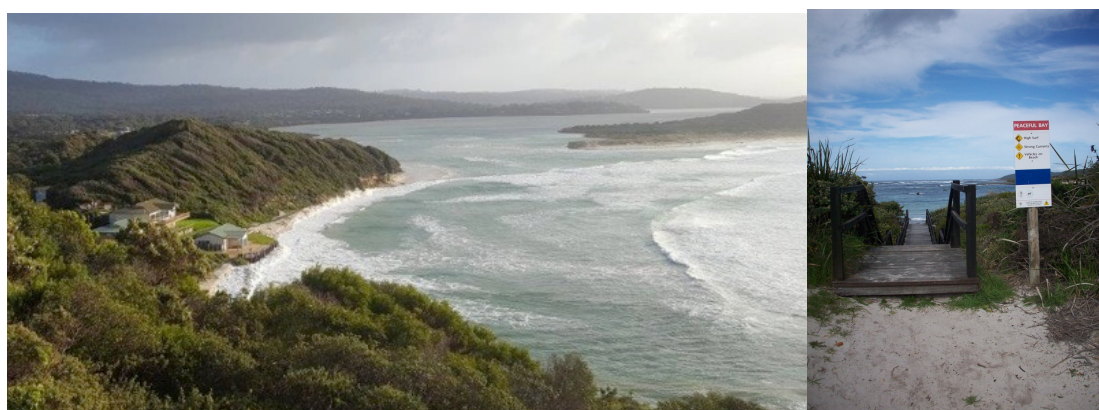
Figure 4: Ocean Beach during a storm in September 2016 and Peaceful Bay Beach Access Stairs

- The design and present condition of the timber seawall and its capacity to provide longer-term protection. This wall provides important protection to the old Denmark SLSC building.
- Ocean Beach has a number of structures located relatively high on the seaward face of steep dunes. The risk of reduced foundation capacity for these structures following an erosion event, due to slope stability issues, requires consideration.
- Beach access infrastructure is presently subject to ocean forces. Adaptation of these assets may be required in order to maintain a high level of public beach access.
- Future Denmark SLSC development requires careful consideration of coastal processes.
- The presence or otherwise of buried rock.
- The interplay between Wilson Inlet and the beach.

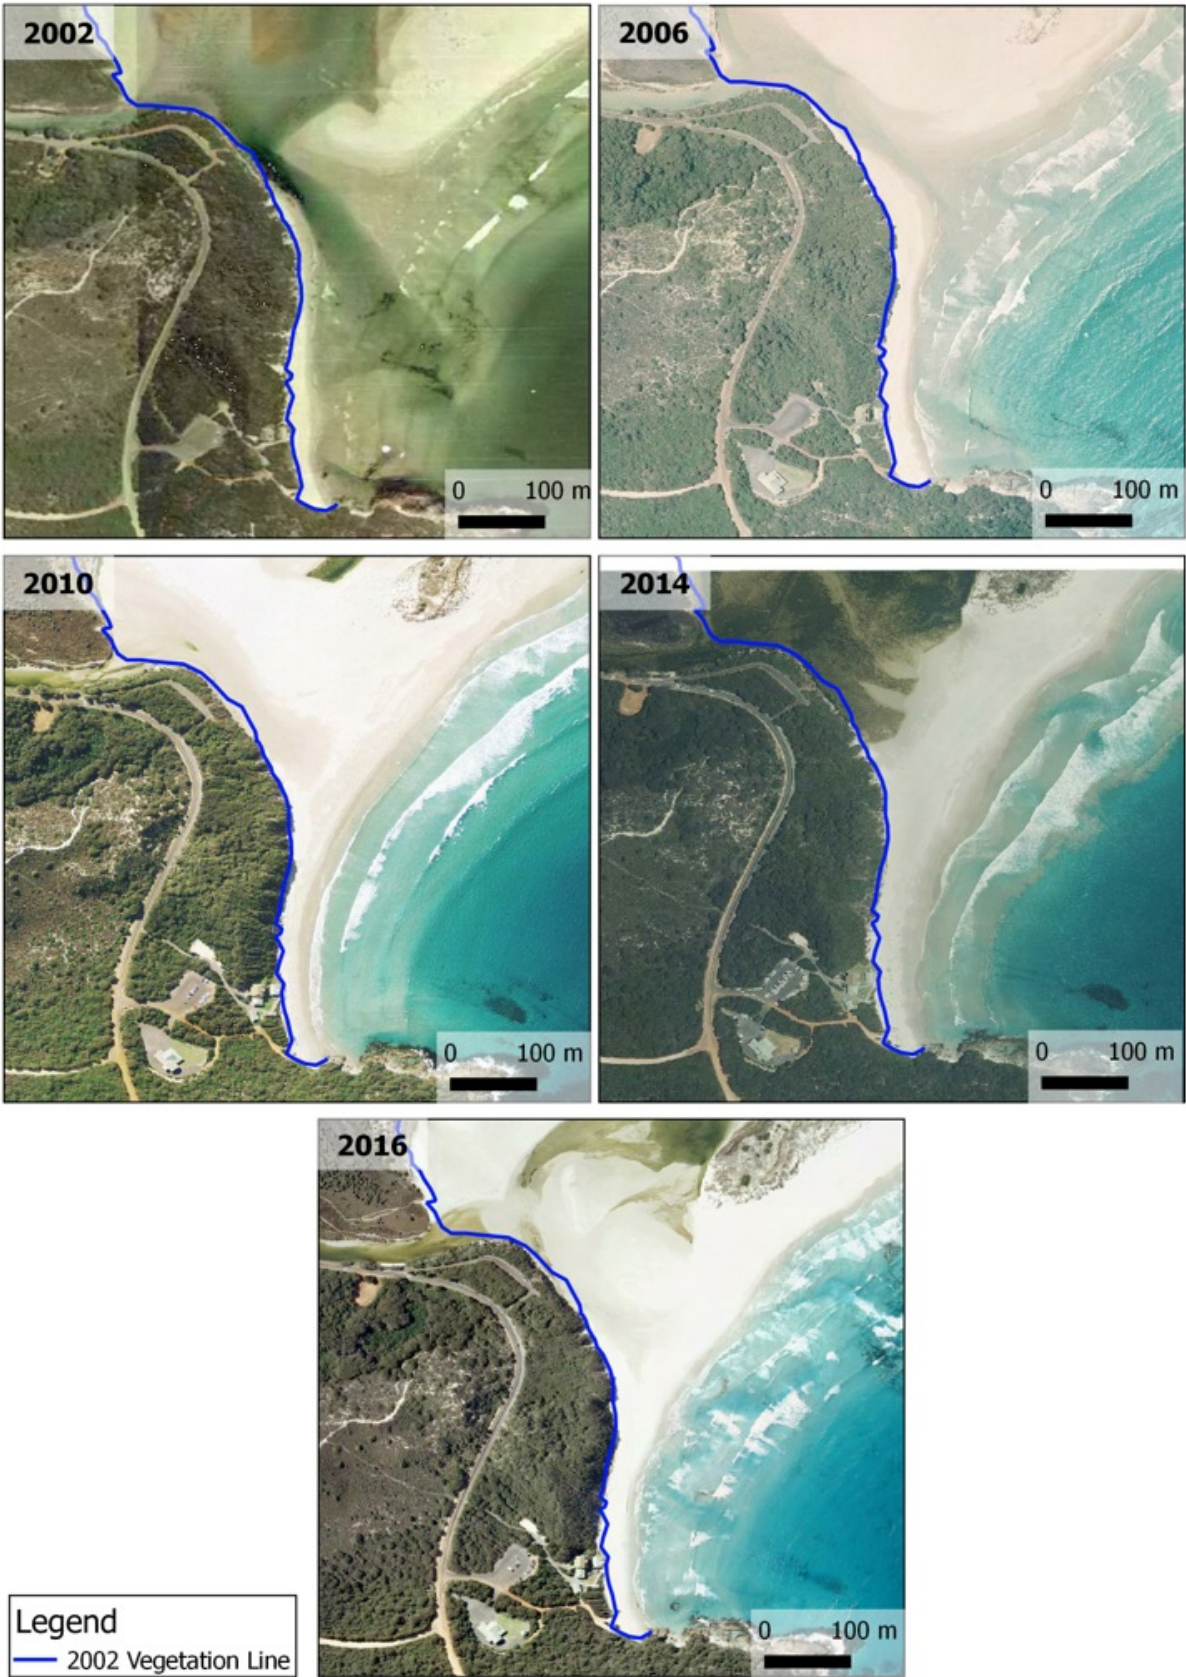
Figure 5: Historic Aerial Imagery for Ocean Beach

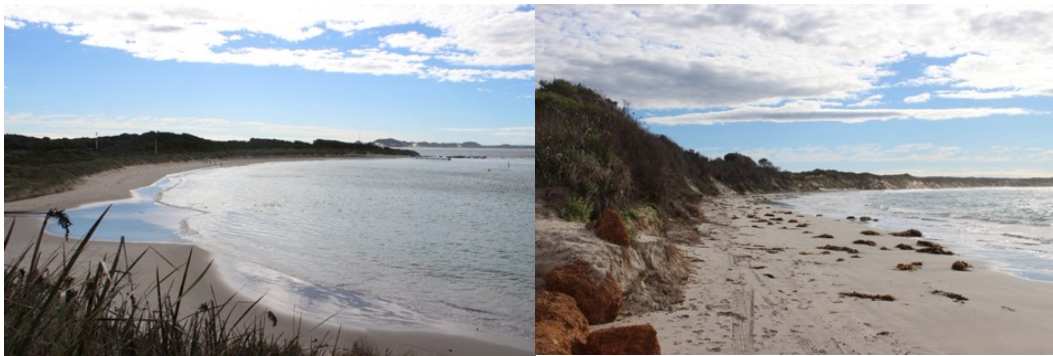
Figure 6: Sandy Beaches at Peaceful Bay (L) and Foul Bay to the North of the Boat Launching Area (R) During Reconnaissance Site Inspection (June 2016)

The coastline north of the Peaceful Bay boat launching area, in Foul Bay, has eroded approximately 15 m between 2002 and 2014, resulting in the retreat of sheds from a Fishermen's lease area. If the current rate of erosion continues, the Shire is concerned about future threats to Peaceful Bay Road, which is an access route for the townsite.

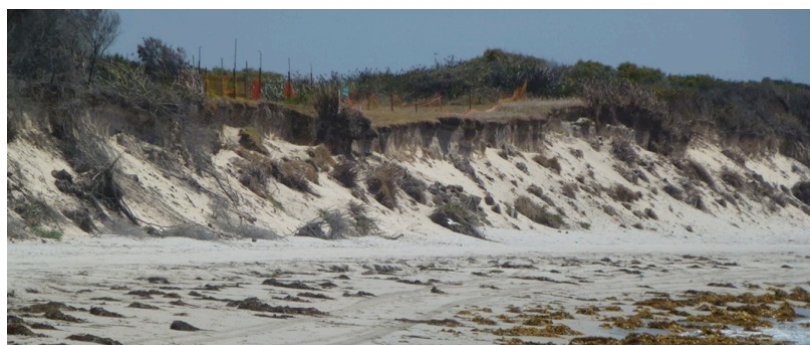
Figure 7: Peaceful Bay – Erosion Near Fisherman's Lease Area (Supplied by Shire)

- The nature of storm events that cause erosion at Peaceful Bay, and the capacity of these beaches to recover between erosive cycles.
- Beach access infrastructure is presently subject to ocean forces, and the design and adaptation of these structures is required to maintain a high level of public beach access.
- The observed erosion trend north of the boat ramp within Foul bay is significant and requires further consideration of potential causes and adaptation.
- The potential implications in longer term planning periods for the Peaceful Bay Road, Caravan Park and coastal residents require consideration.

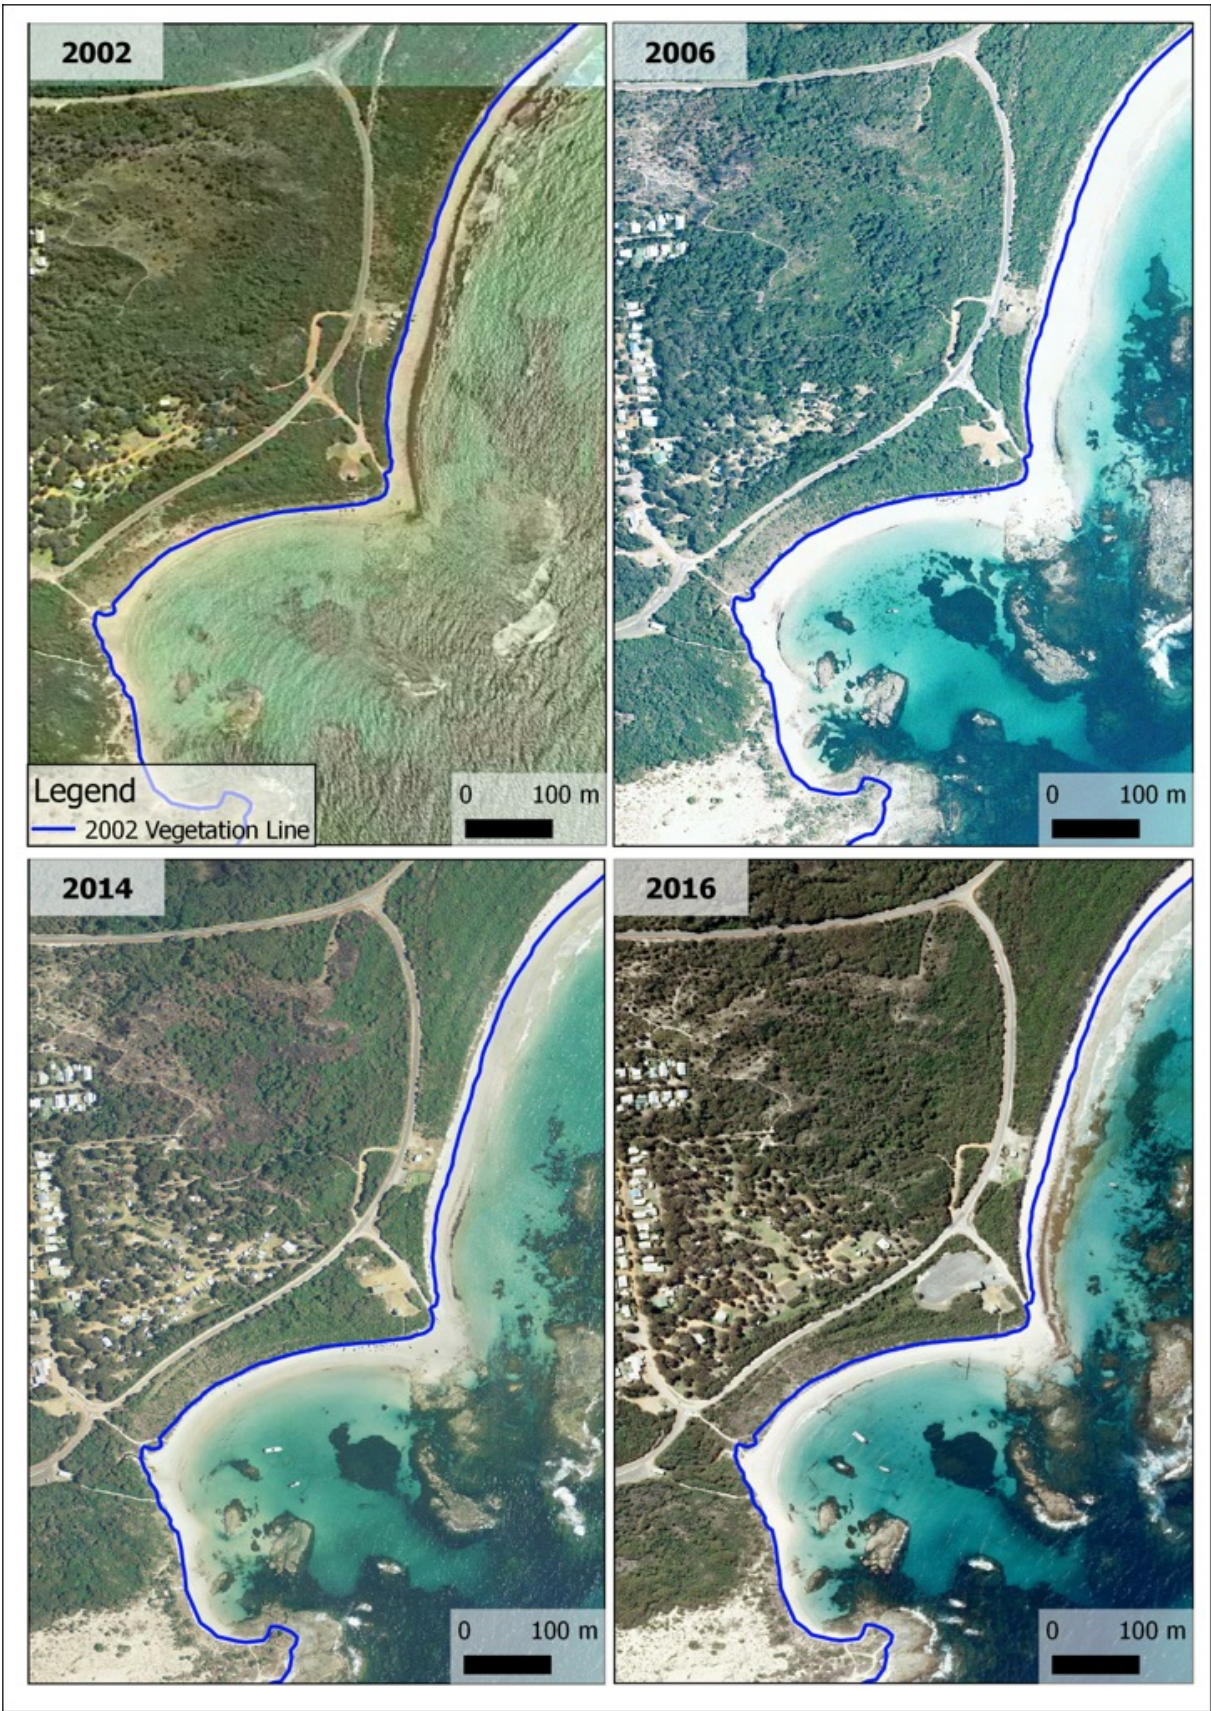
Figure 8 Peaceful Bay Aerial Imagery

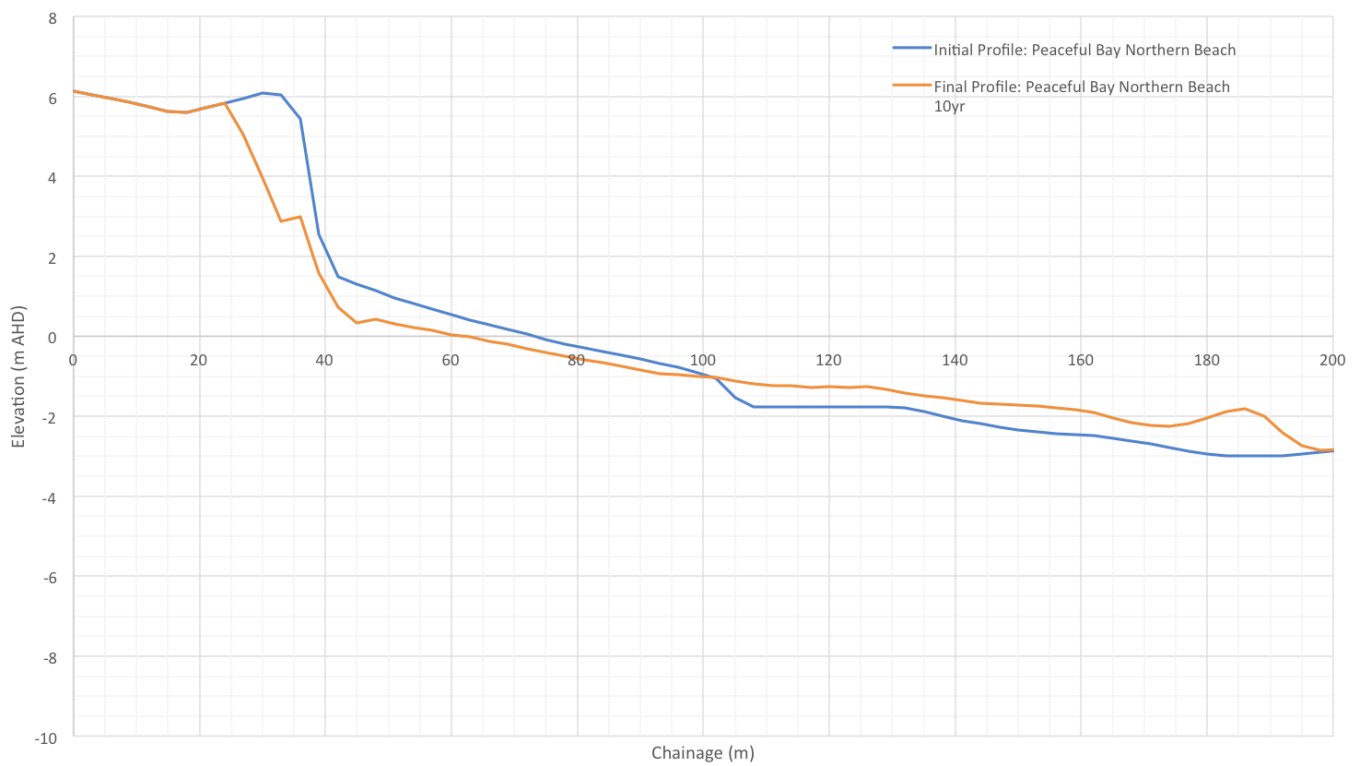
Peaceful Bay Northern Beach SBEACH 10yr Output

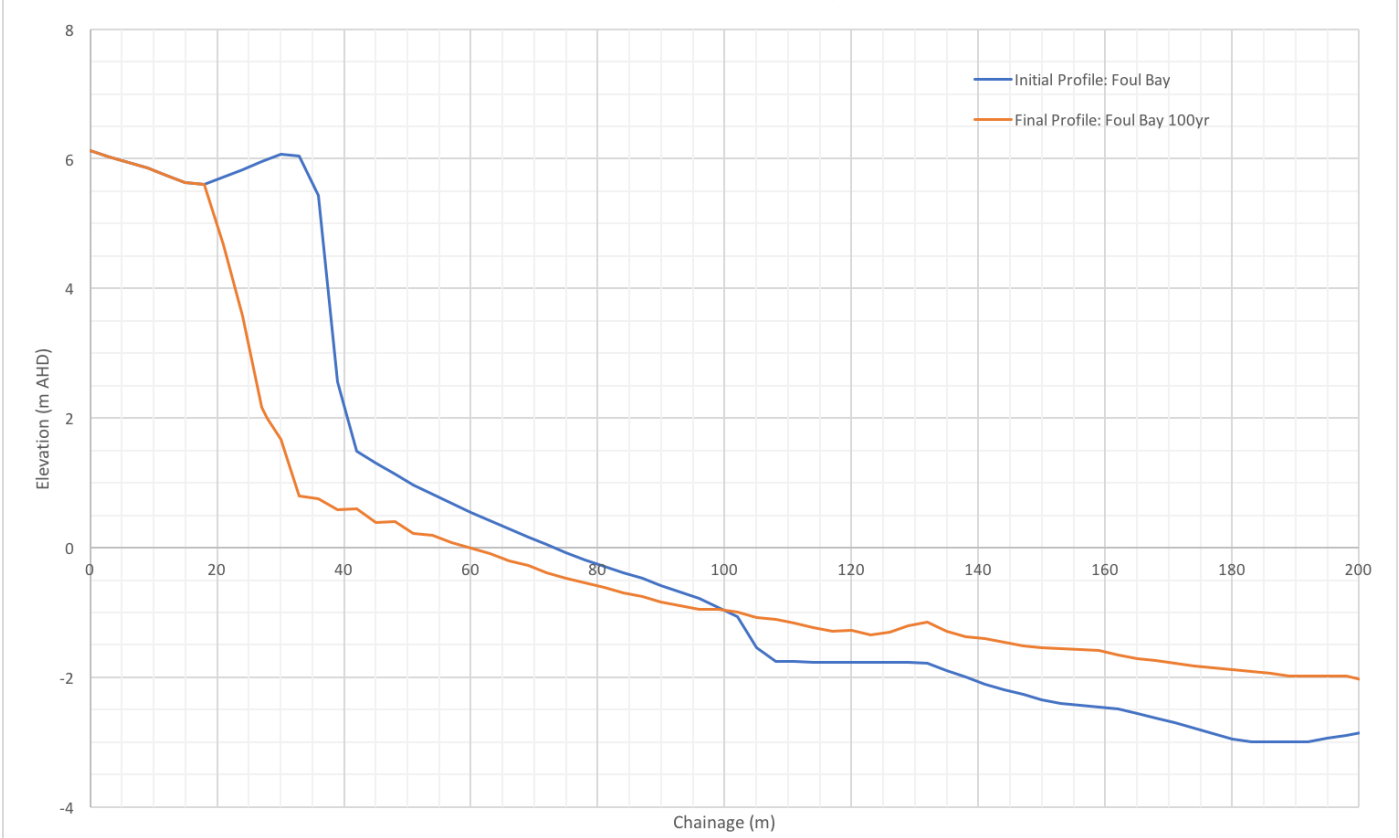
Foul Bay SBEACH 100yr Output

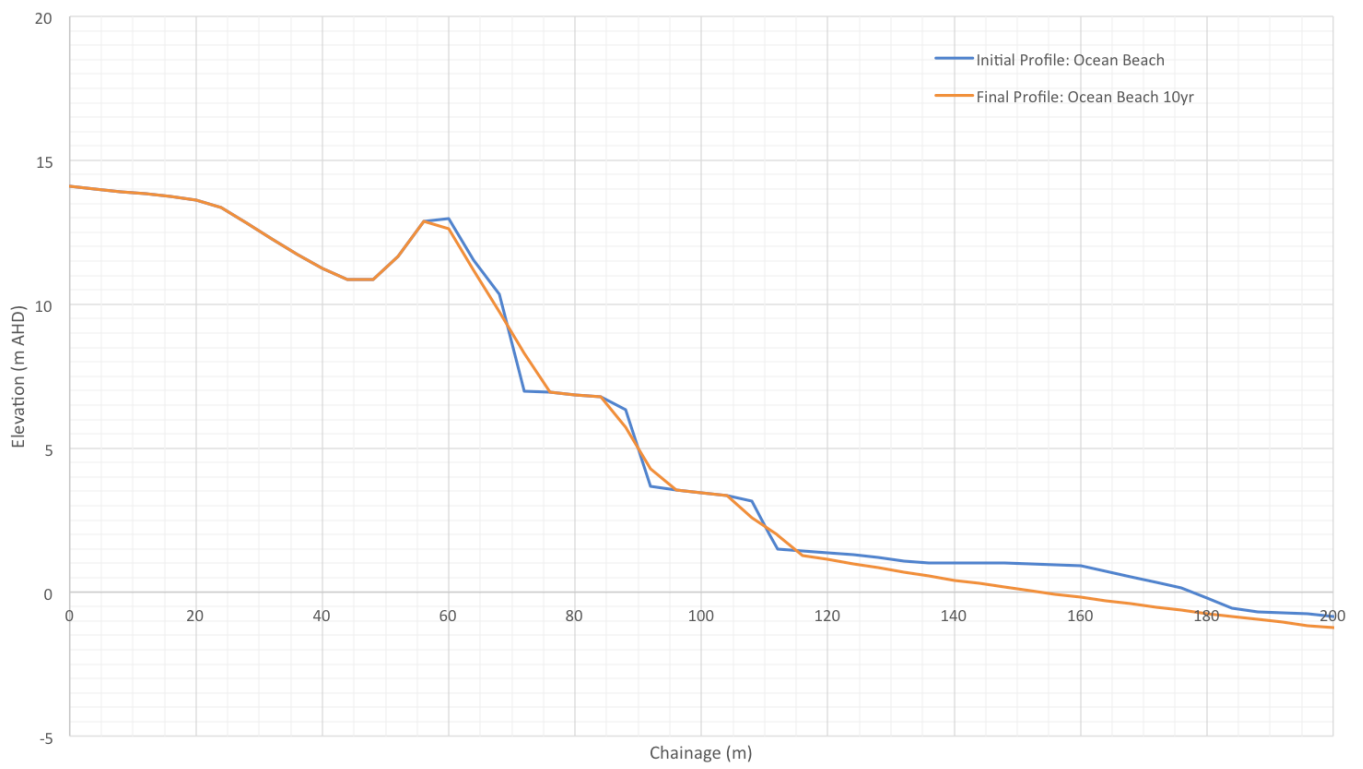
Ocean Beach SBEACH 10yr Output

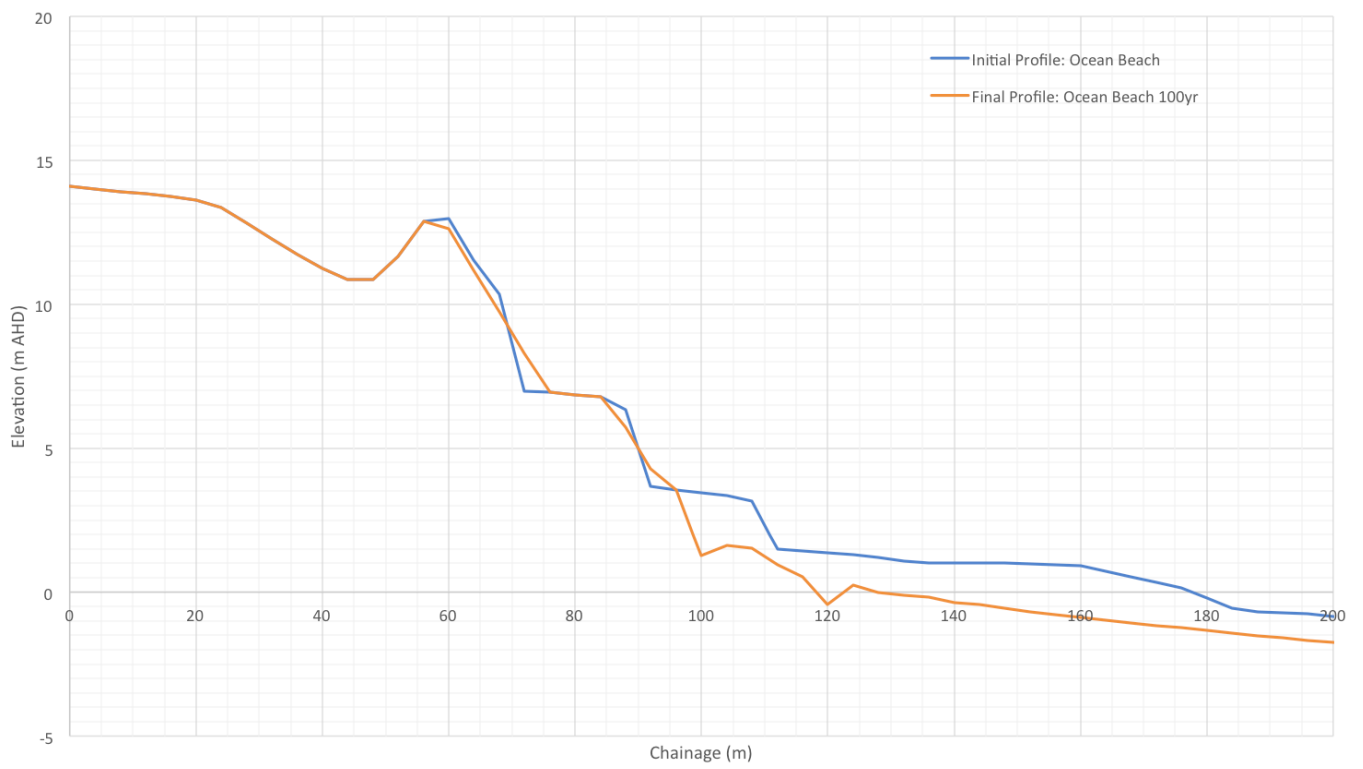
Ocean Beach SBEACH 100yr Output
