Attachment A Coastal Hazard Mapping

SHIRE OF DENMARK COASTAL HAZARD RISK MANAGEMENT AND ADAPTATION PLAN PEACEFUL BAY ALLOWANCE FOR COASTAL PROCESSES

Coastal Hazards Issues Paper

OCEAN BEACH and PEACEFUL BAY Shire of Denmark

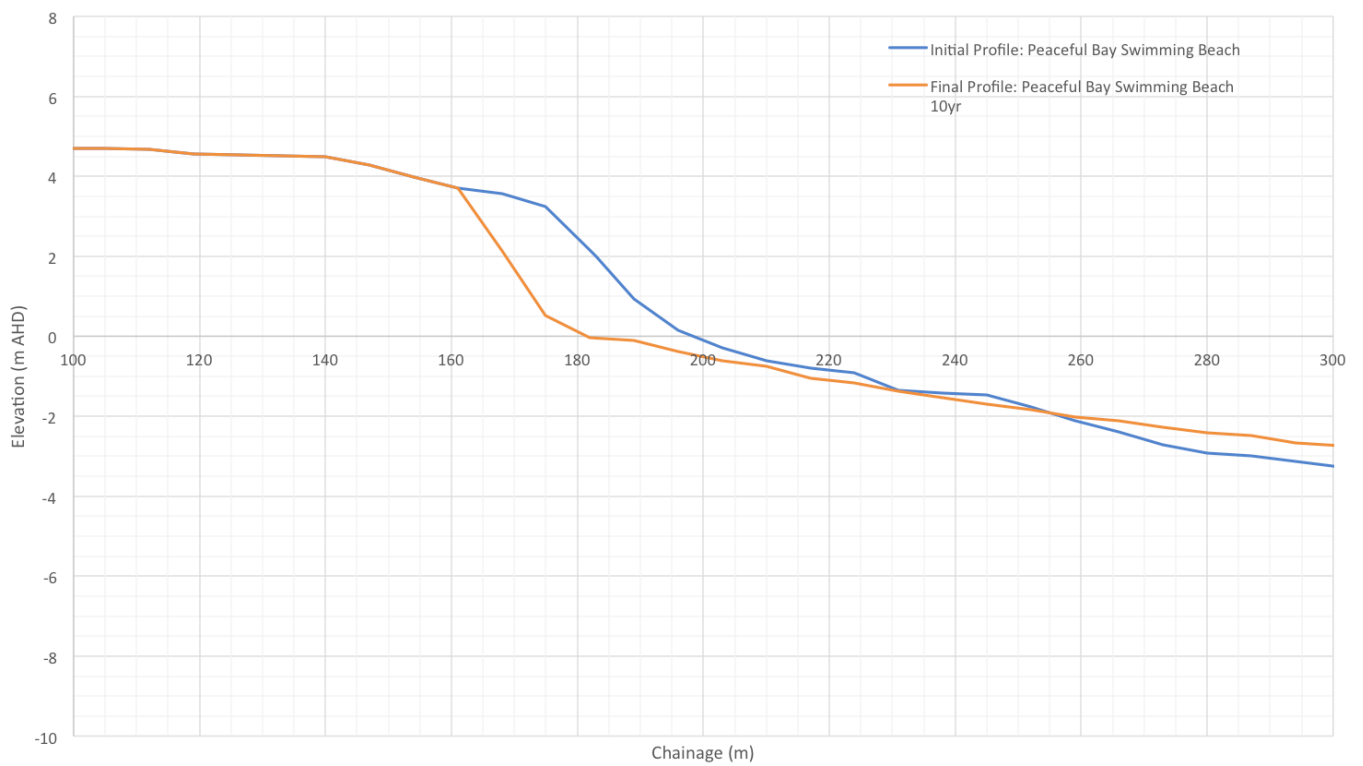
Peaceful Bay (Swimming Beach) SBEACH 10yr Output

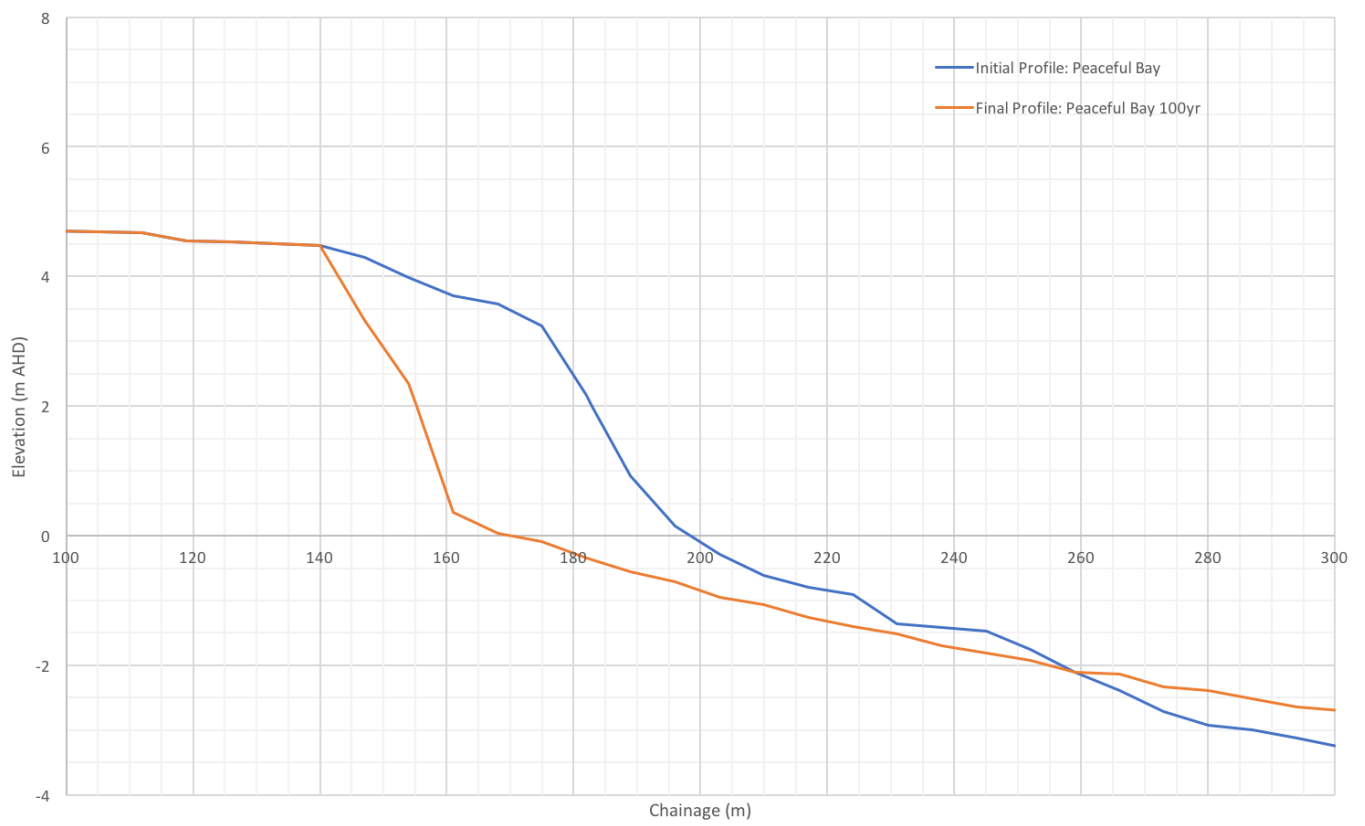
Peaceful Bay SBEACH 100yr Output

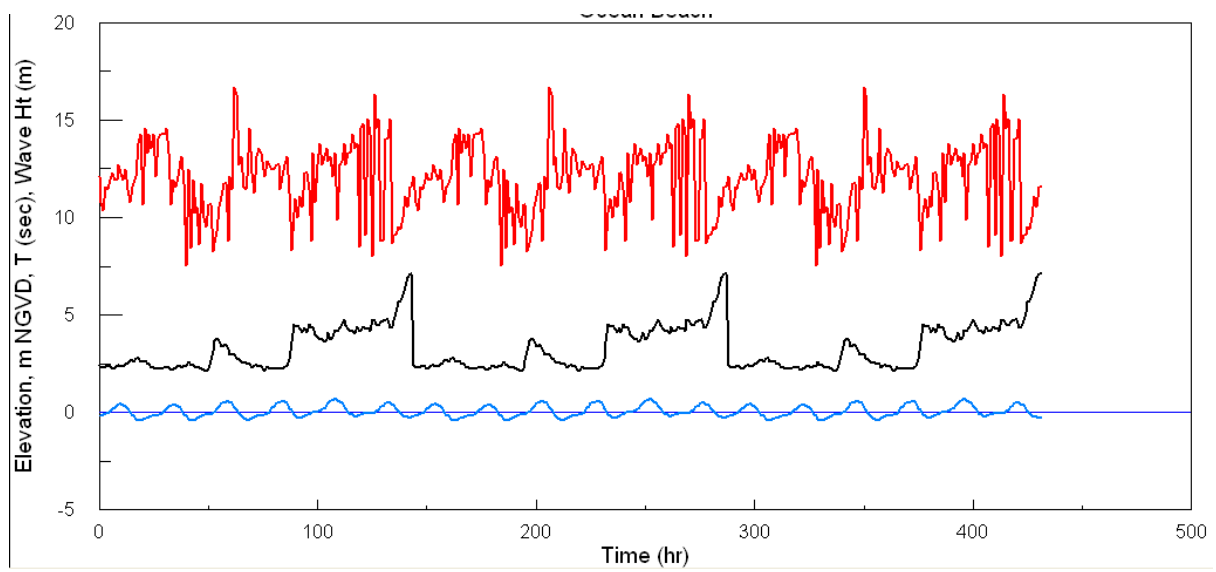
Storm July 2007_1.5

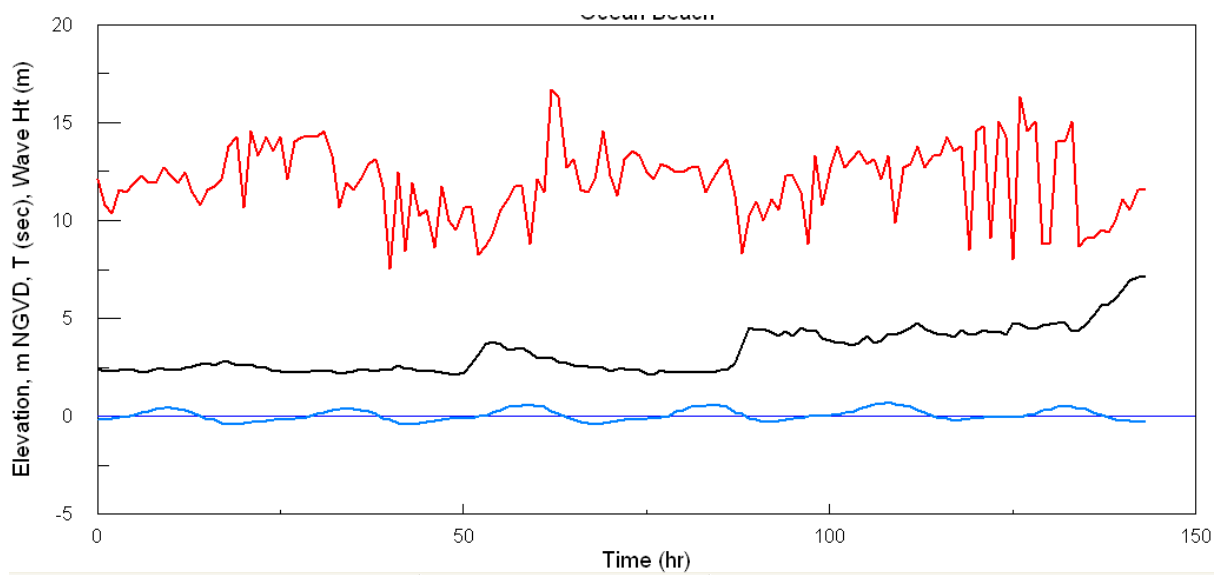
Storm July 2007_1_1.5
