Ocean Beach and Peaceful Bay

Coastal Monitoring Action Plan

CW1055200

Prepared for
Shire of Denmark

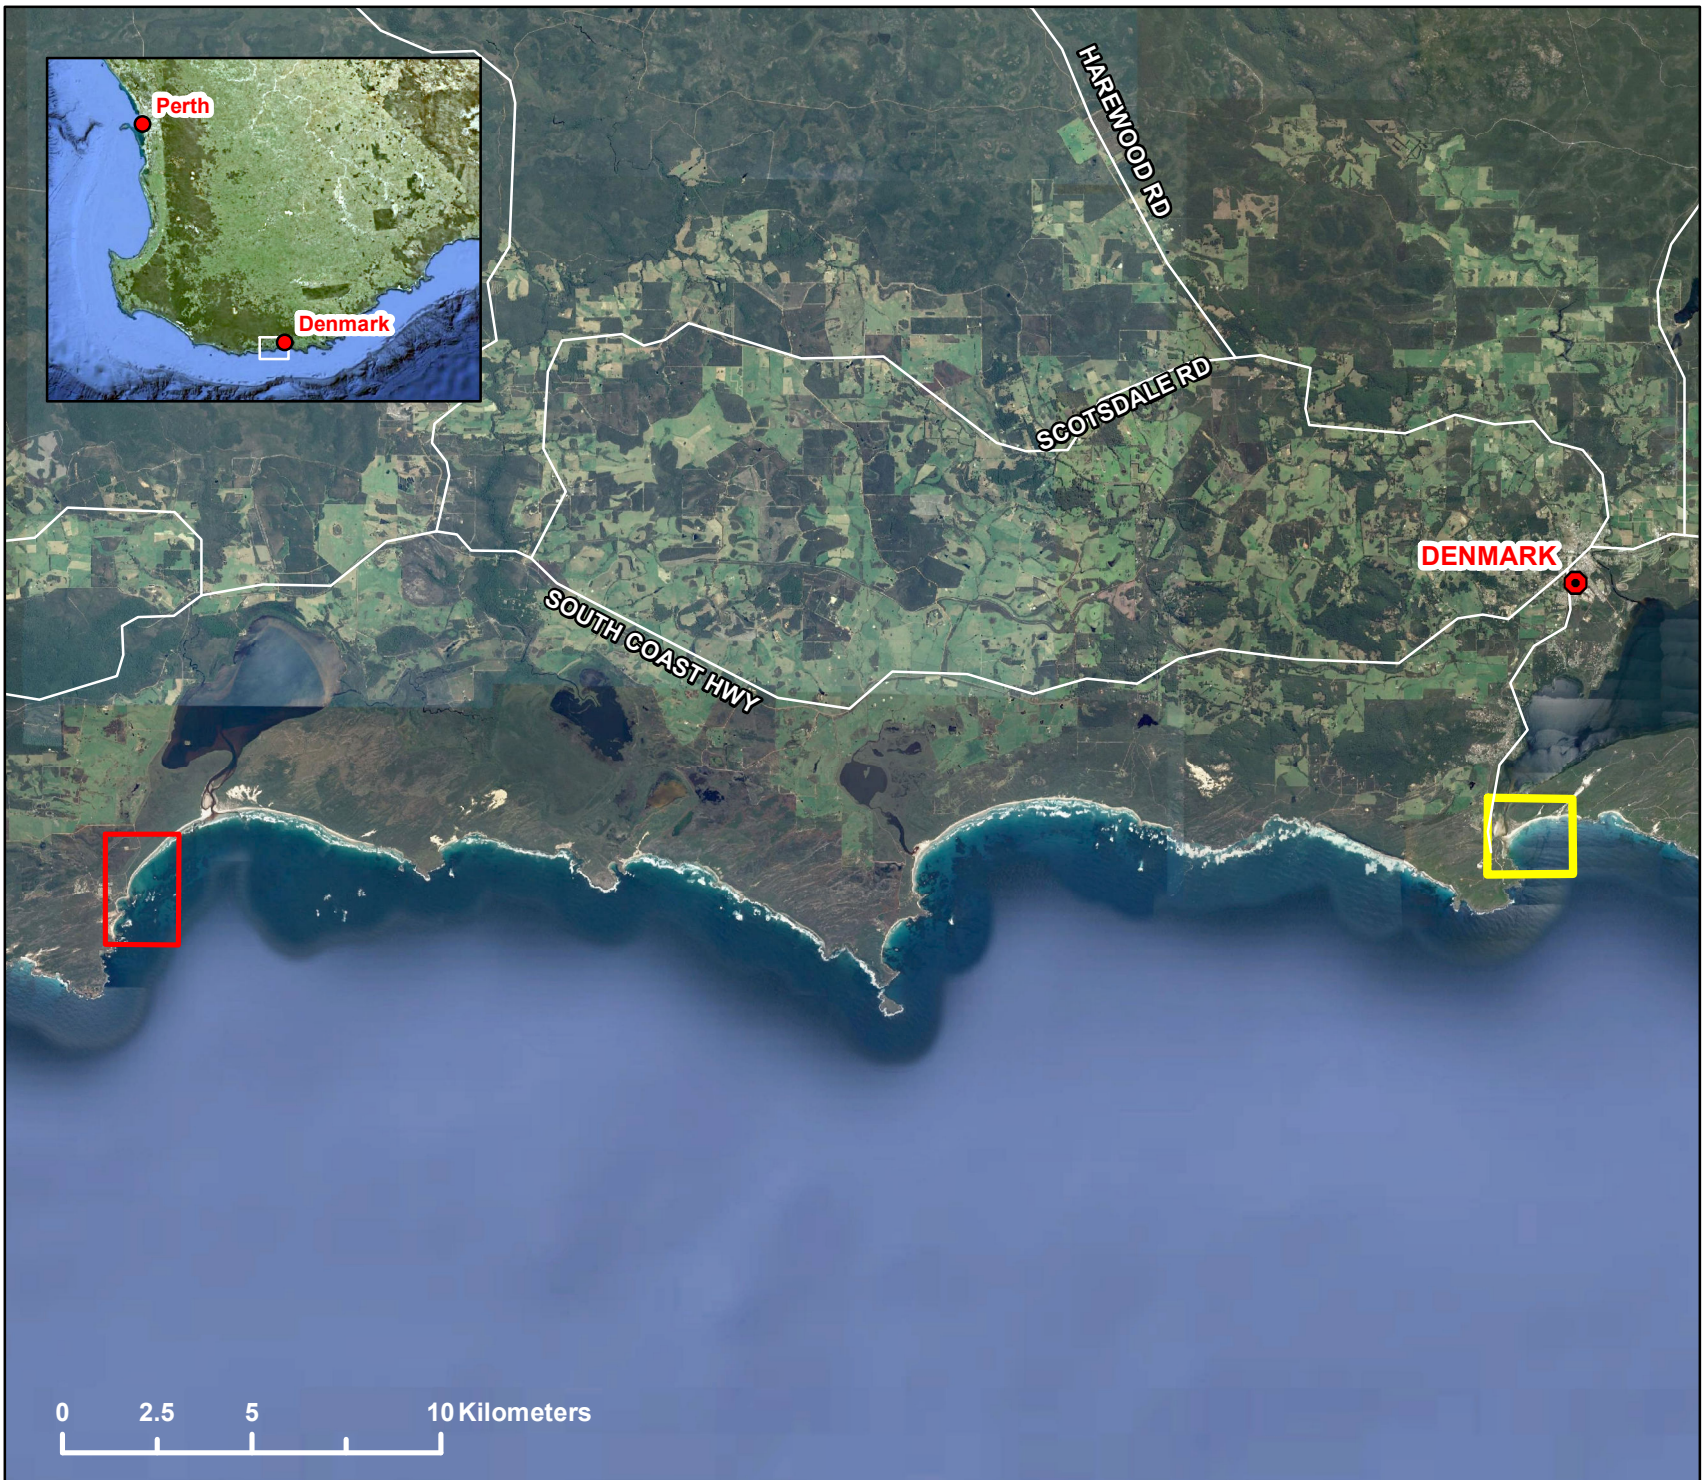
OCEAN BEACH AND PEACEFUL BAY
COASTAL MONITORING ACTION PLAN
FIGURE 1-1

Site Locations

Significant coastal development within the Shire is focused around Ocean Beach and Peaceful Bay (**Figure 1-1**), as these locations have been identified by the Shire as the highest value coastal reserves under their management. Infrastructure adjacent to Ocean Beach includes the Denmark Surf Life Saving Club, the Denmark Boating and Angling Club and a public car park. The Peaceful Bay Sea Rescue Emergency Centre lies adjacent to Peaceful Bay with a key access road also expected to be threatened in the future.

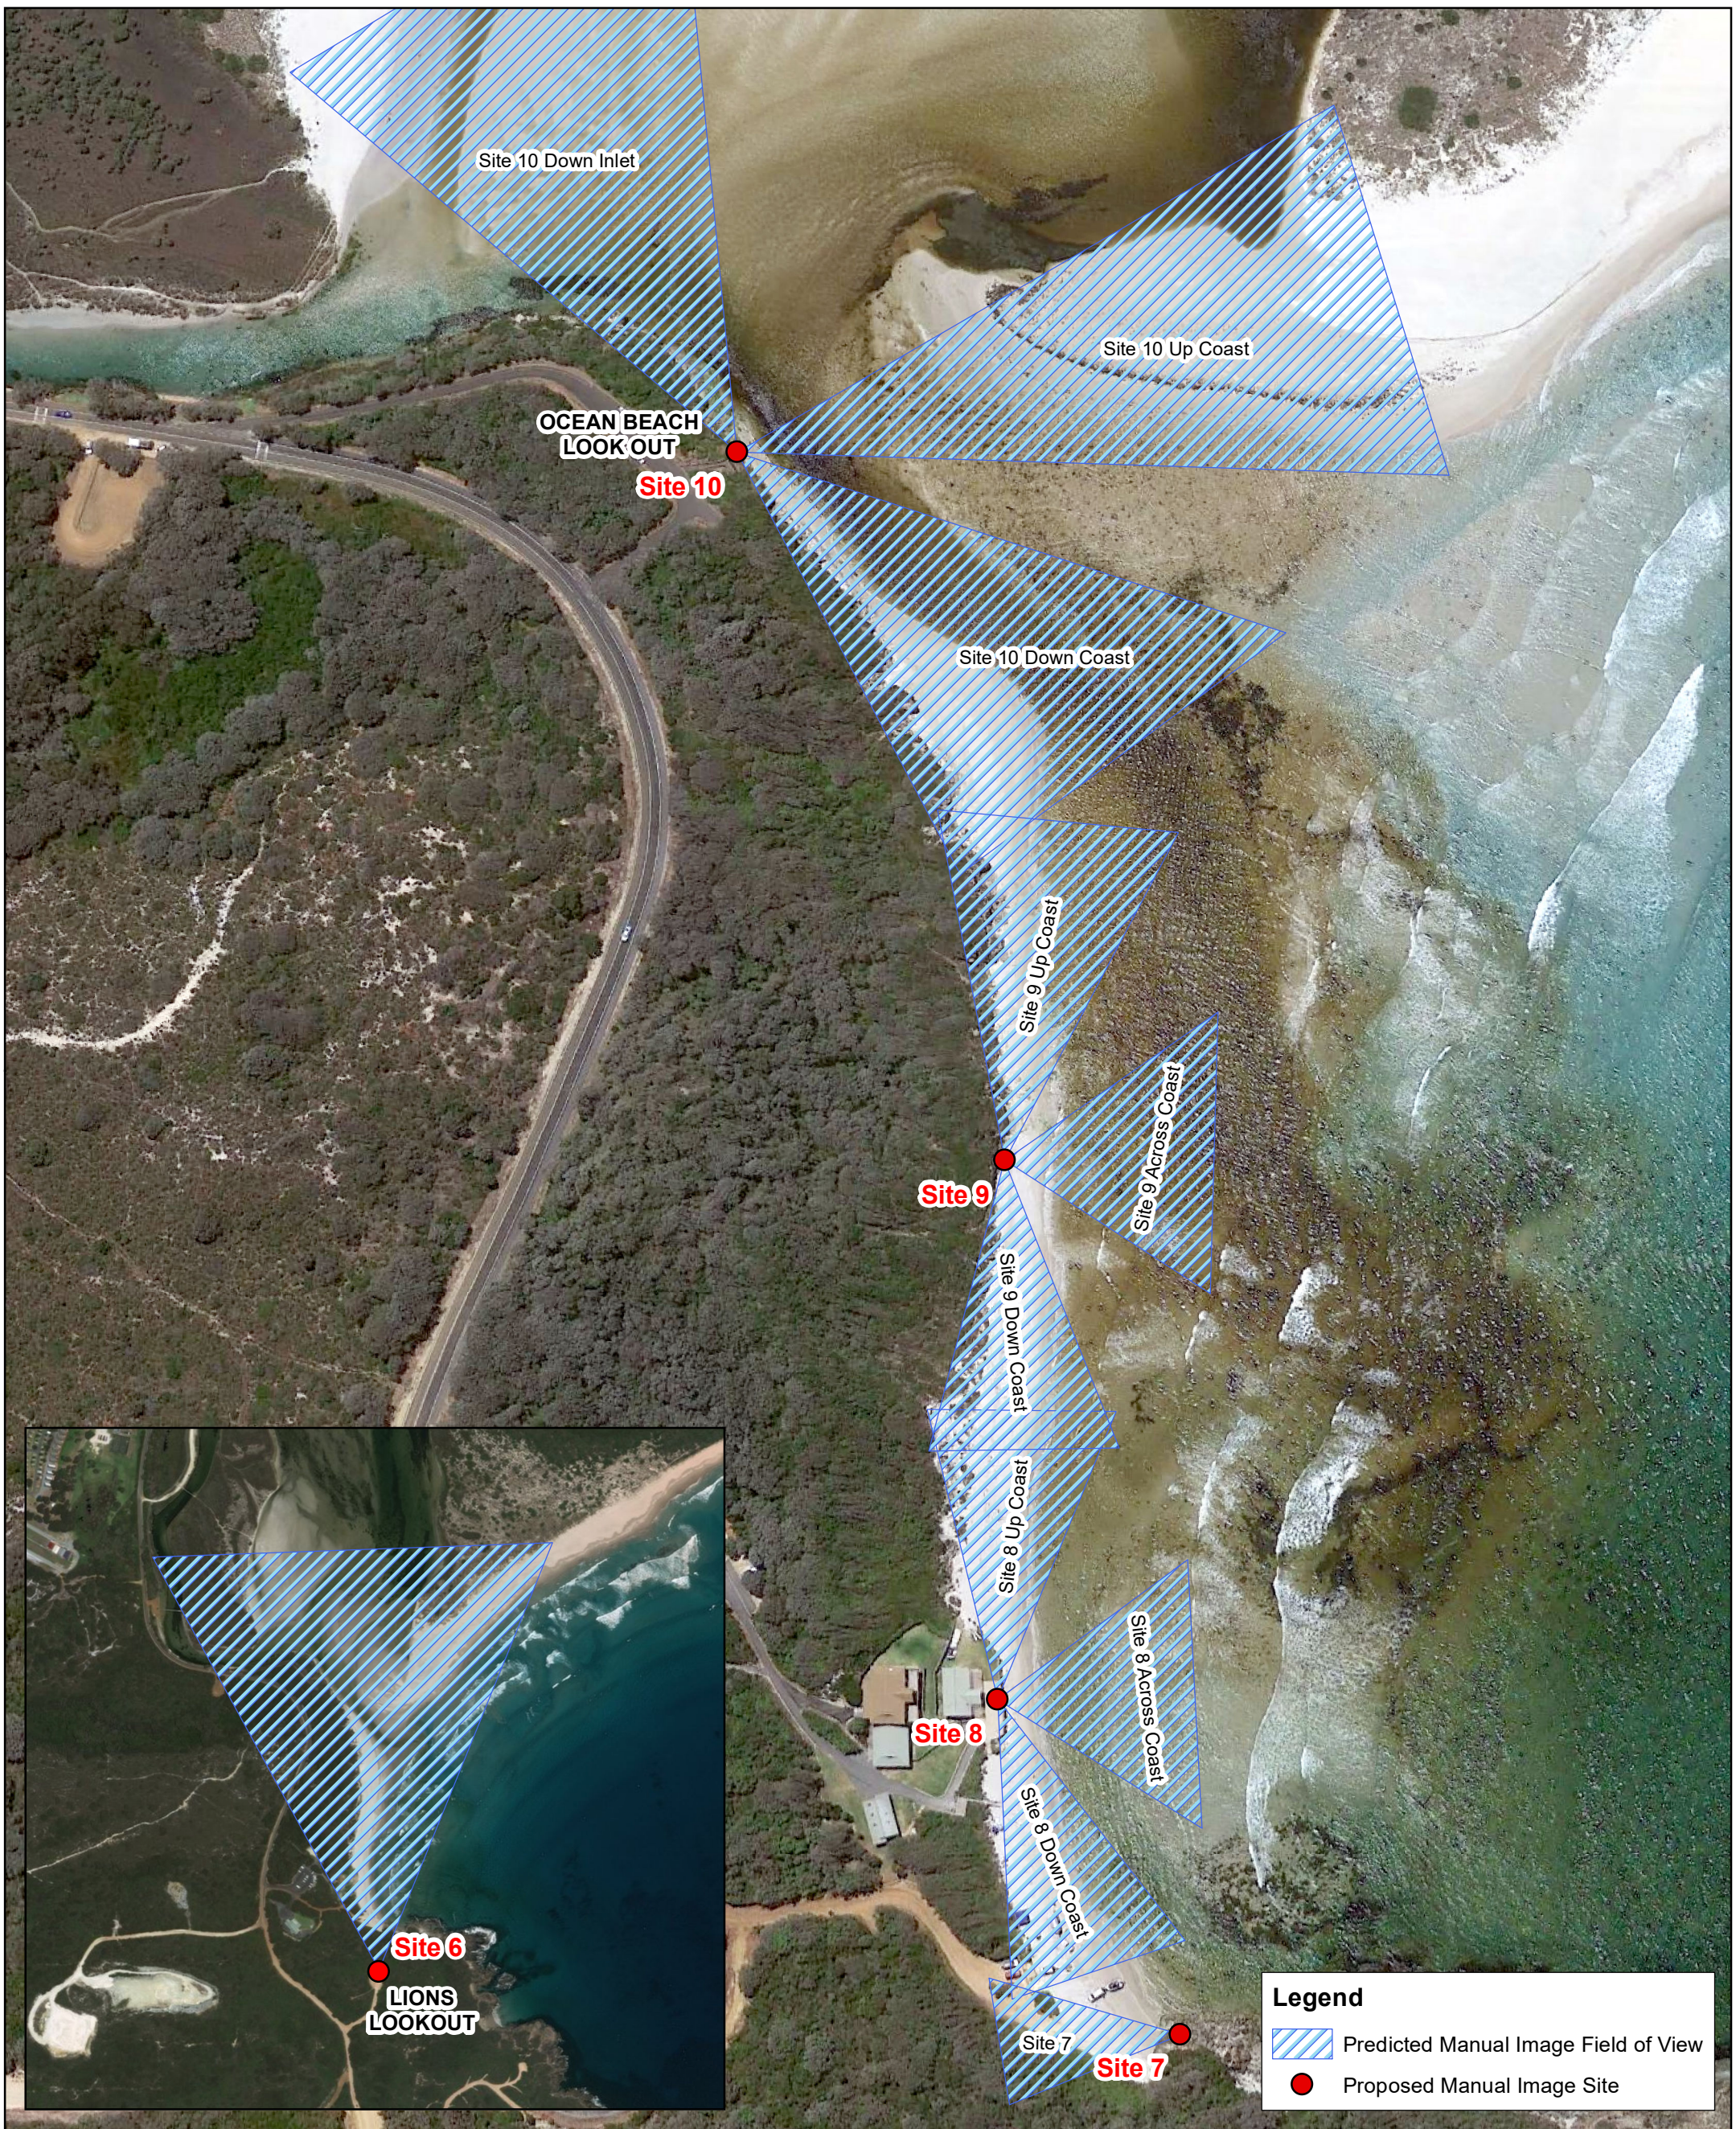
Manual Imagery Photo Monitoring Site Locations

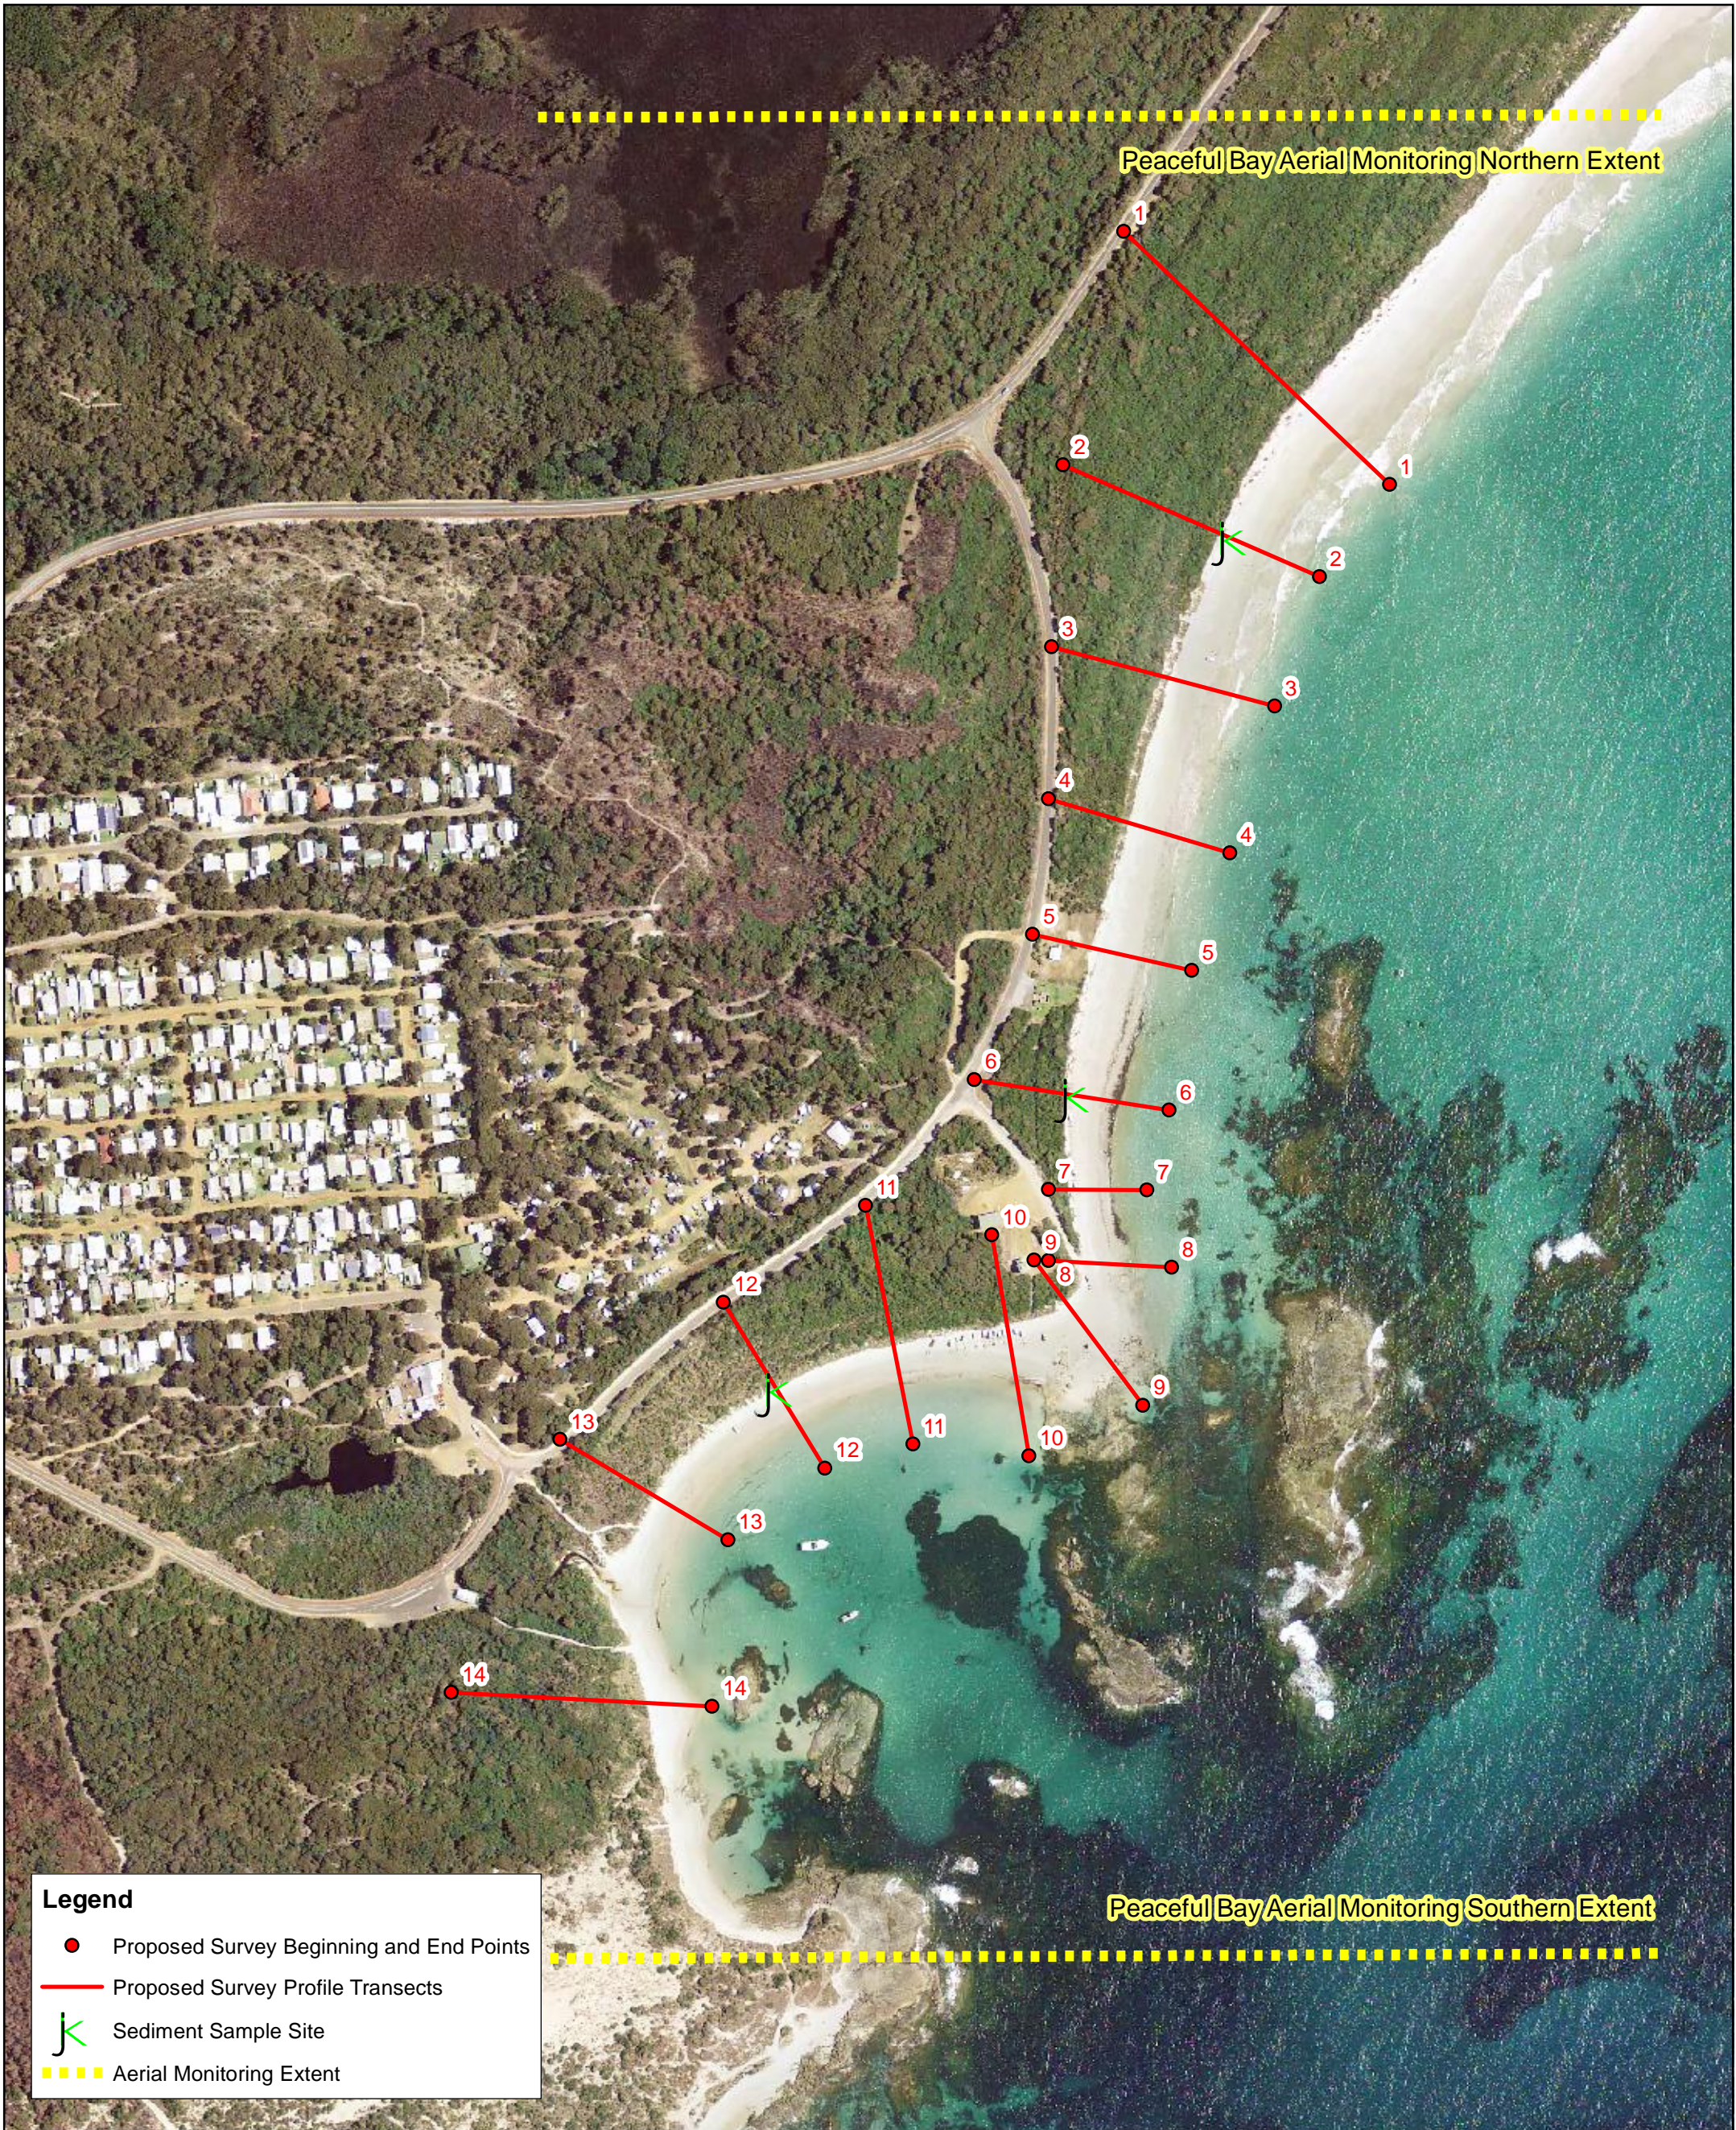
Both LiDAR and photogrammetry can provide very detailed spatial datasets, but only allow a single snapshot in time to be measured for one measurement exercise. The monitoring techniques have the advantage of being able to characterise elevation with respect to a known datum and to a known accuracy. The techniques become confounded, however, in nearshore/shallow areas due to water disturbance and light diffusion. Because of this, key areas of the beach profile can be omitted from LiDAR datasets. LiDAR is relatively expensive to collect. Therefore, it would be expensive to commit to a long-term monitoring program involving the collection of LiDAR data. The technology has become more cost effective with the use of drones, as opposed to light aircraft, and is likely to become cheaper in the future. Proposed beach transects taken from aerial survey at Peaceful Bay

- Proposed Survey Beginning and End Points
- Proposed Survey Profile Transects
- J Sediment Sample Site
- ▬ Aerial Monitoring Extent

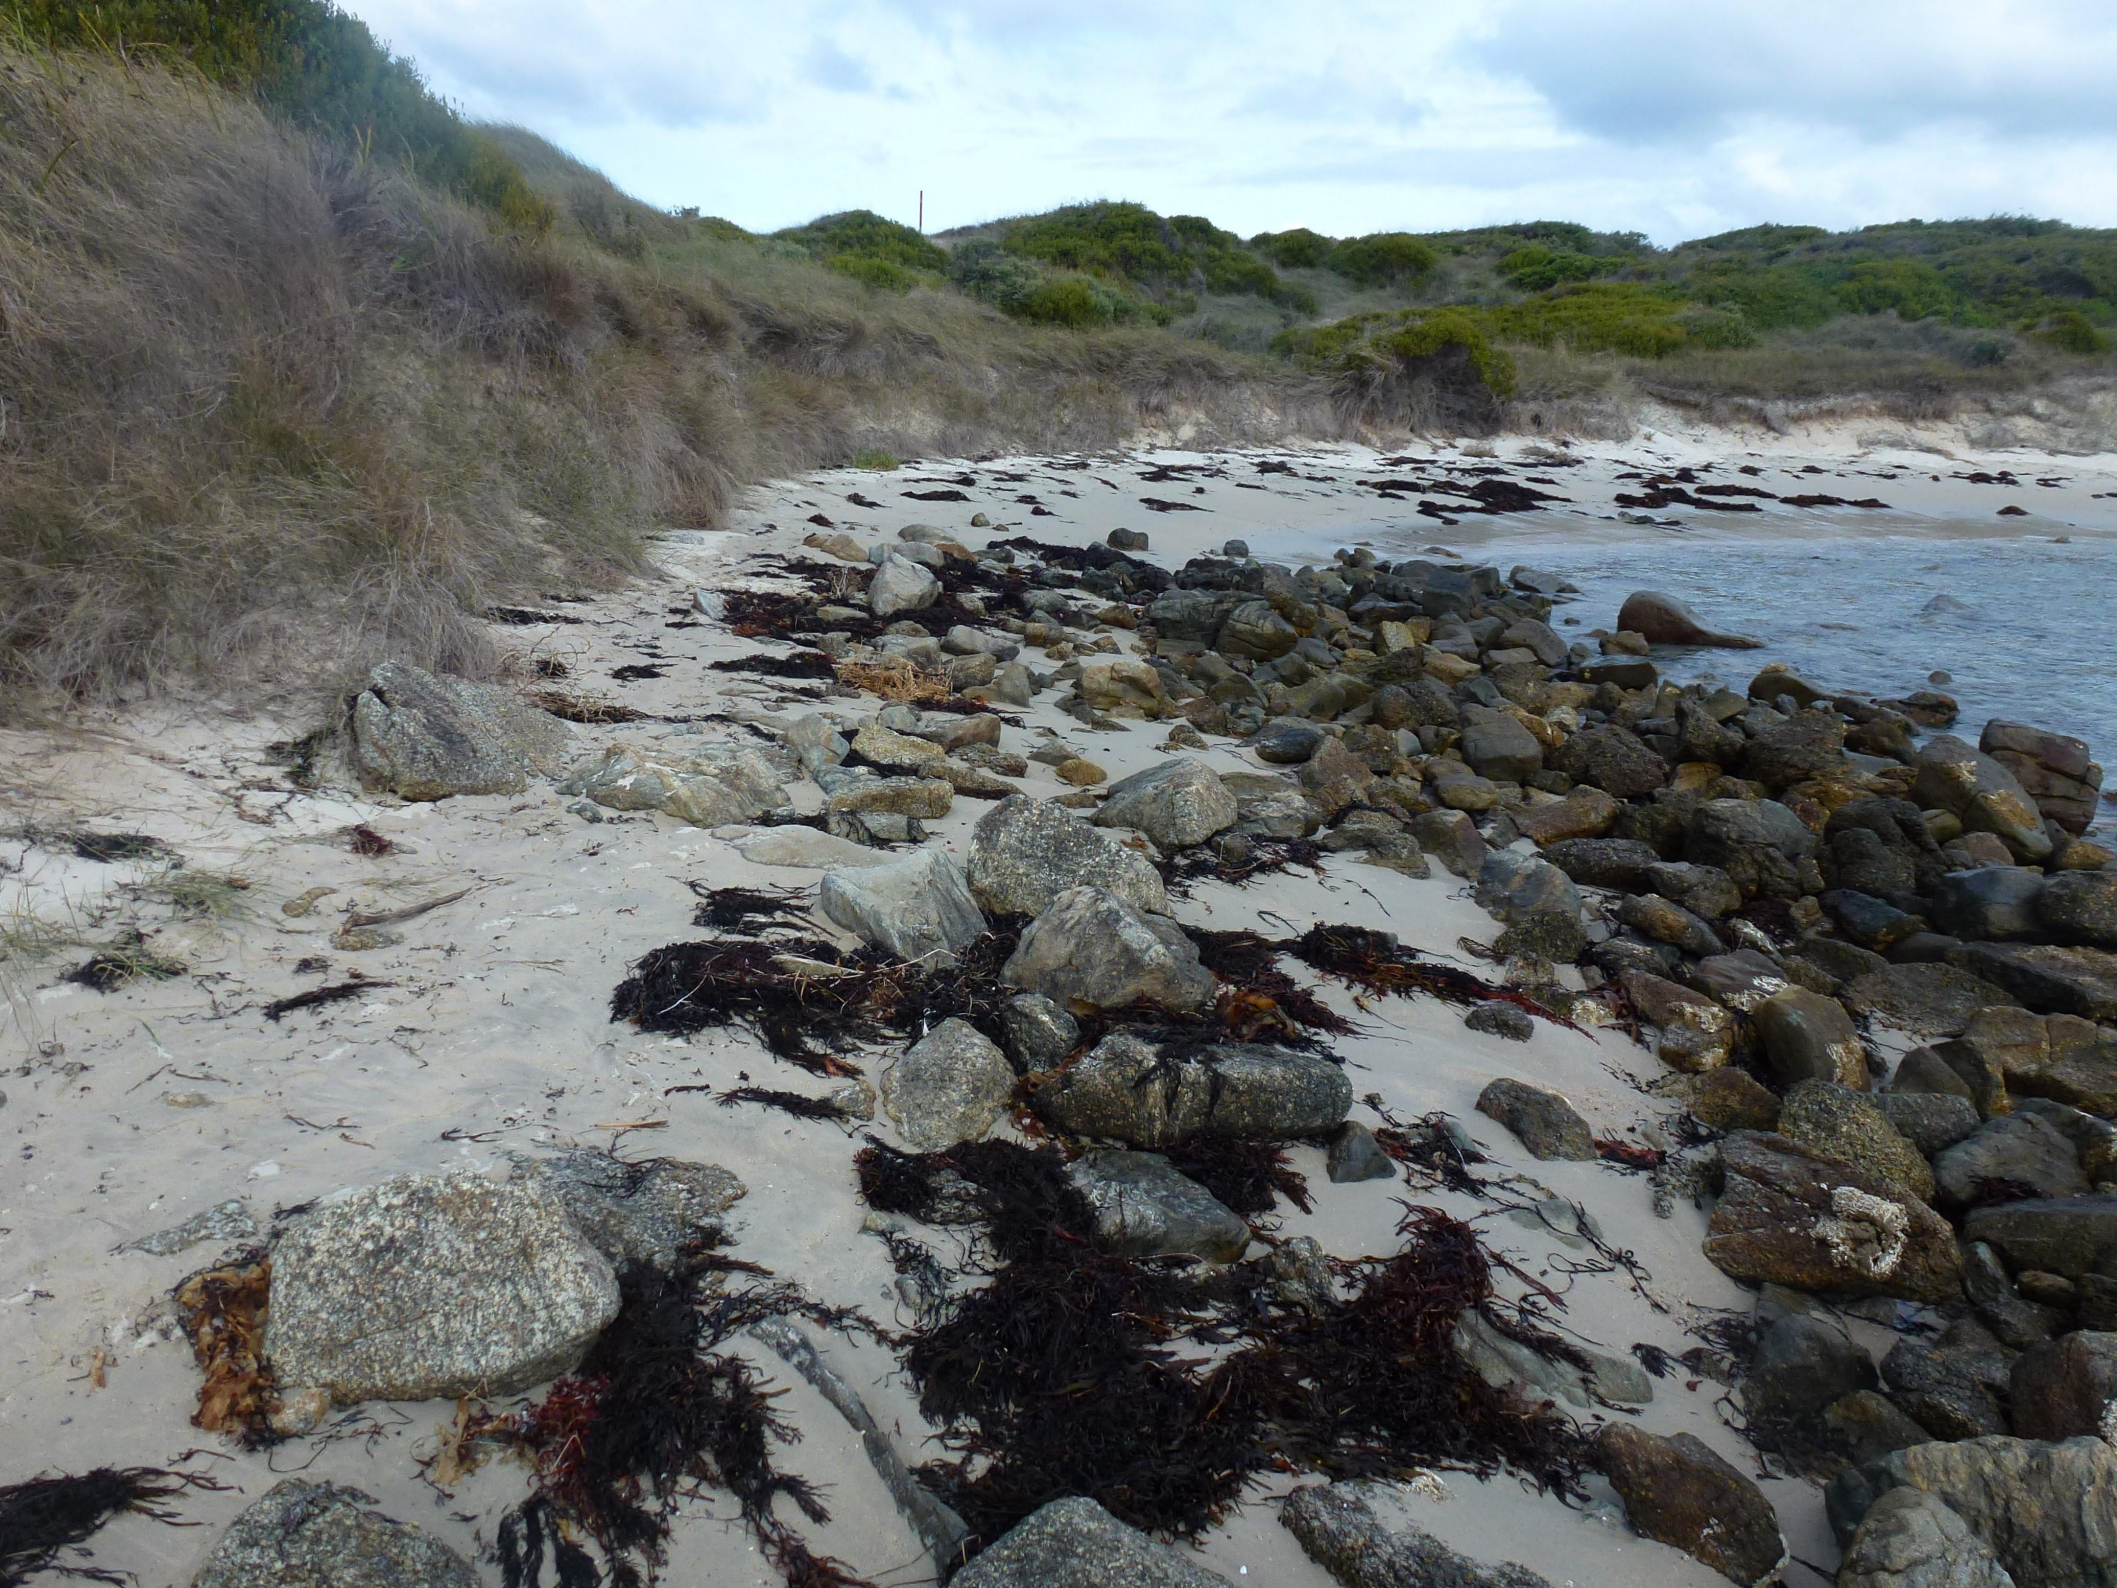
Notes (relevant notes on beach condition, features, works etc.)	Monitoring location at rock headland
	Beach is relatively narrow, ~1:15 slope
	Beach is covered with medium size rock and presence of seaweed wrack
	Dunes eroded and steep

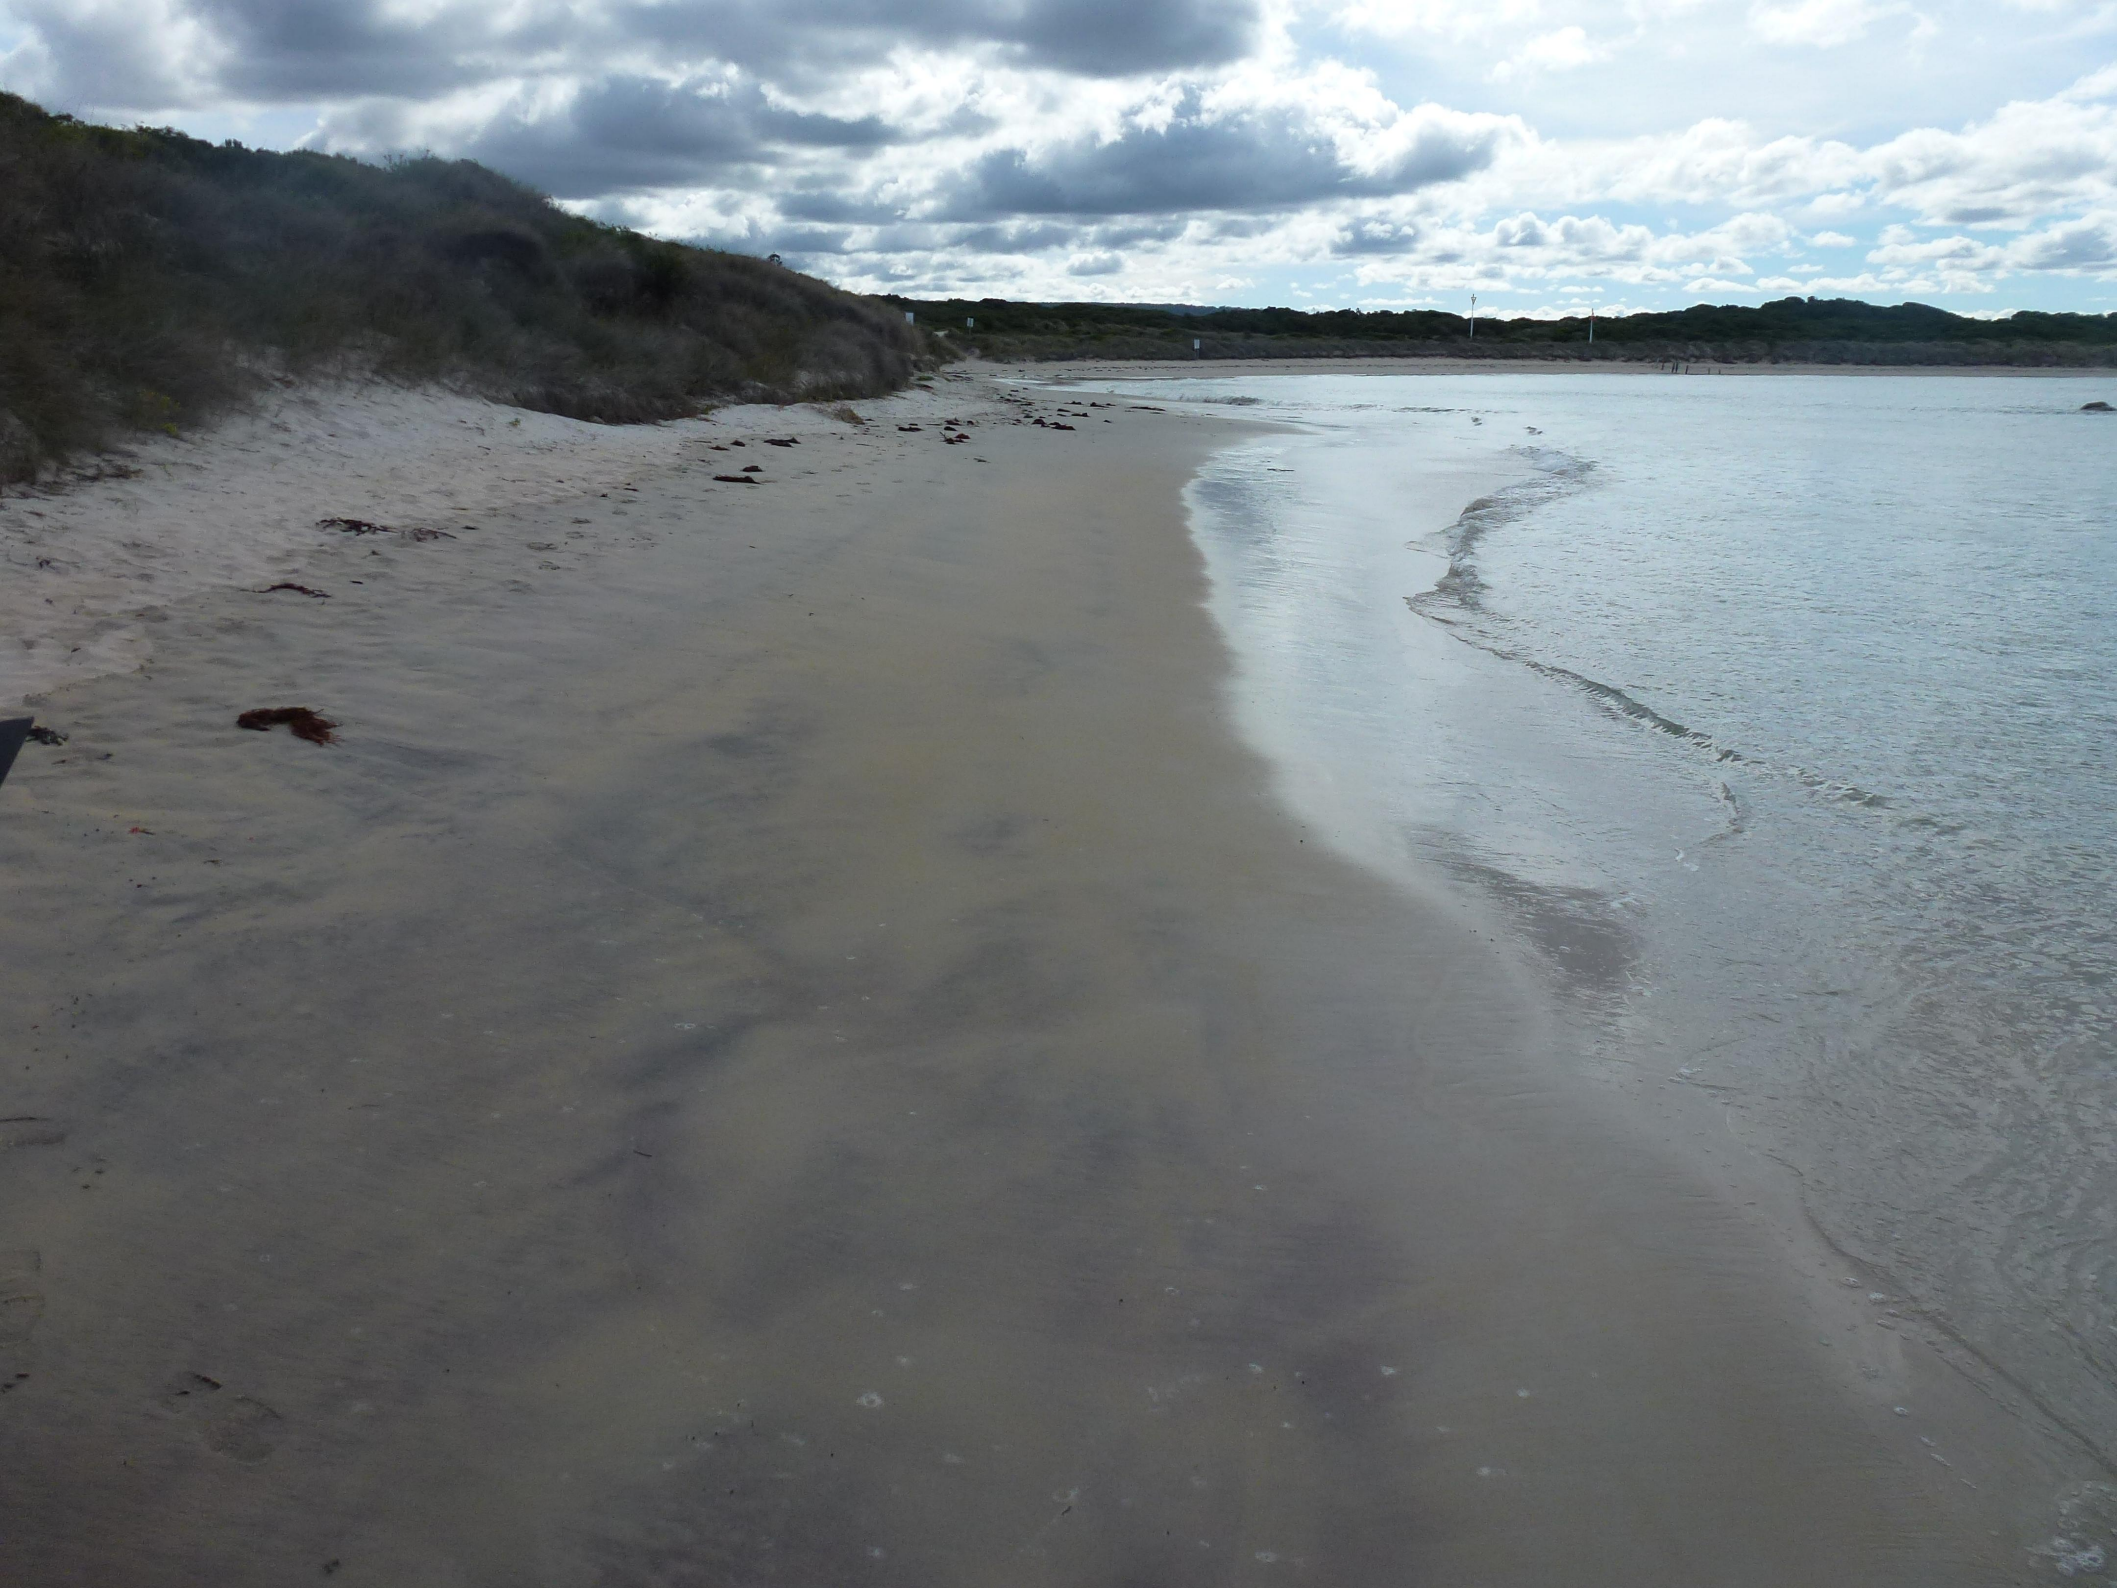
Site ID	Peaceful Bay- Site 2
Location	Rock outcrop - Peaceful Bay south
Date & Time	22/05/2019 12:37PM

Notes (relevant notes on beach condition, features, works etc.)	Monitoring location at rock outcrop between the southern headland and the creek
	Beach is relatively narrow, ~1:10 slope
	10-15m beach width continues north
	Dunes eroded and steep

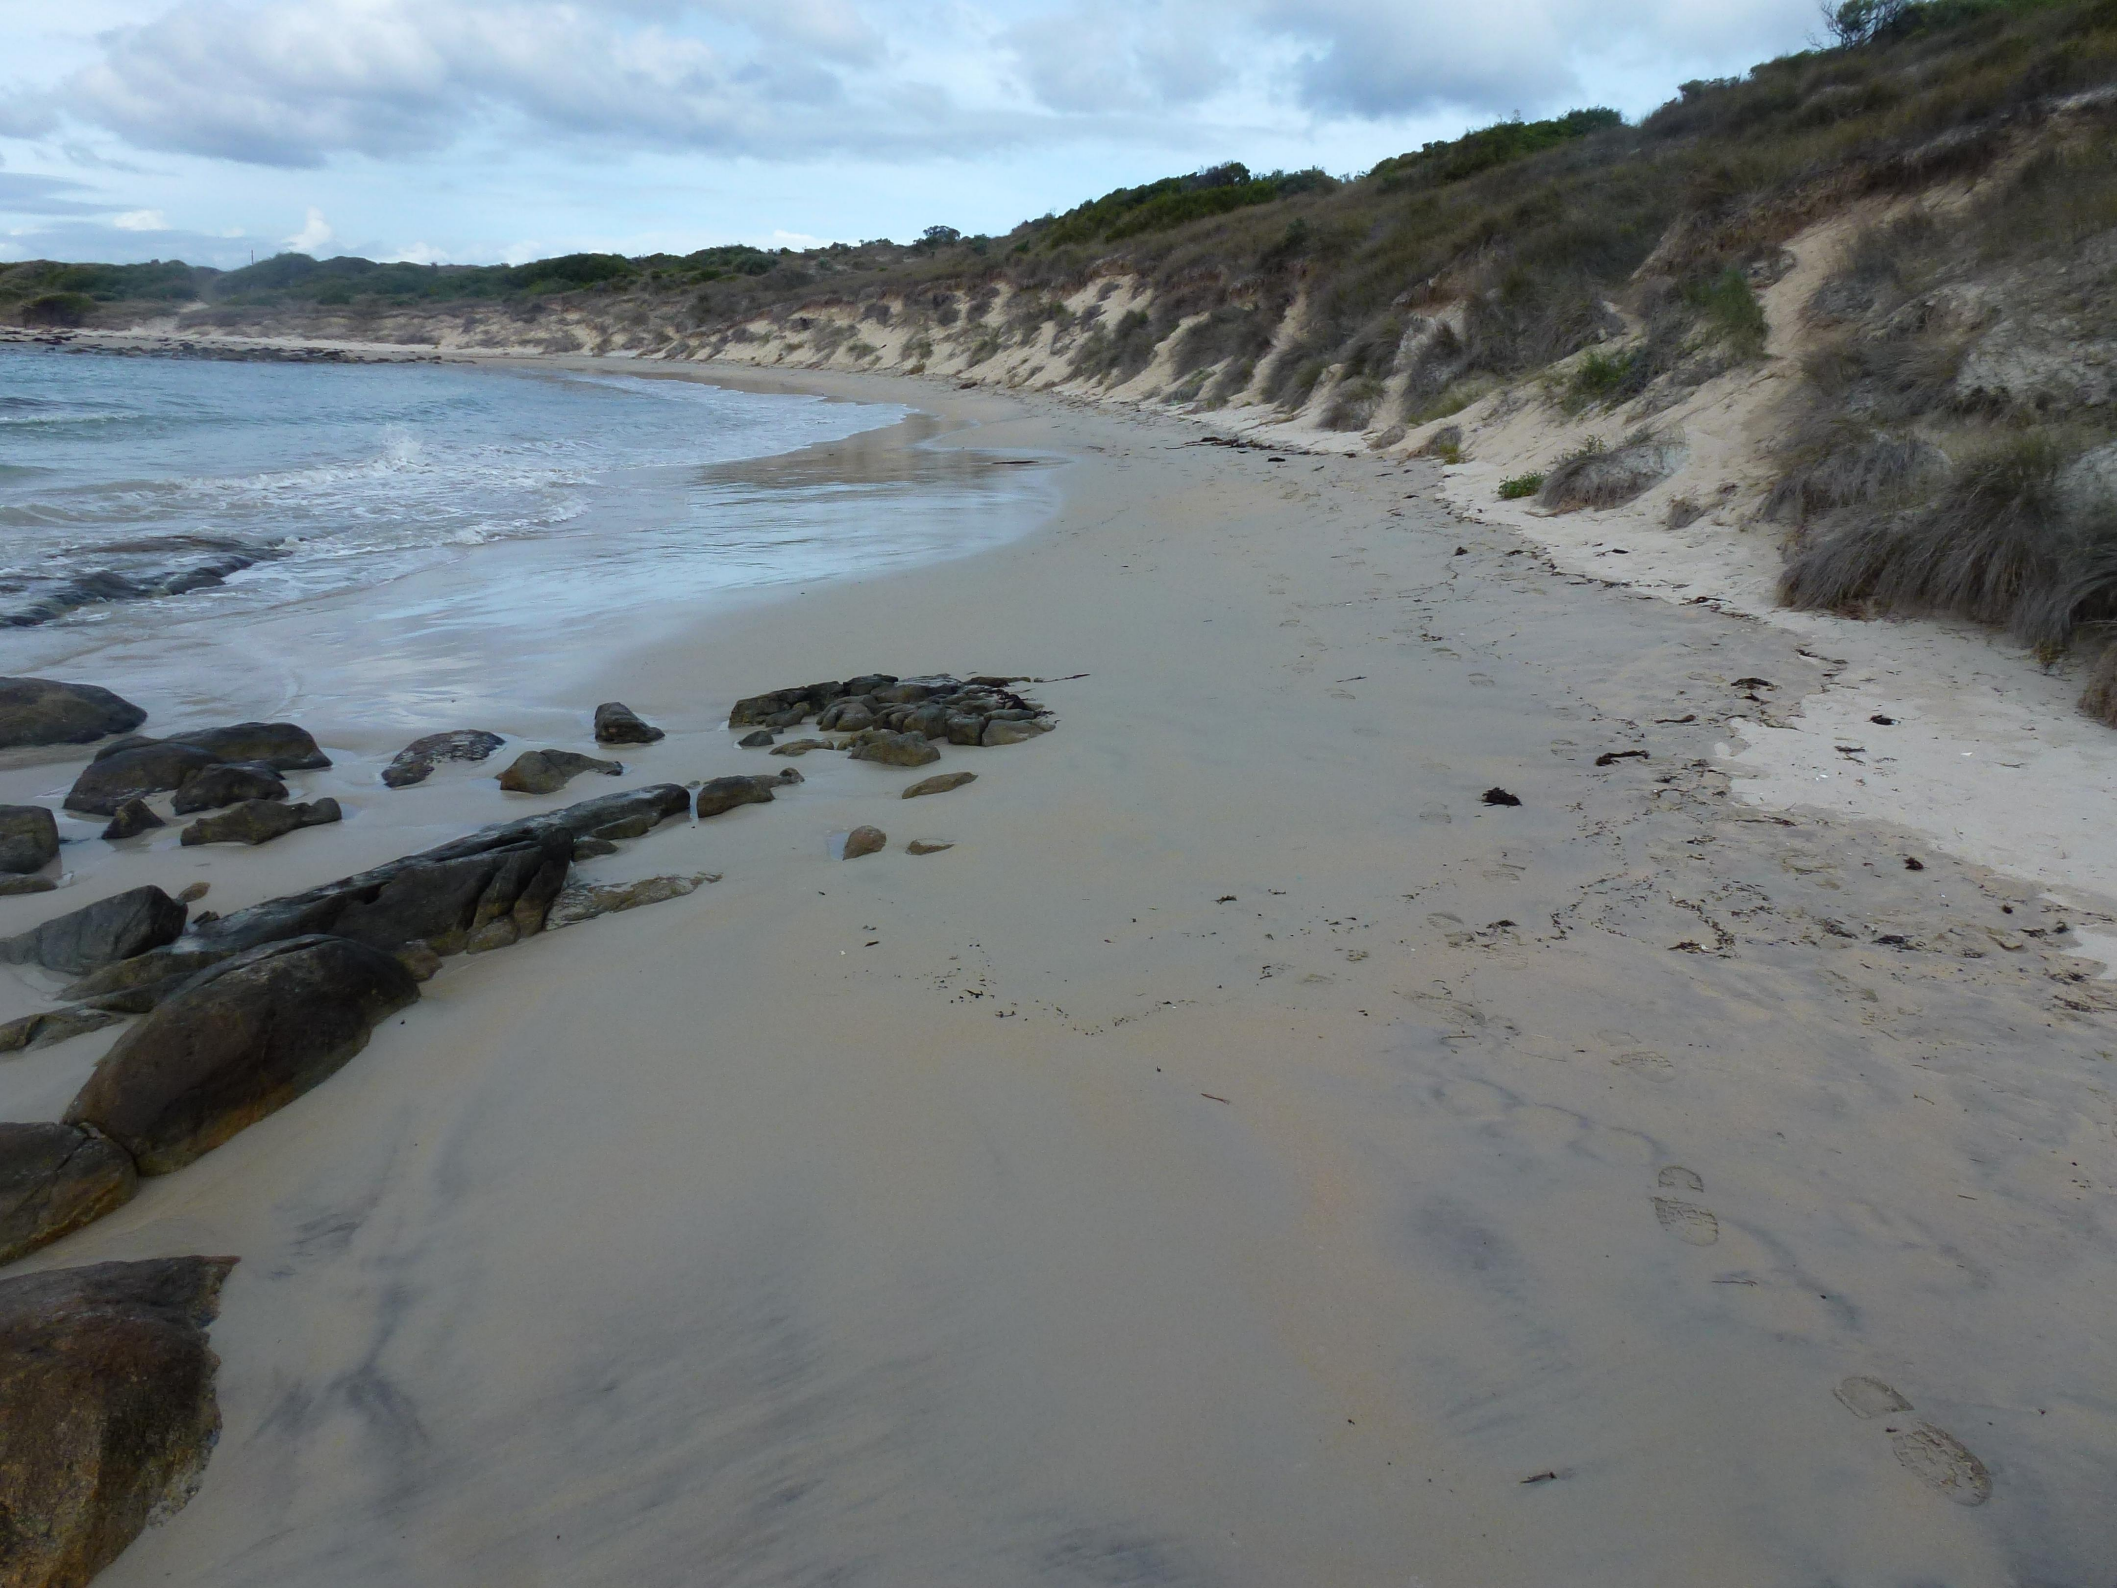
Site ID	Peaceful Bay- Site 2
Location	Rock outcrop - Peaceful Bay south
Date & Time	22/05/2019 12:37PM

Notes (relevant notes on beach condition, features, works etc.)	Monitoring location at rock outcrop between the southern headland and the creek
	Beach is relatively narrow, ~1:10 slope
	High tide mark at toe of dune, narrow beach width continues south
	Dunes eroded and steep
