Ocean Beach and Peaceful Bay

Coastal Monitoring Action Plan

CW1055200

Prepared for
Shire of Denmark

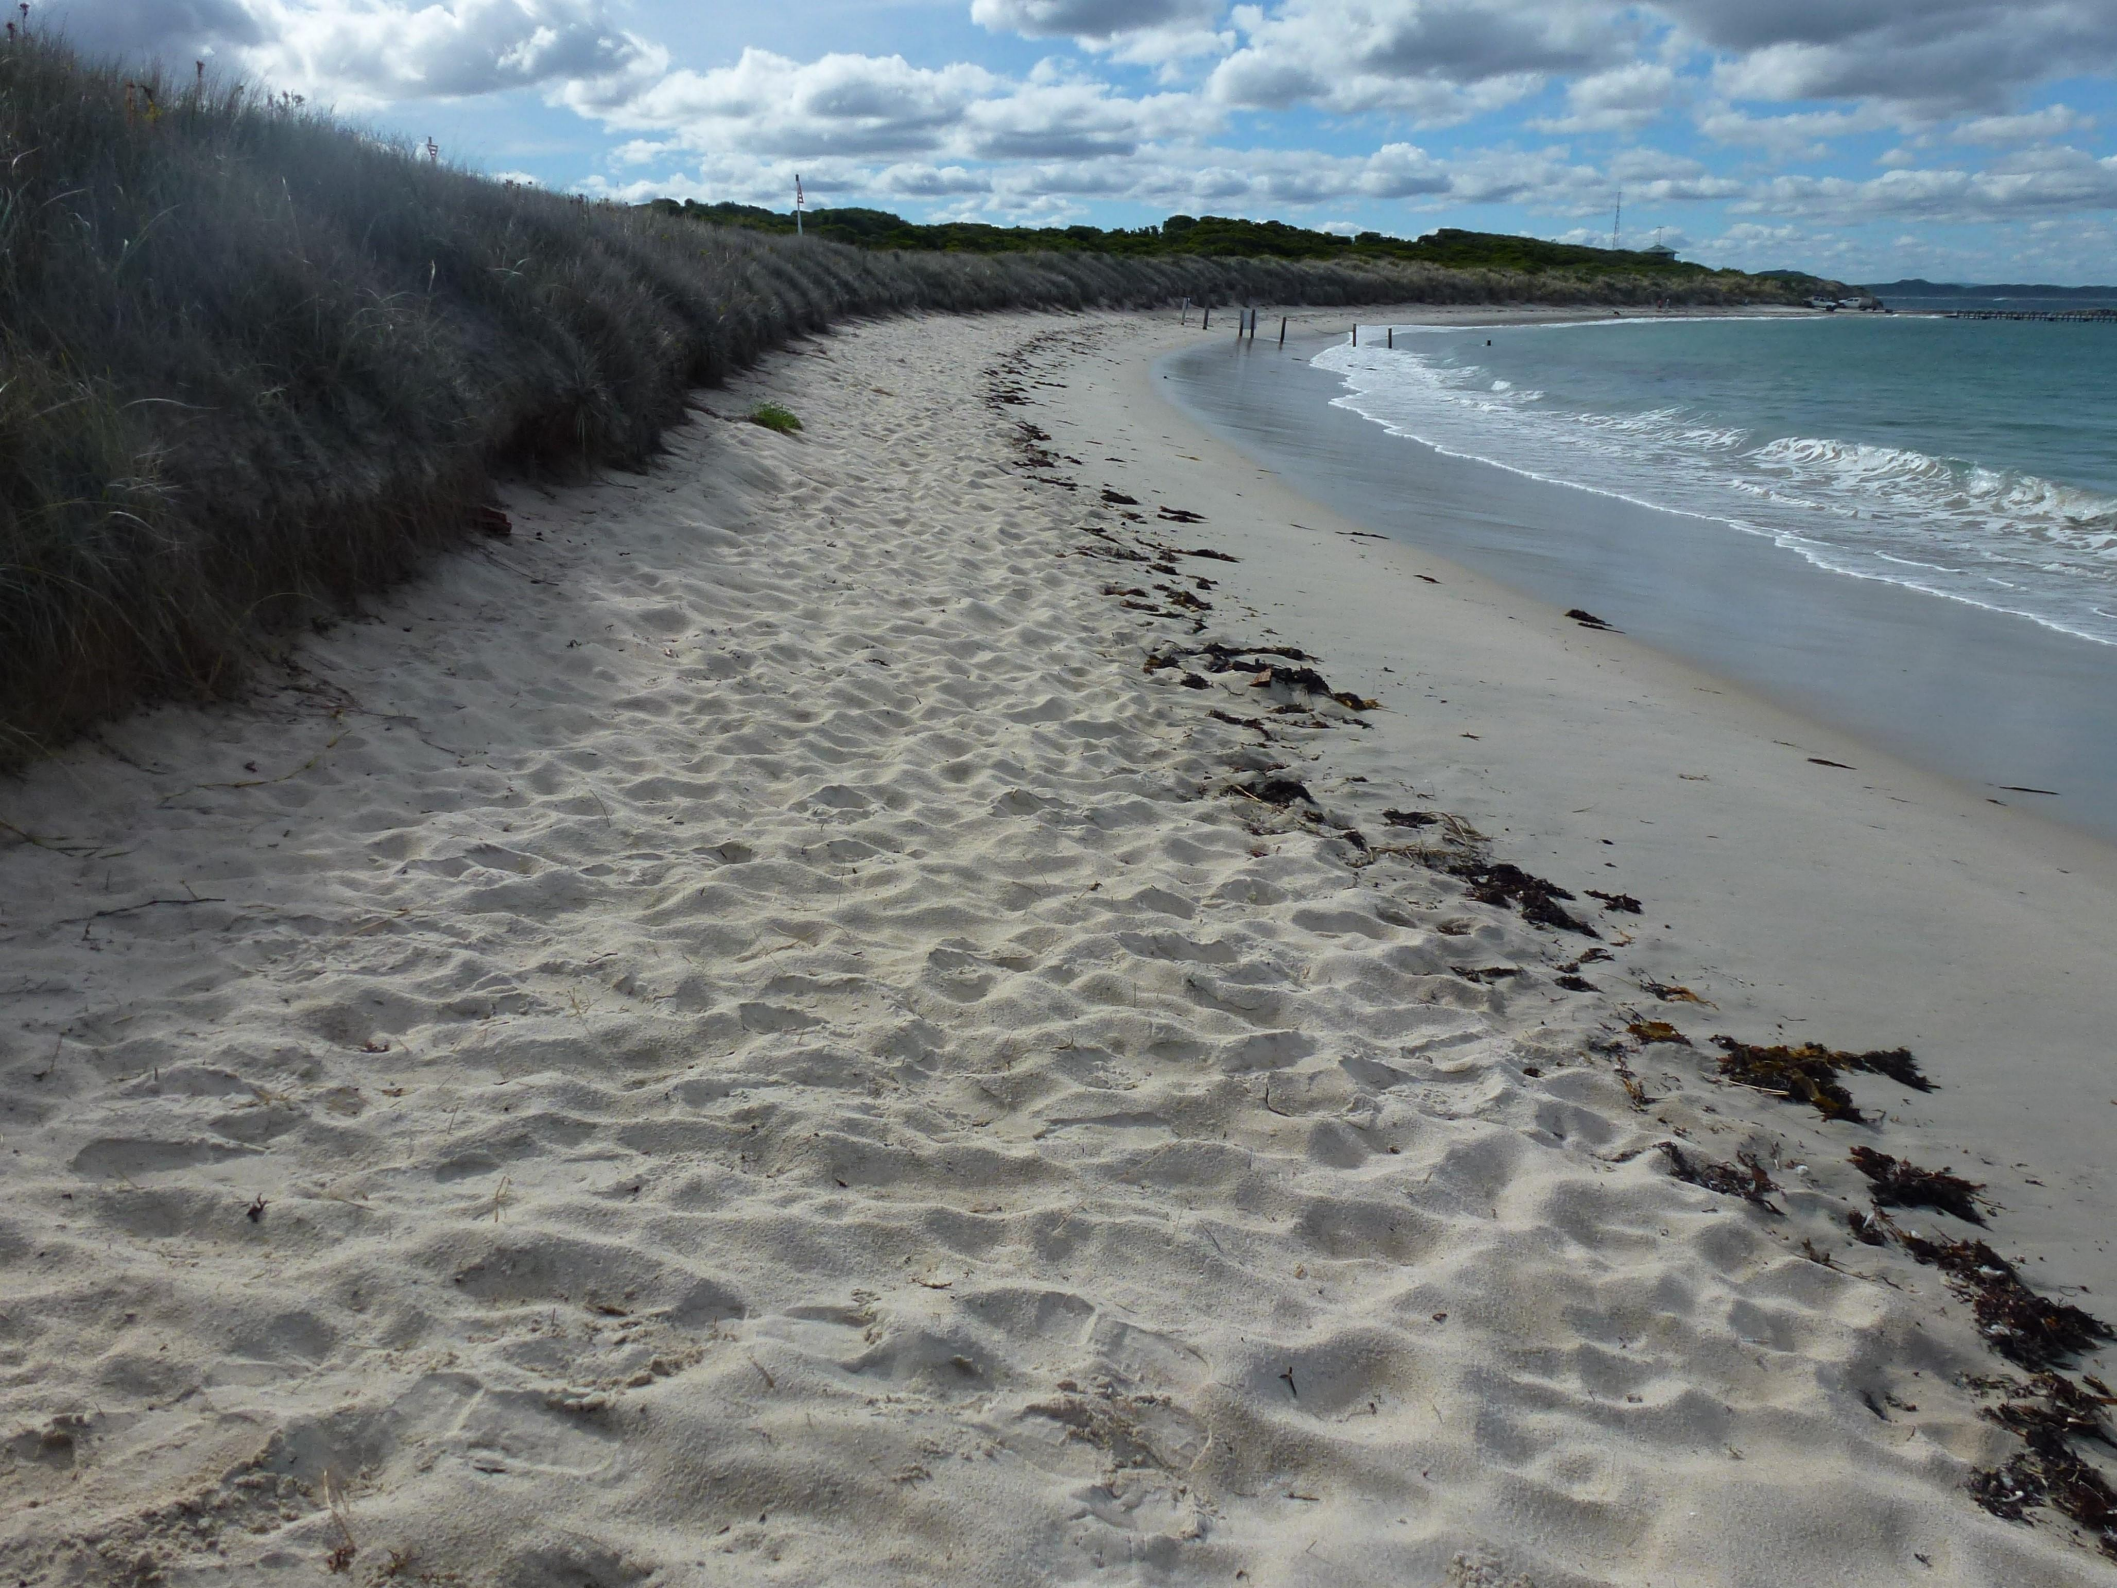
Site ID	Peaceful Bay- Site 3
Location	"Dog Owners" sign - Peaceful Bay north
Date & Time	22/05/2019 12:43PM

Notes (relevant notes on beach condition, features, works etc.)	Monitoring location at "Dog Owners" sign
	Beach is relatively narrow and steep, ~1:5 slope
	High tide mark at toe of dune, narrow beach width continues north
	Dunes eroded and steep

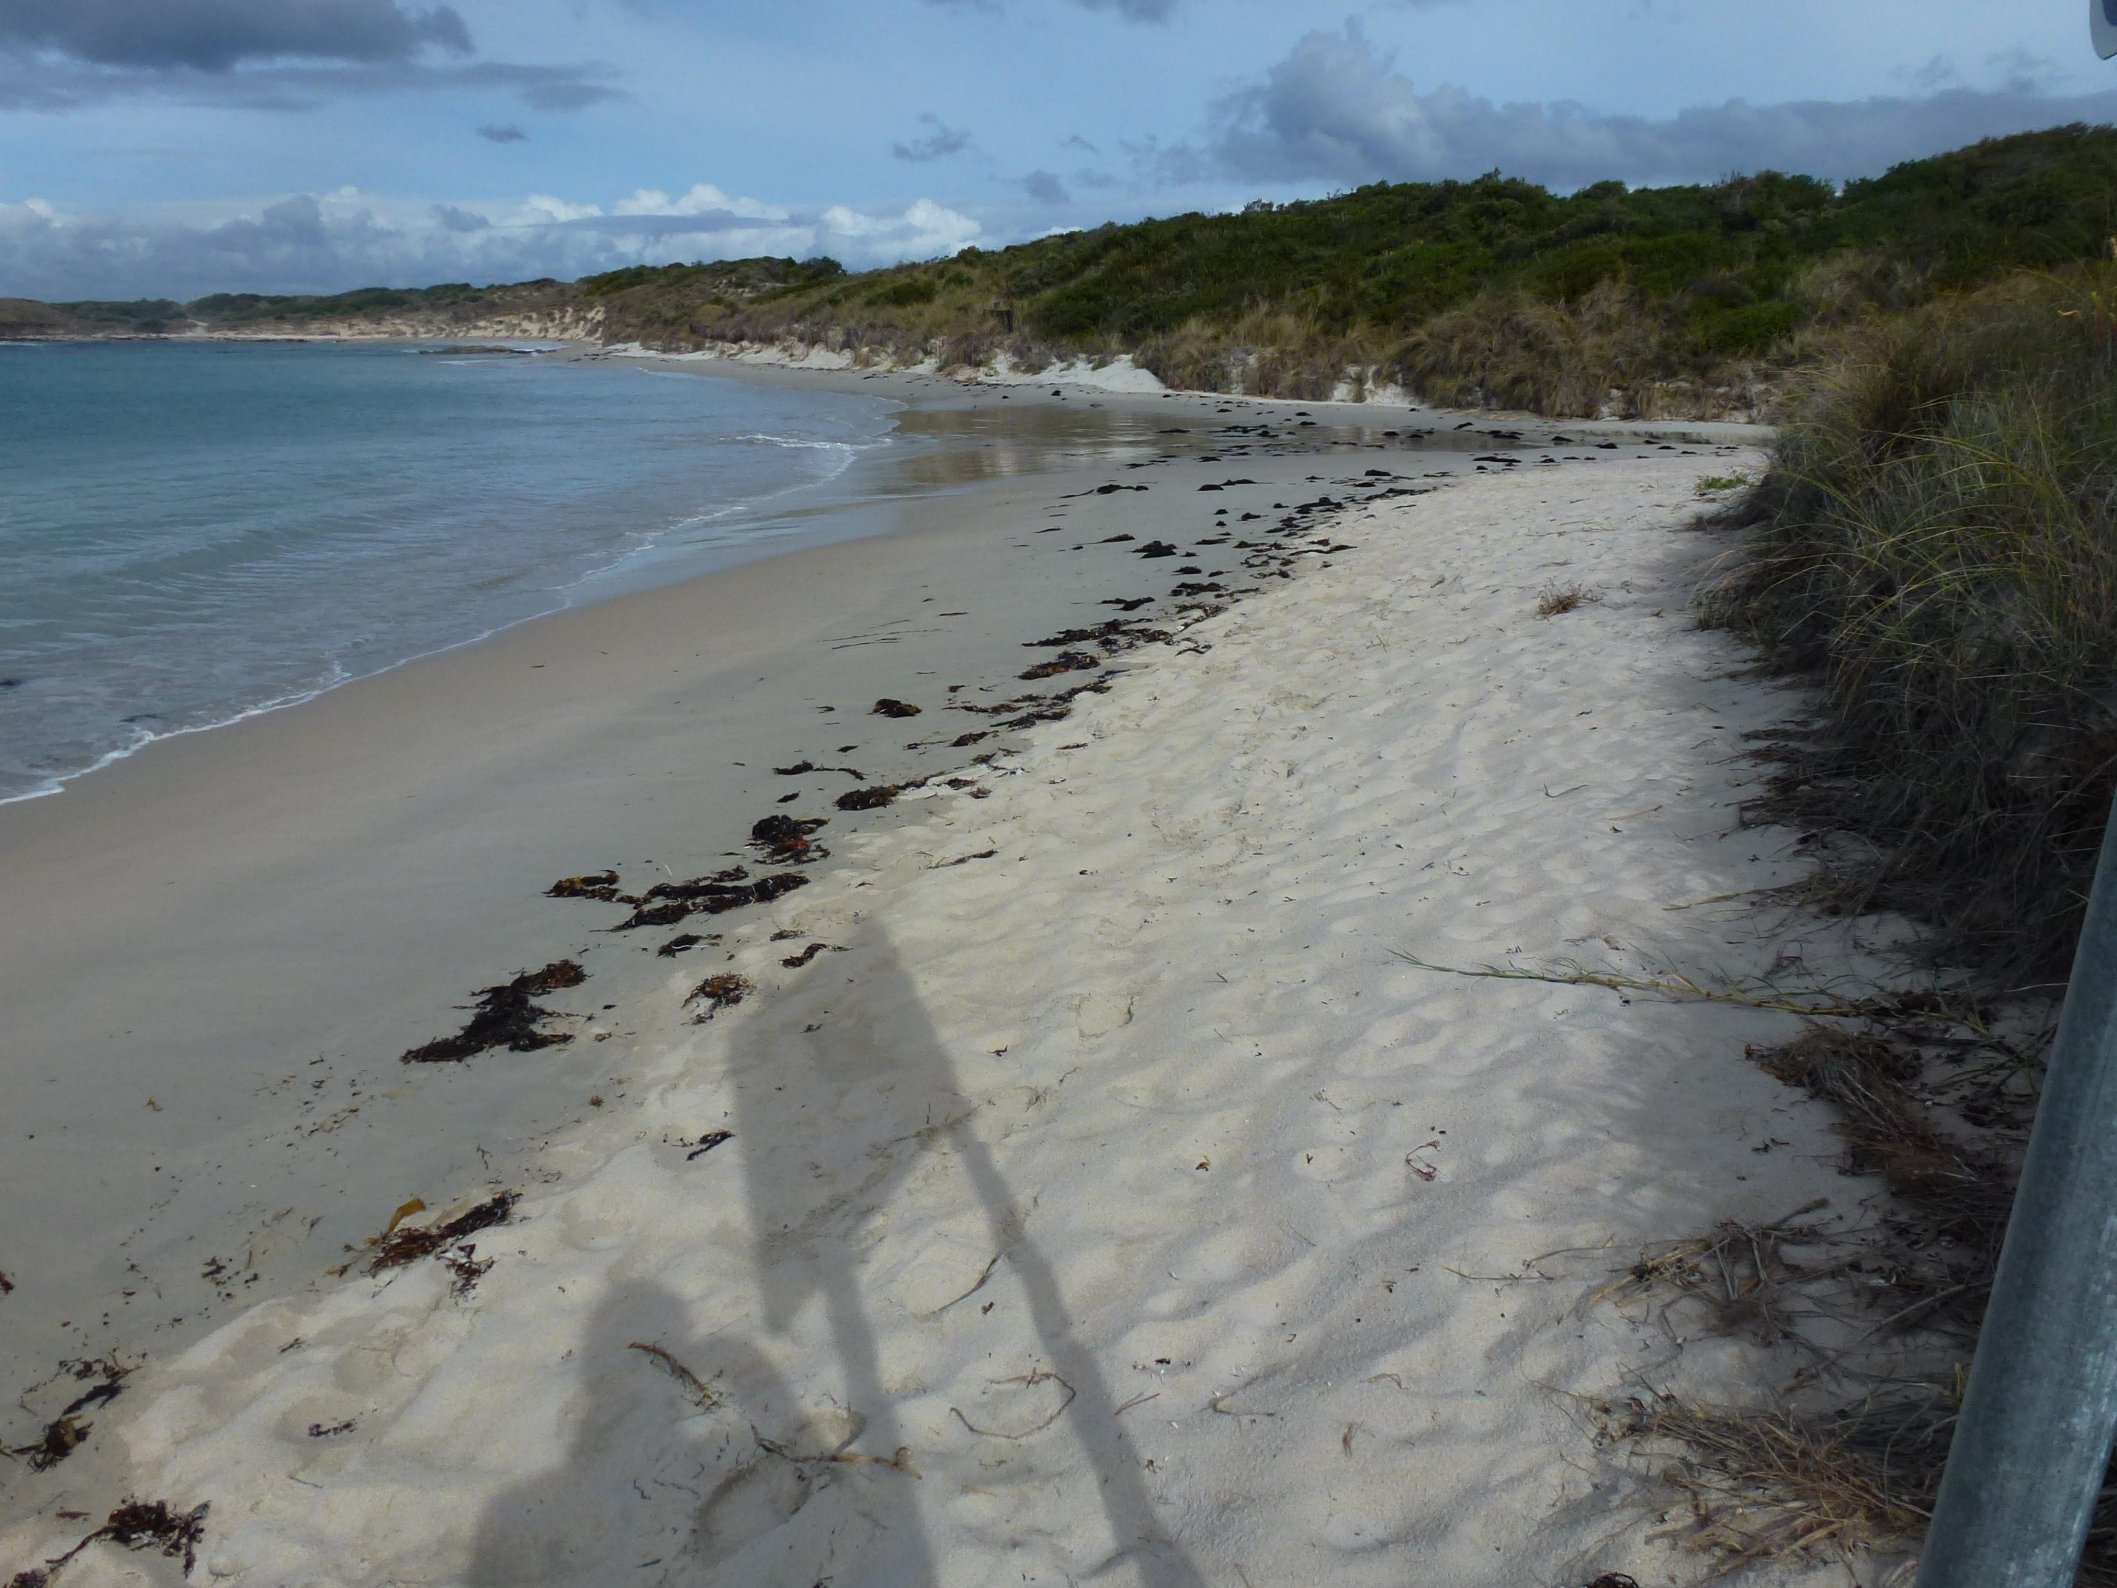
Site ID	Peaceful Bay- Site 3
Location	"Dog Owners" sign - Peaceful Bay north
Date & Time	22/05/2019 12:42PM

Notes (relevant notes on beach condition, features, works etc.)	Monitoring location at "Dog Owners" sign
	Beach is relatively narrow and flat, ~1:20 slope
	10-15m beach width continues south
	Creek partially inundated

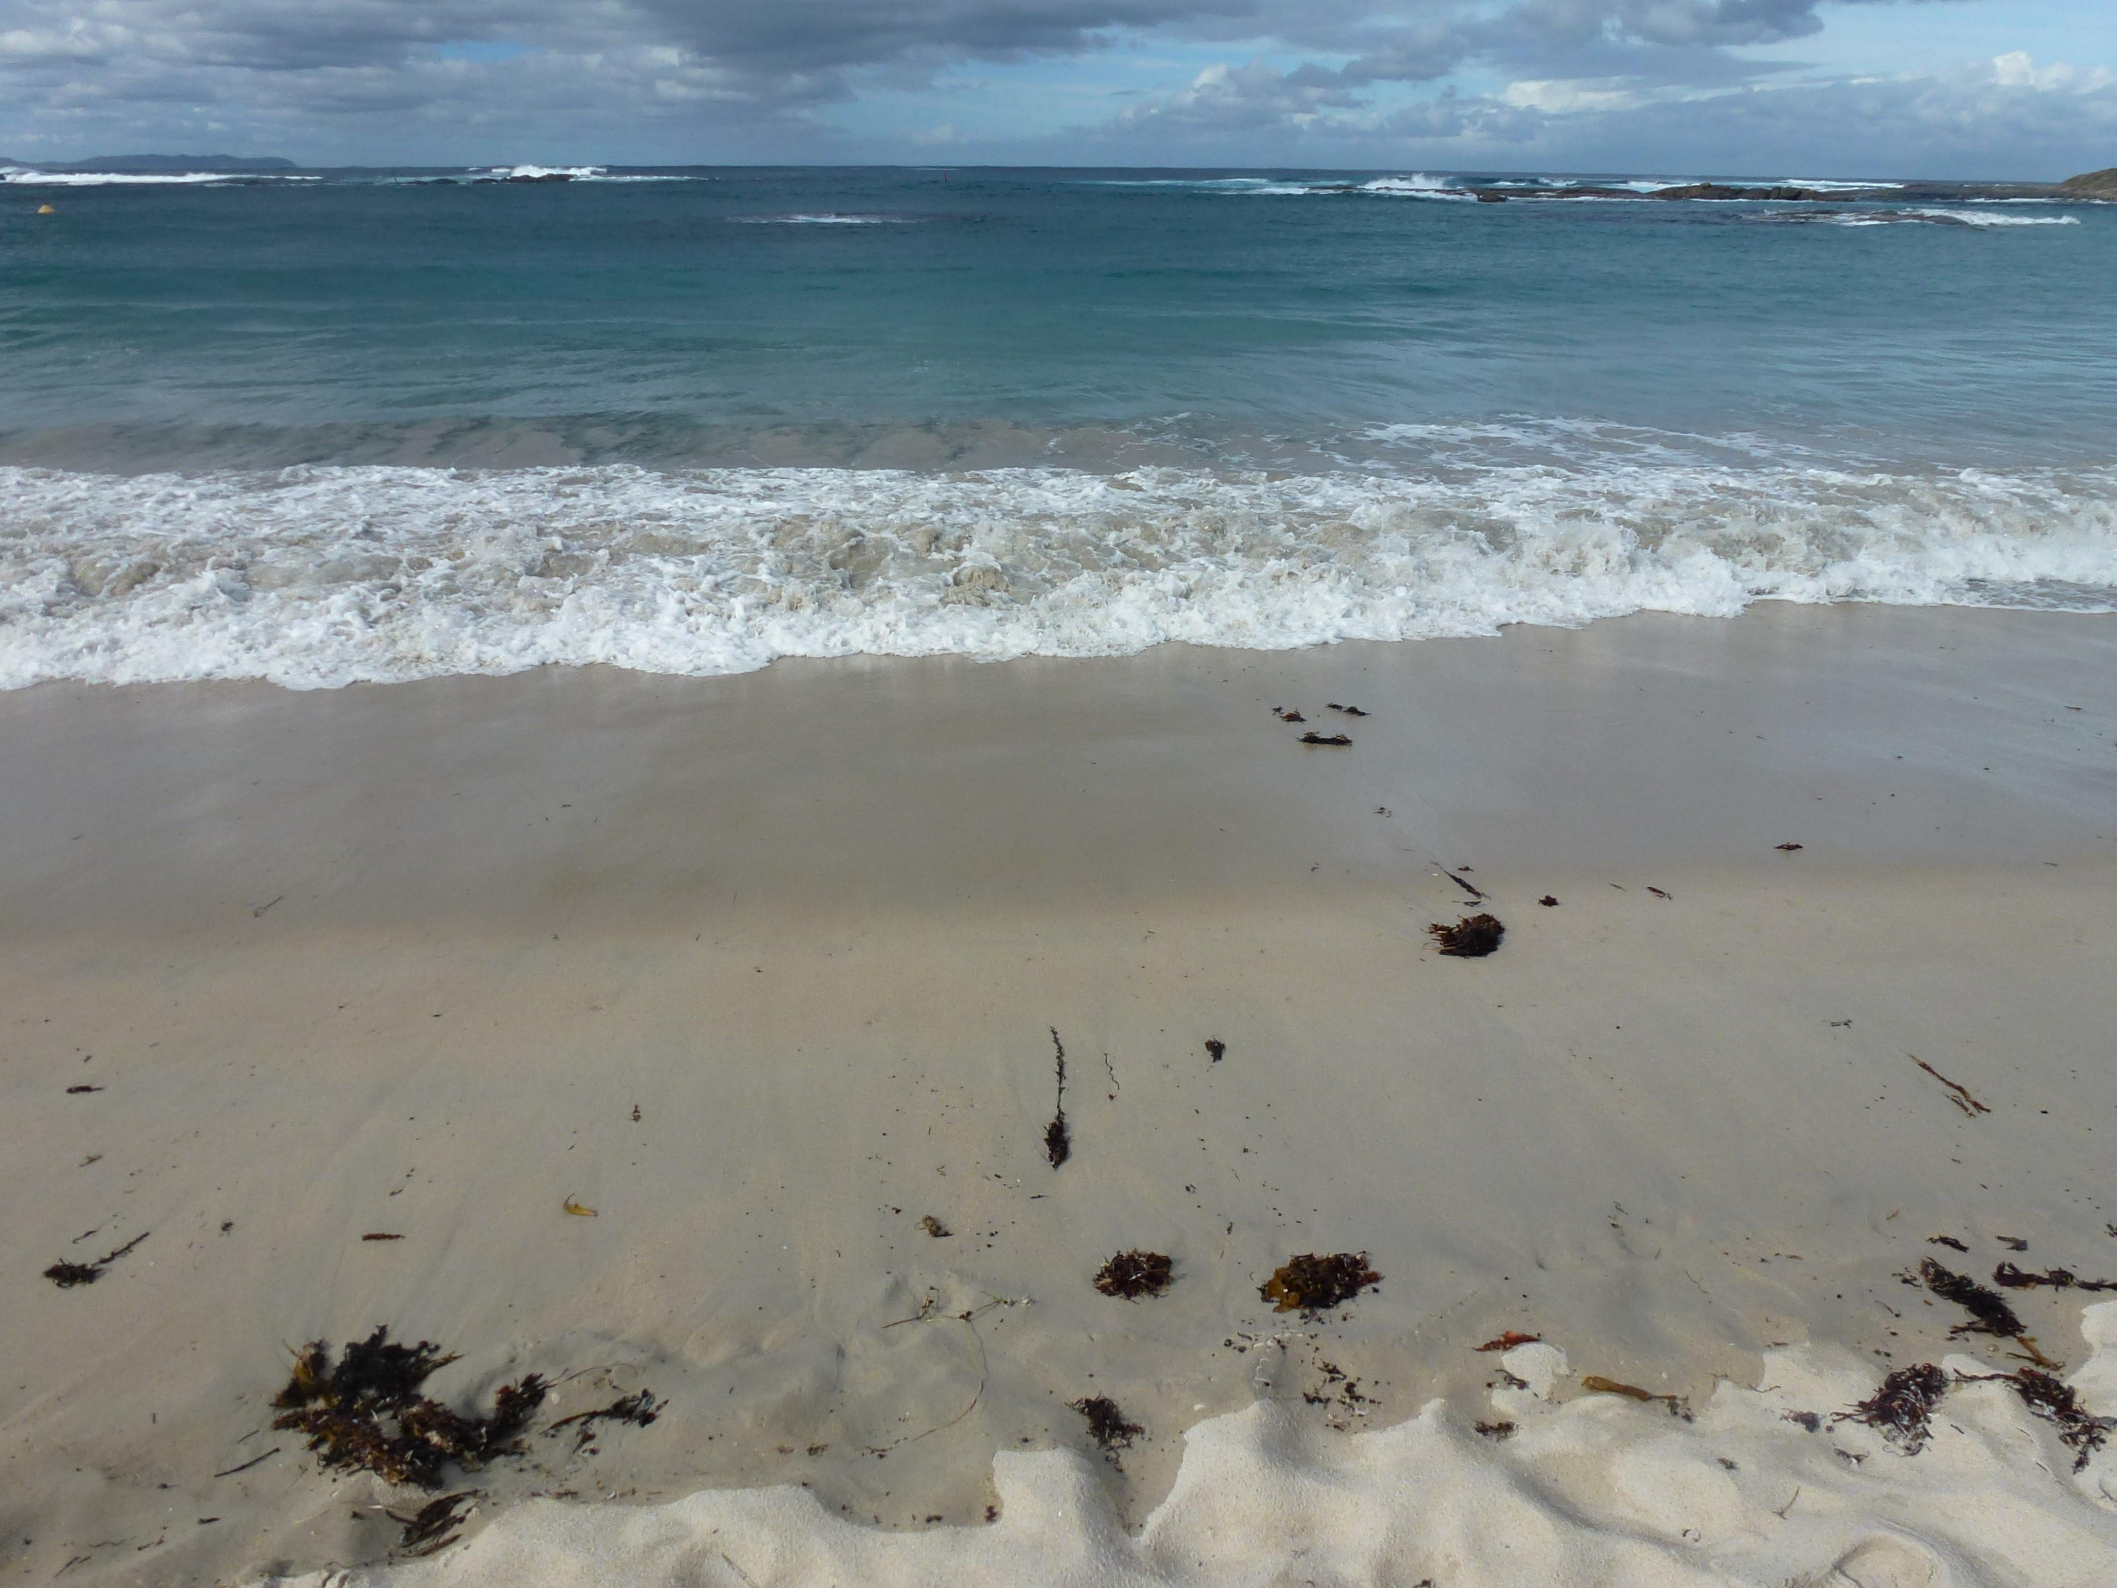
Site ID	Peaceful Bay- Site 3
Location	"Dog Owners" sign - Peaceful Bay north
Date & Time	22/05/2019 12:43PM

Notes (relevant notes on beach condition, features, works etc.)	Monitoring location at "Dog Owners" sign
	Beach is relatively narrow, ~1:10 slope

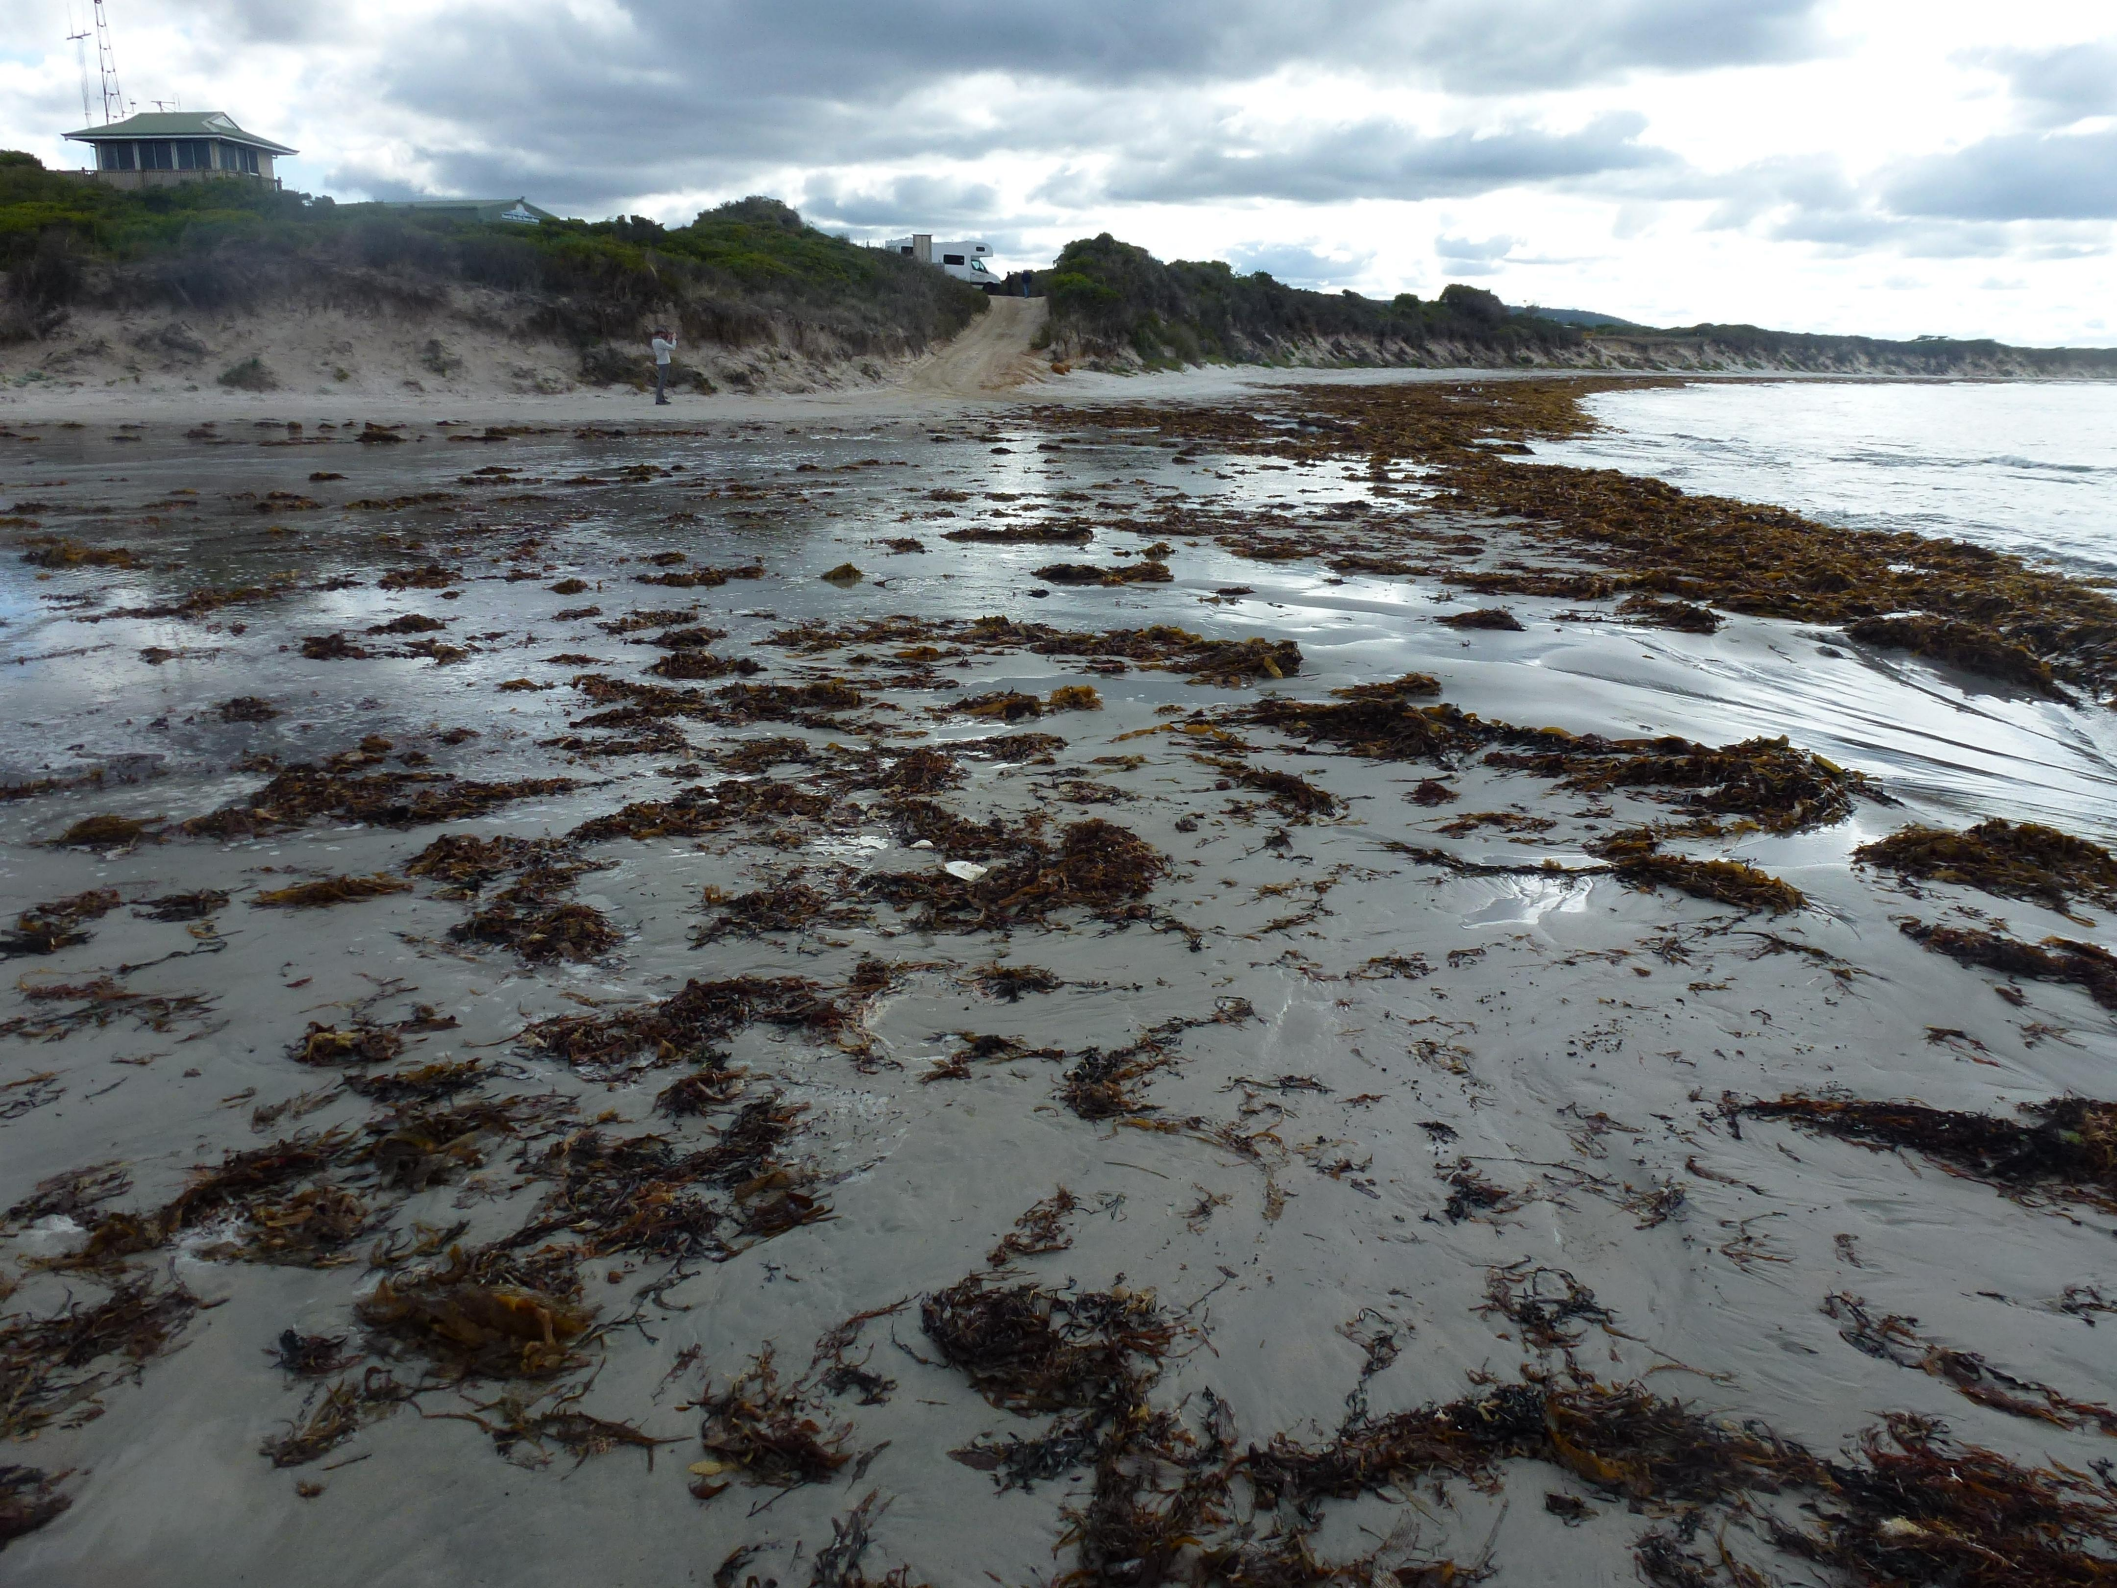
Site ID	Peaceful Bay- Site 4
Location	Tombolo - East of boat ramp
Date & Time	22/05/2019 12:58PM

Notes (relevant notes on beach condition, features, works etc.)	Monitoring location at rock formation on end of tombolo, suitability of monitoring location to be monitored
	Beach is relatively flat, ~1:30 slope
	Seaweed wrack build up to high tide mark
	Monitoring location was inundated during spring tide monitoring campaign

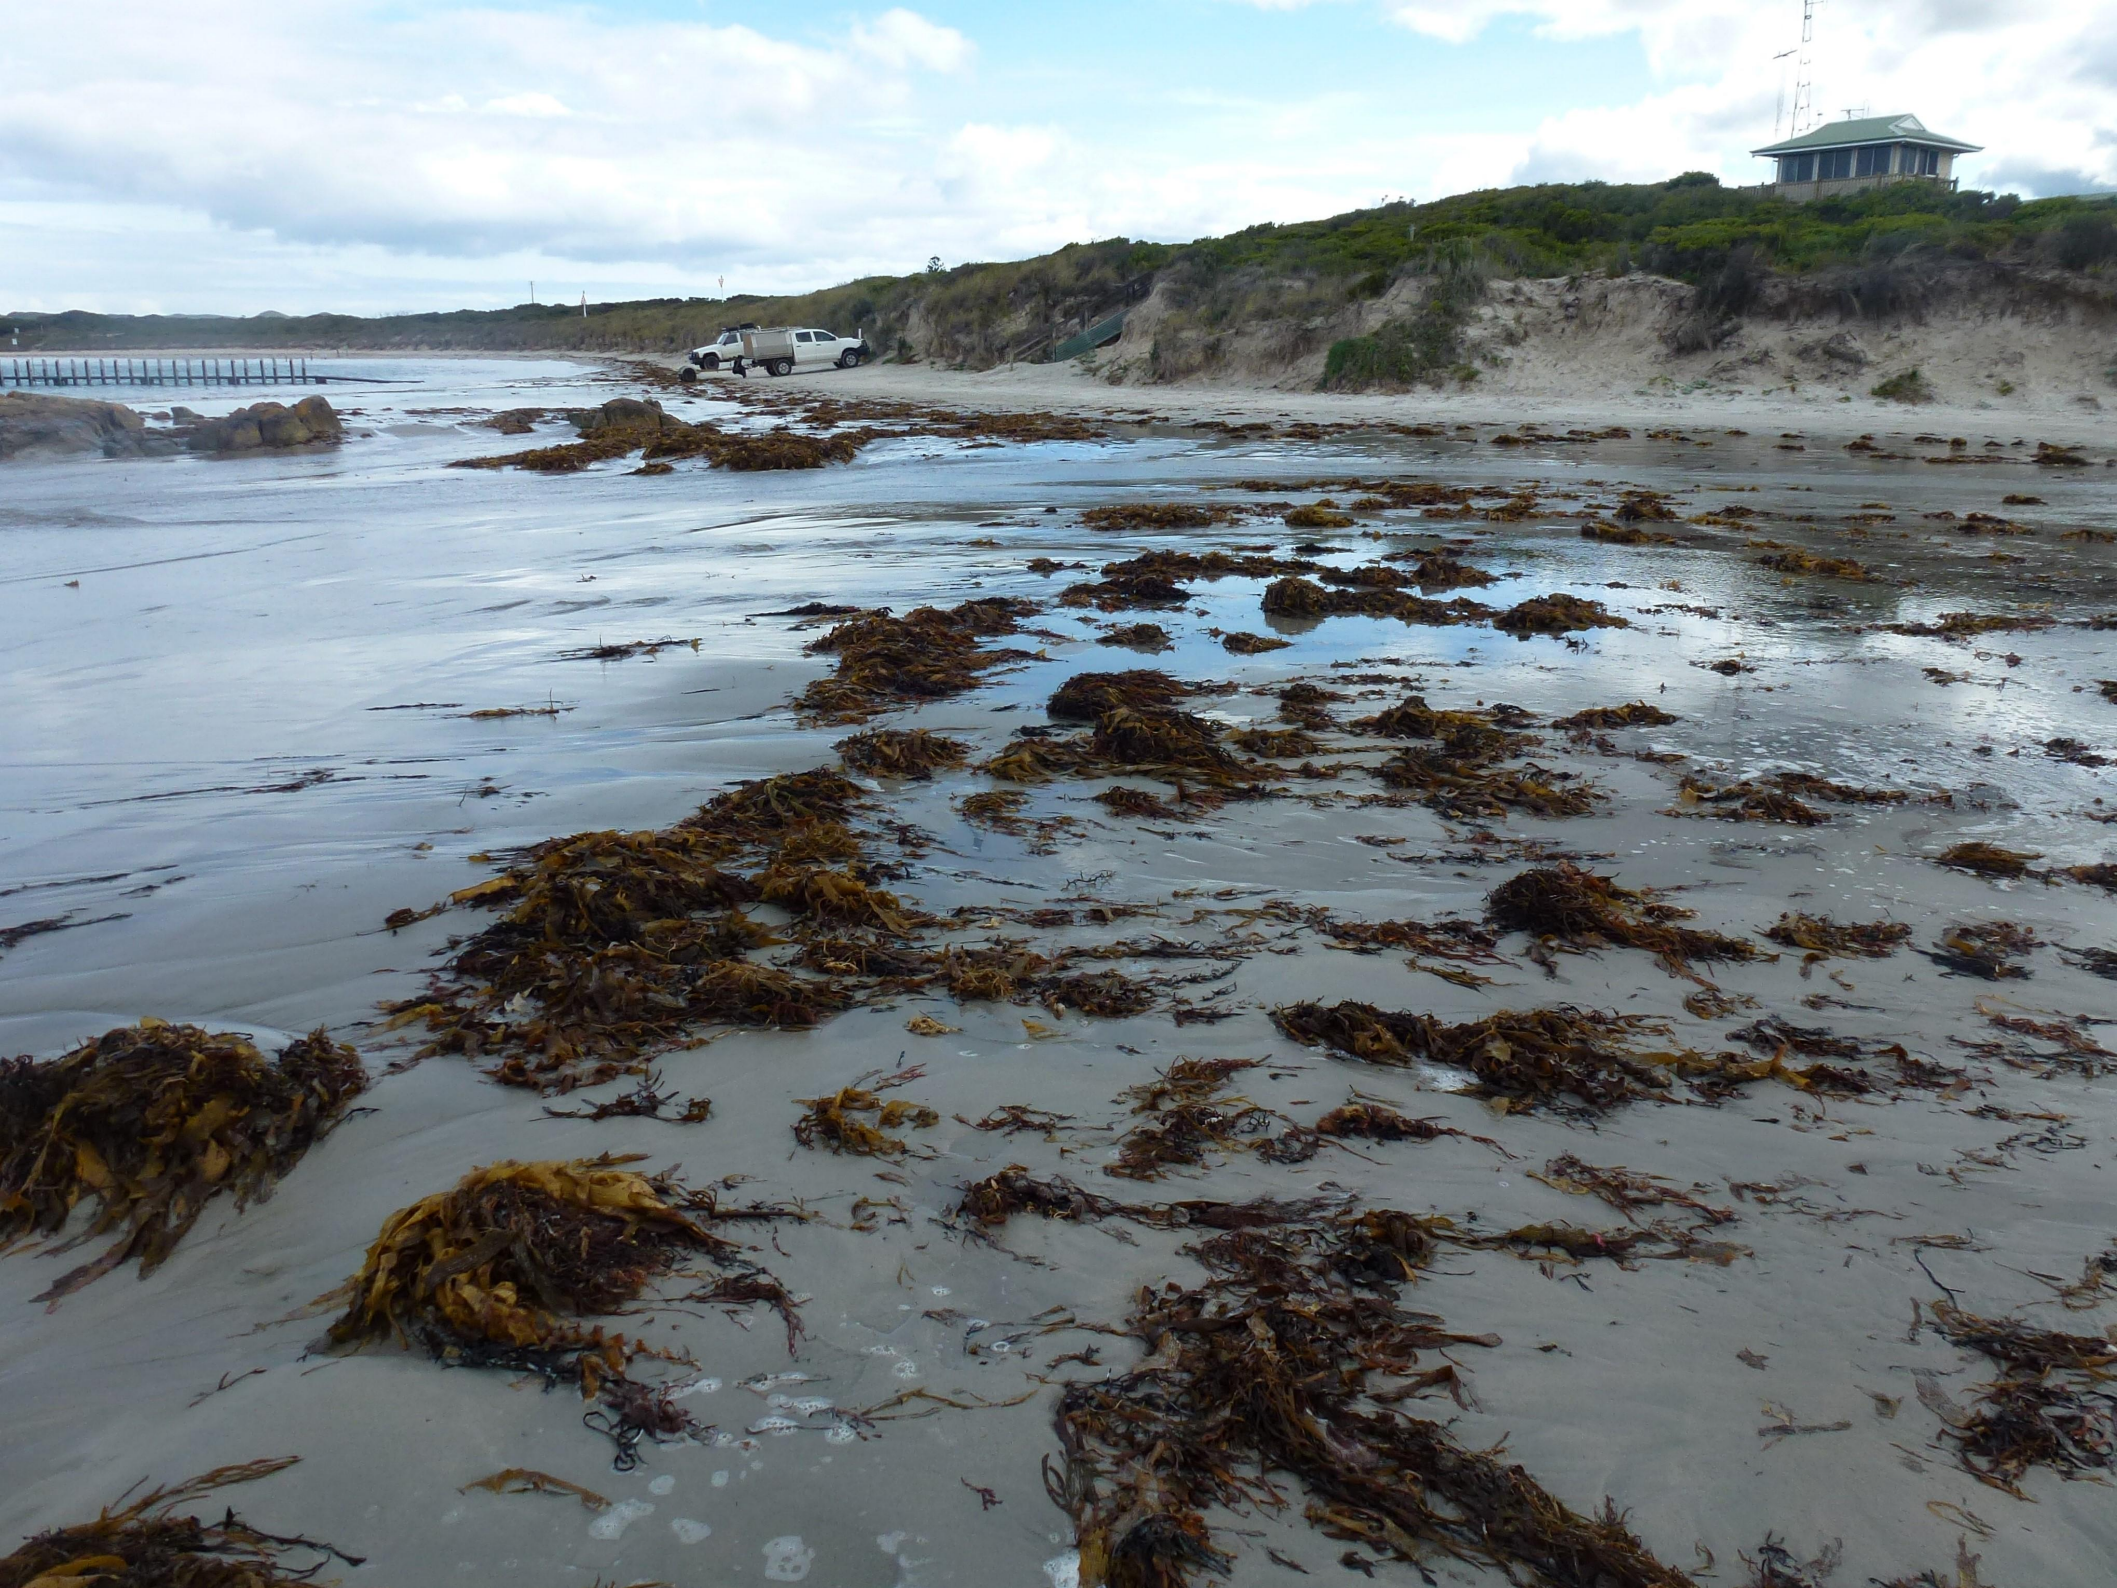
Site ID	Peaceful Bay- Site 4
Location	Tombolo - East of boat ramp
Date & Time	22/05/2019 12:59PM

Notes (relevant notes on beach condition, features, works etc.)	Monitoring location at rock formation on end of tombolo, suitability of monitoring location to be monitored
	Beach is relatively flat, ~1:30 slope
	Seaweed wrack build up to high tide mark
	Monitoring location was inundated during spring tide monitoring campaign

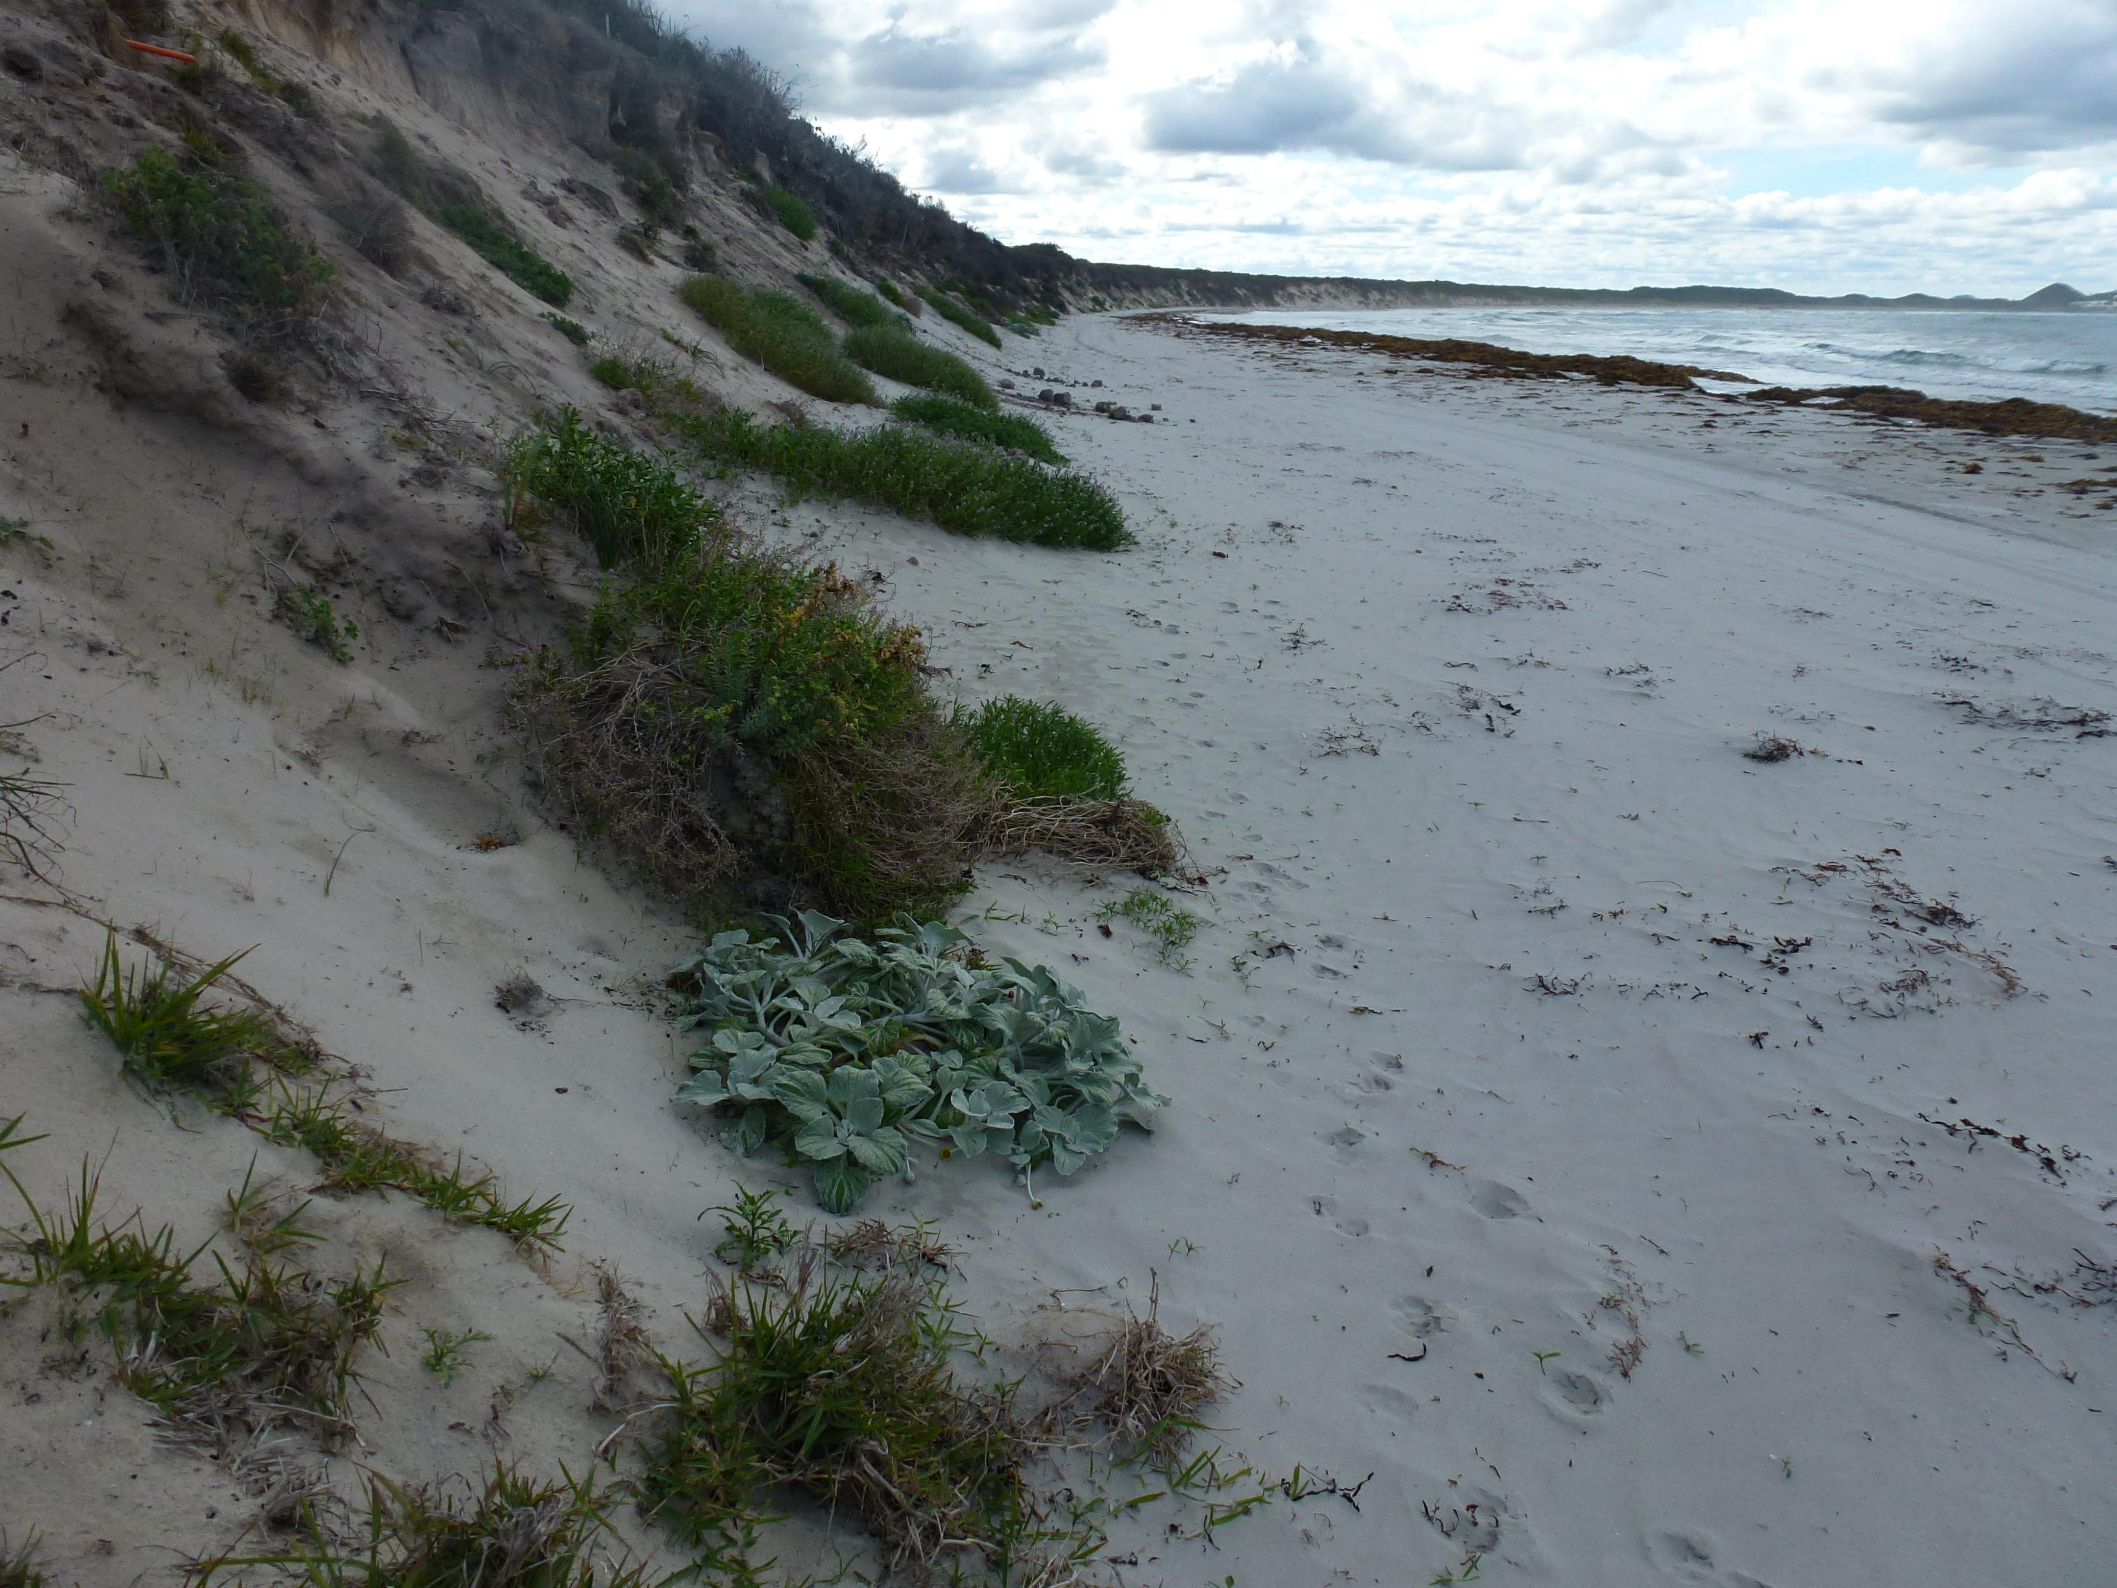
Site ID	Peaceful Bay- Site 5
Location	"Danger Keep Out Sign" - Foul Bay
Date & Time	22/05/2019 1.06PM

Notes (relevant notes on beach condition, features, works etc.)	Monitoring location at existing "Danger Keep Out" sign
	Beach is relatively narrow and flat, ~1:25 slope
	20-30m wide beach continues north, vehicles in use along beach
	Heavily eroded dunes continue north
