Ocean Beach and Peaceful Bay

Coastal Monitoring Action Plan

CW1055200

Prepared for
Shire of Denmark

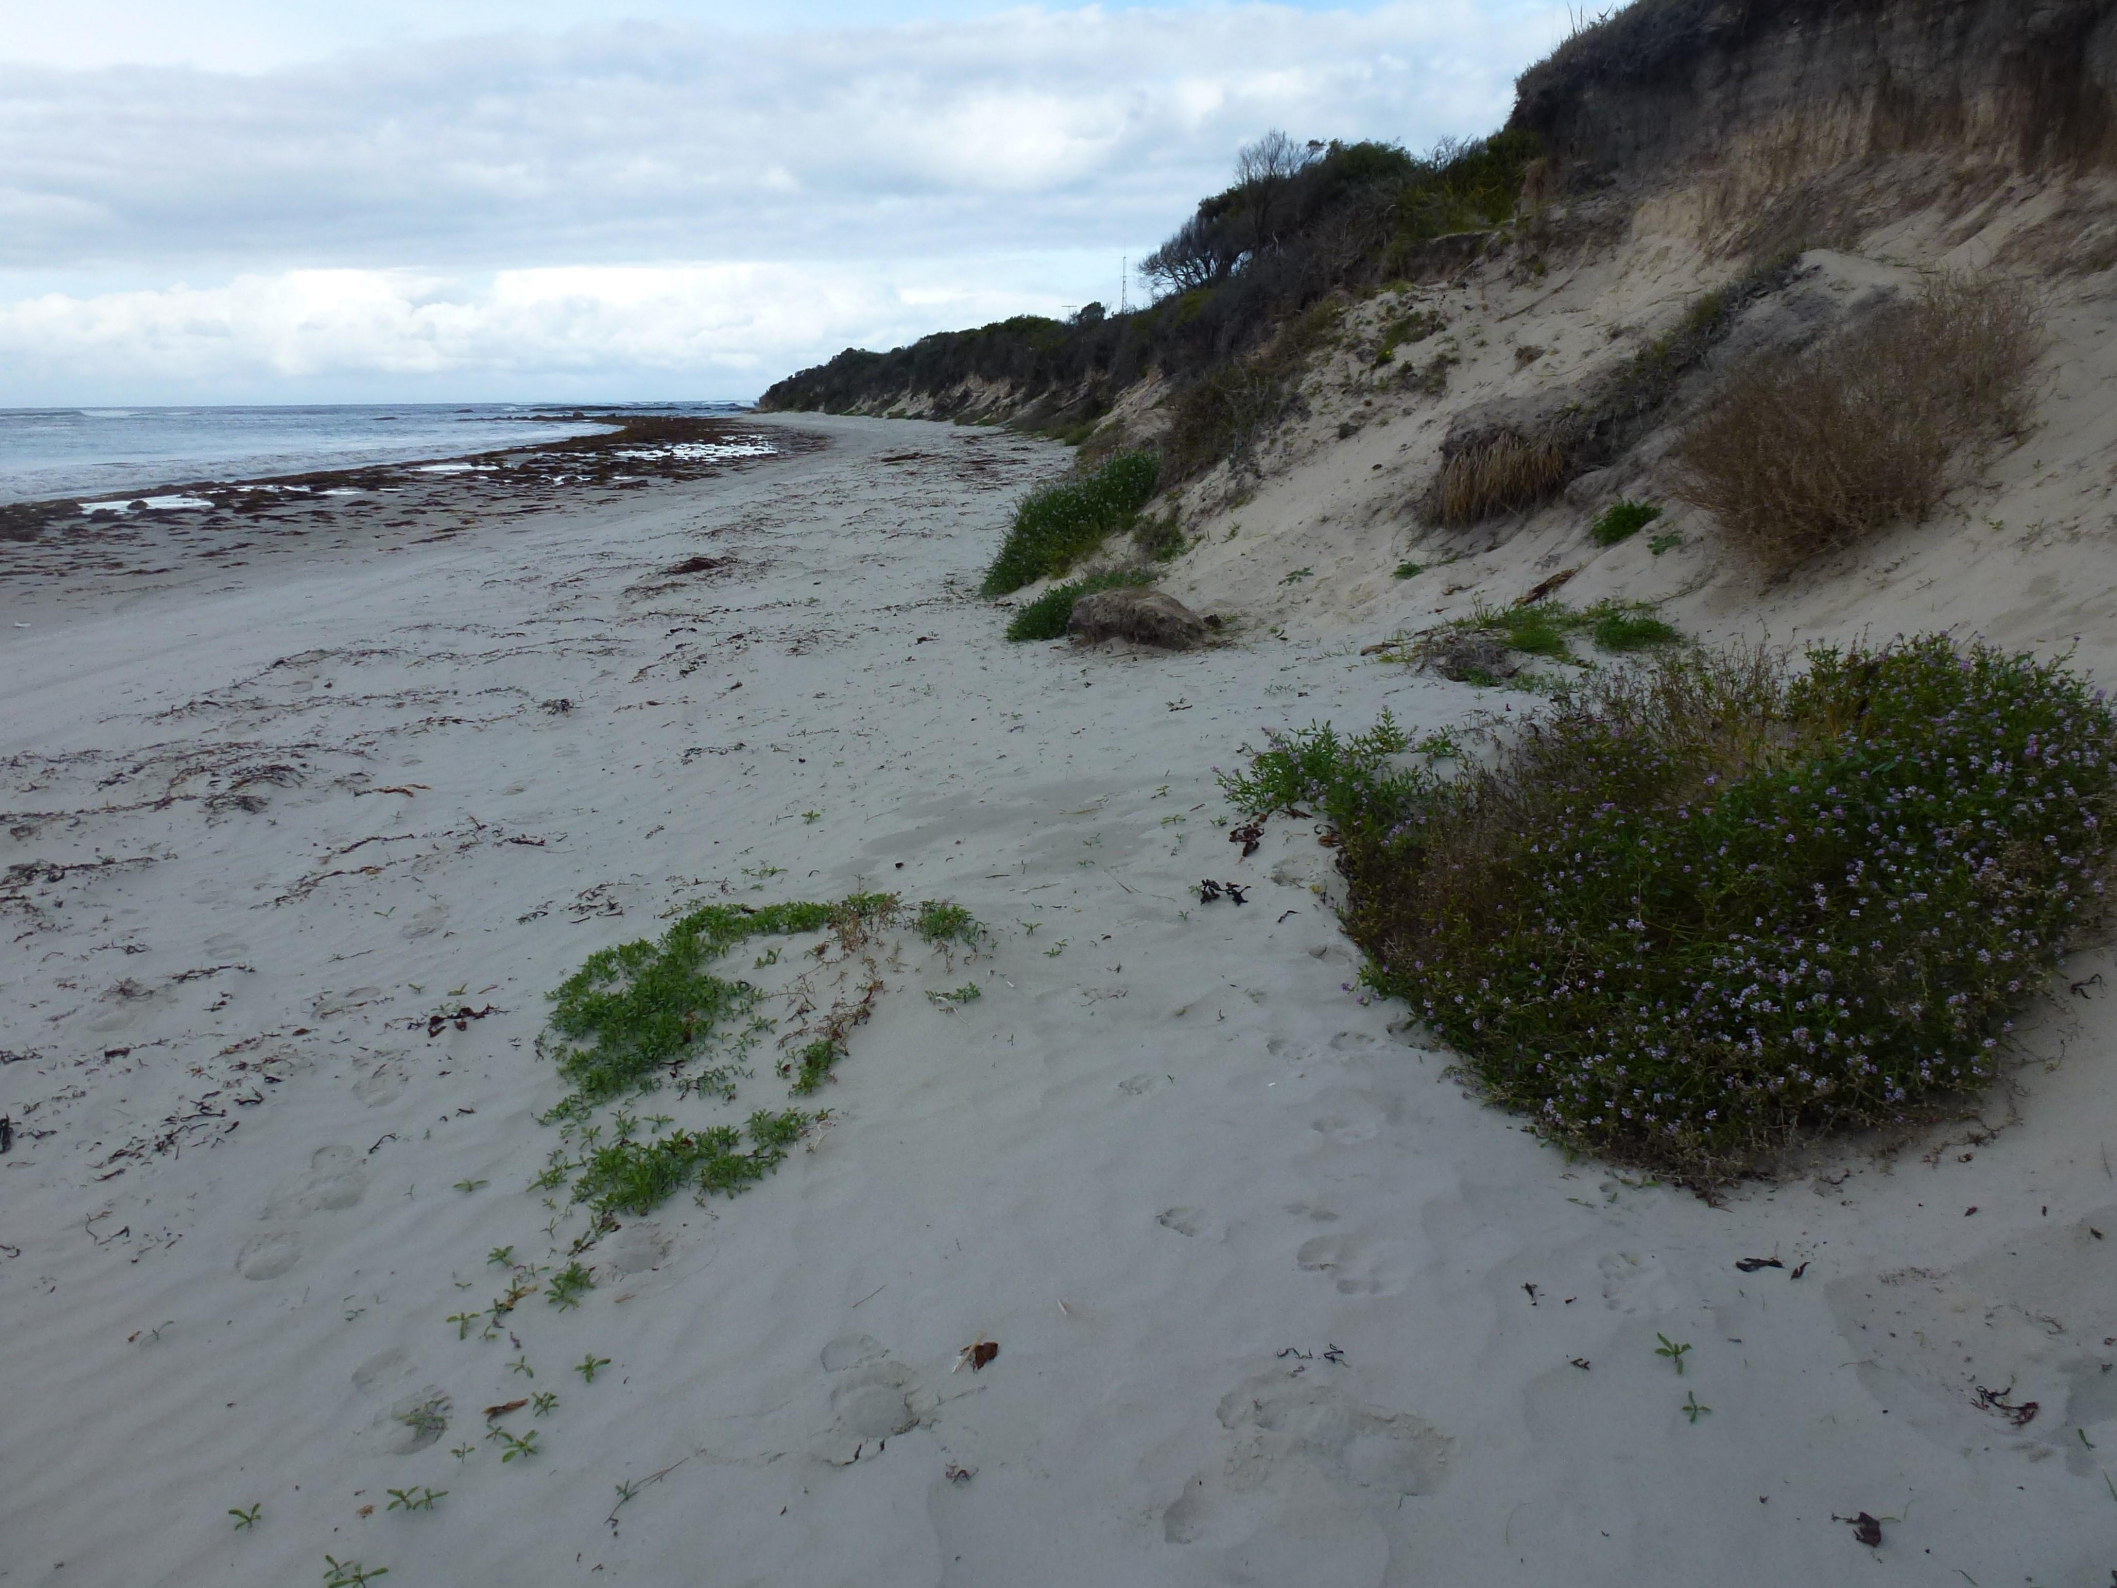
Site ID	Peaceful Bay- Site 5
Location	"Danger Keep Out" sign - Foul Bay
Date & Time	22/05/2019 1.07PM

Notes (relevant notes on beach condition, features, works etc.)	Monitoring location at existing "Danger Keep Out" sign
	Beach is relatively narrow and flat, ~1:30 slope
	20-30m wide beach continues south, vehicles in use along beach
	Heavily eroded dunes continue south

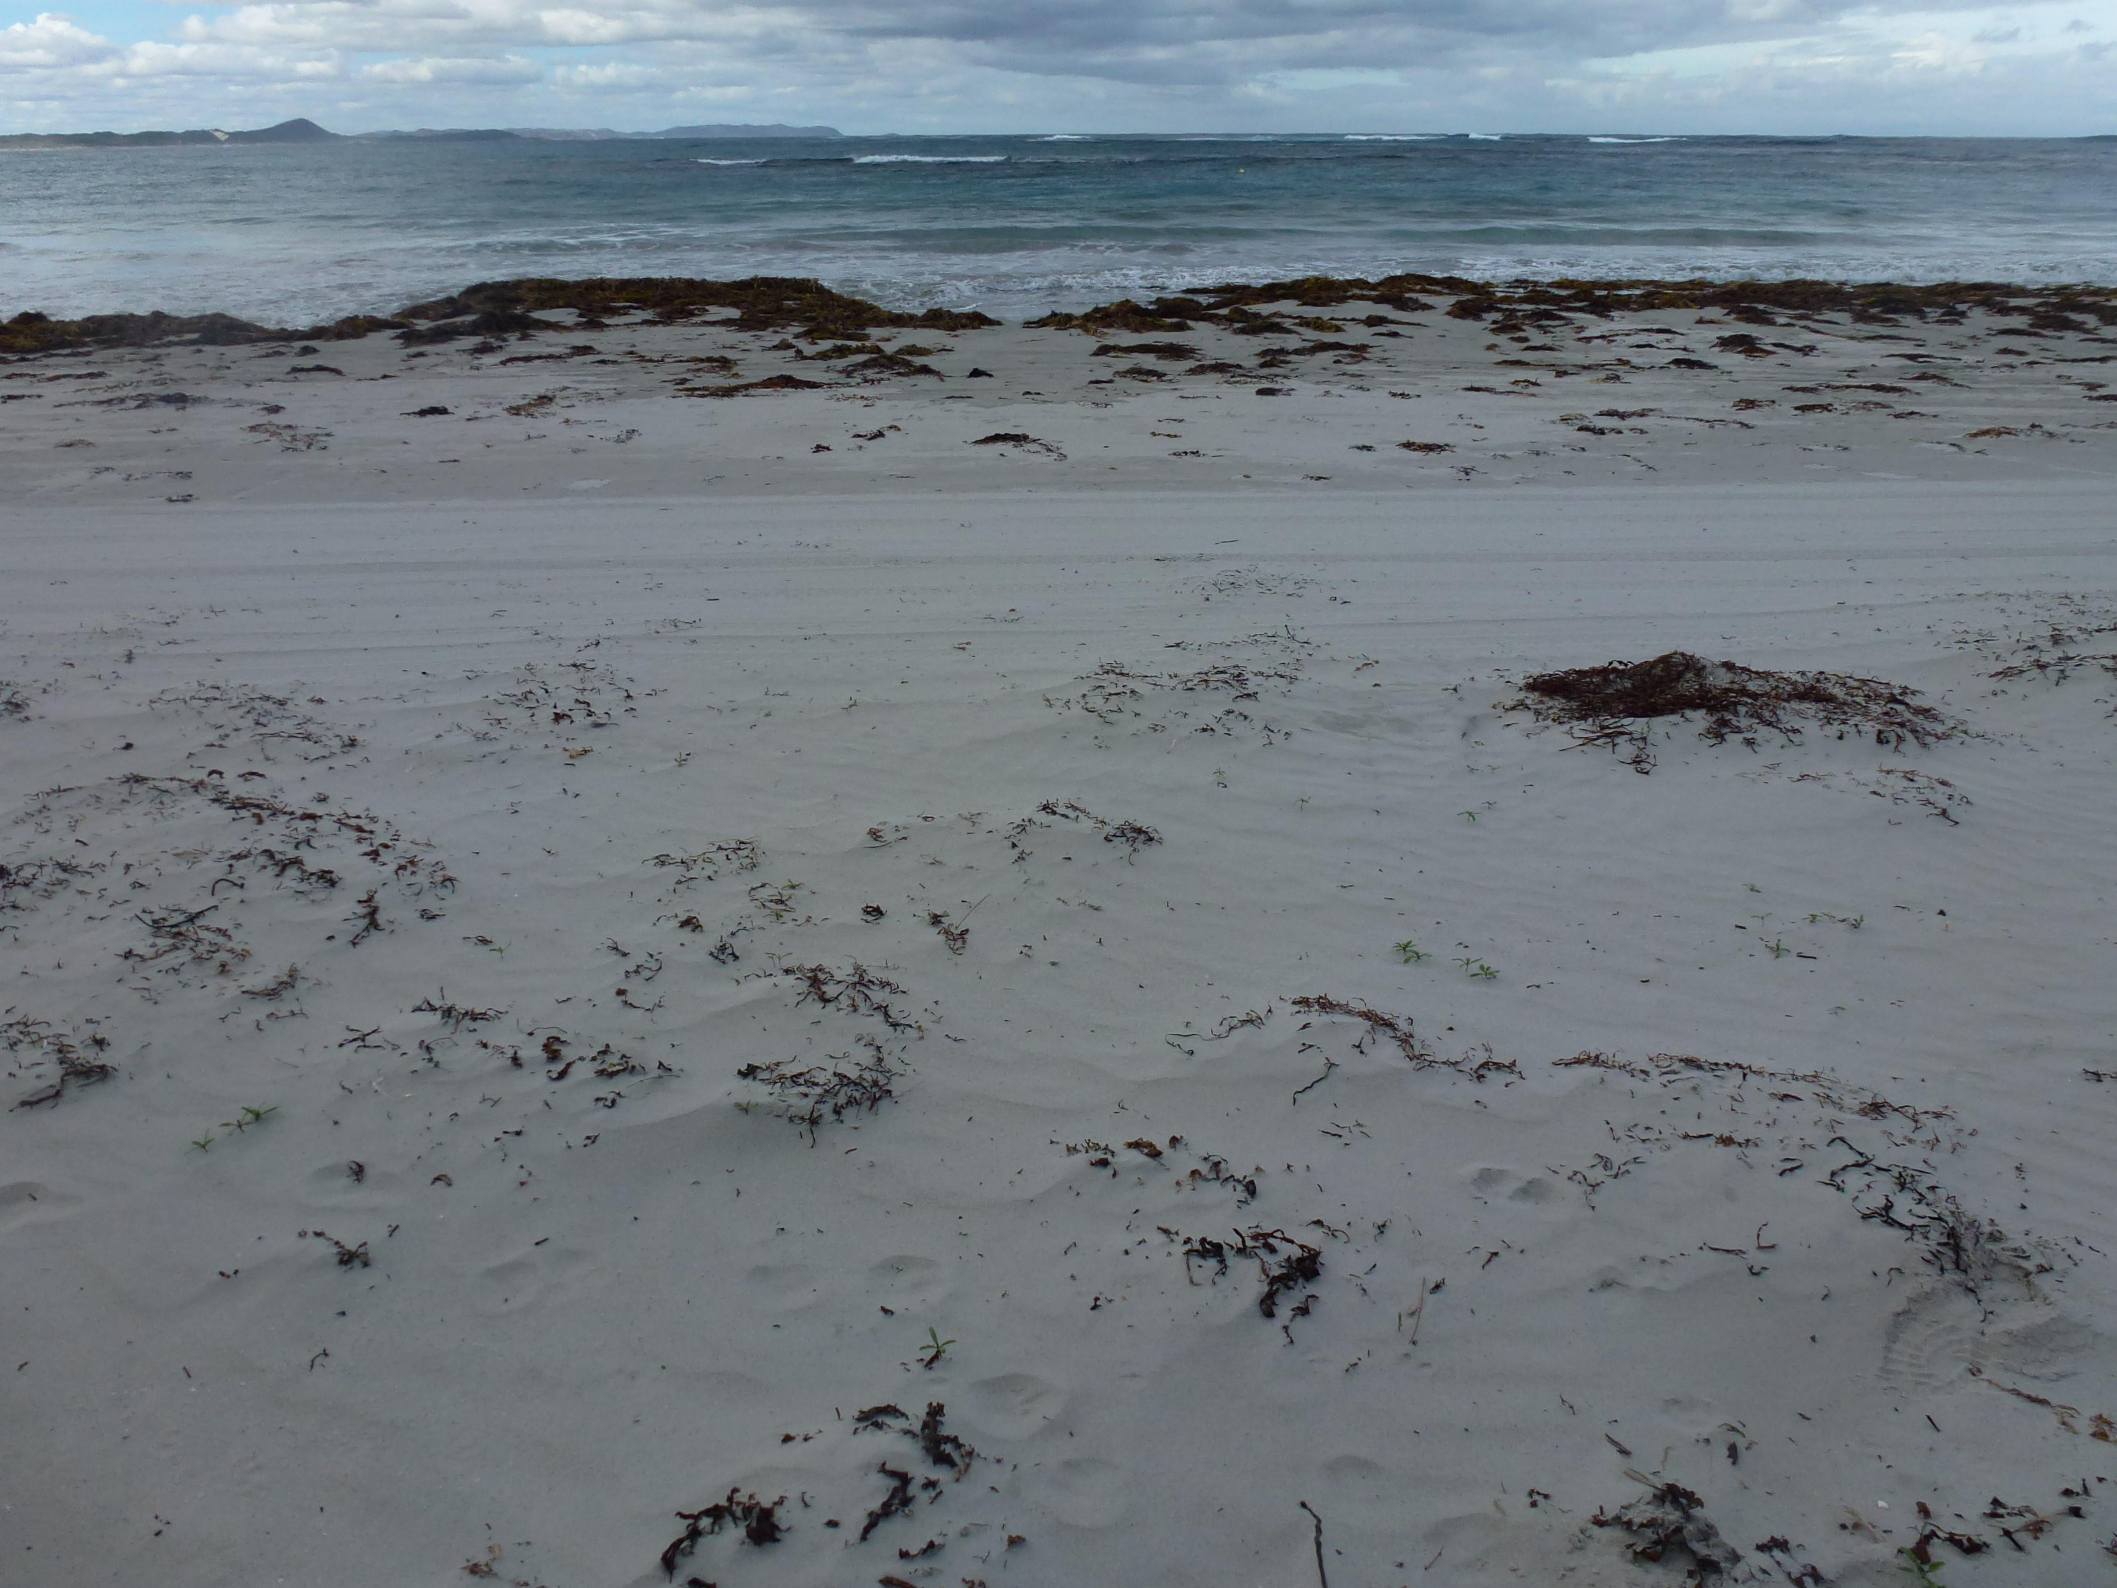
Site ID	Peaceful Bay- Site 5
Location	"Danger Keep Out" sign - Foul Bay
Date & Time	22/05/2019 1.07PM

Notes (relevant notes on beach condition, features, works etc.)	Monitoring location at existing "Danger Keep Out" sign
	Beach is relatively narrow and flat, ~1:30 slope
	Seaweed wrack build up at high tide mark
	Vehicles in use along beach

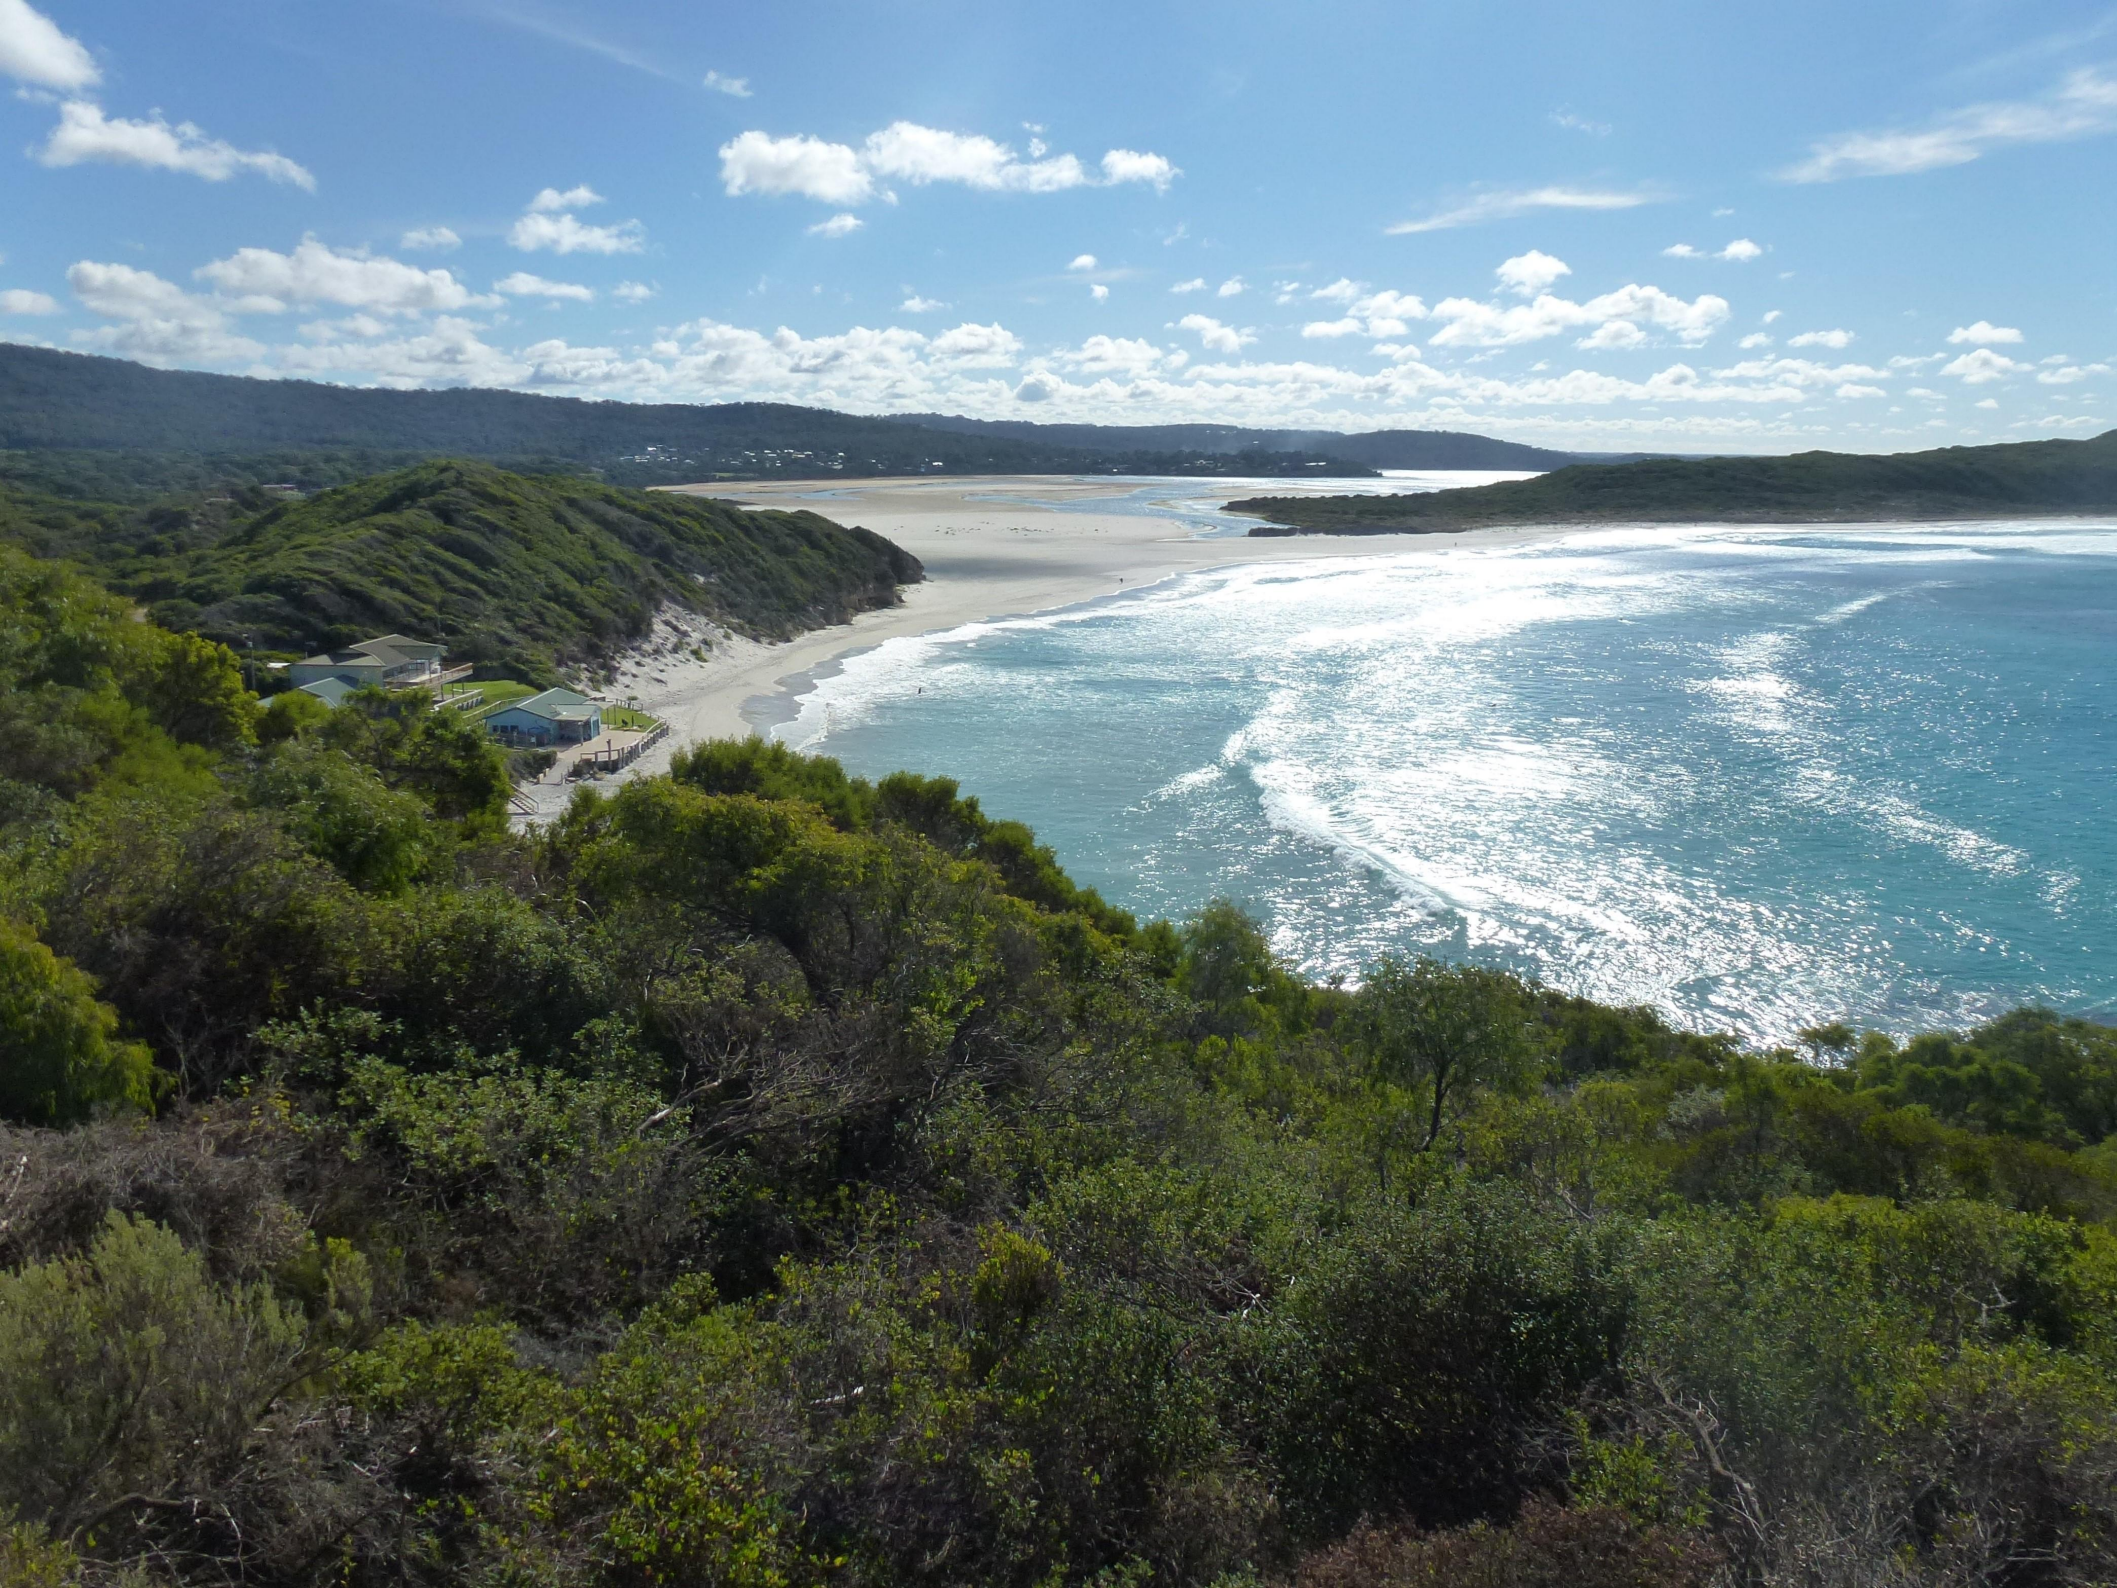
Notes (relevant notes on beach condition, features, works etc.)	Wilson inlet closed
	Narrow beach width in front of Surf life saving Club
	Eroded dune with no vegetation north of Surf Life Saving Club
	Several surfers in water

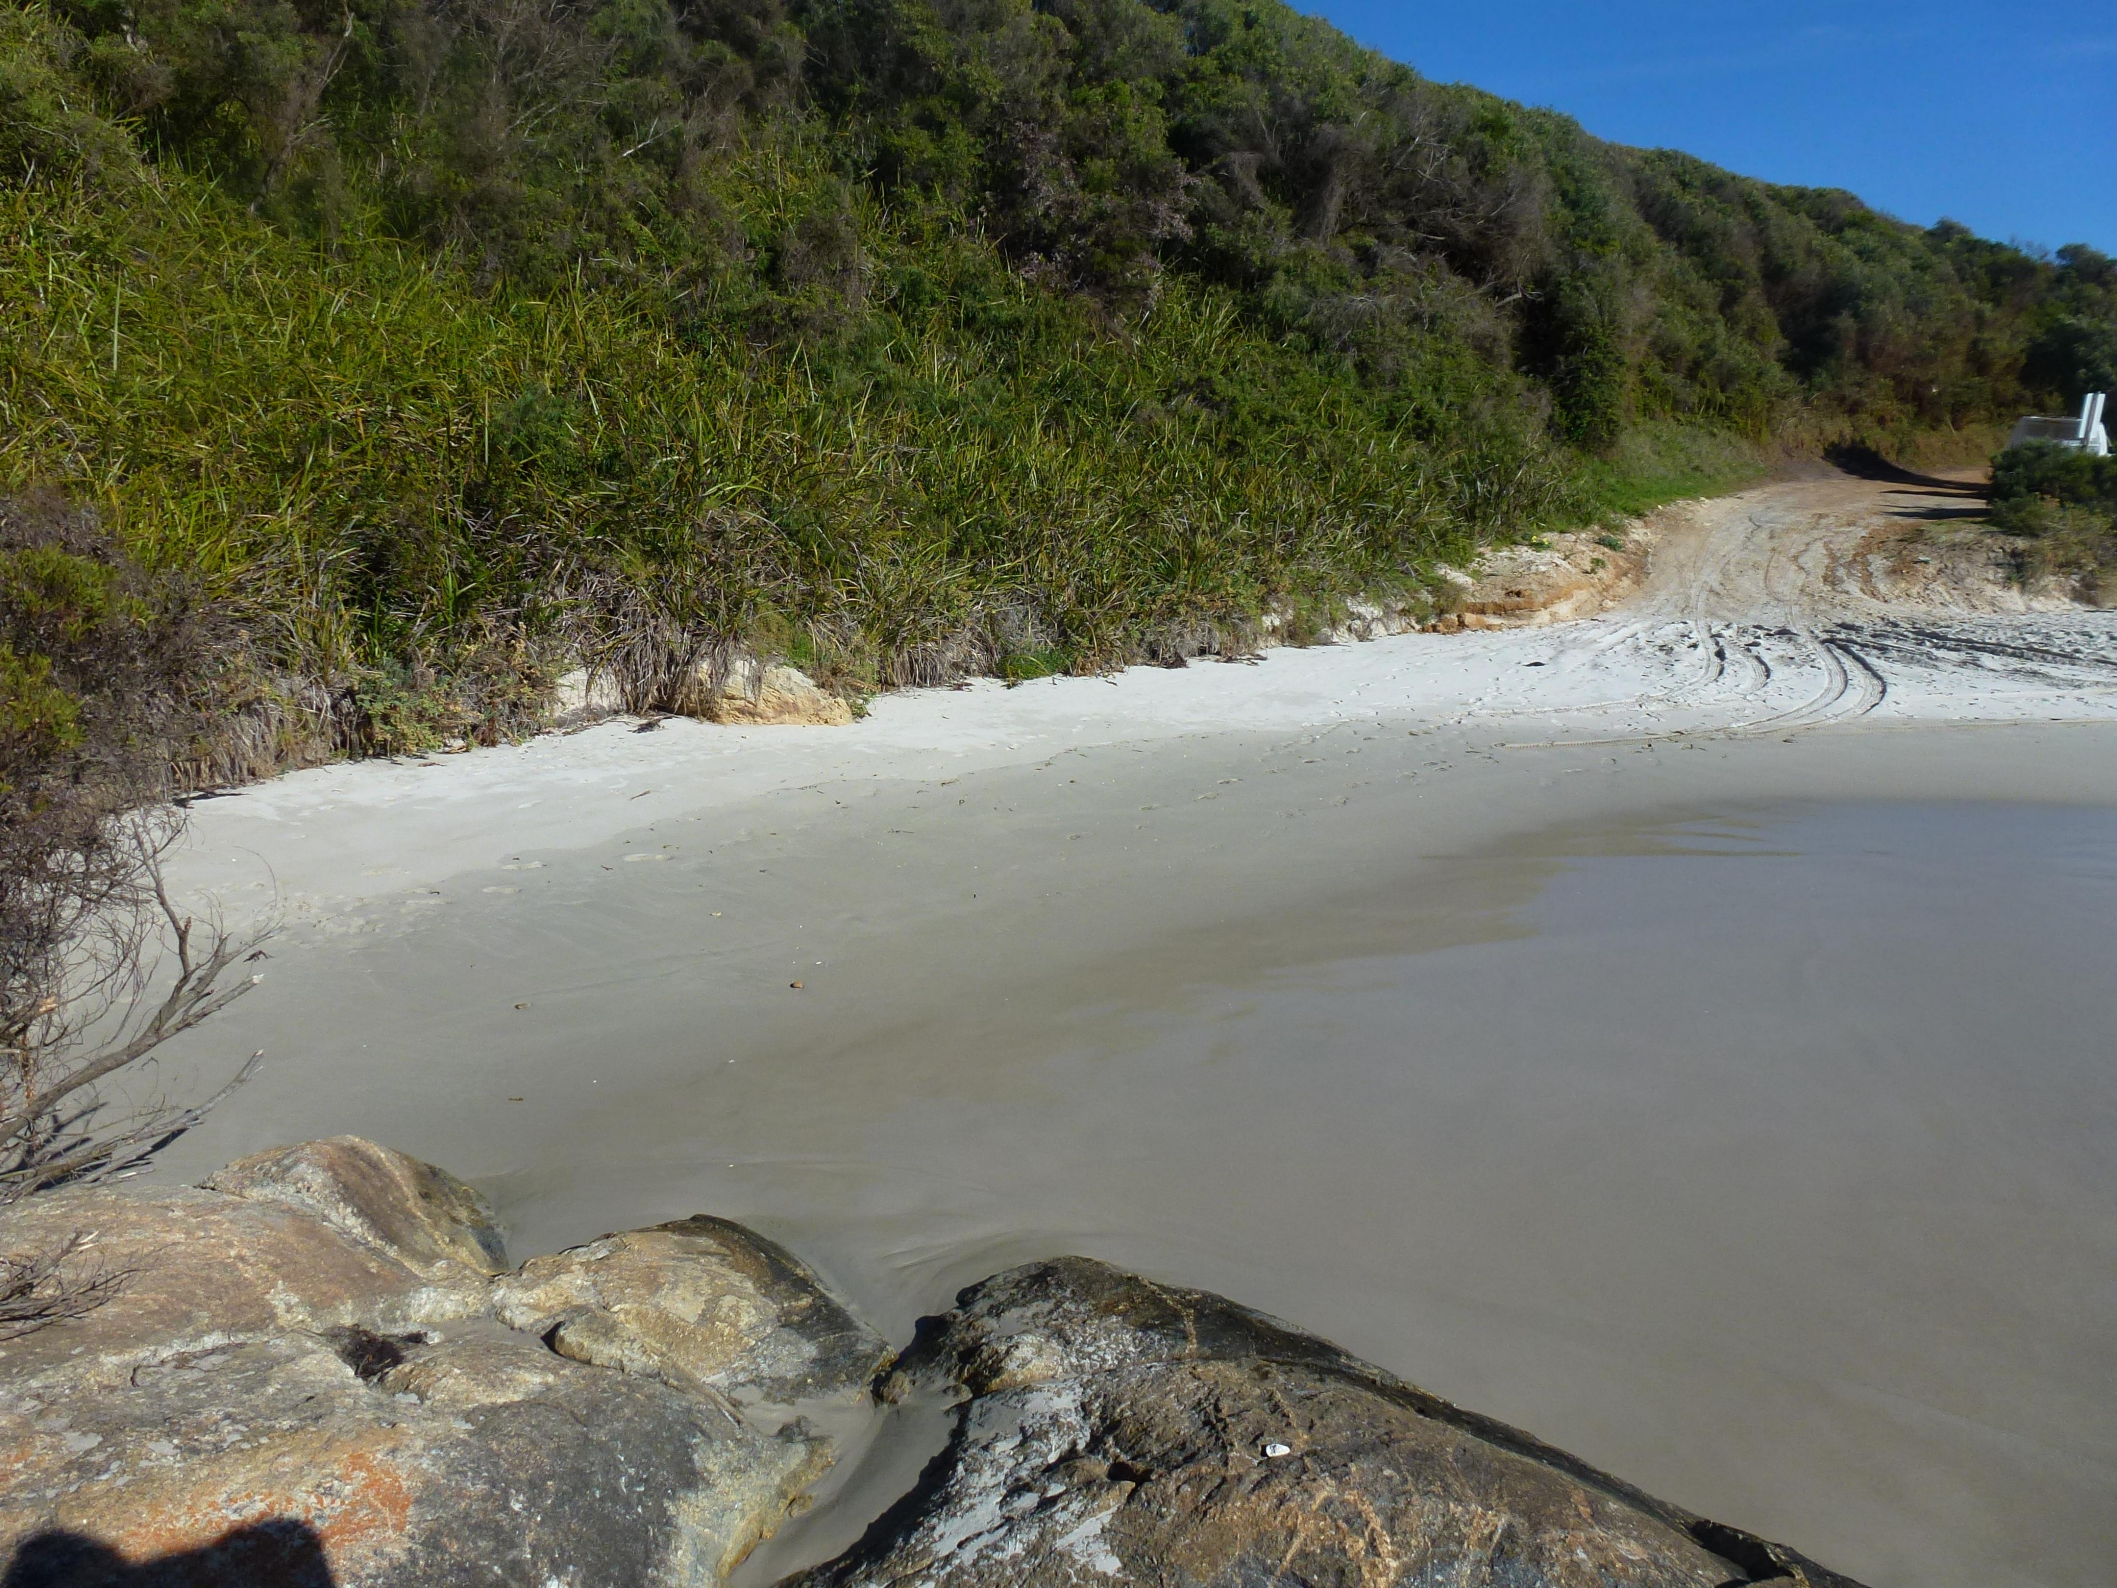
Site ID	Ocean Beach - Site 7
Location	Rock headland - Ocean Beach south
Date & Time	22/05/2019 10.50AM

Notes (relevant notes on beach condition, features, works etc.)	Monitoring location on rock headland south of Ocean Beach, suitability of monitoring location to be monitored
	Beach is very narrow, less than 5m wide at high tide mark, ~1:15 slope
	Scoured tyre markings at toe of access ramp
	Sediment appears quite fine at toe of headland

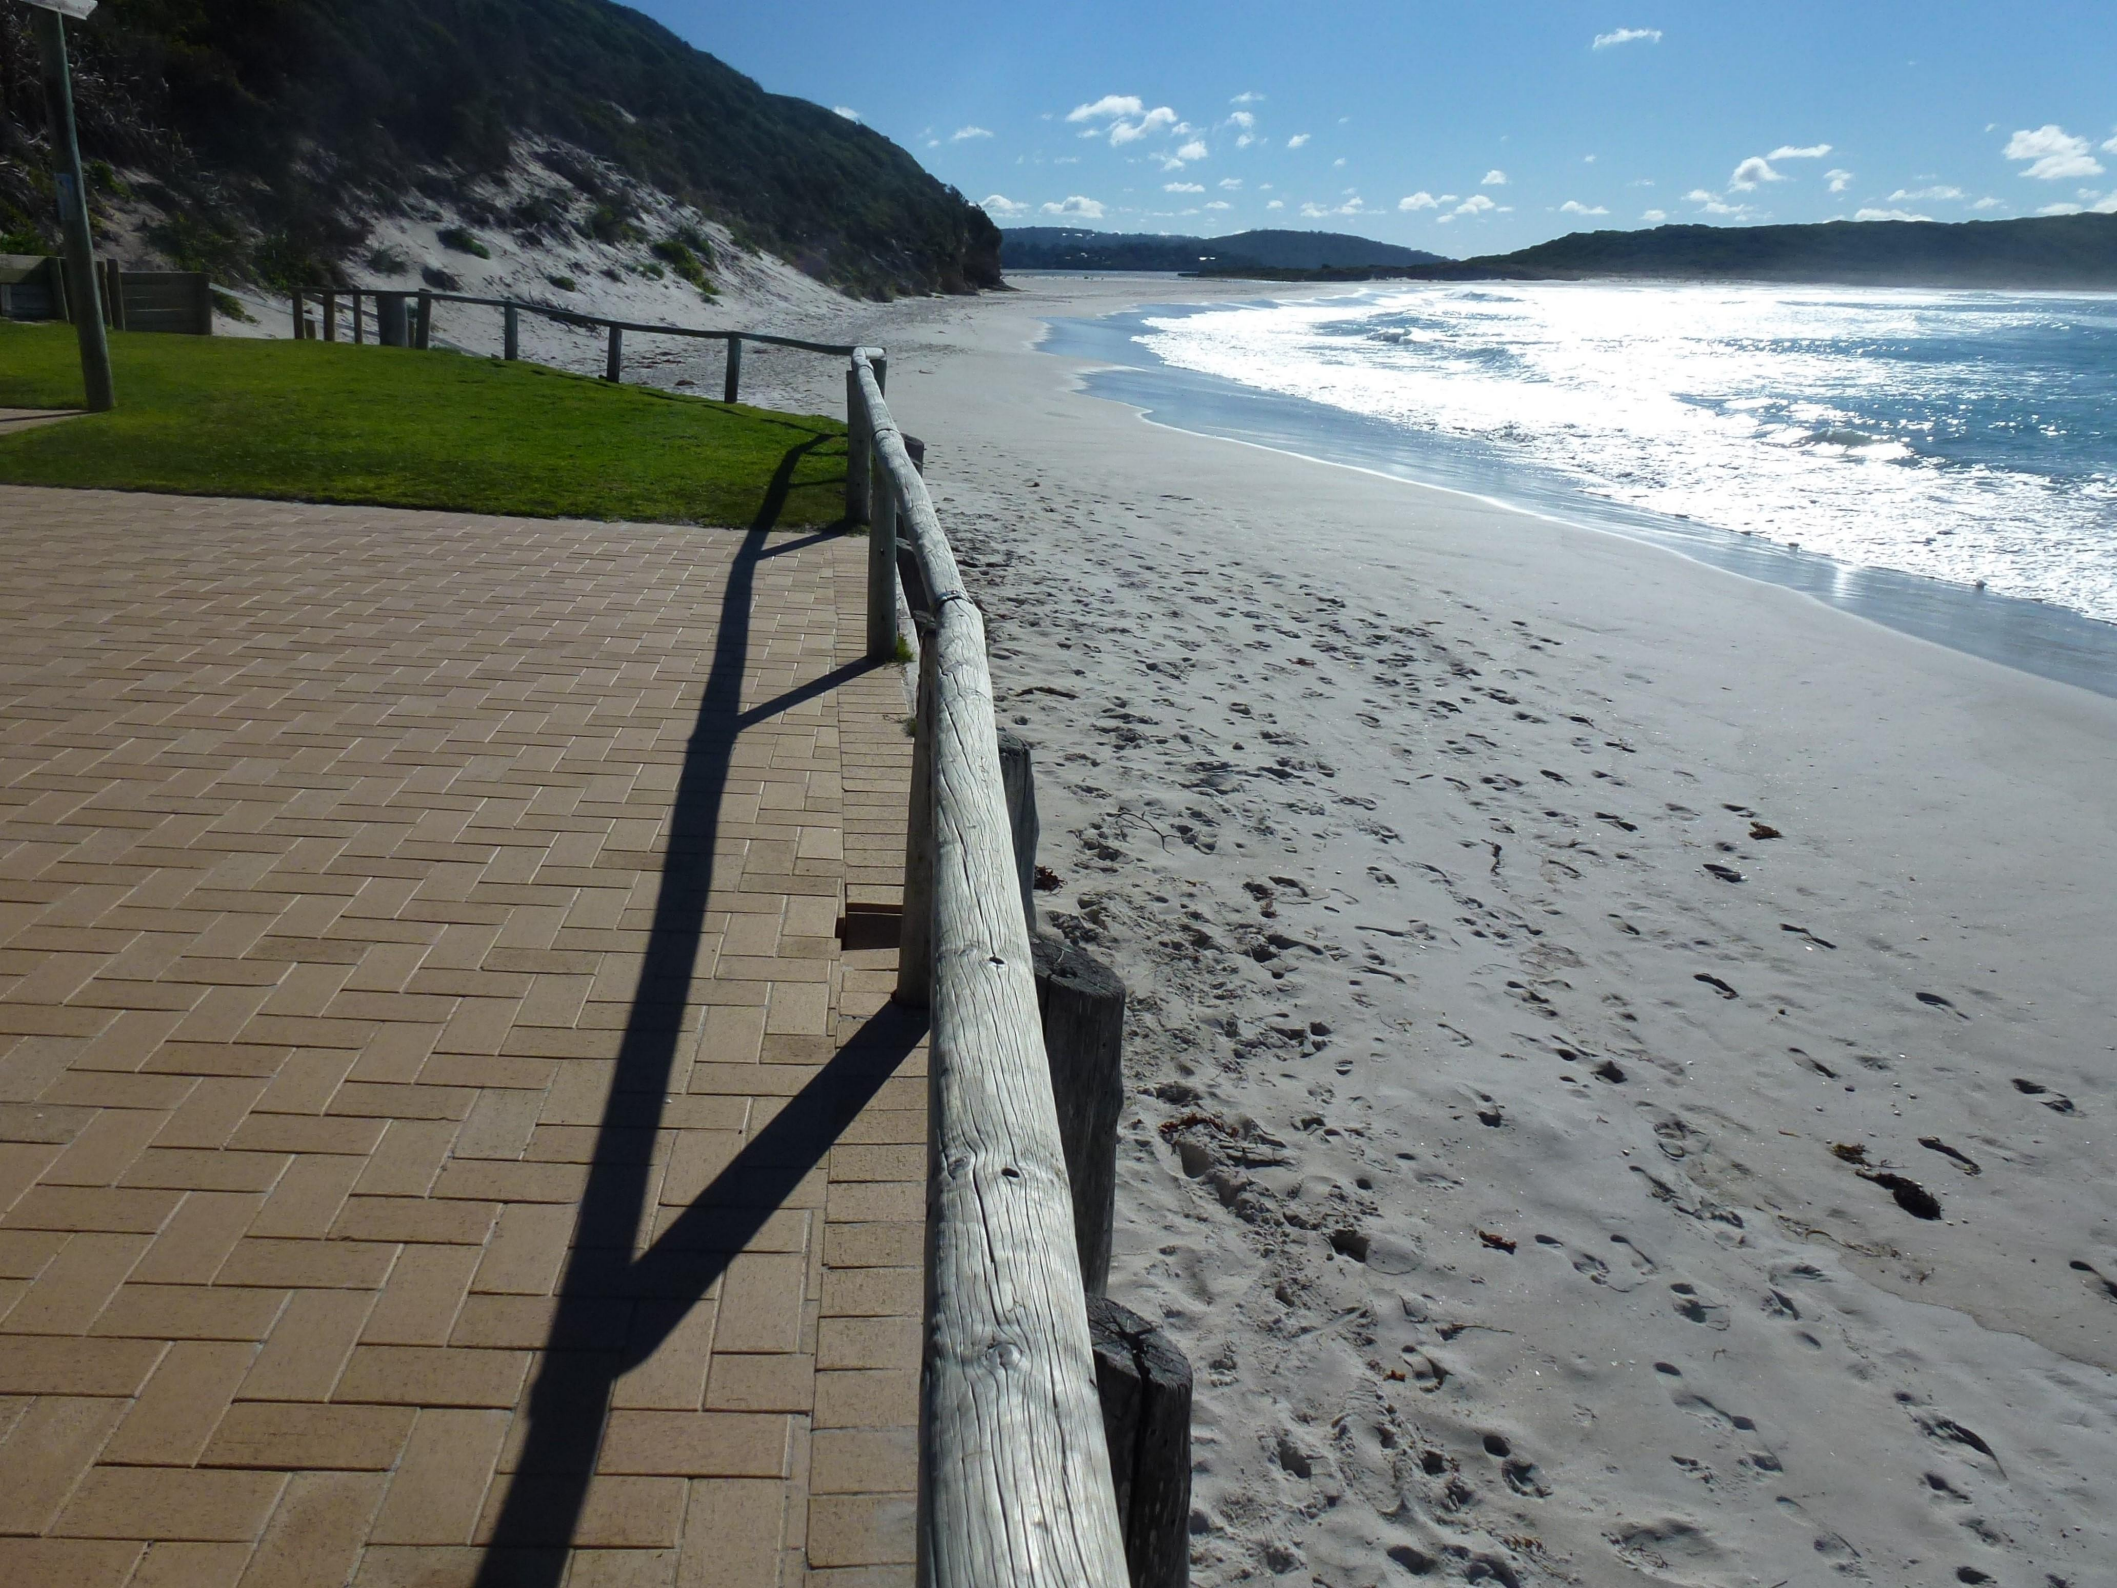
Notes (relevant notes on beach condition, features, works etc.)	Monitoring location at approximately mid point of brick paving, monitoring location to be monitored and revised upon completion of new Surf Life saving Club
	Beach relatively narrow, approximately 15-20m wide at high tide mark, ~1:20 slope
	Eroded vegetation immediately north of Surf Life Saving Club

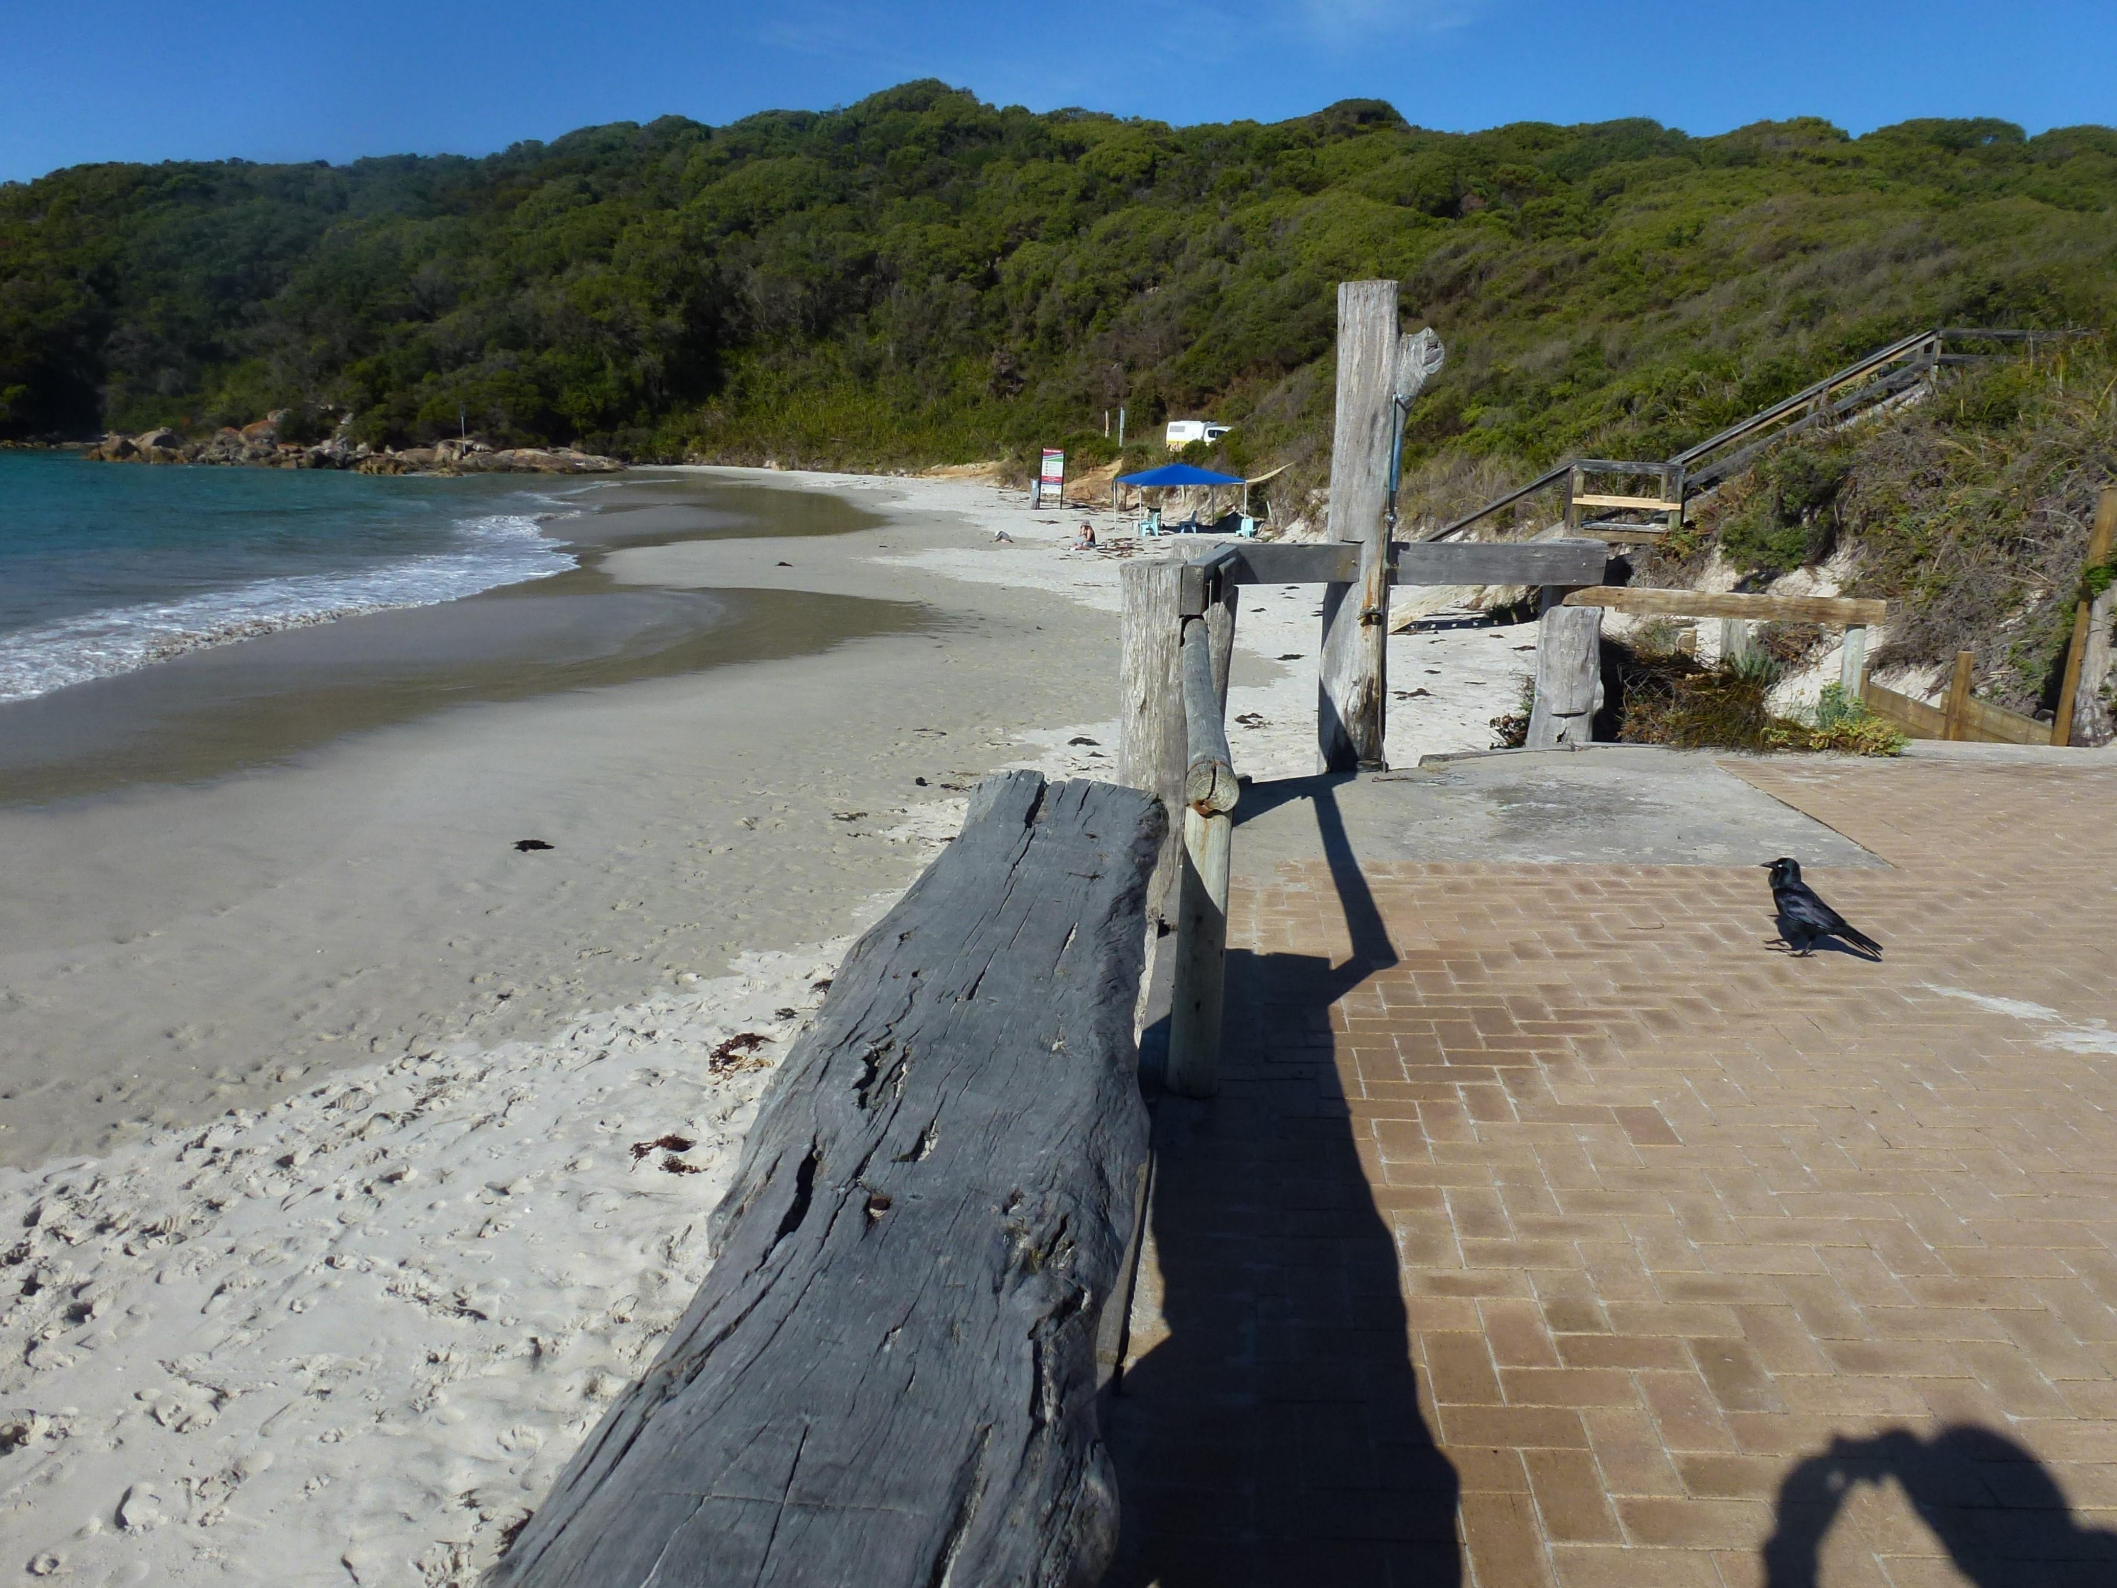
Site ID	Ocean Beach - Site 8
Location	Surf Life Saving Club
Date & Time	22/05/2019 10.54AM

Notes (relevant notes on beach condition, features, works etc.)	Monitoring location at approximately mid point of brick paving, monitoring location to be monitored and revised upon completion of new Surf Life saving Club
	Prominent beach cusps south of Surf Life Saving Club
	Beach width approximately 10m at highest tide mark
	Surf Life Saving Club protrudes seaward of natural dune line
