Ocean Beach and Peaceful Bay

Coastal Monitoring Action Plan

CW1055200

Prepared for
Shire of Denmark

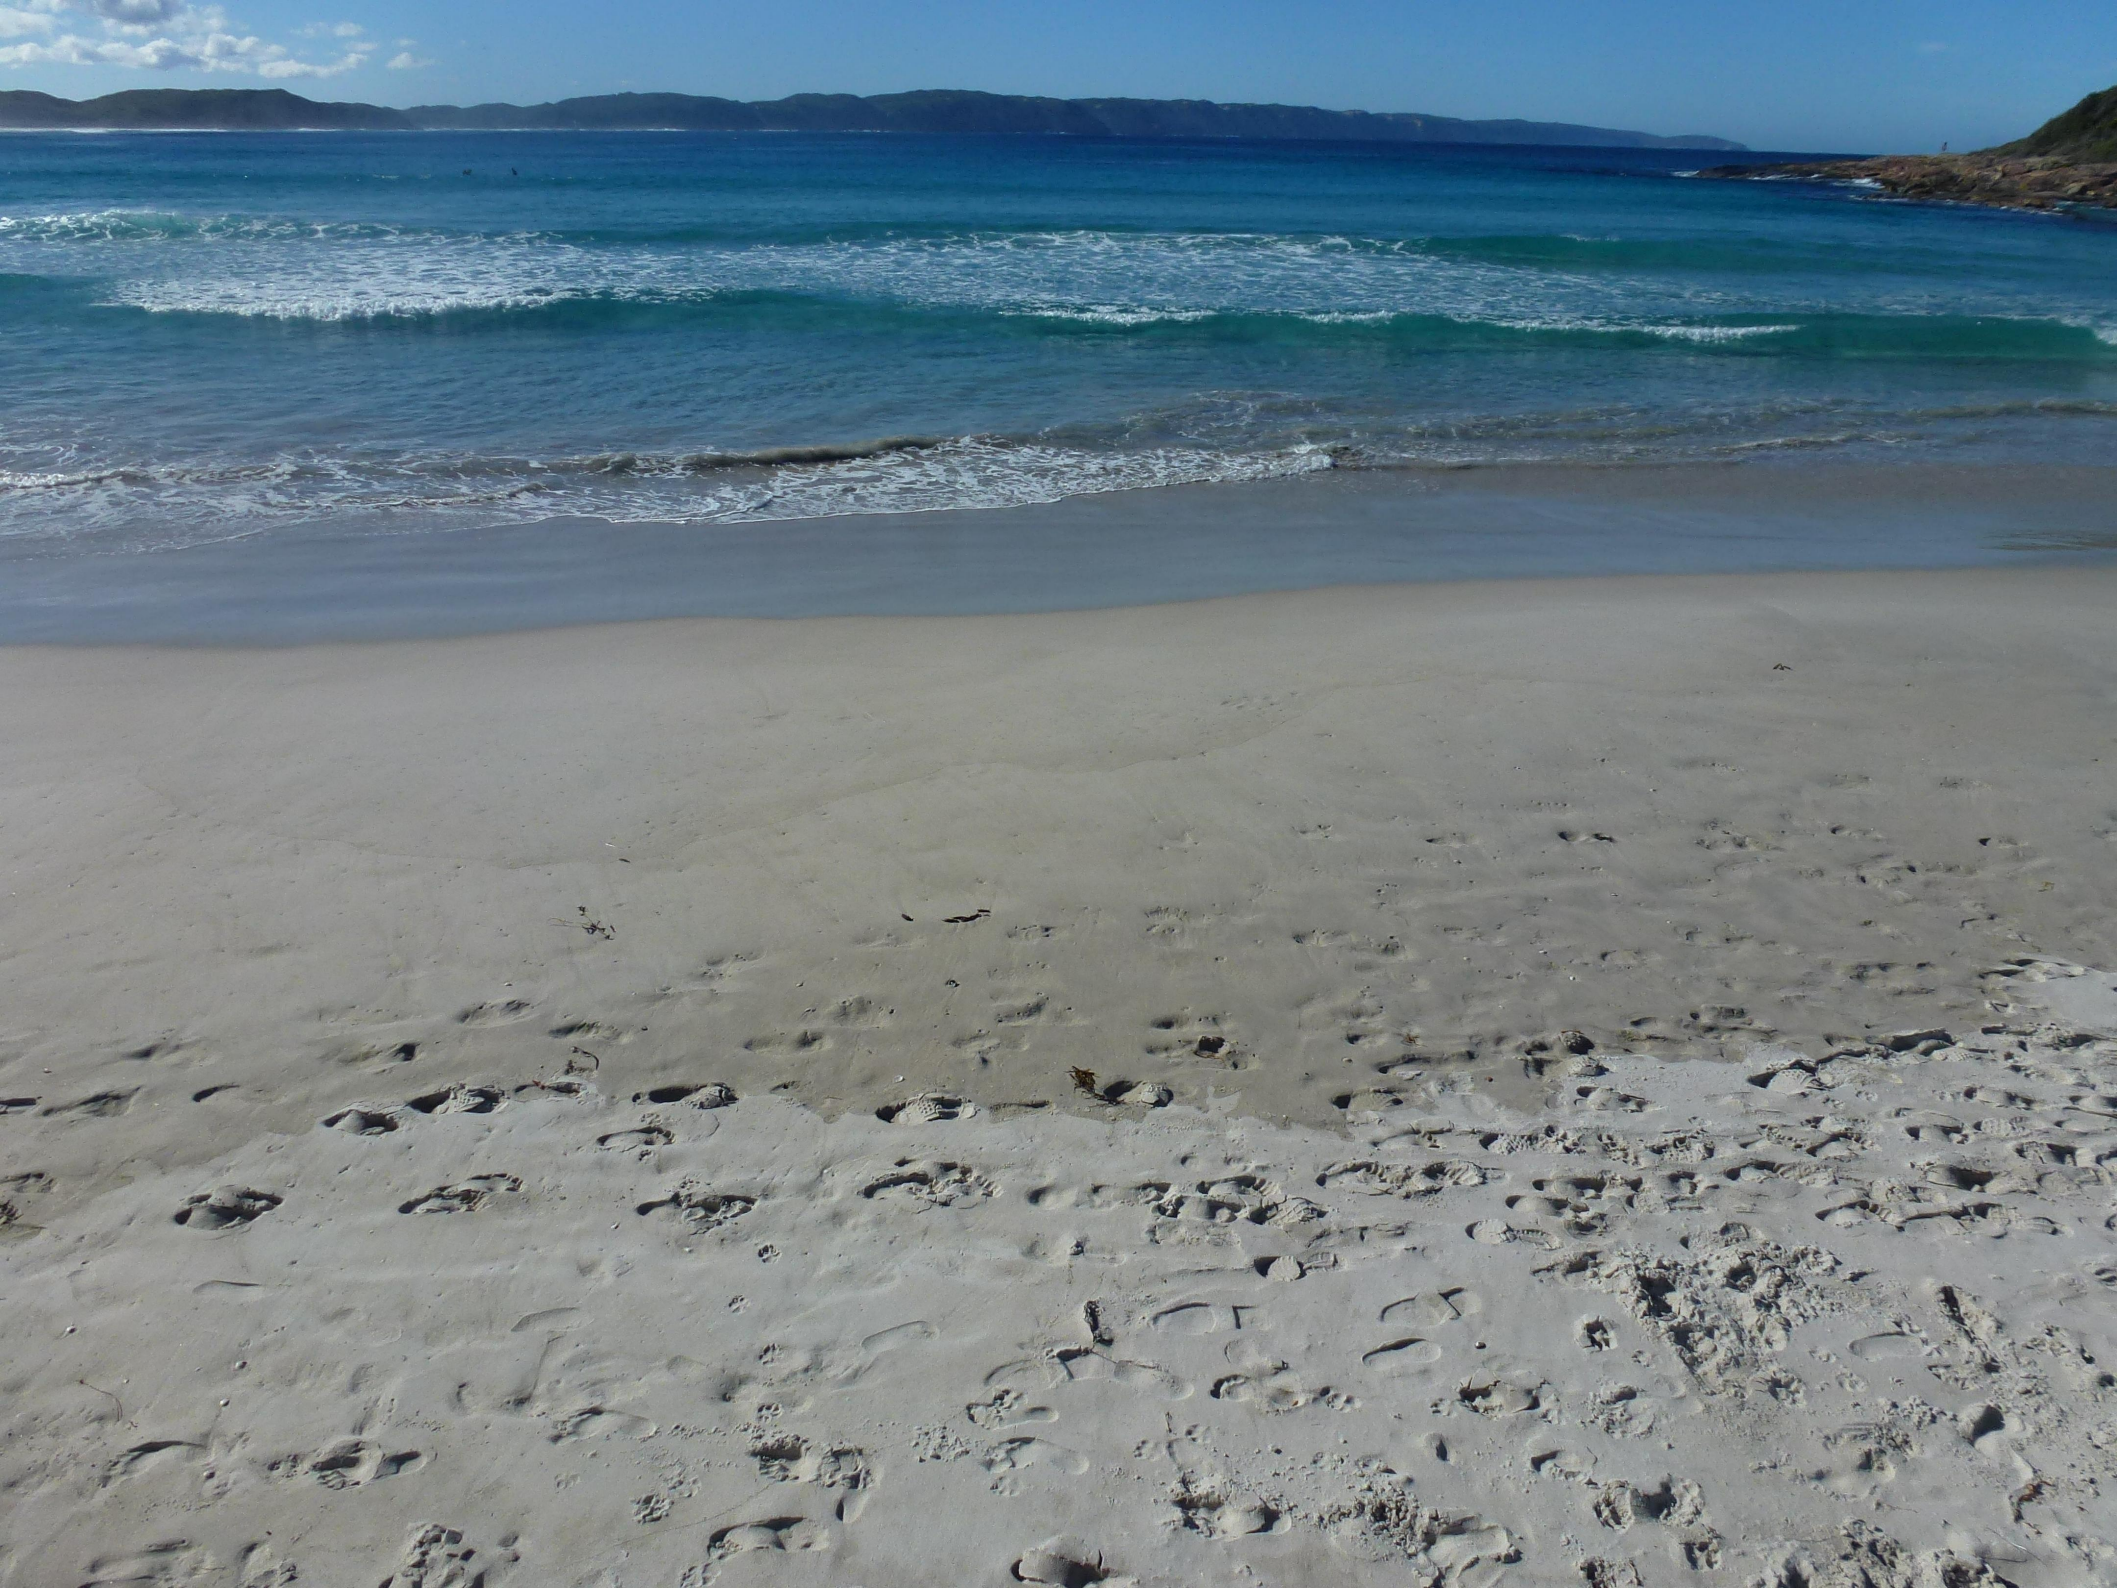
Site ID	Ocean Beach - Site 8
Location	Surf Life Saving Club
Date & Time	22/05/2019 10.56AM

Notes (relevant notes on beach condition, features, works etc.)	Monitoring location at approximately mid point of brick paving, monitoring location <u>to be monitored and revised upon completion of new Surf Life saving Club</u>
	High tide mark less than 10m from Surf Life Saving Club
	Several surfers in water

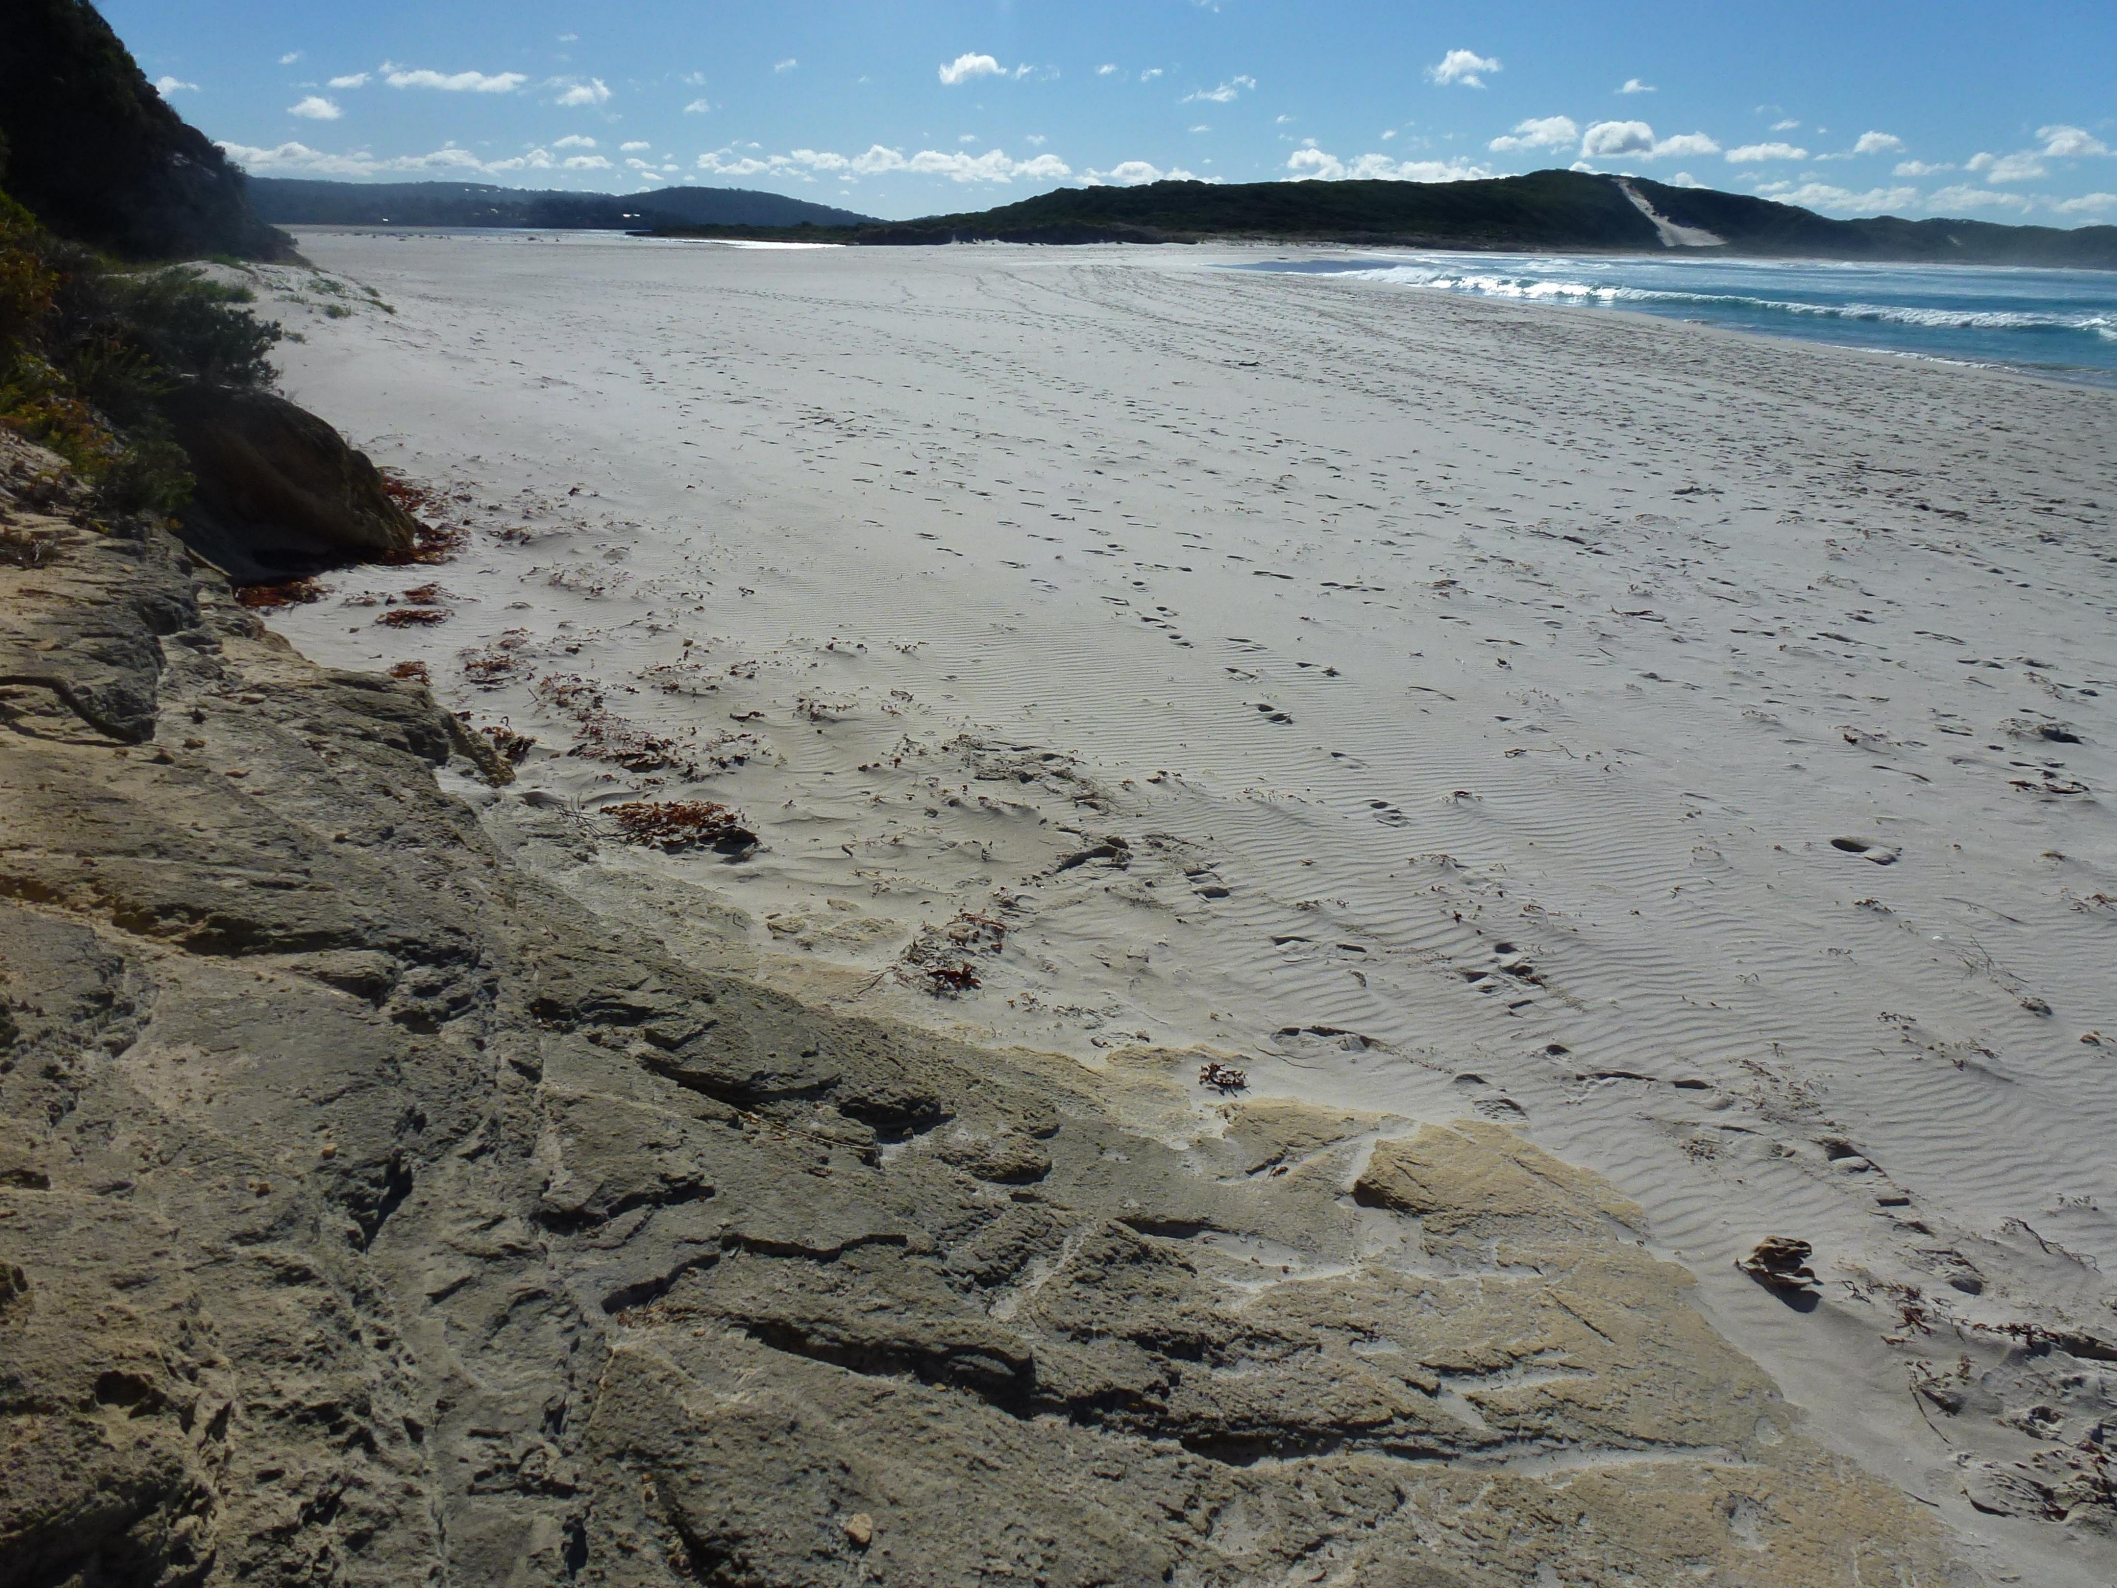
Site ID	Ocean Beach - Site 9
Location	Rock outcrop - Ocean Beach north
Date & Time	22/05/2019 11.02AM

Notes (relevant notes on beach condition, features, works etc.)	Inlet closed, beach wide and flat, ~1:50 slope
	Footprints indicate popular pedestrian access

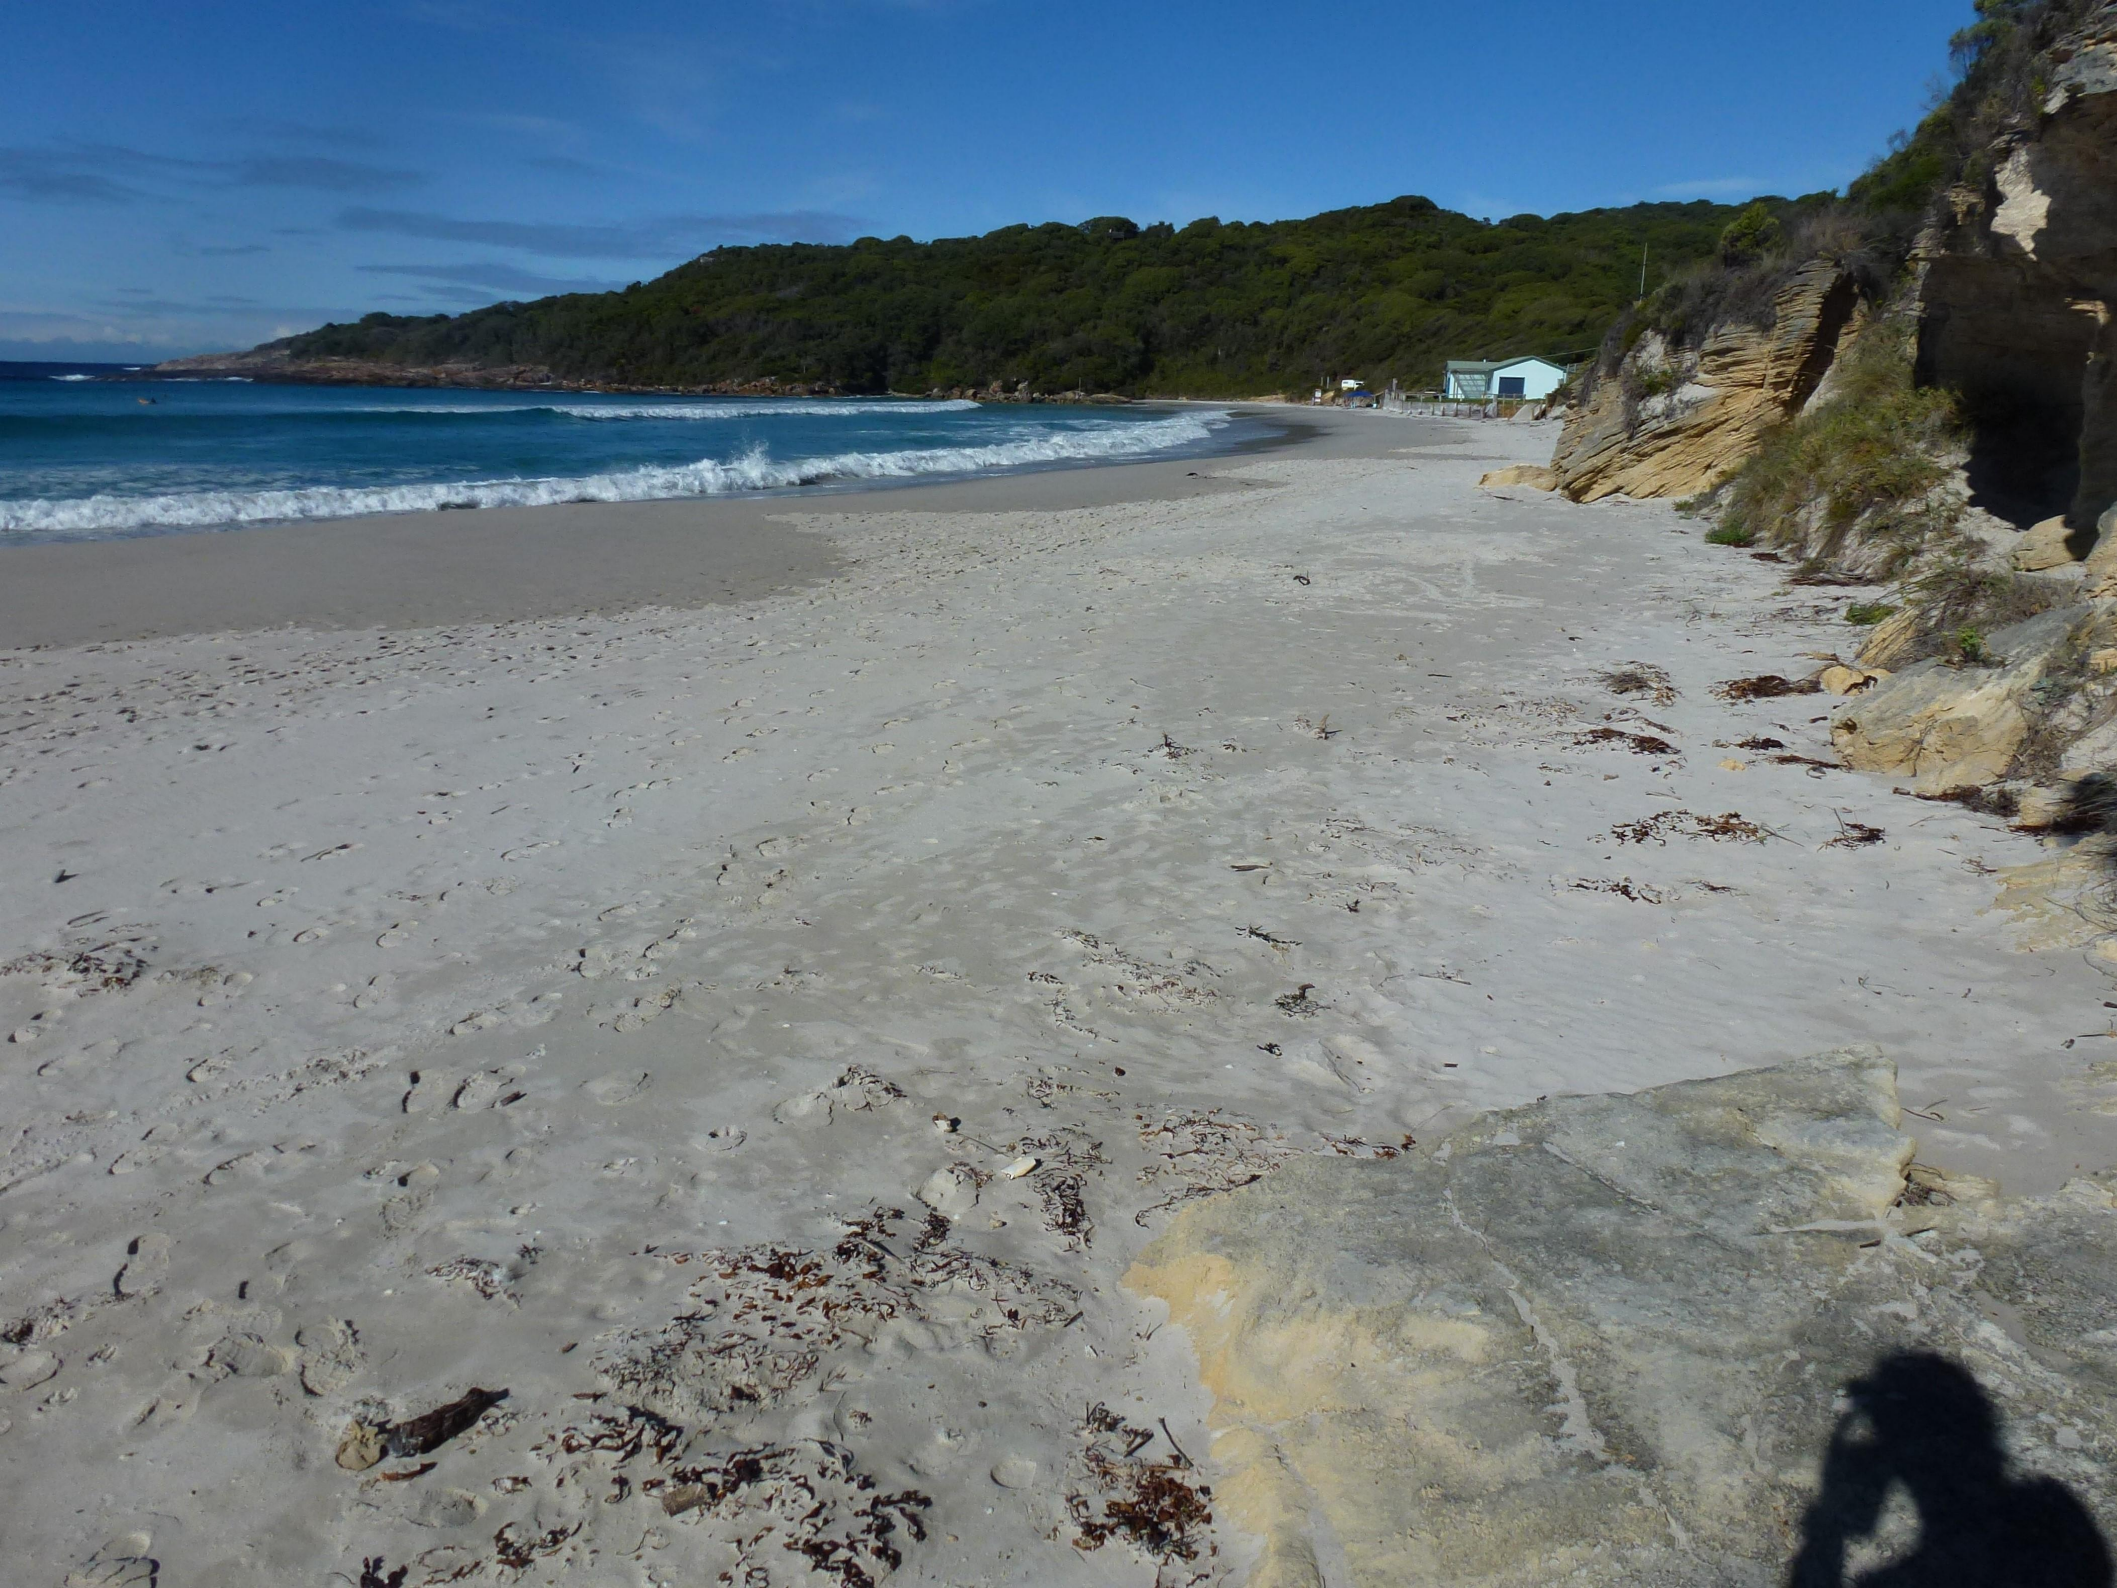
Site ID	Ocean Beach - Site 9
Location	Rock outcrop - Ocean Beach north
Date & Time	22/05/2019 11.01AM

Notes (relevant notes on beach condition, features, works etc.)	Prominent beach cusps along high tide mark
	Exposed rock in dune face
	Beach relatively narrow and flat, 15-20m wide at high tide mark, ~1:30 slope

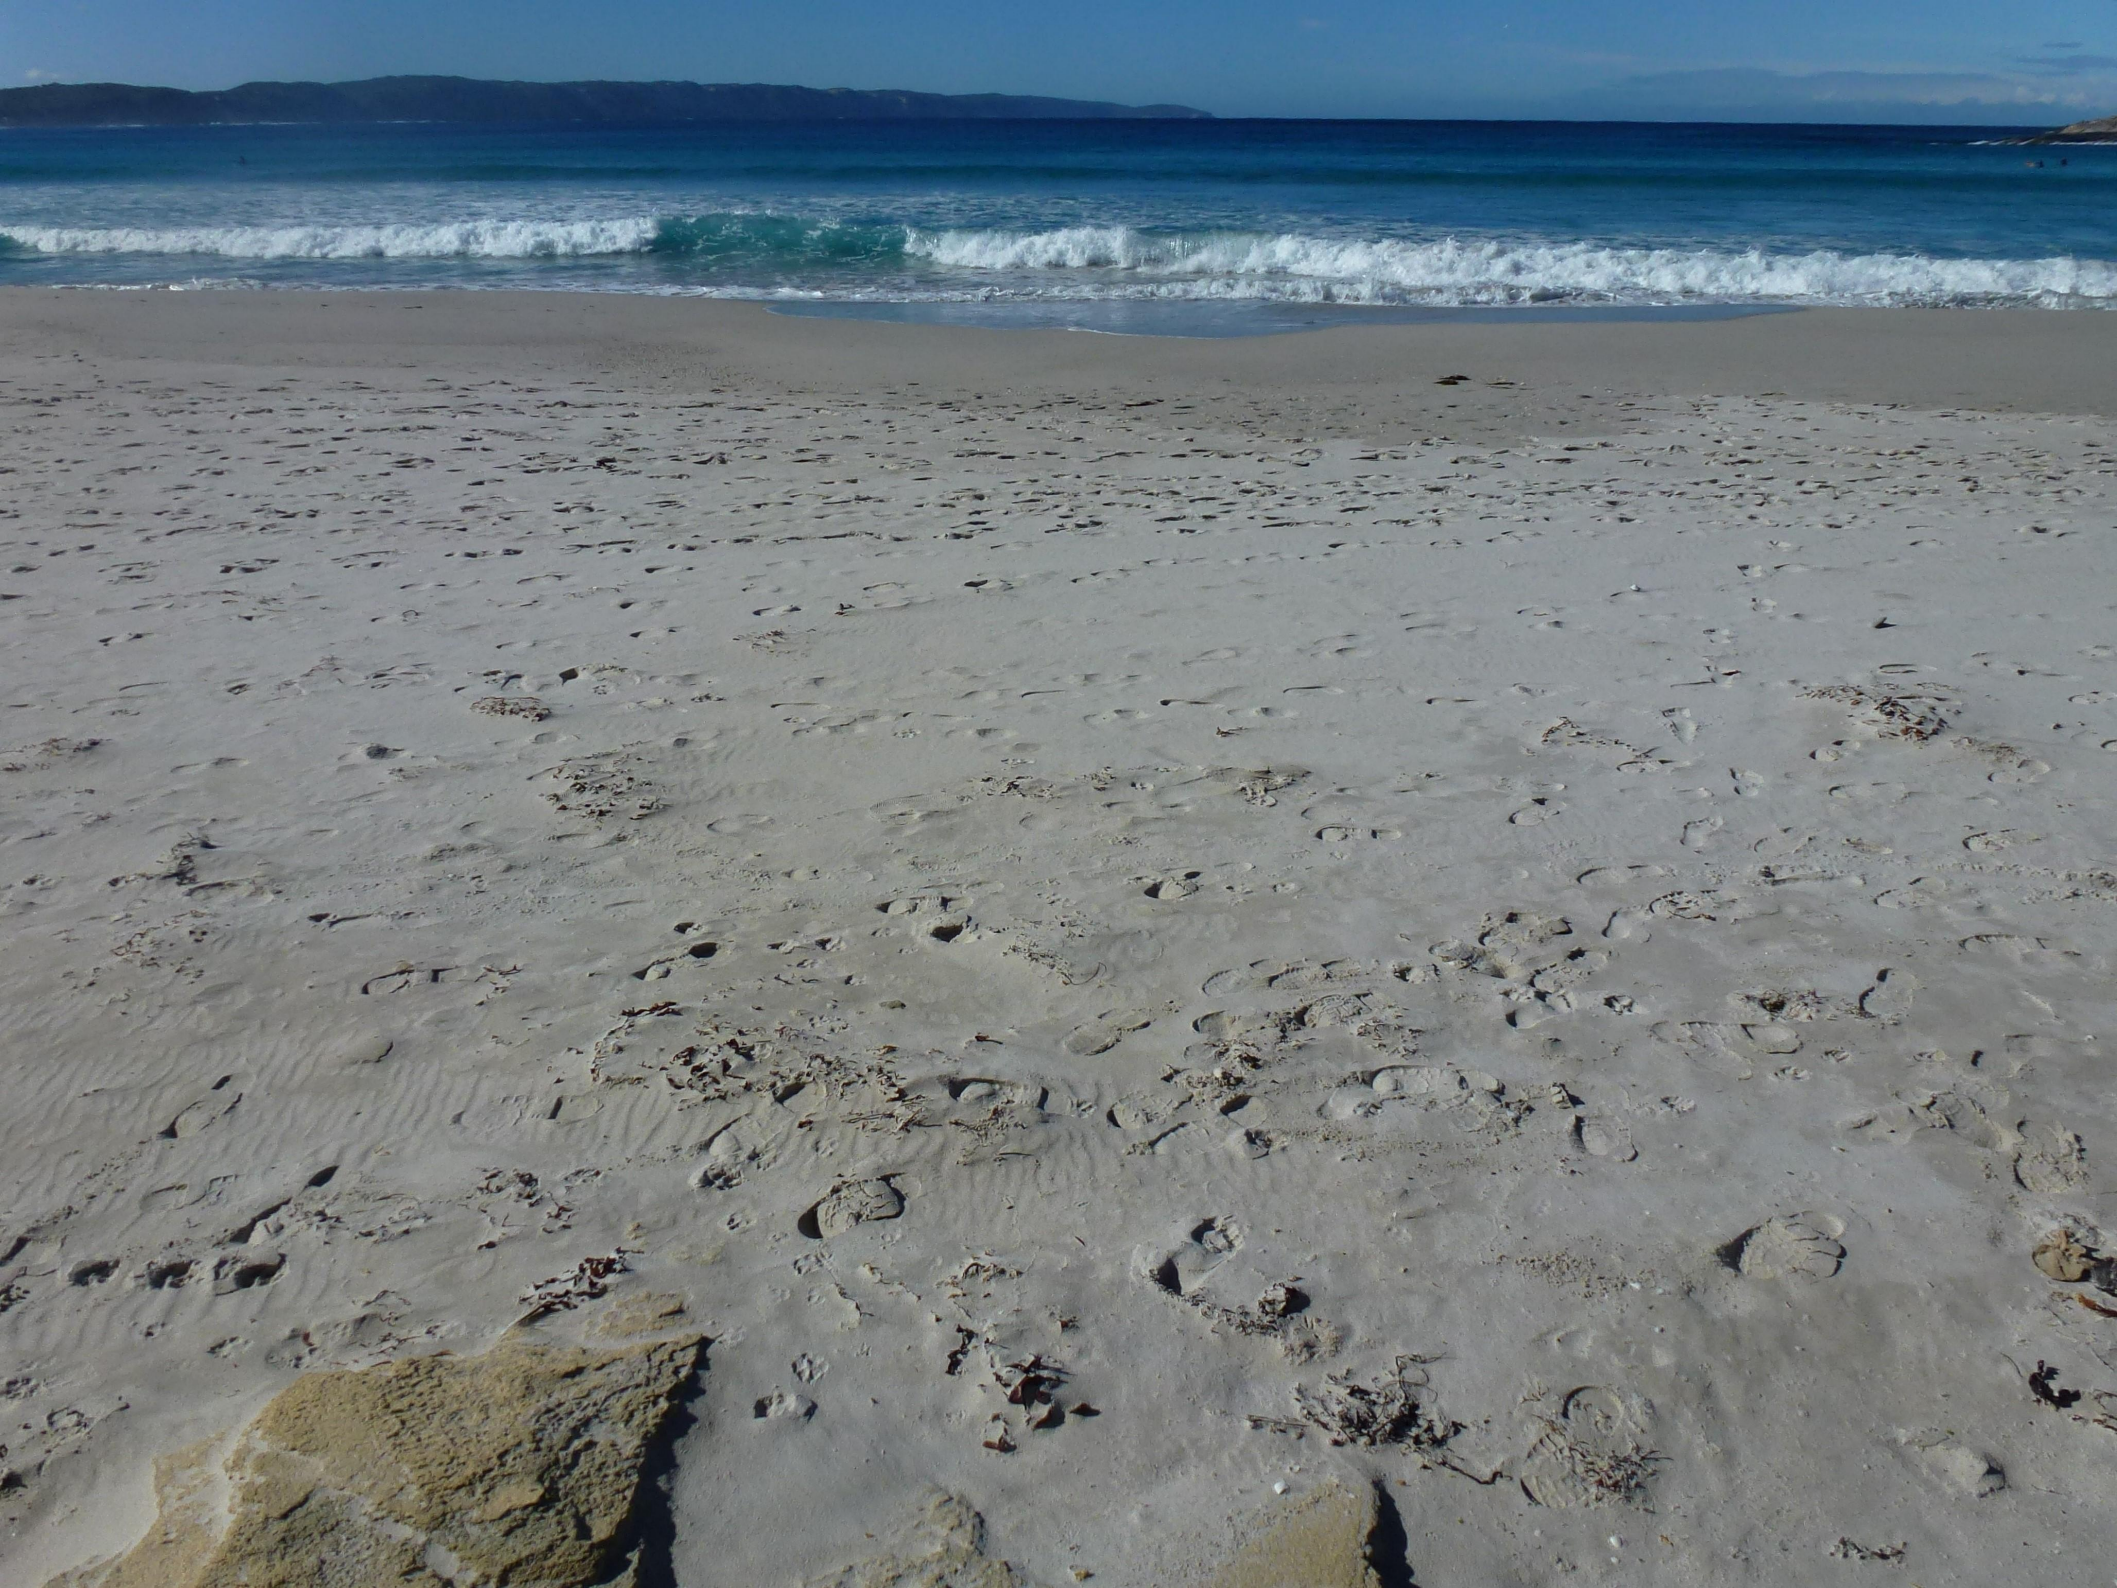
Site ID	Ocean Beach - Site 9
Location	Rock outcrop - Ocean Beach north
Date & Time	22/05/2019 11.02AM

Notes (relevant notes on beach condition, features, works etc.)	Prominent beach cusps along high tide mark
	Beach approximately 15-20m wide at high tide mark, ~1:30 slope

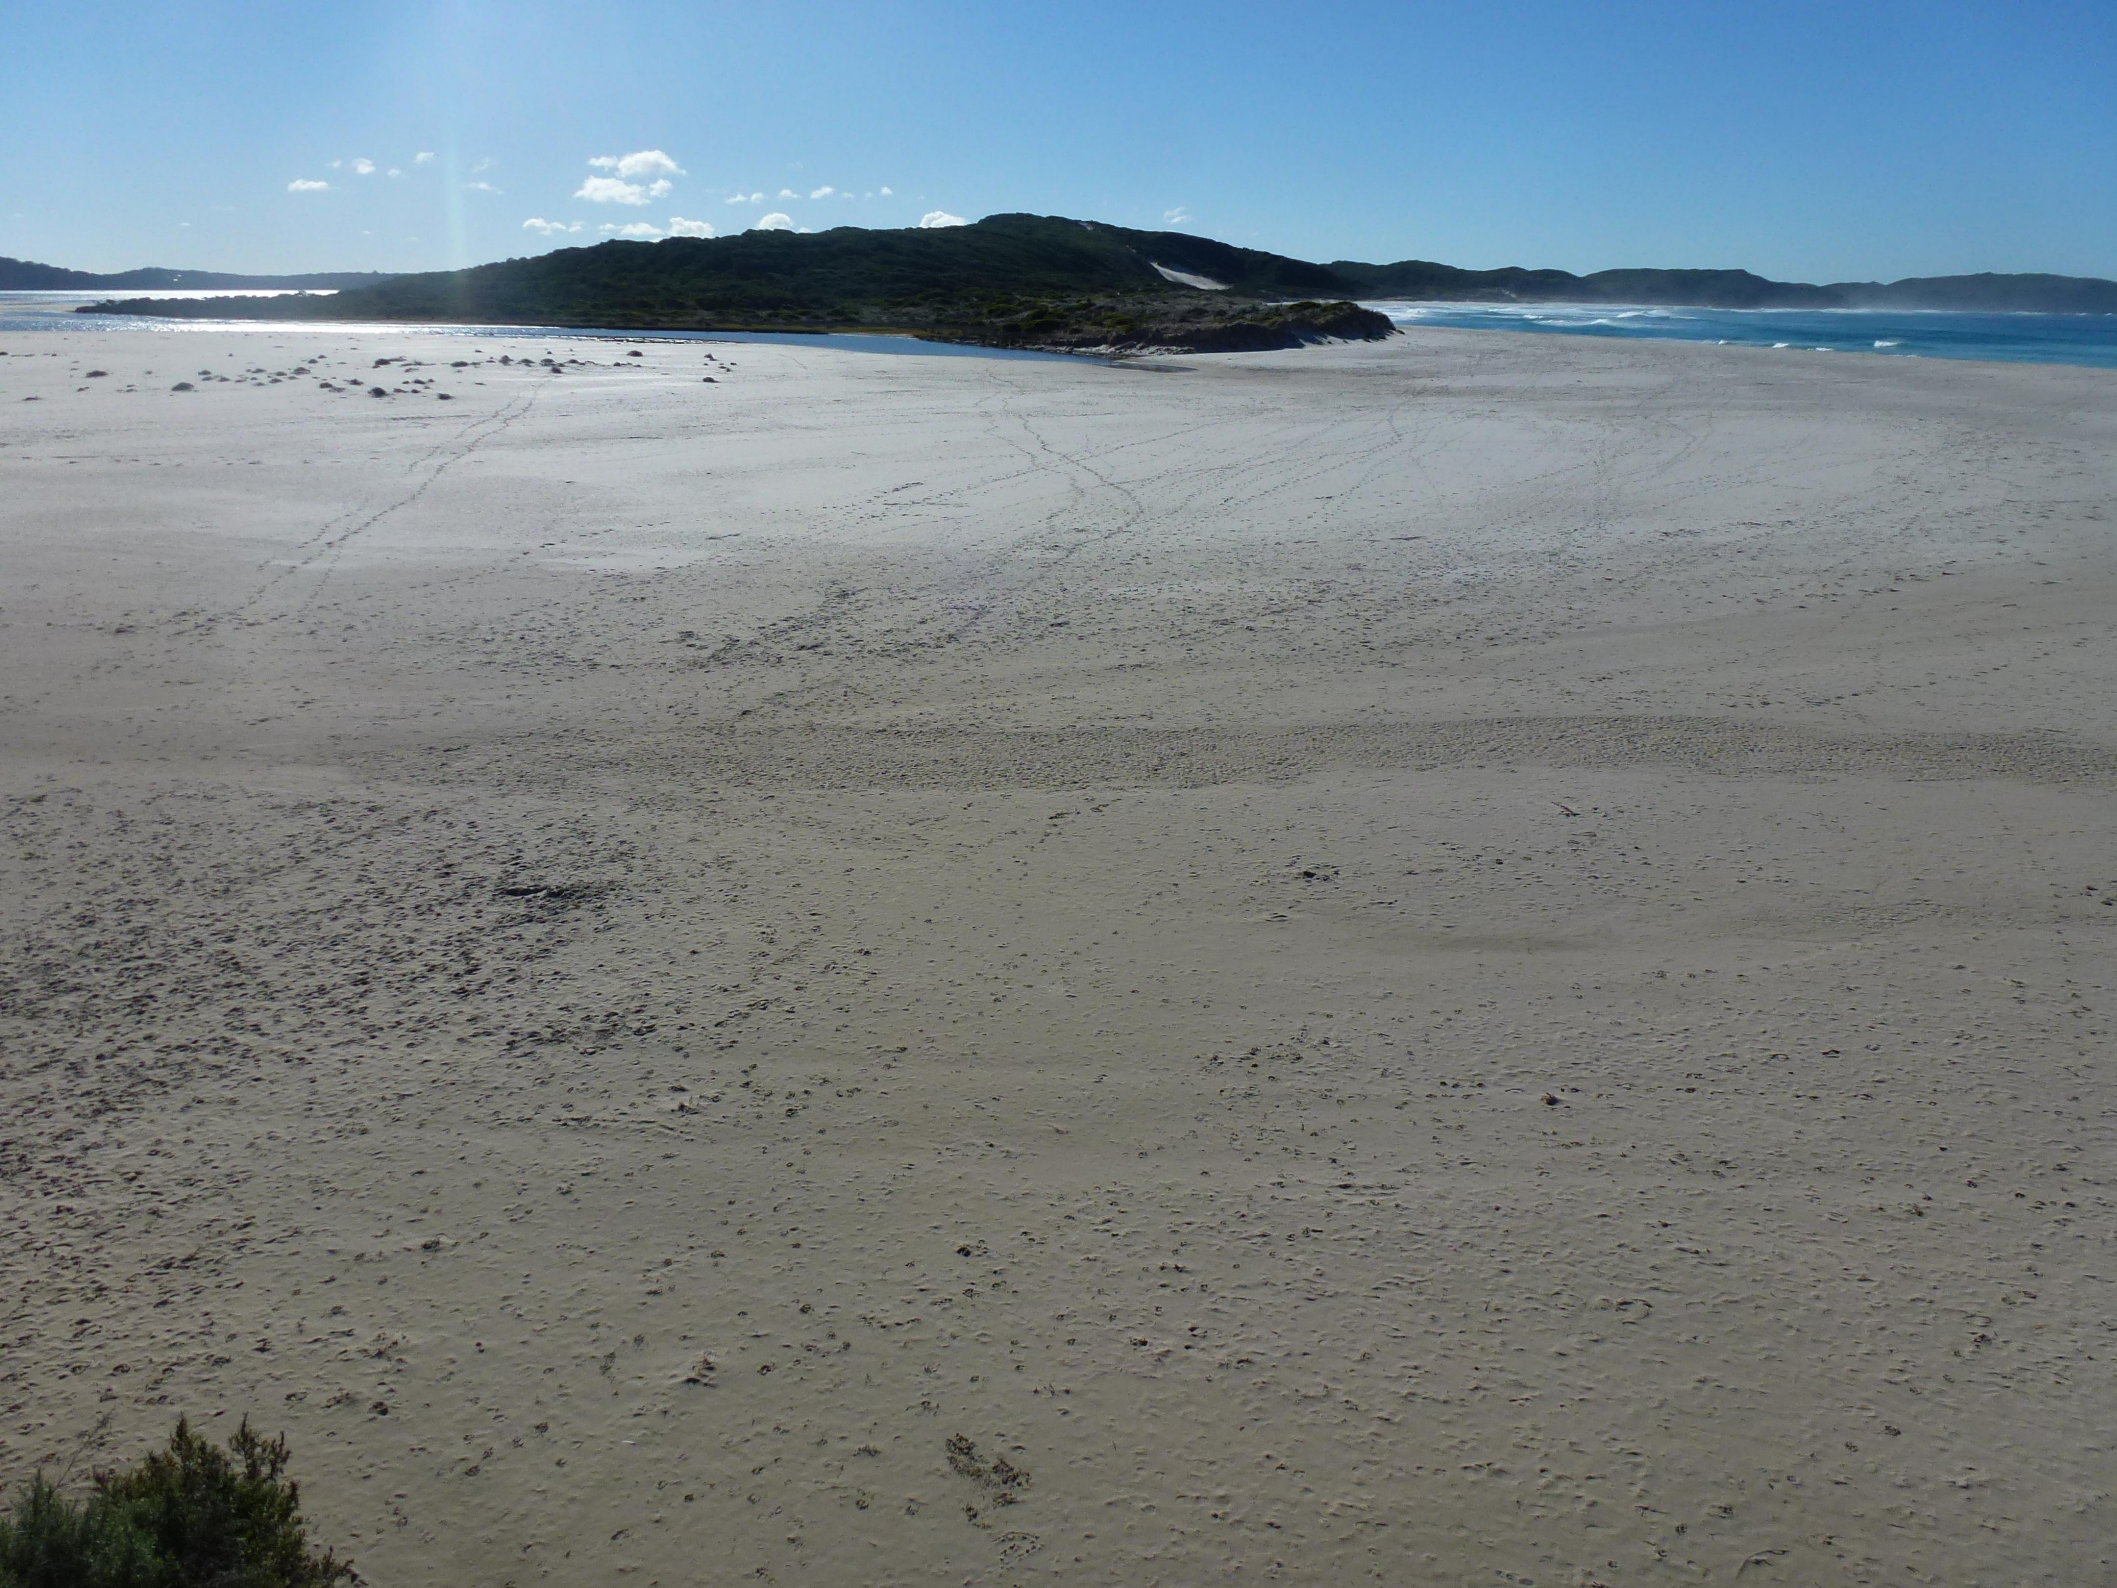
Site ID	Ocean Beach - Site 10
Location	Ocean Beach lookout
Date & Time	22/05/2019 10.32AM

Notes (relevant notes on beach condition, features, works etc.)	Inlet closed
	Beach is very flat
	Footprints indicate popular walking route across inlet

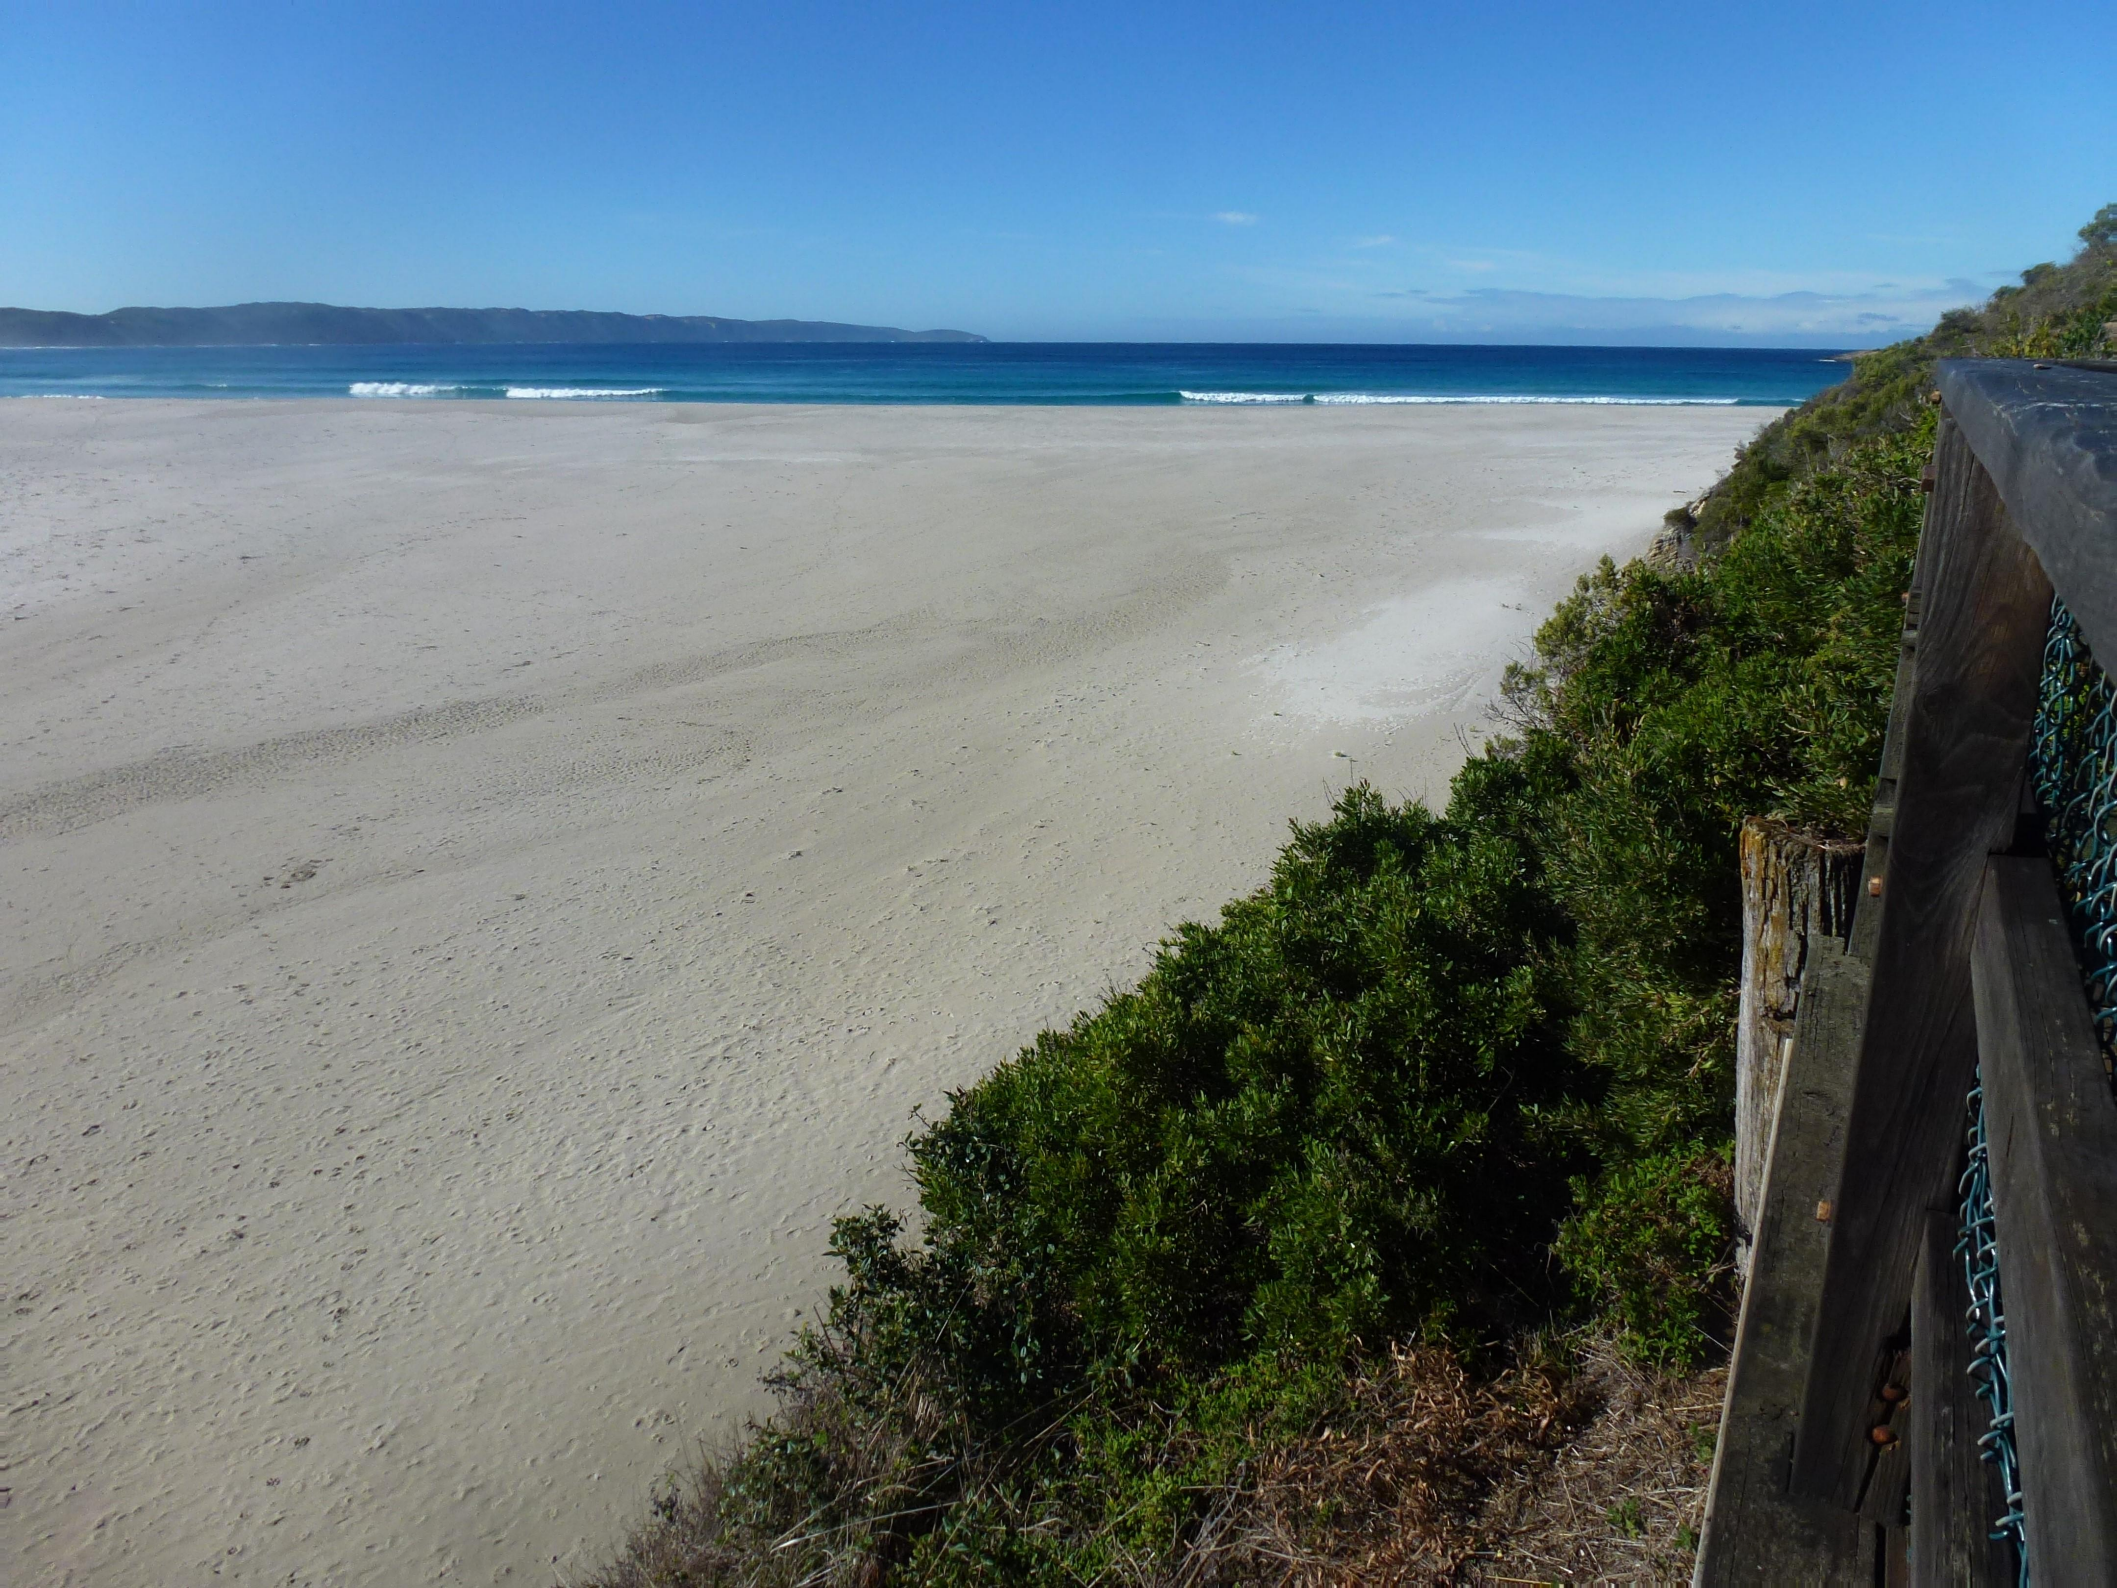
Site ID	Ocean Beach - Site 10
Location	Ocean Beach lookout
Date & Time	22/05/2019 10.35AM

Notes (relevant notes on beach condition, features, works etc.)	Inlet closed
	Beach offset several hundred meters
