Ocean Beach and Peaceful Bay

Coastal Monitoring Action Plan

CW1055200

Prepared for
Shire of Denmark

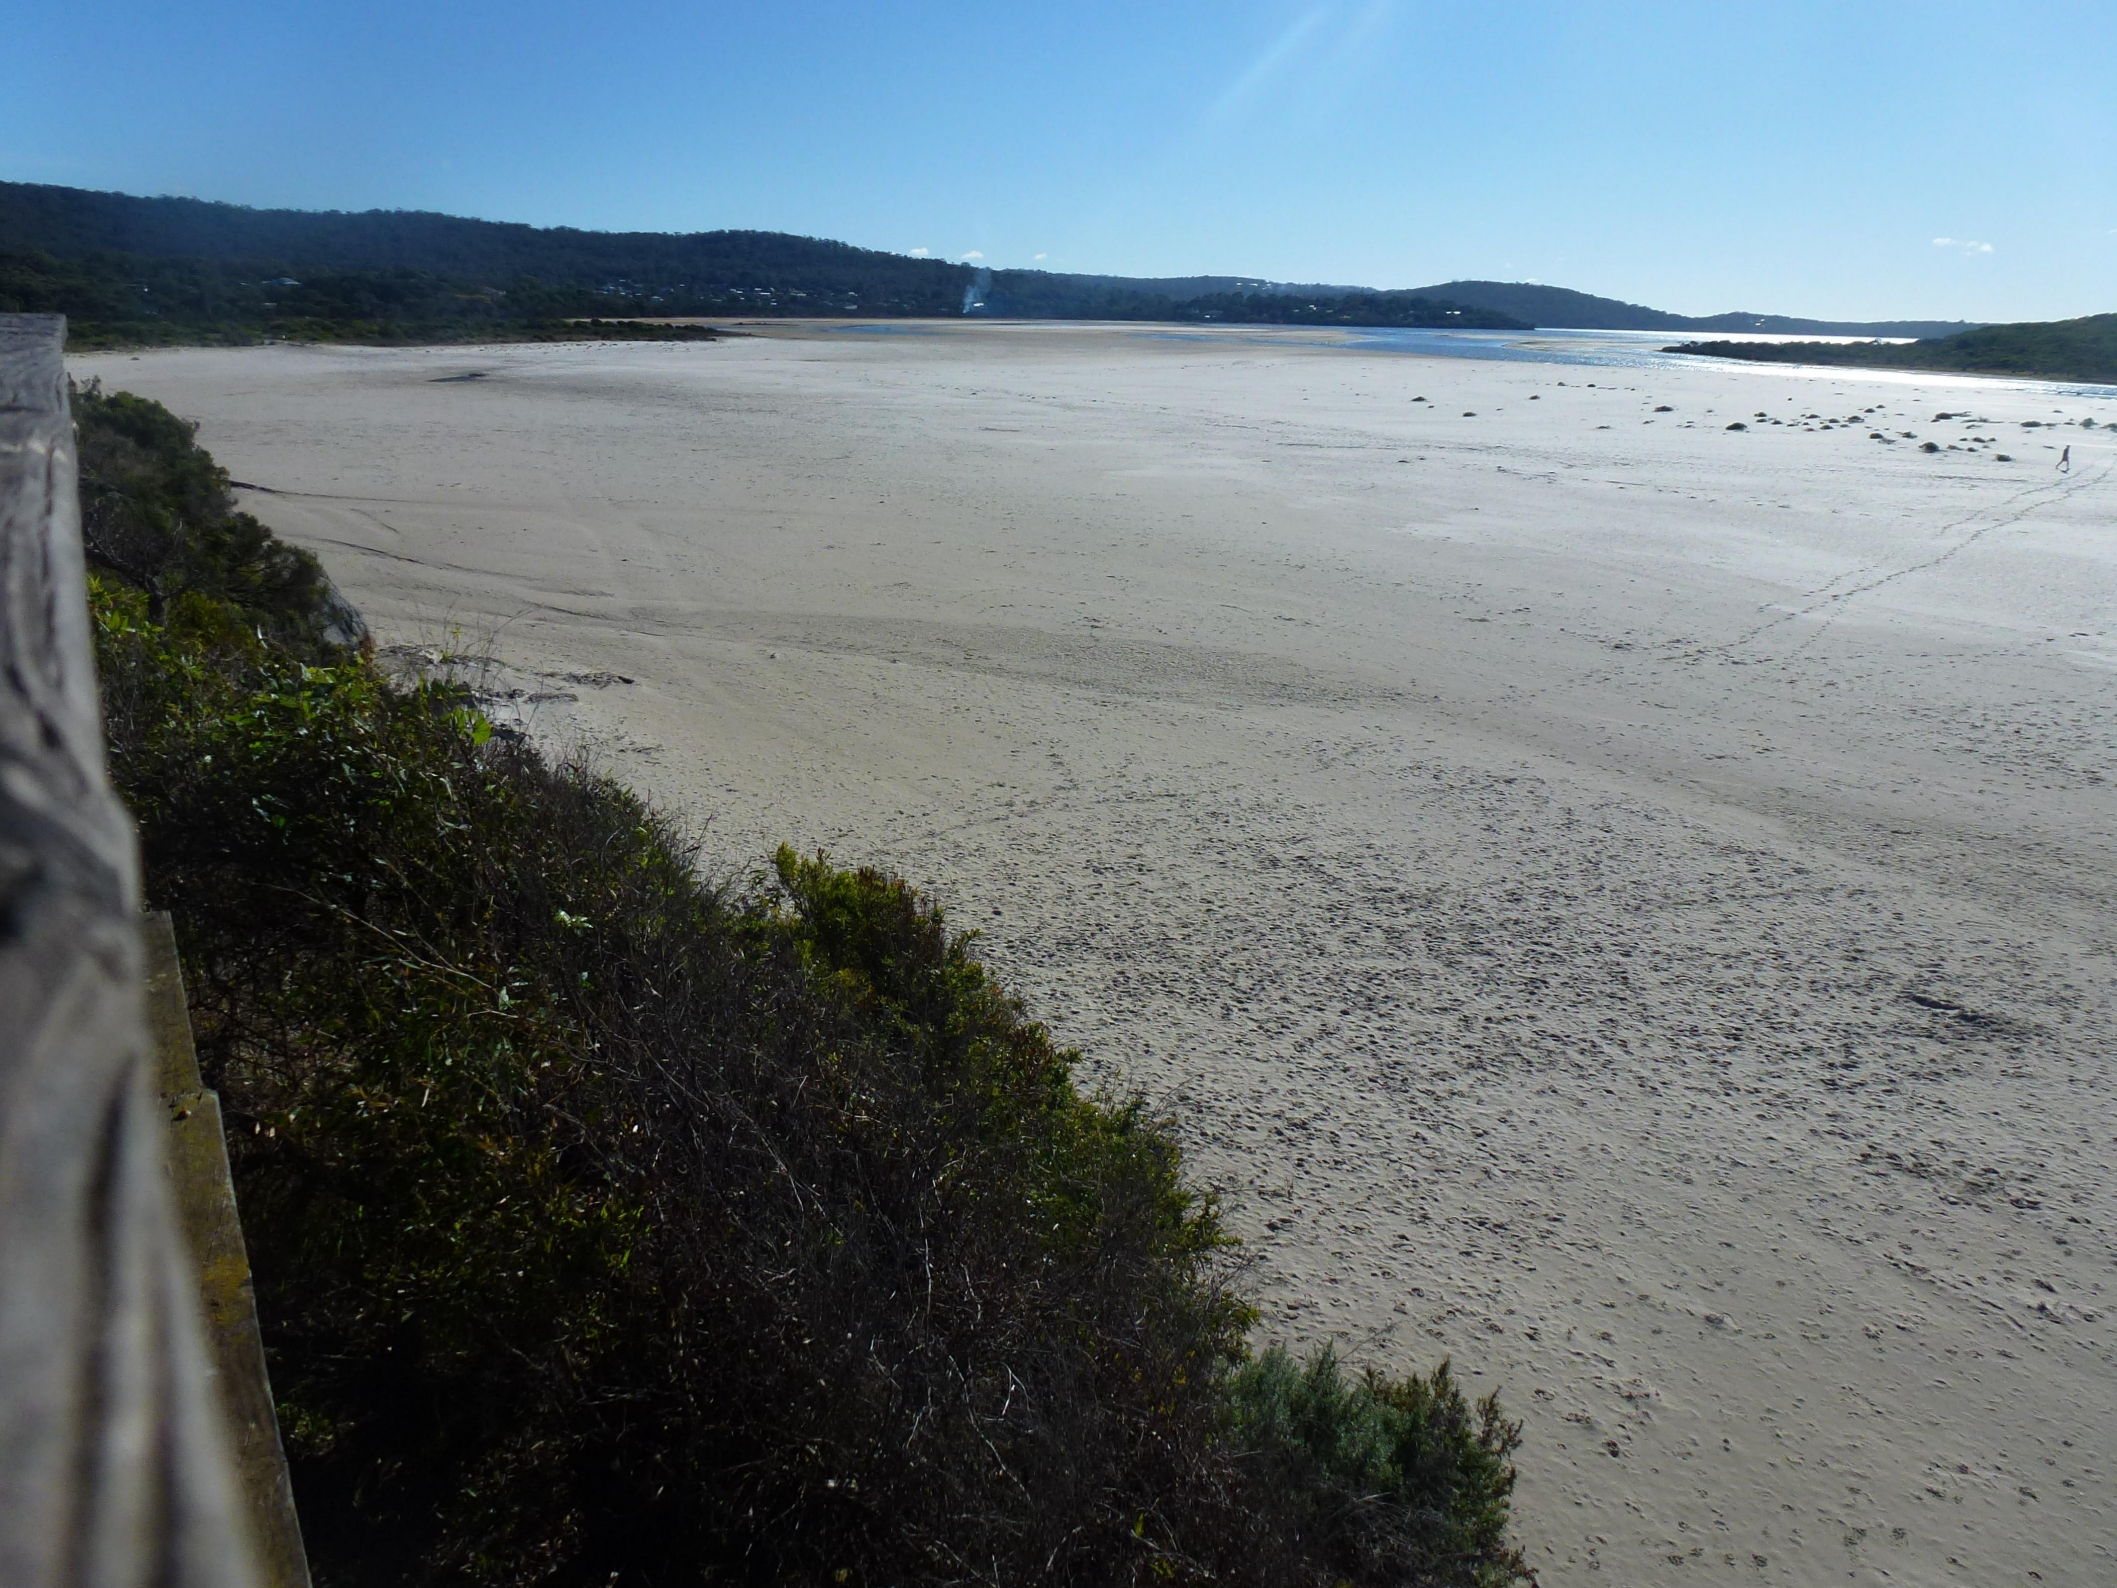
Site ID	Ocean Beach - Site 10
Location	Ocean Beach lookout
Date & Time	22/05/2019 10.35AM

Notes (relevant notes on beach condition, features, works etc.)	Inlet closed and very flat

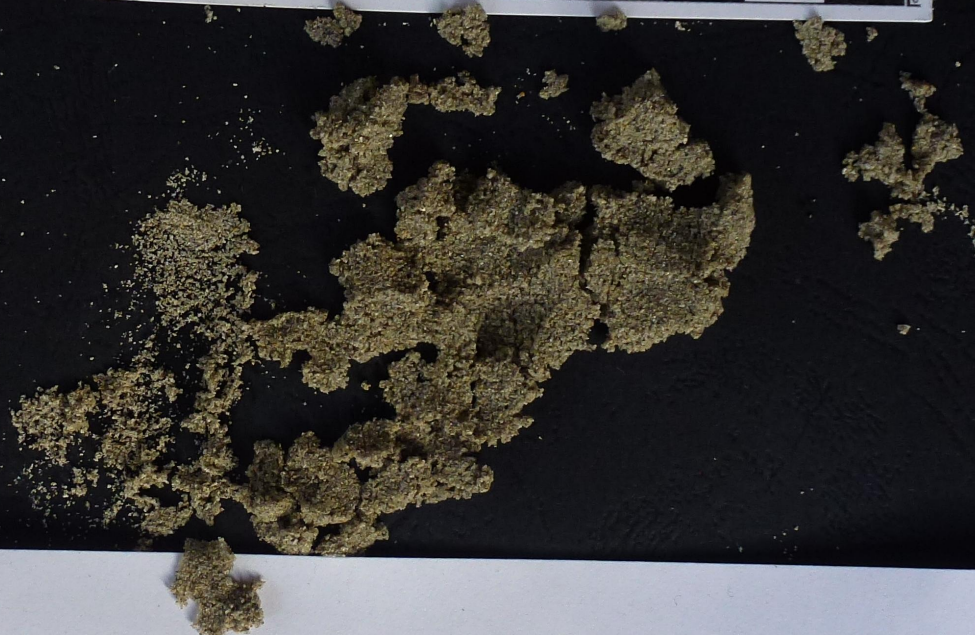
Peaceful Bay and Ocean Beach
Sediment Sample Log Sheet

Sorting	Wentworth Sand Size Class				VC	C	M	F	VF
	Very Well	Well	Moderate	Poor					
	Very	1410 – 2000 μ							
	Coarse	1000 – 1410 μ							
	Coarse	710 – 1000 μ							
		500 – 710 μ							
	Medium	350 – 500 μ							
		250 – 350 μ							
Fine	177 – 250 μ								
	125 – 177 μ								
Very Fine	88 – 125 μ								
	62 – 88 μ

Sorting: Angular, Subangular, Subrounded, Rounded, Well Rounded
