## **Shire of Denmark**

### **26 Hardy St Denmark - Remediation Project Remediation and Validation Report**

October 2020

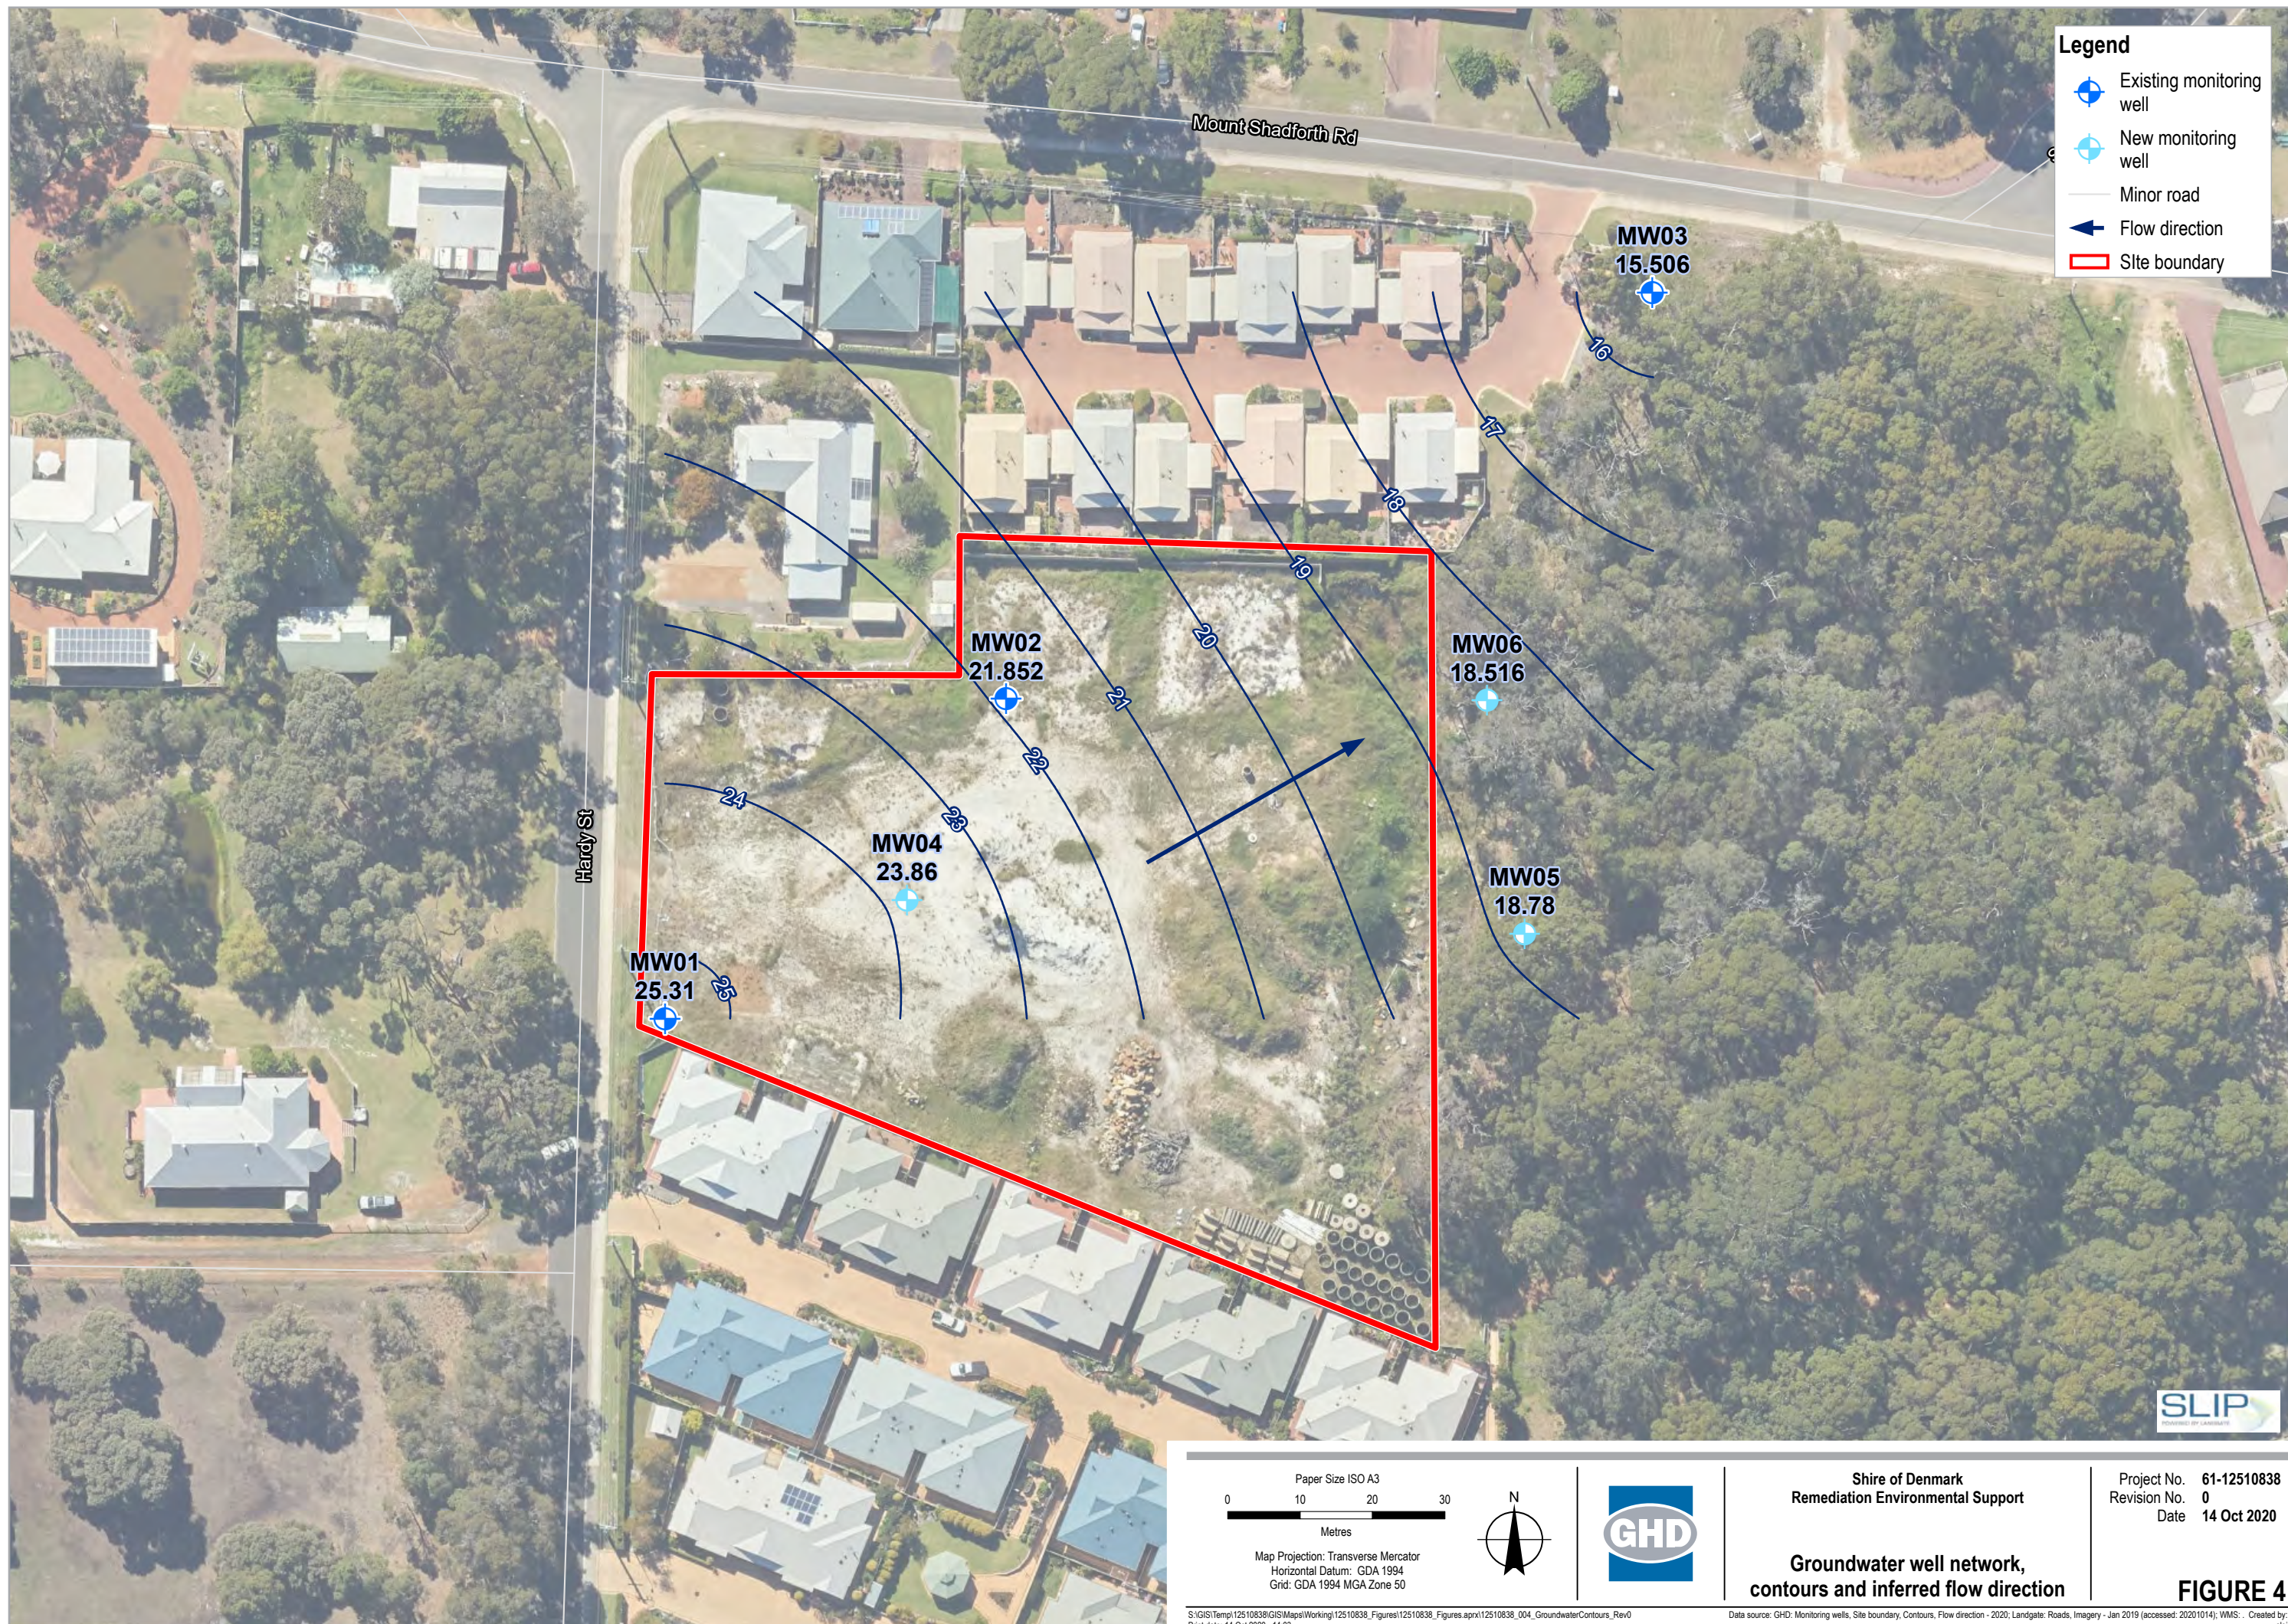
The findings from the ACM inspection and removal program are presented on Figure 5 with a detailed overview of the PACMs removed including locations, descriptions, weights, calculated %w/w and photographs is provided in Appendix D.

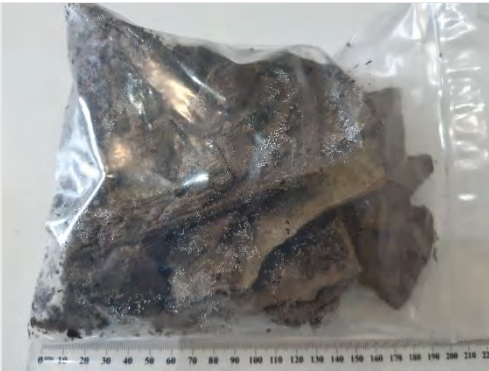
| GRID ID<br>(with reference to<br>Figure 5) | Area[m2] | Pass 1 | | Pass 2 | | Pass 3 | | Photo |
|---|---|---|---|---|---|---|---|---|
| C14 | 31.51 | 712 | 0.0205418 | - | - | - | - | |

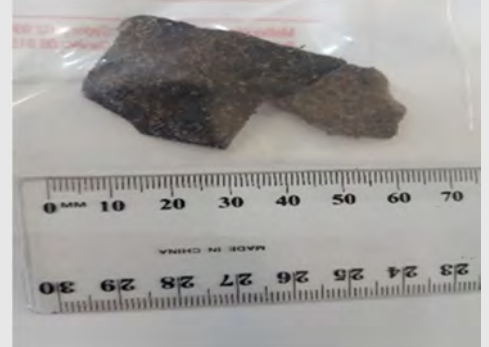
| GRID ID<br>(with reference to<br>Figure 5) | Area[m2] | Pass 1 | | Pass 2 | | Pass 3 | | Photo |
|---|---|---|---|---|---|---|---|---|
| H10 | 100 | 16 | 0.0001455 | - | - | - | - | |

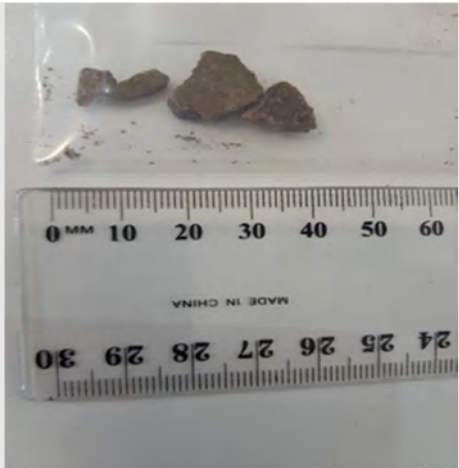
| GRID ID<br>(with reference to<br>Figure 5) | Area[m2] | Pass 1 | | Pass 2 | | Pass 3 | | Photo |
|---|---|---|---|---|---|---|---|---|
| H12 | 100 | 1 | 0.0000091 | - | - | - | - | |

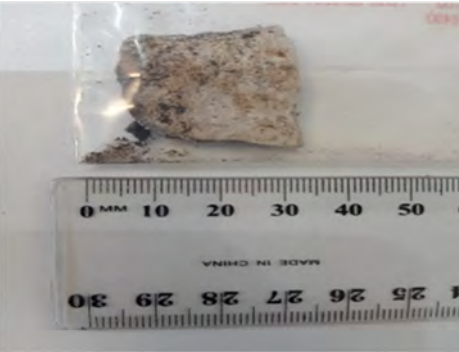
| GRID ID<br>(with reference to<br>Figure 5) | Area[m2] | Pass 1 | | Pass 2 | | Pass 3 | | Photo |
|---|---|---|---|---|---|---|---|---|
| I9 | 100 | 2 | 0.0000182 | - | - | - | - | |

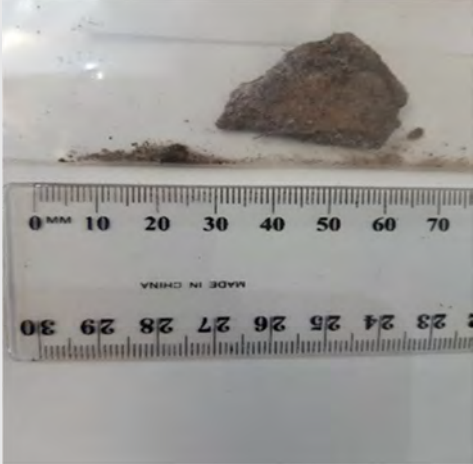
| GRID ID<br>(with reference to<br>Figure 5) | Area[m2] | Pass 1 | | Pass 2 | | Pass 3 | | Photo |
|---|---|---|---|---|---|---|---|---|
| J5 | 100 | - | - | 4 | 0.0000364 | - | - | |

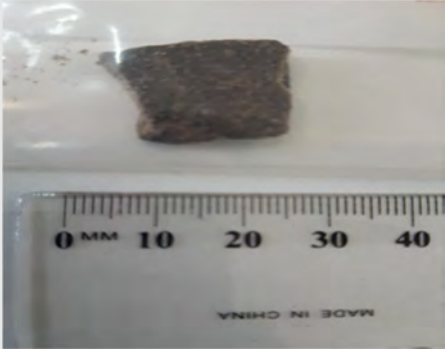
| GRID ID<br>(with reference to<br>Figure 5) | Area[m2] | Pass 1 | | Pass 2 | | Pass 3 | | Photo |
|---|---|---|---|---|---|---|---|---|
| J7 | 100 | - | - | - | - | 2 | 0.0000018 | |

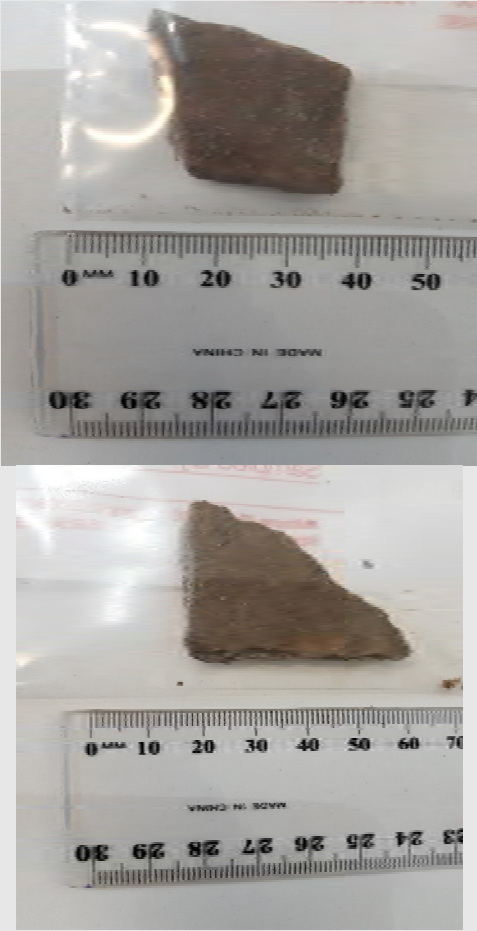
| GRID ID<br>(with reference to<br>Figure 5) | Area[m2] | Pass 1 | | Pass 2 | | Pass 3 | | Photo |
|---|---|---|---|---|---|---|---|---|
| J8 | 100 | - | - | 4 | 0.0000364 | 8 | 0.0000073 | |

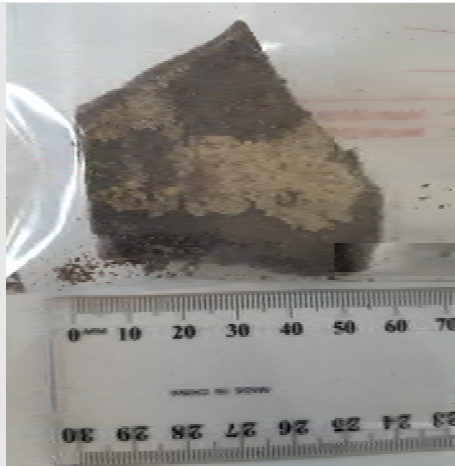
| GRID ID<br>(with reference to<br>Figure 5) | Area[m2] | Pass 1 | | Pass 2 | | Pass 3 | | Photo |
|---|---|---|---|---|---|---|---|---|
| J9 | 100 | 40 | 0.0003636 | - | - | - | - | |

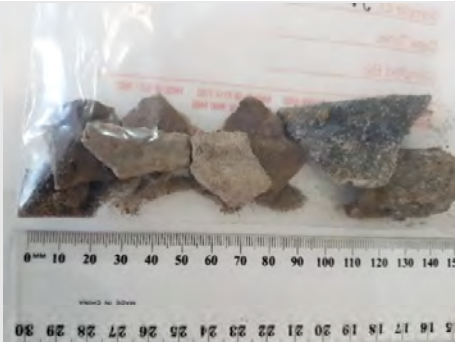
| GRID ID<br>(with reference to<br>Figure 5) | Area[m2] | Pass 1 | | Pass 2 | | Pass 3 | | Photo |
|---|---|---|---|---|---|---|---|---|
| J10 | 100 | 42 | 0.0003818 | - | - | - | - | |

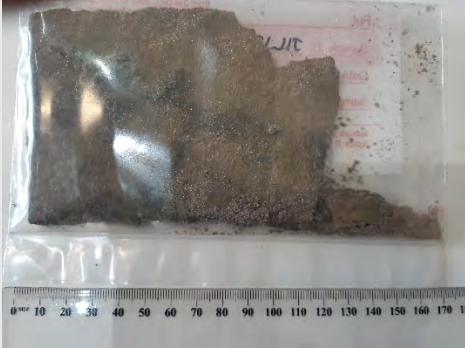
| GRID ID<br>(with reference to<br>Figure 5) | Area[m2] | Pass 1 | | Pass 2 | | Pass 3 | | Photo |
|---|---|---|---|---|---|---|---|---|
| J11 | 100 | 89 | 0.0008091 | - | - | - | - | |

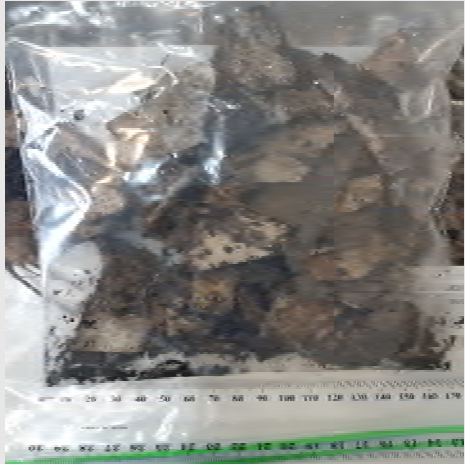
| GRID ID<br>(with reference to<br>Figure 5) | Area[m2] | Pass 1 | | Pass 2 | | Pass 3 | | Photo |
|---|---|---|---|---|---|---|---|---|
| K1 | 42.63 | 1,800 | 0.0383853 | - | - | - | - | |

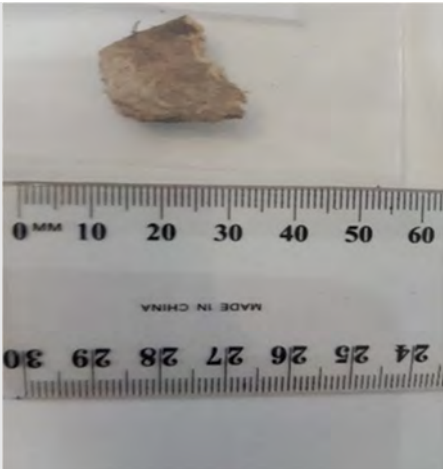
| GRID ID<br>(with reference to<br>Figure 5) | Area[m2] | Pass 1 | | Pass 2 | | Pass 3 | | Photo |
|---|---|---|---|---|---|---|---|---|
| K4 | 100 | - | - | - | - | <1* | 0.0000009 | |

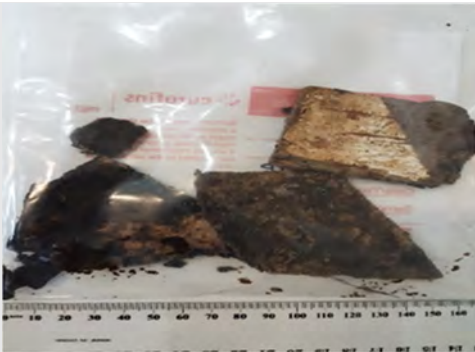
| GRID ID<br>(with reference to<br>Figure 5) | Area[m2] | Pass 1 | | Pass 2 | | Pass 3 | | Photo |
|---|---|---|---|---|---|---|---|---|
| K5 | 100 | 140 | 0.0012727 | - | - | - | - | |

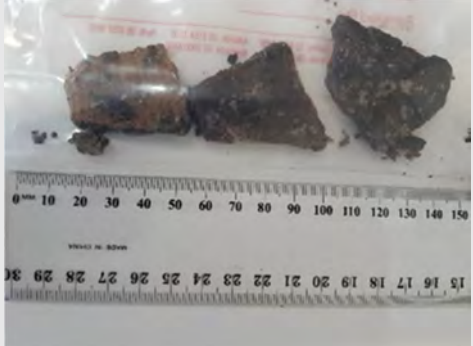
| GRID ID<br>(with reference to<br>Figure 5) | Area[m2] | Pass 1 | | Pass 2 | | Pass 3 | | Photo |
|---|---|---|---|---|---|---|---|---|
| K7 | 100 | 32 | 0.0002909 | - | - | - | - | |

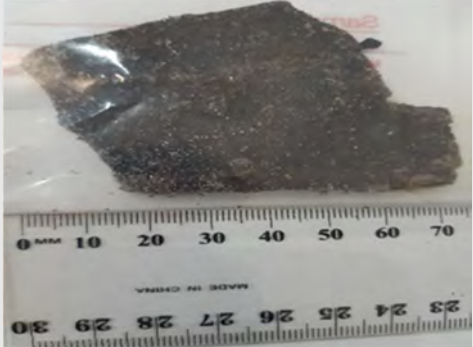
| GRID ID<br>(with reference to<br>Figure 5) | Area[m2] | Pass 1 | | Pass 2 | | Pass 3 | | Photo |
|---|---|---|---|---|---|---|---|---|
| K8 | 100 | 22 | 0.0002000 | - | - | - | - | |

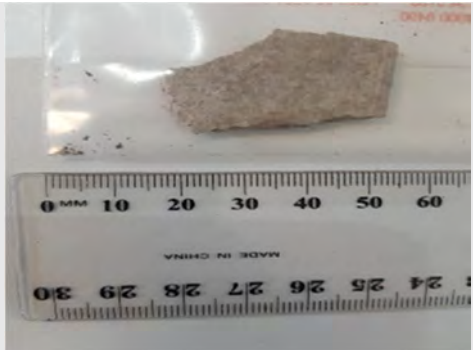
| GRID ID<br>(with reference to<br>Figure 5) | Area[m2] | Pass 1 | | Pass 2 | | Pass 3 | | Photo |
|---|---|---|---|---|---|---|---|---|
| K9 | 75.42 | - | - | 3 | 0.0000362 | - | - | |

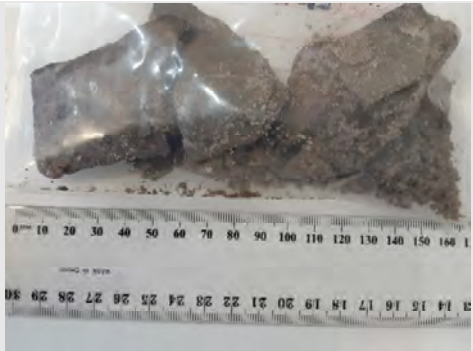
| GRID ID<br>(with reference to<br>Figure 5) | Area[m2] | Pass 1 | | Pass 2 | | Pass 3 | | Photo |
|---|---|---|---|---|---|---|---|---|
| L6 | 100 | 113 | 0.0010273 | 94 | 0.0008545 | - | - | |

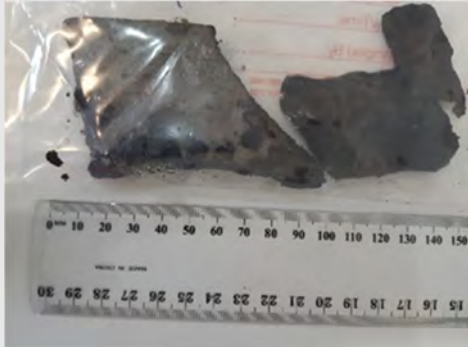
| GRID ID<br>(with reference to<br>Figure 5) | Area[m2] | Pass 1 | | Pass 2 | | Pass 3 | | Photo |
|---|---|---|---|---|---|---|---|---|
| J1 (offsite) | - | 75 | - | - | - | - | - | |
