APPENDIX E
LAND CAPABILITY & ENVIRONMENTAL
ASSESSMENT REPORT

**Lot 1
Ocean Beach Road
Denmark
WA**

Land Capability & Environmental Assessment Report

Job No. : WCP001

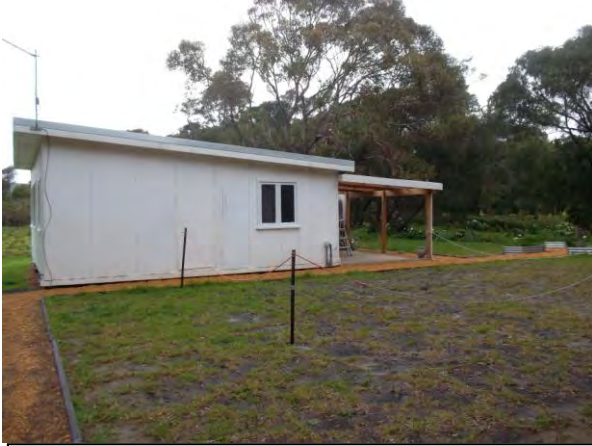
Photograph 1 – View of the existing house north central of the Subject Site.

The Subject Site is currently has 2 existing buildings and an old disused shed located in the north of the property. The lot was previously used for grazing (cattle) from the previous owners (pre-2008) and possibly potato farming pre 1990's in the lower wetter areas (*Pers Comms M. Allen September 2013*).Please refer to Photographs 1 and 2 below.

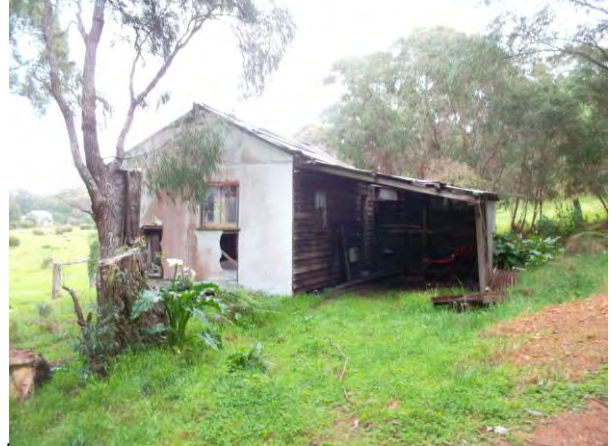
Photograph 2 – View of old shed in north west of Subject Site.

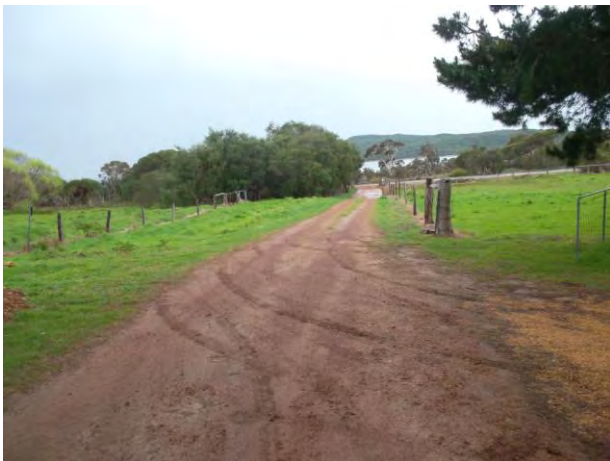
Photograph 3 – View of existing driveway access off Ocean Beach Road to the north.

Access is restricted to the Subject Site along a driveway in the north off Ocean Beach Road, please refer to Photographs 3 and 4 below.

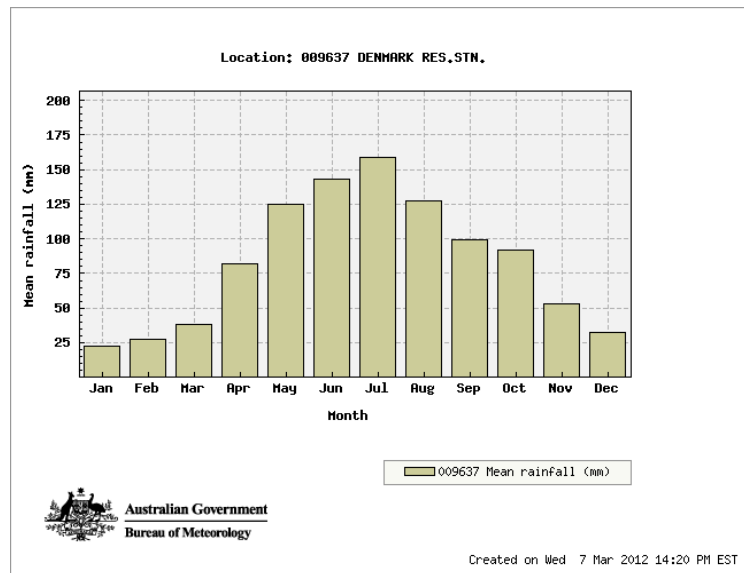
Figure 2 – Mean Rainfall Denmark Station (BOM)

July is the wettest month, with the wettest month recorded in August 1955 of 292.6, rain occurs on two days out of every three during an average winter. The driest month is January with a mean of 22.3 mm and in winter the average is 158.9mm (July). Please refer to Figure 2 below - Mean Rainfall Denmark (BOM 2012).

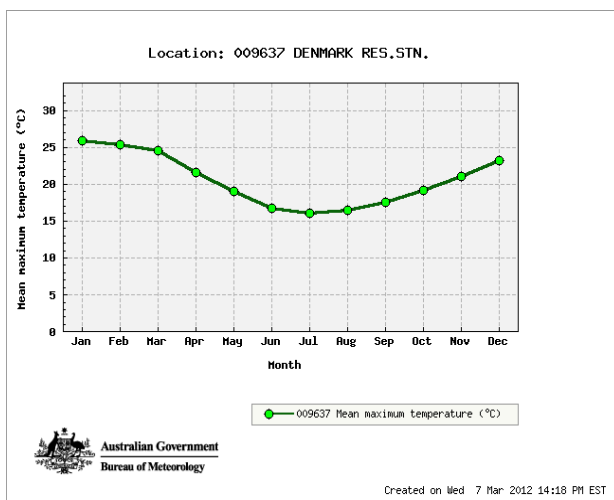
Figure: 3 Mean maximum temperature

Winter daily maximum temperatures average approximately 16.1°C, while the average minimum is approximately 6.9°C in July and August. Daily minimum temperatures below 5°C can be expected about once or twice a month in winter, but Denmark daily temperature records between 1907 and 1965 show no occasion where the temperature fell to zero. Please refer to Figure 3 and Figure 4 illustrating Average Temperatures Denmark (BOM 2012).

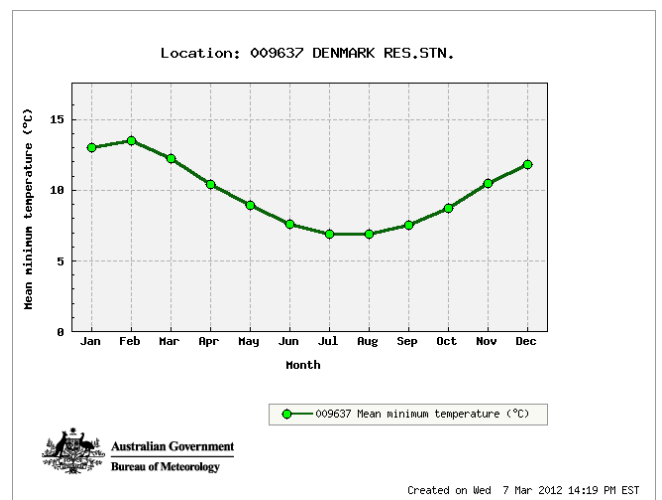
Figure 4: Mean minimum temperature

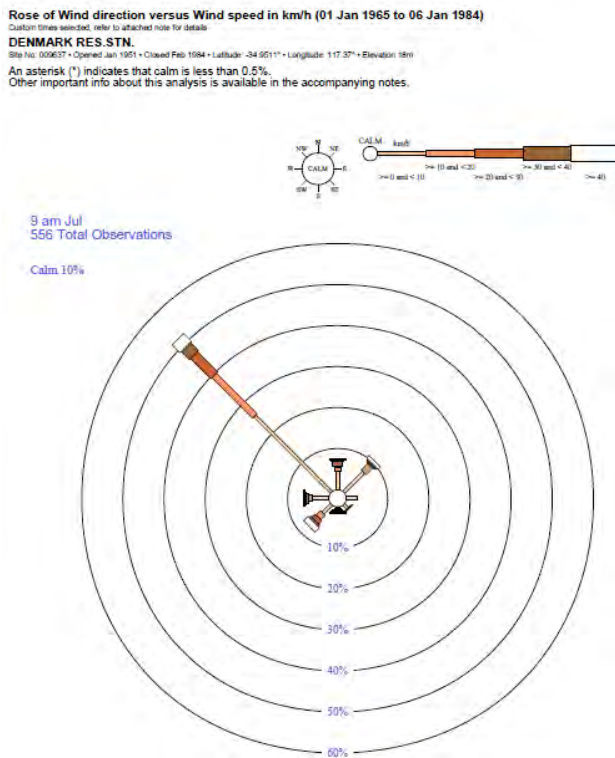
Figure 5 – Summer (Jan) wind rose BoM

The dominant wind direction in summer is from the north west and afternoon sea breezes occur from the south west/south east. During winter, southwest winds prevail and northwest storm events occur (BOM, 2012). Although fronts and depressions may bring strong to gale force winds, winter winds are more variable and generally lighter than those of summer. Please refer to Figure 5 and 6.

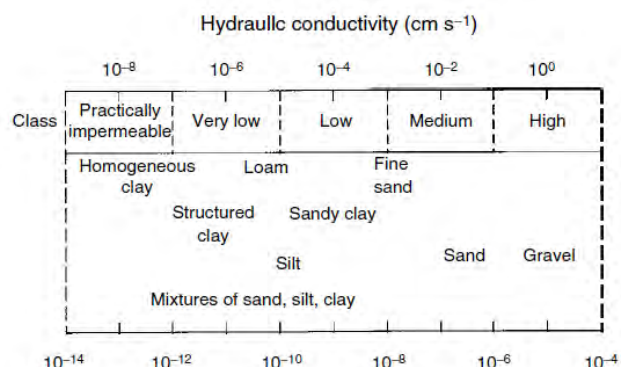
Figure 7 – Generalised Permeability (Hydraulic Conductivity of Soil Types)

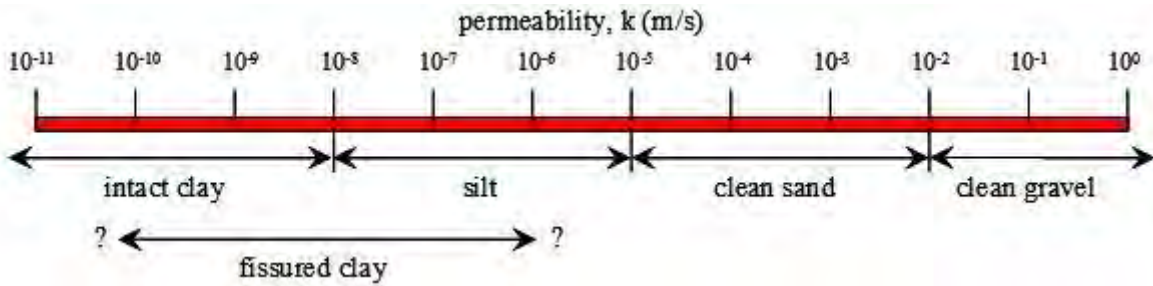
Figure 8 – Permeability scale m/sec

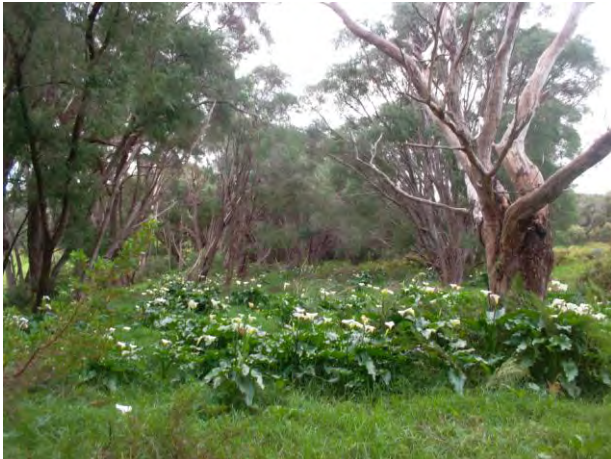
Photograph 7 – View of Low Open Peppermint Woodland in southern portion of site.

This vegetation type comprises of 60% of the Subject Site and is confined to the north and western portion of the site. The Peppermint trees (*Agonis flexuosa*) comprise almost 100% of the canopy cover with Peppermints generally 3m – 5m in height. Flora survey revealed there is a lack of middle storey and a degraded understorey present. The sedge and herb storey in this vegetation complex has over 70% ground cover. The majority of species were less than 1m in height however some herbs were between 1m – 2m in height. Native species recorded within this vegetation unit included Native Wisteria (*Hardenbergia comptoniana*), *Tremandra stelligera*, *Pimelea clavata*, and Bracken Fern (*Pteridium esculentum*). Introduced (weed) species identified within this cover class including: Kikuyu grass (*Pennisetum clandestinum*), Bridal creeper (*Asparagus asparagoides*), Deadly nightshade (*Solanum nigrum*), water couch grass (*Paspalum distichum*), Inkweed (*Phytolacca octandra*), Arum lily (*Zantedeschia aethiopica*), Spear thistle (*Cirsium vulgare*) and an introduced sedge *Juncus acutus*.

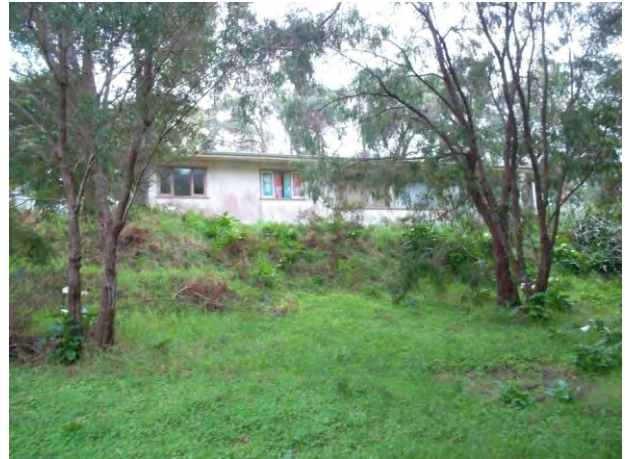
Photograph 8 – View of Peppermint Woodland in north of Subject site.

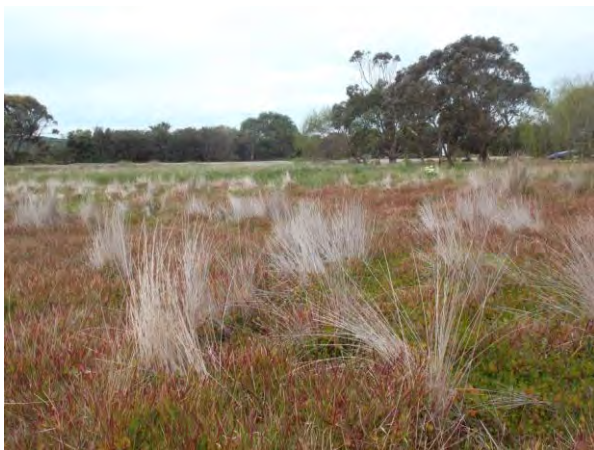
Photograph 9 – View of Low flats of *Centella asiatica*.

The south/south western portion of the Subject site is predominantly low flats of *Centella asiatica* (dominant species) with a variety of sedges and rushes such as *Juncus kraussii*, Seablite (*Suaeda australis*), *Juncus acutus* (introduced) and occasional Saltwater paperbarks (*Melaleuca cuticularis*) in the south eastern corner. Species surveyed indicate that this portion of the site could be subject (or was previously subject to) tidal inundation from the adjacent Wilson Inlet. Please refer to Photographs 9 and 10 below and Vegetation Mapping Appendix E.

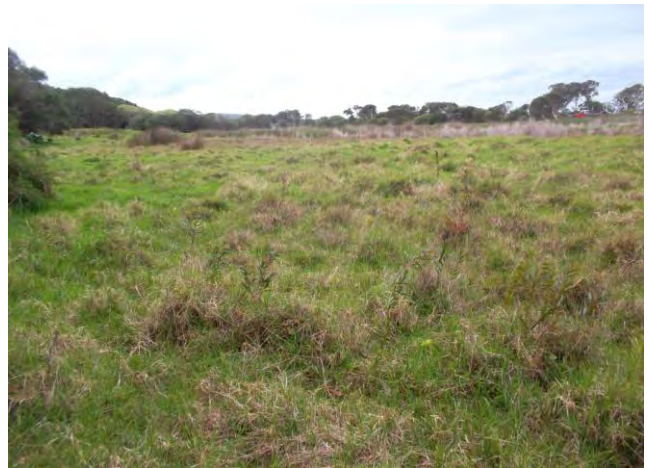
Photograph 10 – View of interface of Peppermint Woodland and low flats central of Subject site.

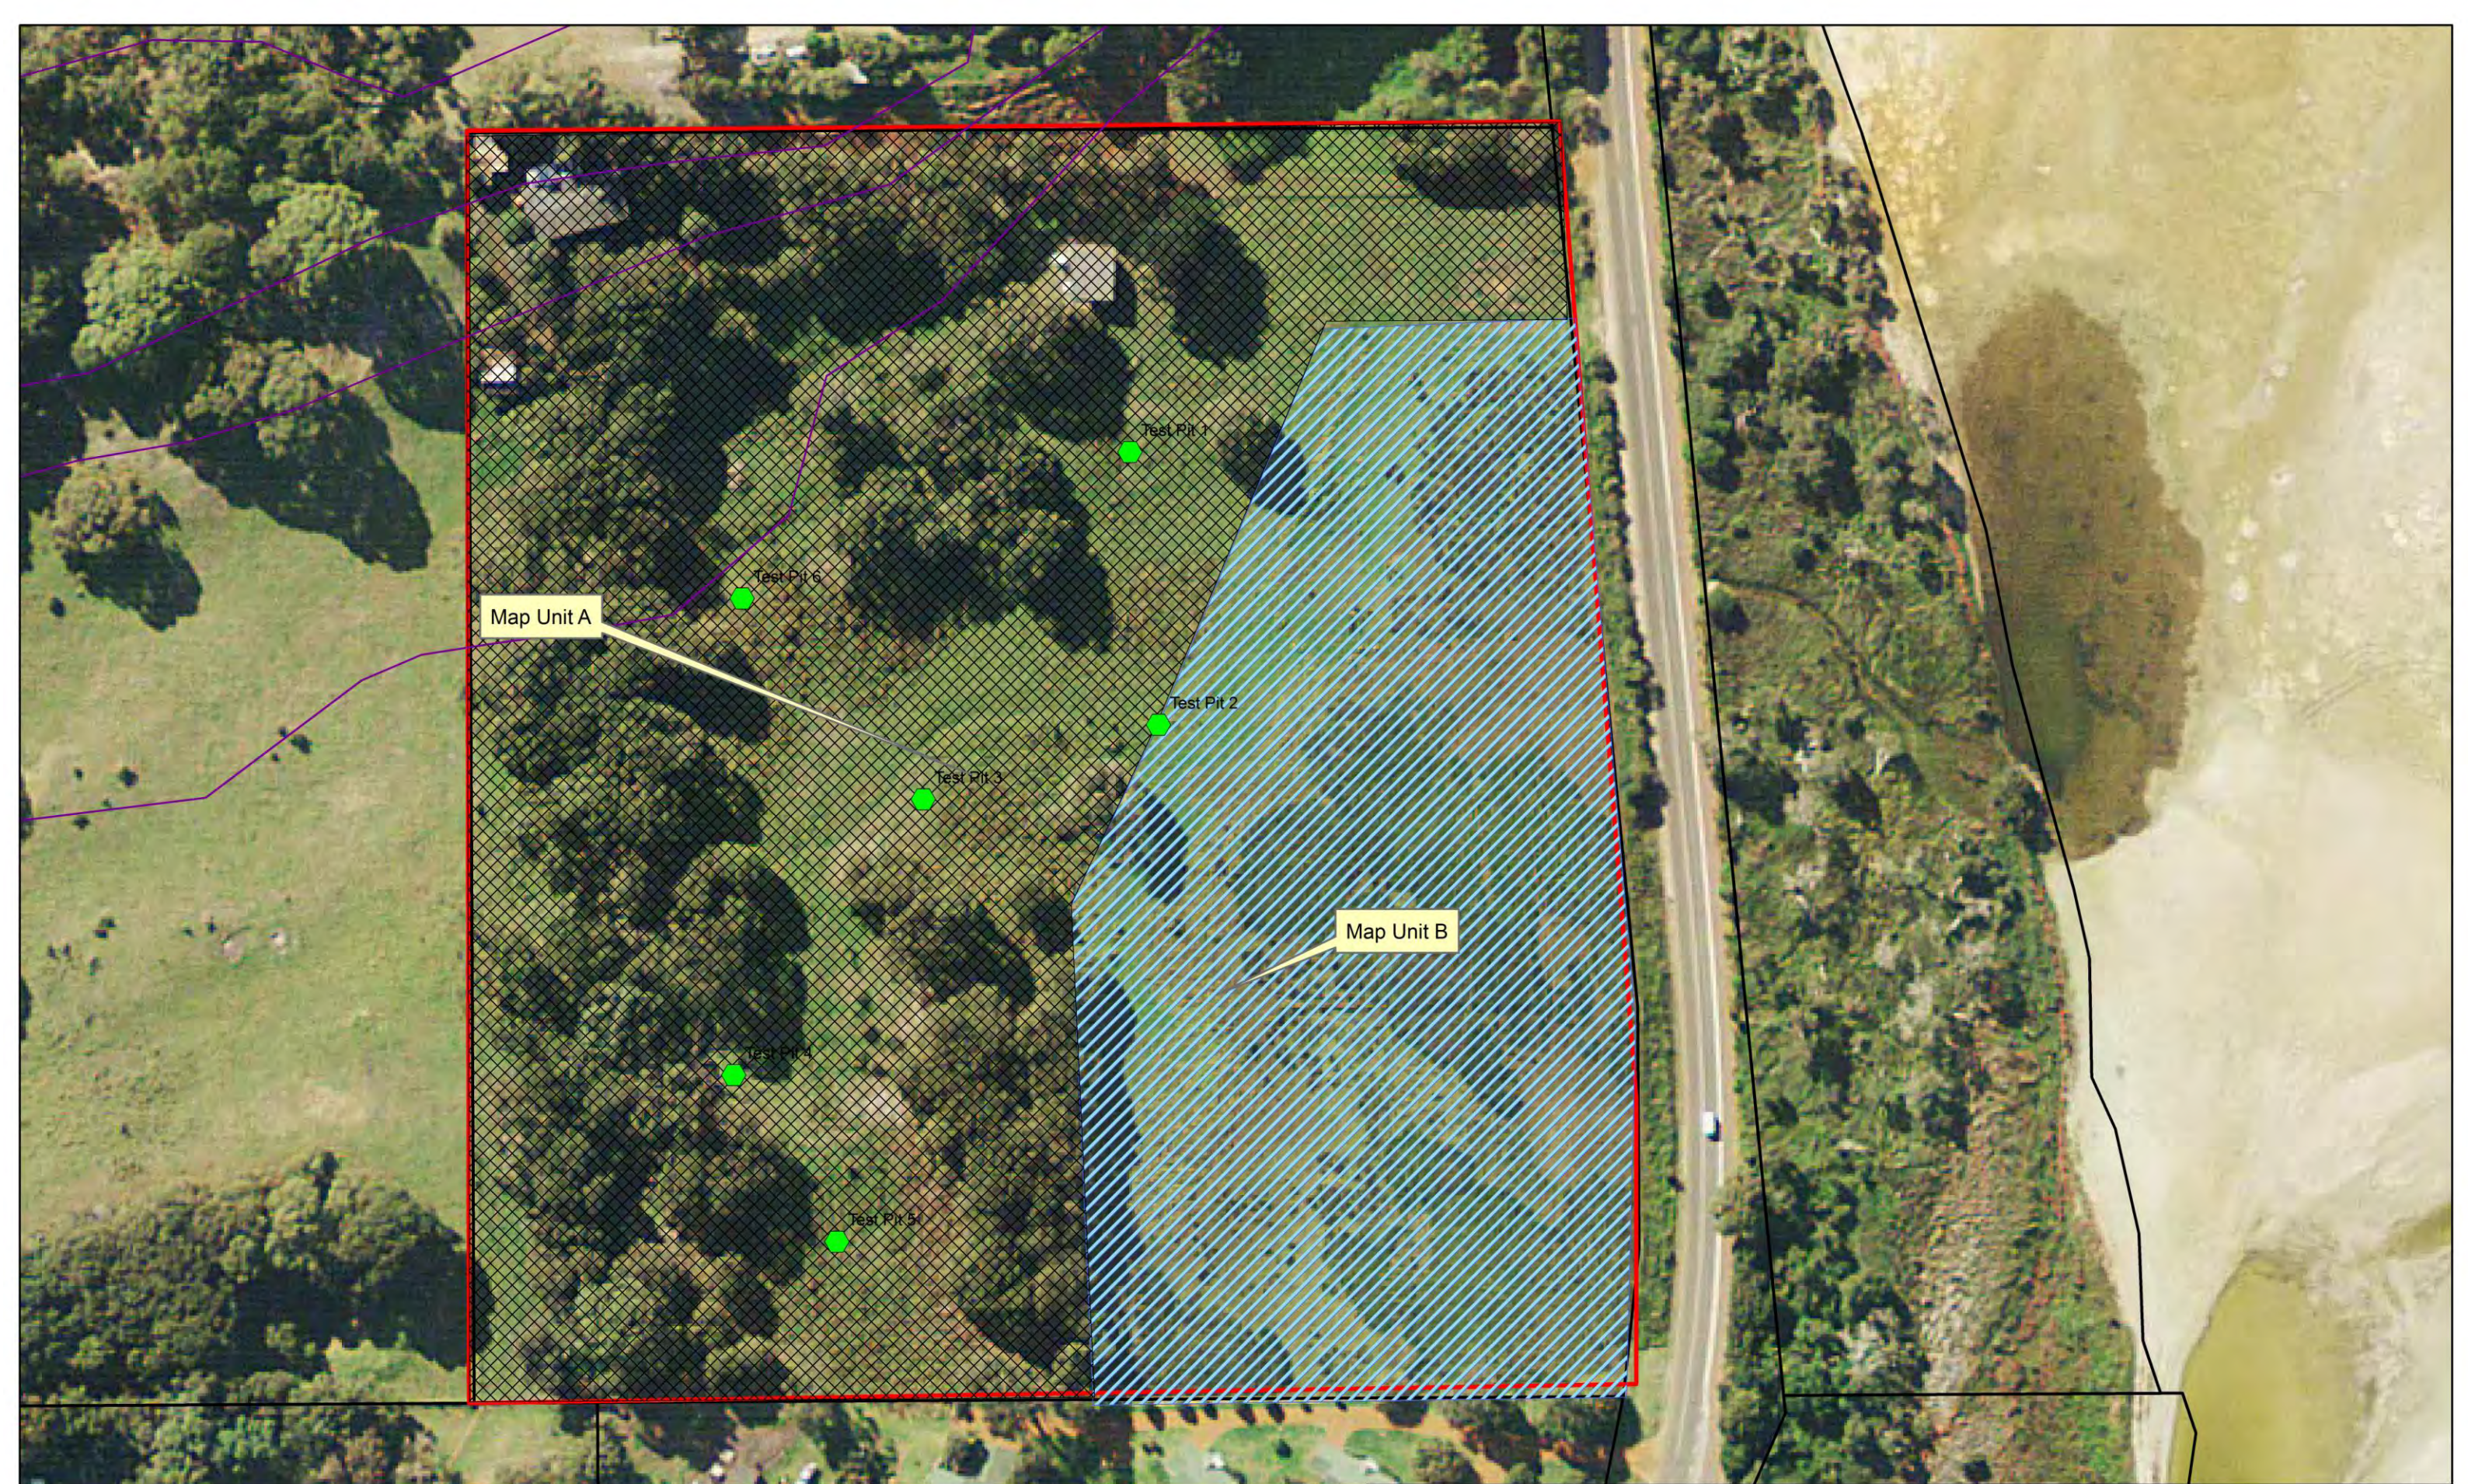
Table 3 – Mapping Units Proposed Rural Residential Lot 1 Ocean Road Denmark

Map Unit	Characteristics
Map Unit A	Sandy topsoil grading to silty sands, predominantly Peppermint woodland. Slopes <5° PRI very low, moderate permeability.
Map Unit B	Low flat areas, possibly seasonally inundated. Low flats of <i>Centella asiatica</i> .

The overall capability of the subject area to sustain the proposed developments is summarised as **Map Unit A – areas with a High capability (Land Capability Class II) of supporting the land use and limitations can be overcome by design and management inputs. Map Unit B - Low (Land Capability Class IV) of supporting the land use. There is a high degree of physical limitations which are either not easily overcome by standard development techniques or which result in a high risk of land degradation without extensive conservation requirements.**

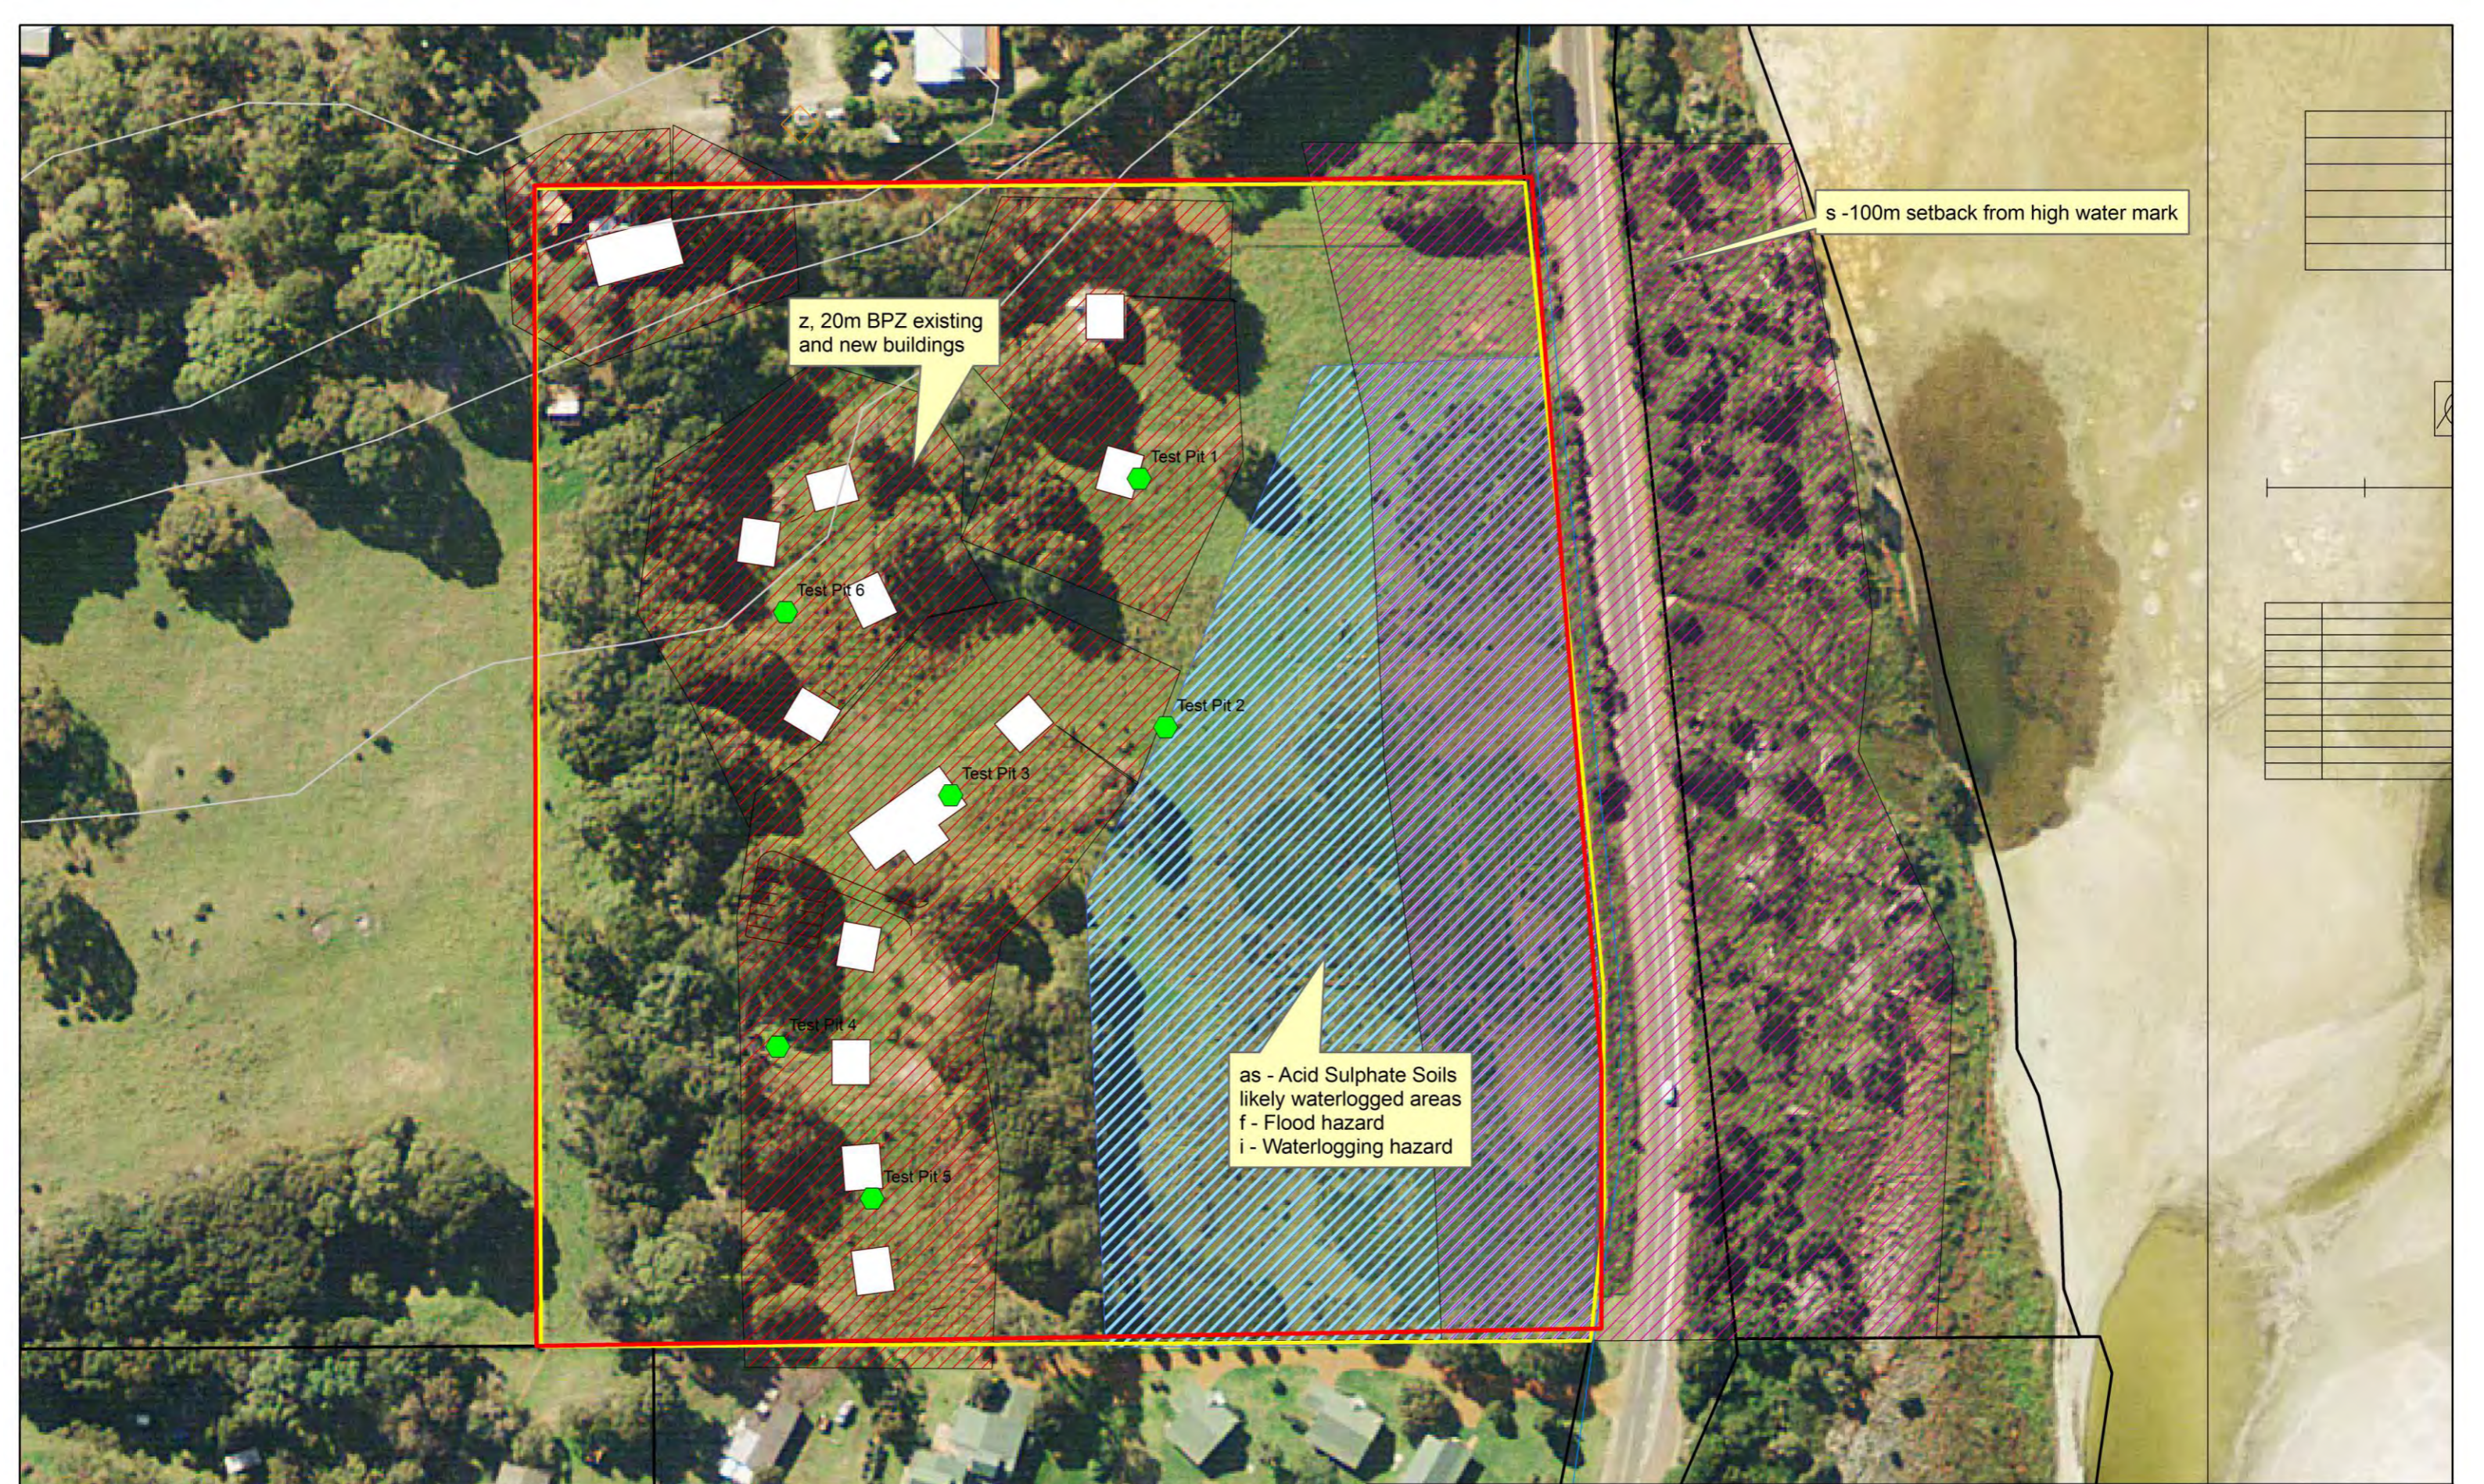
- Subject Site
- 20m BPZ
- 100m setback
- Waterlogging

Please refer to Limitations Mapping over the page.

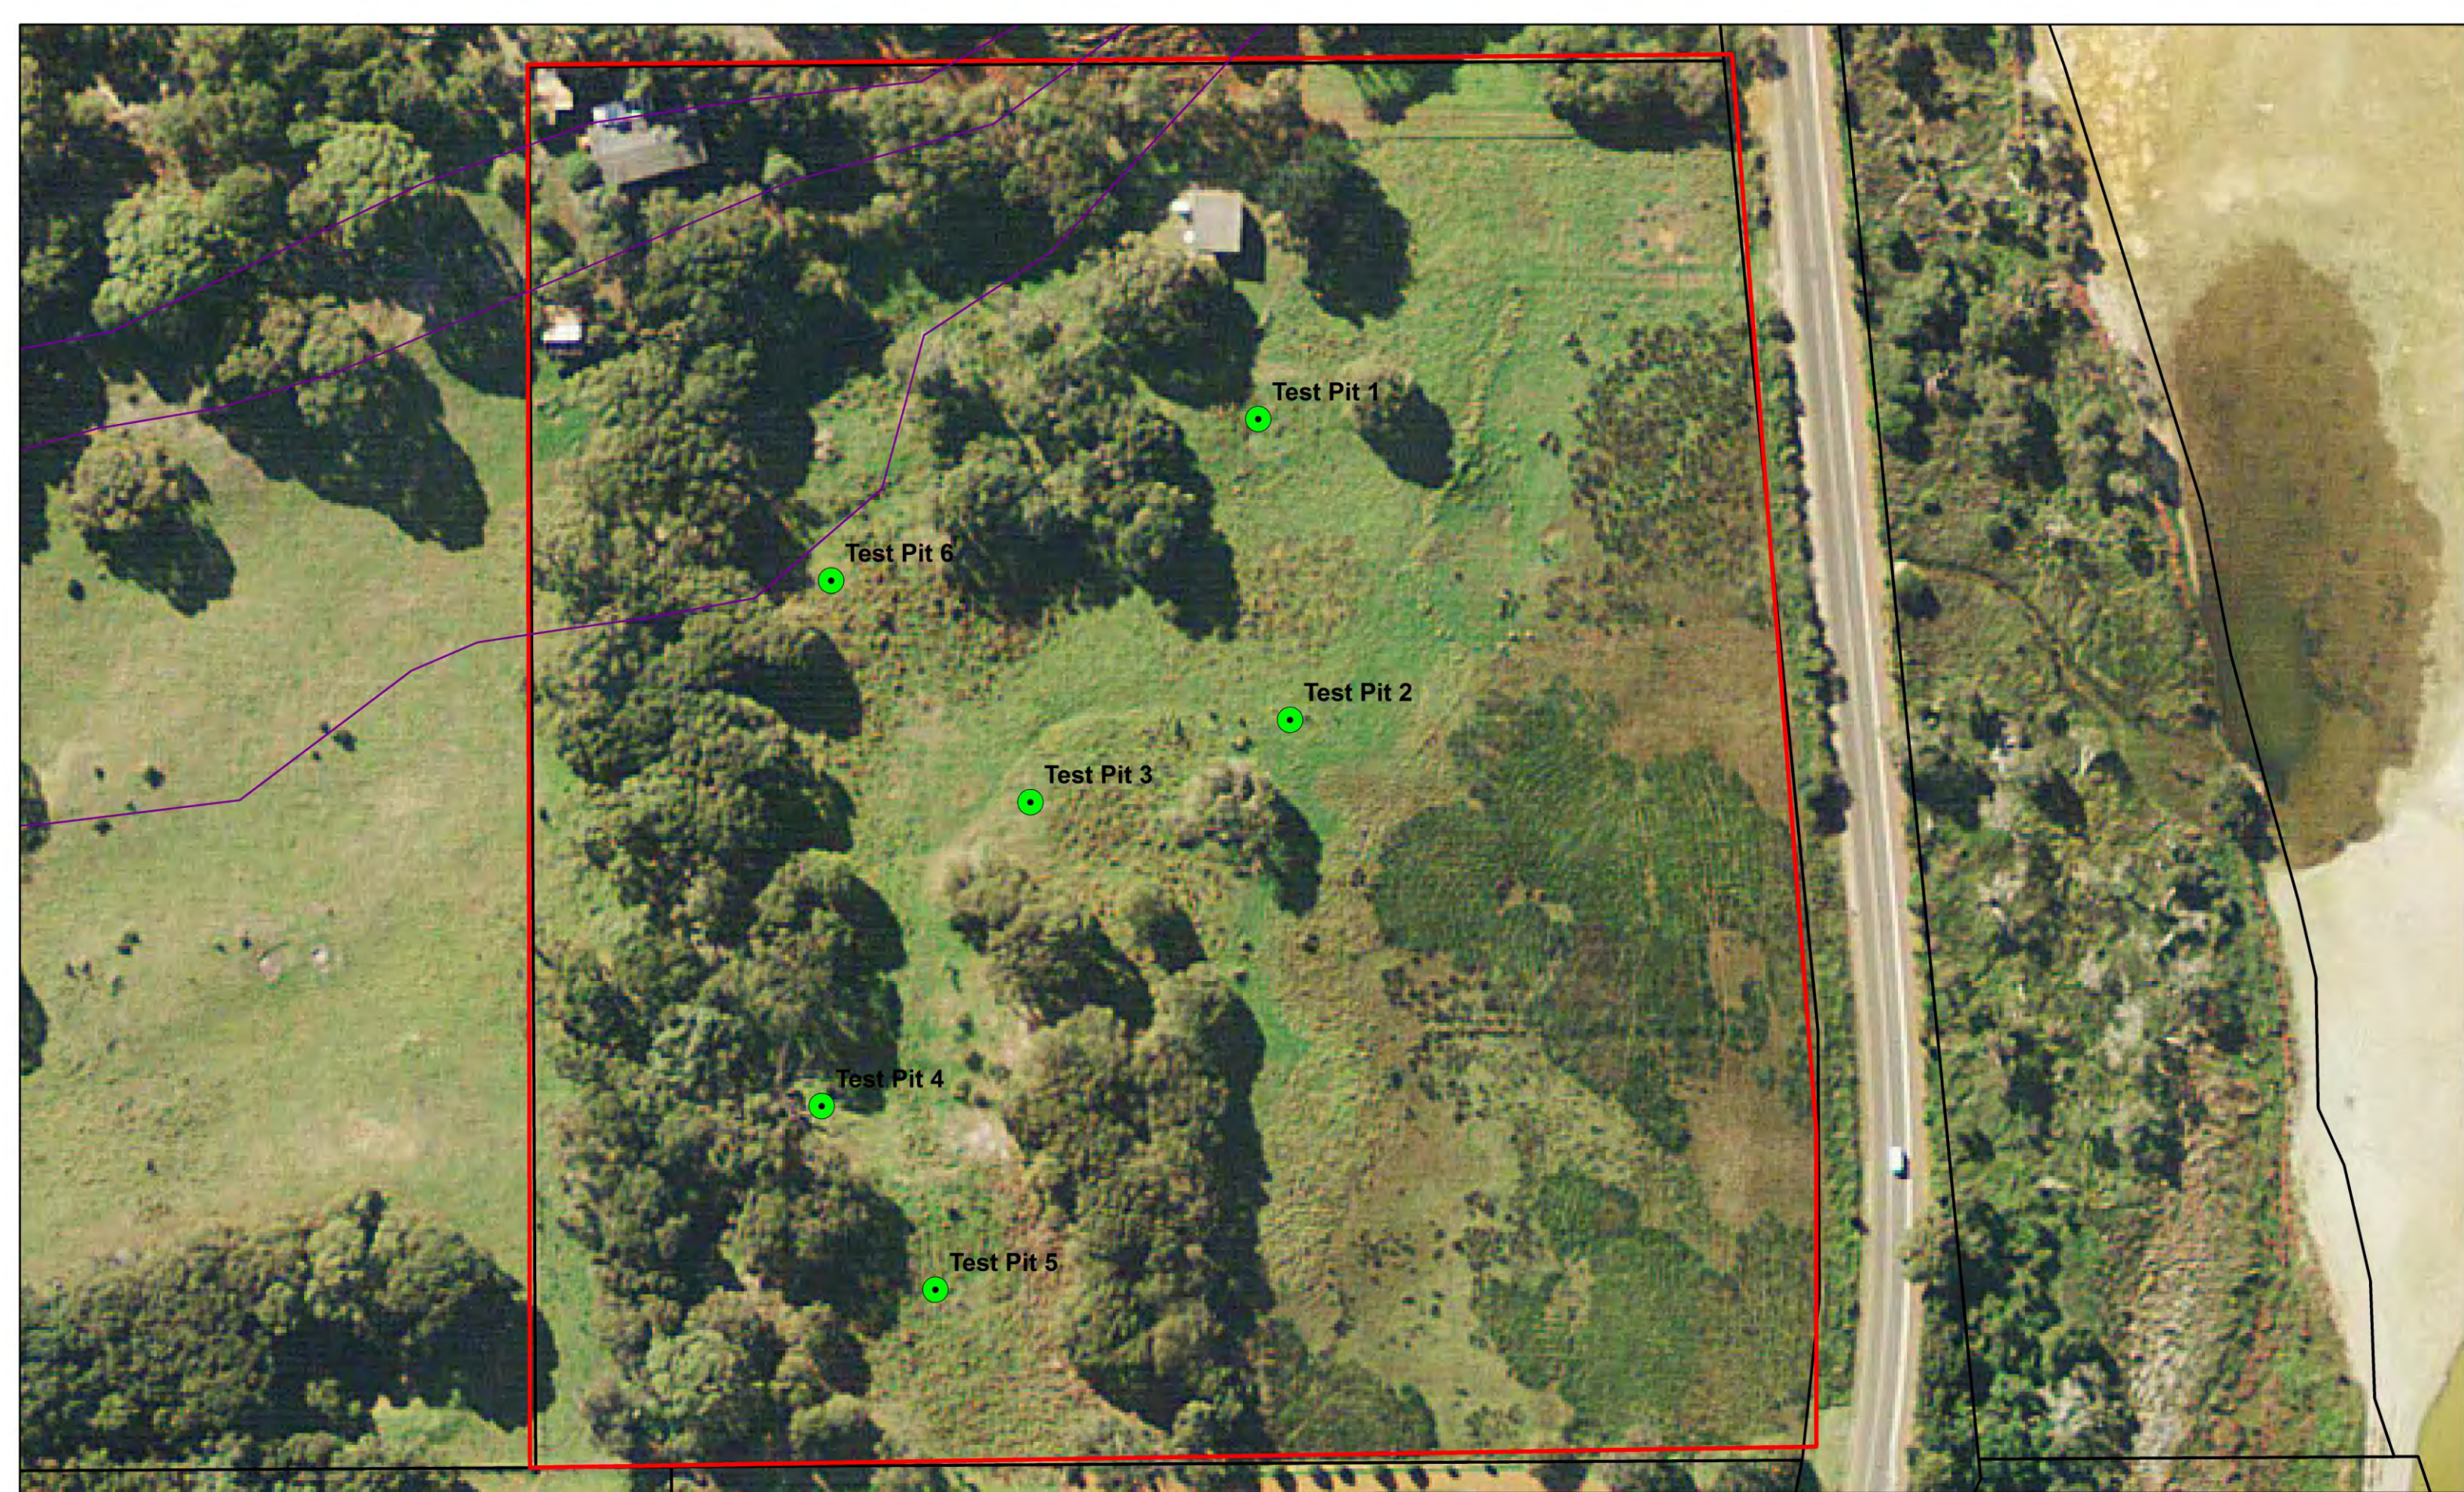
Soil Test Pit Mapping

- Test pits
- Subject Site

Site soil testing was undertaken in late winter conditions (September 2013) by Bio Diverse Solutions. The soil sampling strategy focussed on the proposed disturbed areas with the lower weta areas inaccessible due to inundation (and not deemed to be disturbed through the development process). Site soil testing confirmed the site to be one soil category – Deep sands. Please refer to the Soil Profile Sampling record sheets at Appendix C.

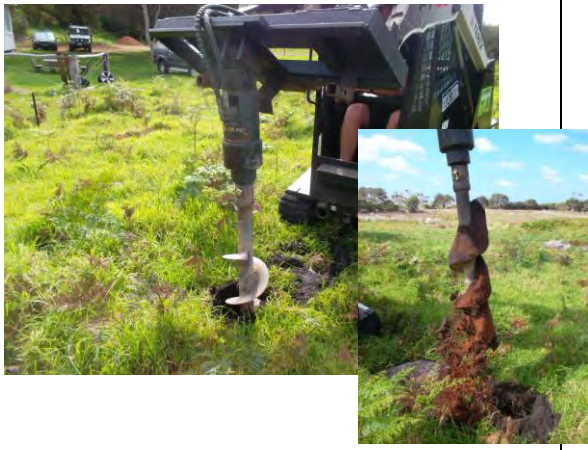
<u>Location</u>	<u>Site description</u>	<u>Depth of profile (mm)</u>	<u>Soil Description</u>	<u>Laboratory Sample ID</u>
Test Pit 1 0529663 6124851	North central south of existing house	0-350 350-650 650-1100 1100-1500 1500-2000	Dark brown sandy peat (organic matter), moist Dark grey sand, moist Brown coarse sand, moist Light brown coarse sand, moist Cream sand, wet Water Table 1300mm BGL

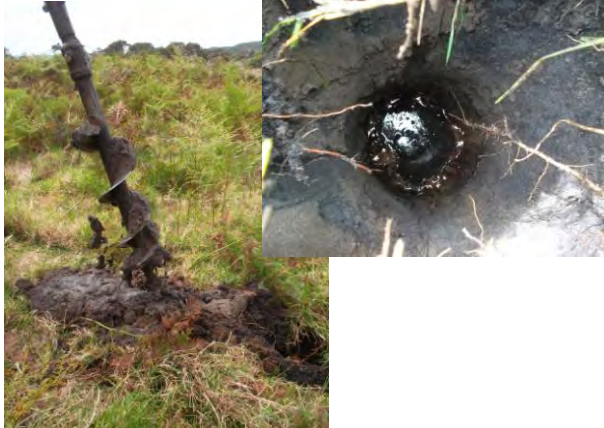
Sample 1 (S1)
Test Pit 2 0529661 6124812	Mid block east near wet area	0-180 180-650 650-900 900-1100 1100-2000	Dark grey sandy peat (organic matter), moist Dark grey sand, moist Brown coarse sand, wet Dark brown sandy silt, wet Dark brown sandy silt, wet Water Table 510mm BGL

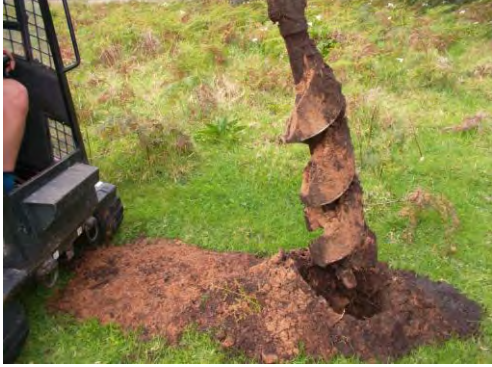
<u>Location</u>	<u>Site description</u>	<u>Depth of profile (mm)</u>	<u>Soil Description</u>	<u>Laboratory Sample ID</u>
Test Pit 3 0529625 6124788	Mid block higher ground, near proposed lodge	0-100 100-650 650-1000 1000-1600 1600-2000	Dark grey sandy peat (organic matter), moist Sark grey sand, moist Brown sand, moist Light brown coarse sand wet Brown silty sand, wet Water table 1130mm BGL

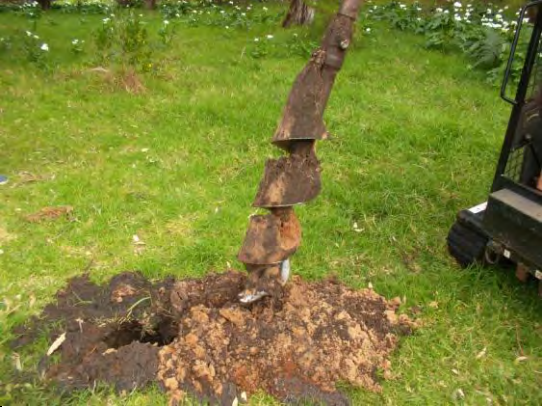
Test Pit 4 0529590 6124735	South west of lot mid lower	0-50 50-650 650-1100 1100-1800 1800-2000	Dark grey sand (organic matter), moist Dark grey sand, moist Brown coarse sand, moist Light brown sand, moist grading to wet Brown silty sand, wet Water Table 1310mm BGL

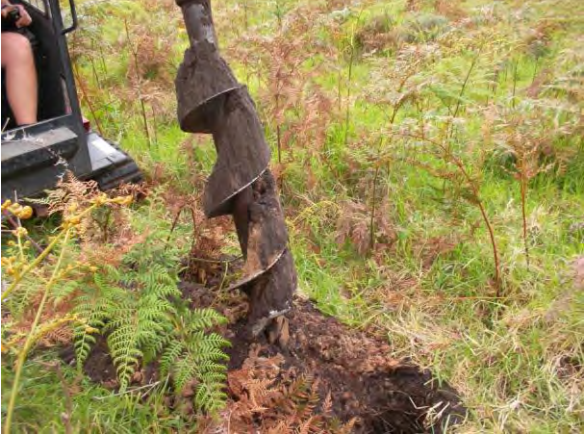
<u>Location</u>	<u>Site description</u>	<u>Depth of profile (mm)</u>	<u>Soil Description</u>	<u>Laboratory Sample ID</u>
Test Pit 5 0529609 6124705	South end of block 20m from boundary	0-150 150-1000 1000-1300 1300-1500 1500-2000	Dark grey sand (organic matter), moist Dark grey sand, moist Grey sand, moist Brown coarse sand, moist Light brown/cream sand, wet Water Table 1840mm BGL

The sandy soil profiles throughout the Subject site (moderately draining and moderate-low PRI) indicate that traditional septic style systems for on-site effluent would not be appropriate. It is recommended that Phosphorous Removing Alternative Treatment Units (ATU's) are installed across the site. Given the proposal is for a Tourist Development, consideration could be given to a central treatment system installed which is located on the near or adjacent to the lowest known groundwater (Test pit 5, south east of the property 1840mm BGL)

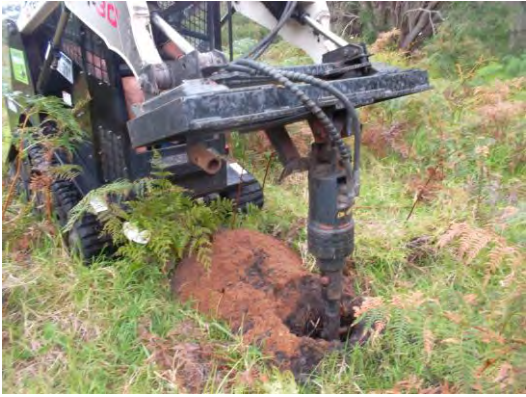
Sample 1 (S1) PRI only
Test Pit 6 0529592 6124825	North east of block	0-150 50-650 650-850 850-1300 1300-2000	Dark grey sand (organic matter), moist Dark grey sand, moist Grey sand Brown sand Light brown/cream sand, wet Water Table 1430 BGL

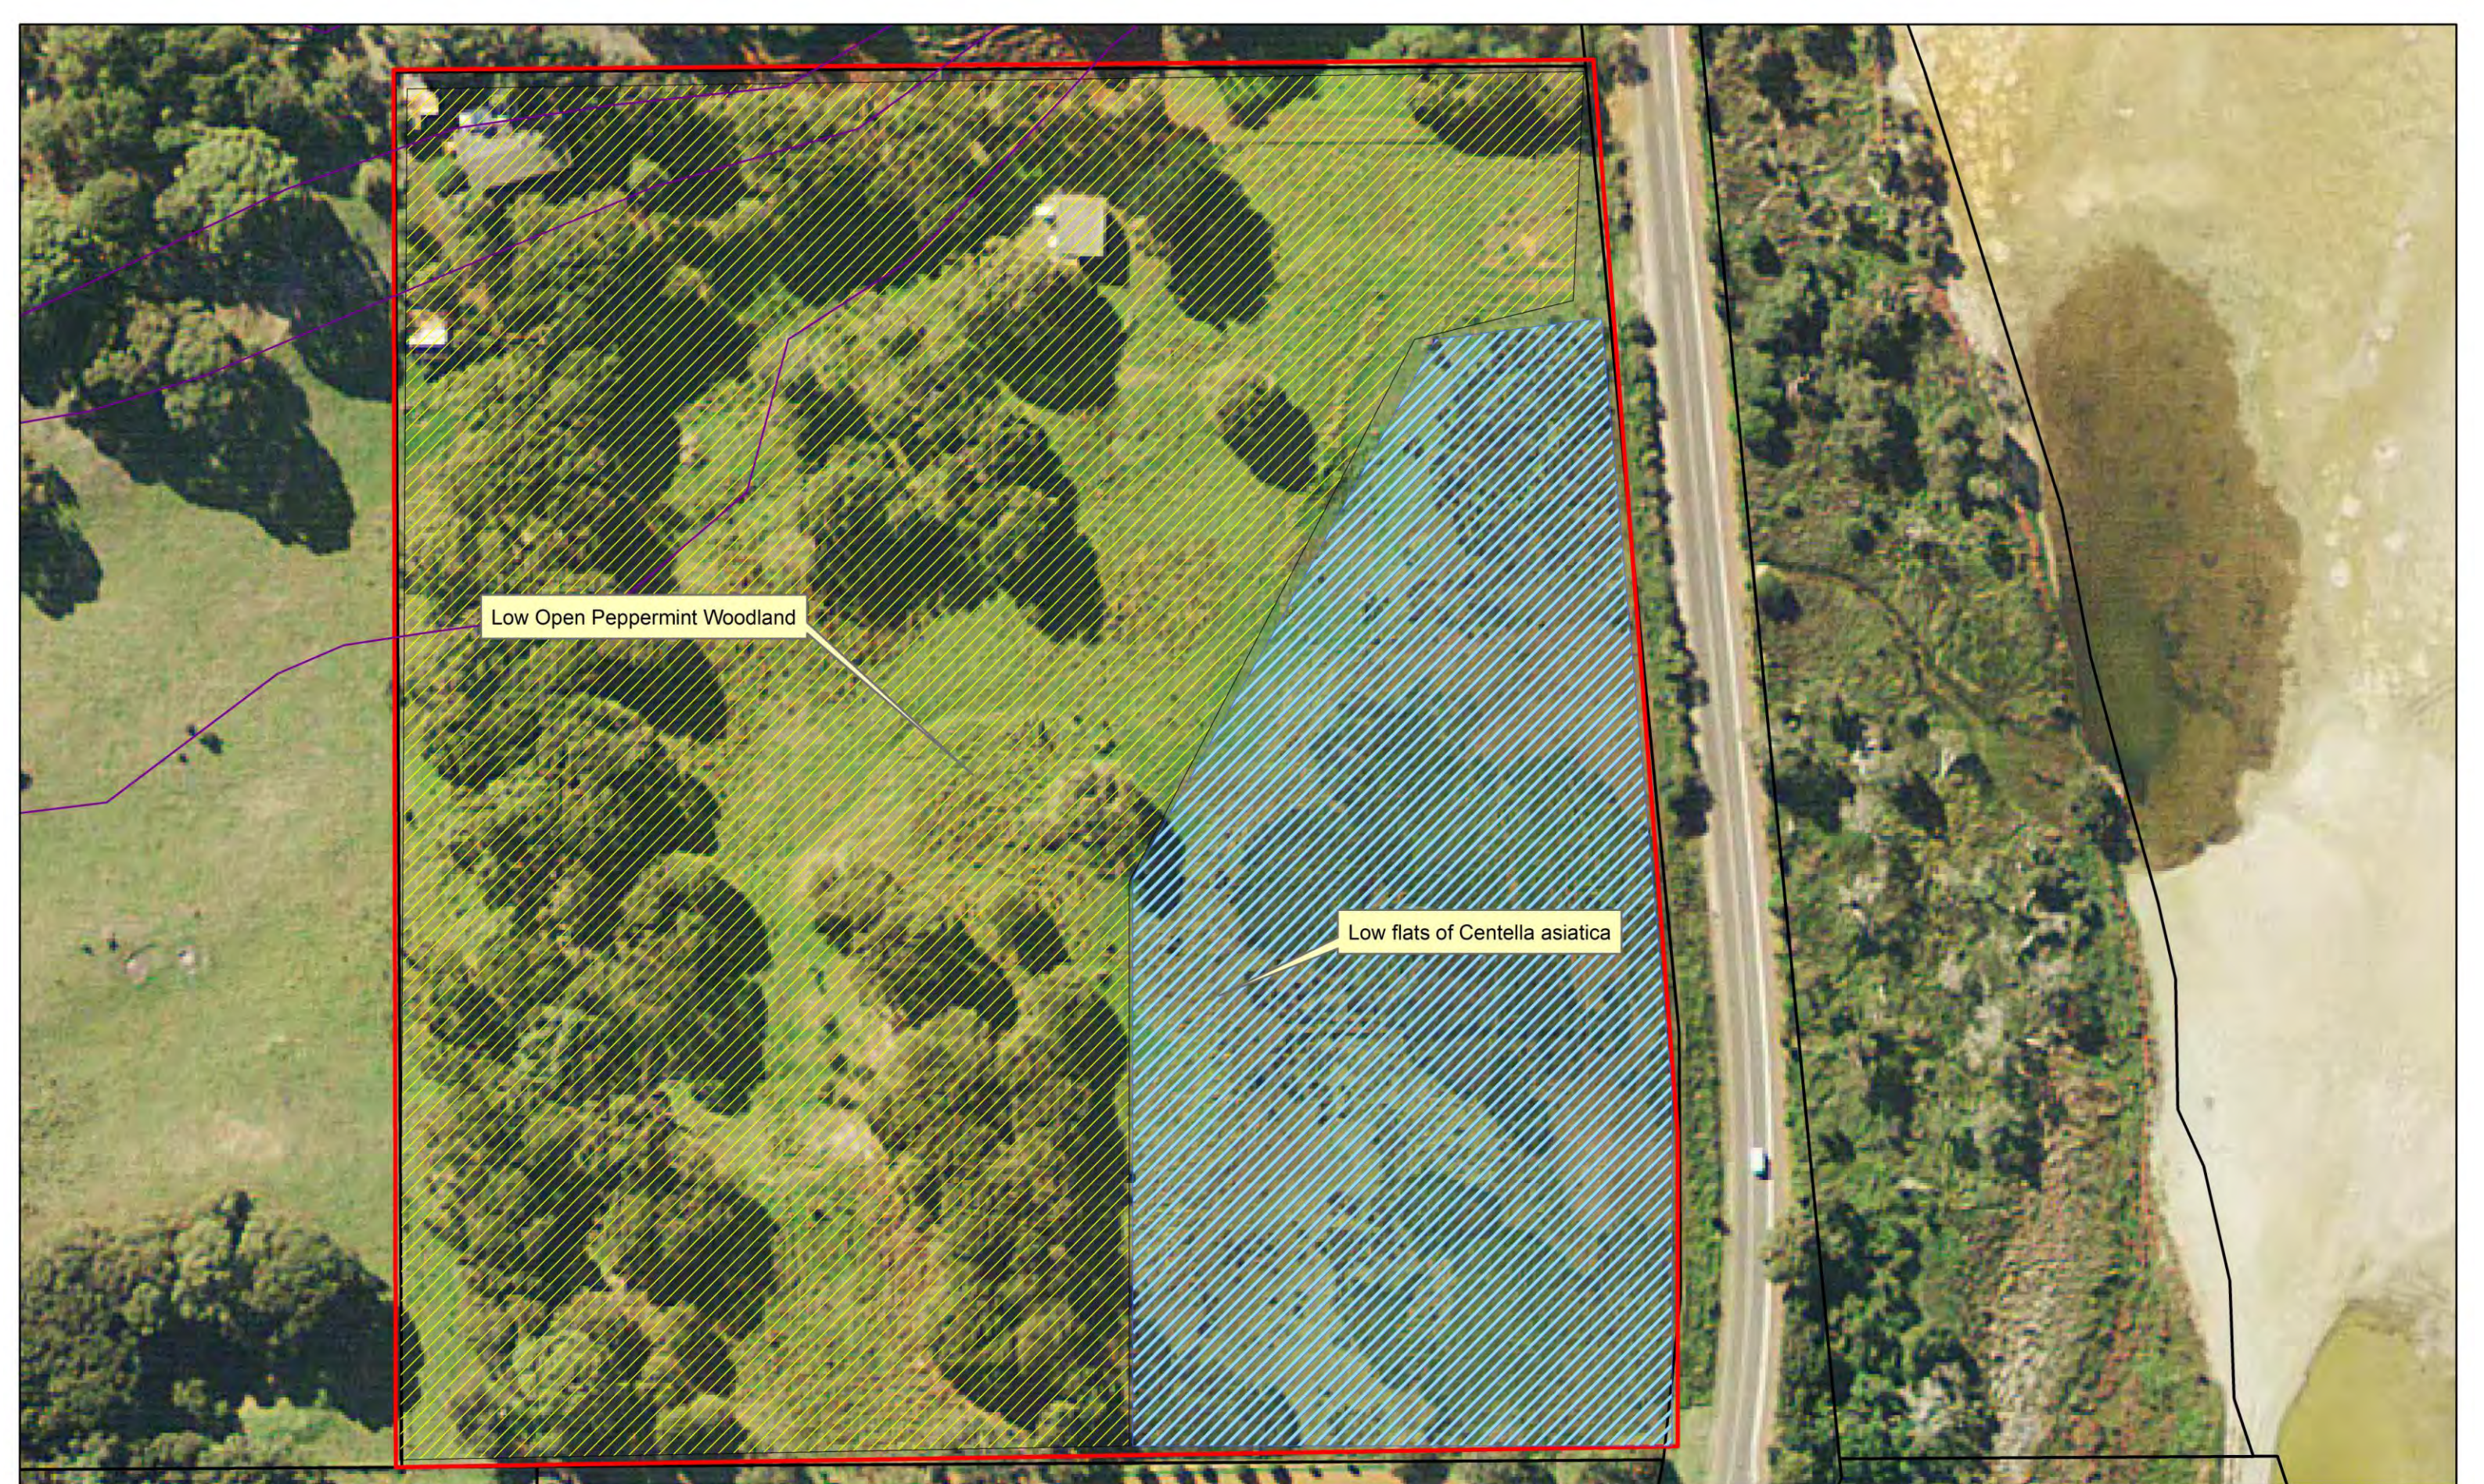
Low Open Peppermint Woodland

Low flats of Centella asiatica

Please refer to Photographs 7 and 8 below and Vegetation Mapping Appendix E.
