11<sup>th</sup> October 2016

RE: Arborist Report – Riverbend Lane, Denmark WA

## Arborist Report – Riverbend Lane, Denmark WA

Prepared for LandCorp

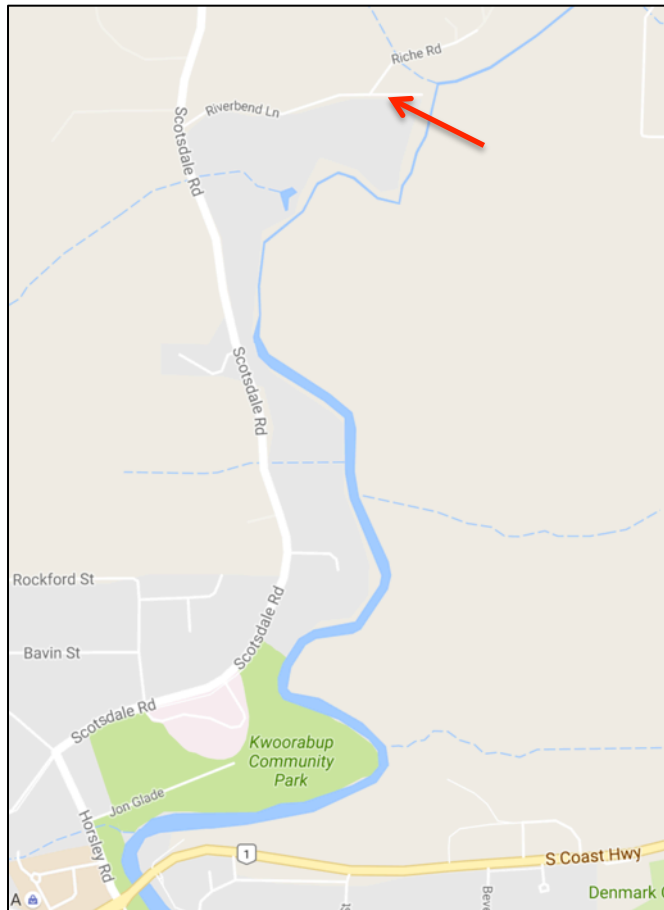
**Image 1: Location of the subject tree**

- 3.2 The eastern end of the lane enters remnant native forest. This forest is predominantly Marri (*Corymbia calophylla*) and Karri (*Eucalyptus diversicolor*).
- 3.3 The subject tree is located in the 'V' between Riverbend lane and Riche Road. Located as it is between the two roads, approximately two-thirds of the root zone is compacted road base.
