Wilson Inlet Foreshore Flora Survey- *Revisit to Vegetation Monitoring Sites established in March 2011*

September 2016

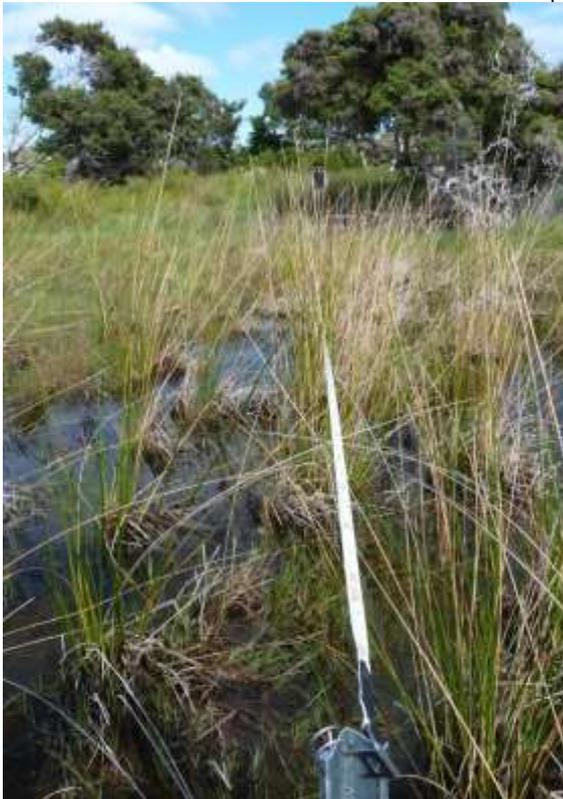
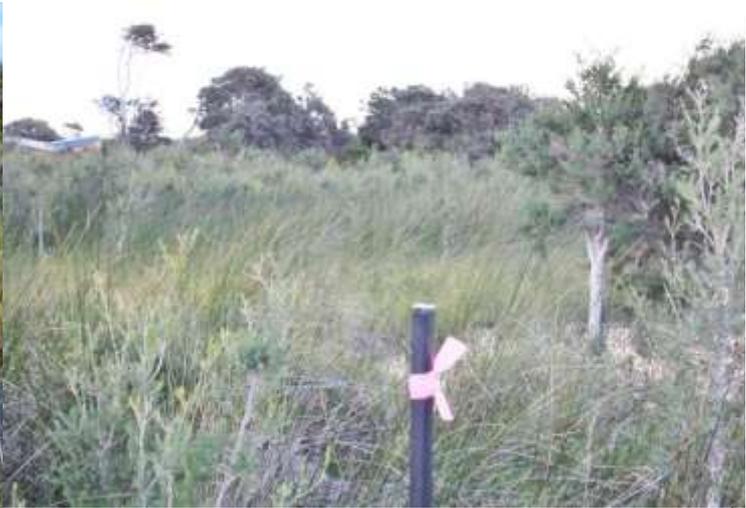
March 2011 Photo of Prawn Rock Channel transect line	June 2016 Photo of Prawn Rock Channel Transect line.

- Planted *Melaleuca cuticularis* (2011) are growing very well
- *Juncus Krausii* looks to have improved
- *Paspalum spp.* (Couch) has declined, as has Kikiyu
- A cycle path has been constructed parallel to the shore and west of the land peg.

This site seems to have improved.

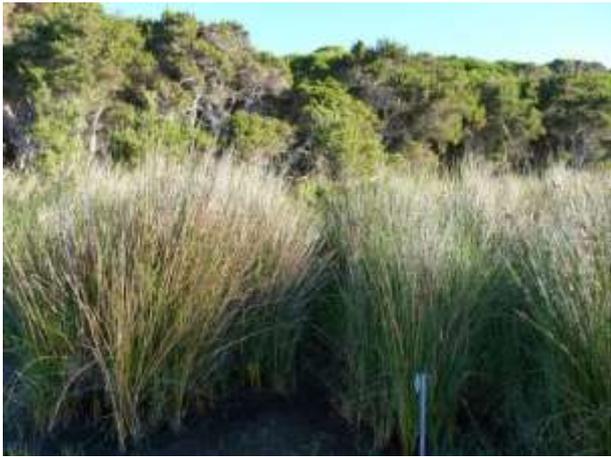
March 2011 Photo of Poddyshot transect line	June 2016 Photo of Poddyshot transect line.

Juncus krausii on the shore are inundated and looking stressed as is the samphire

The *Juncus krausii* beneath the paperparks at the land end are stressed (very brown)

Overall vegetation condition has declined.

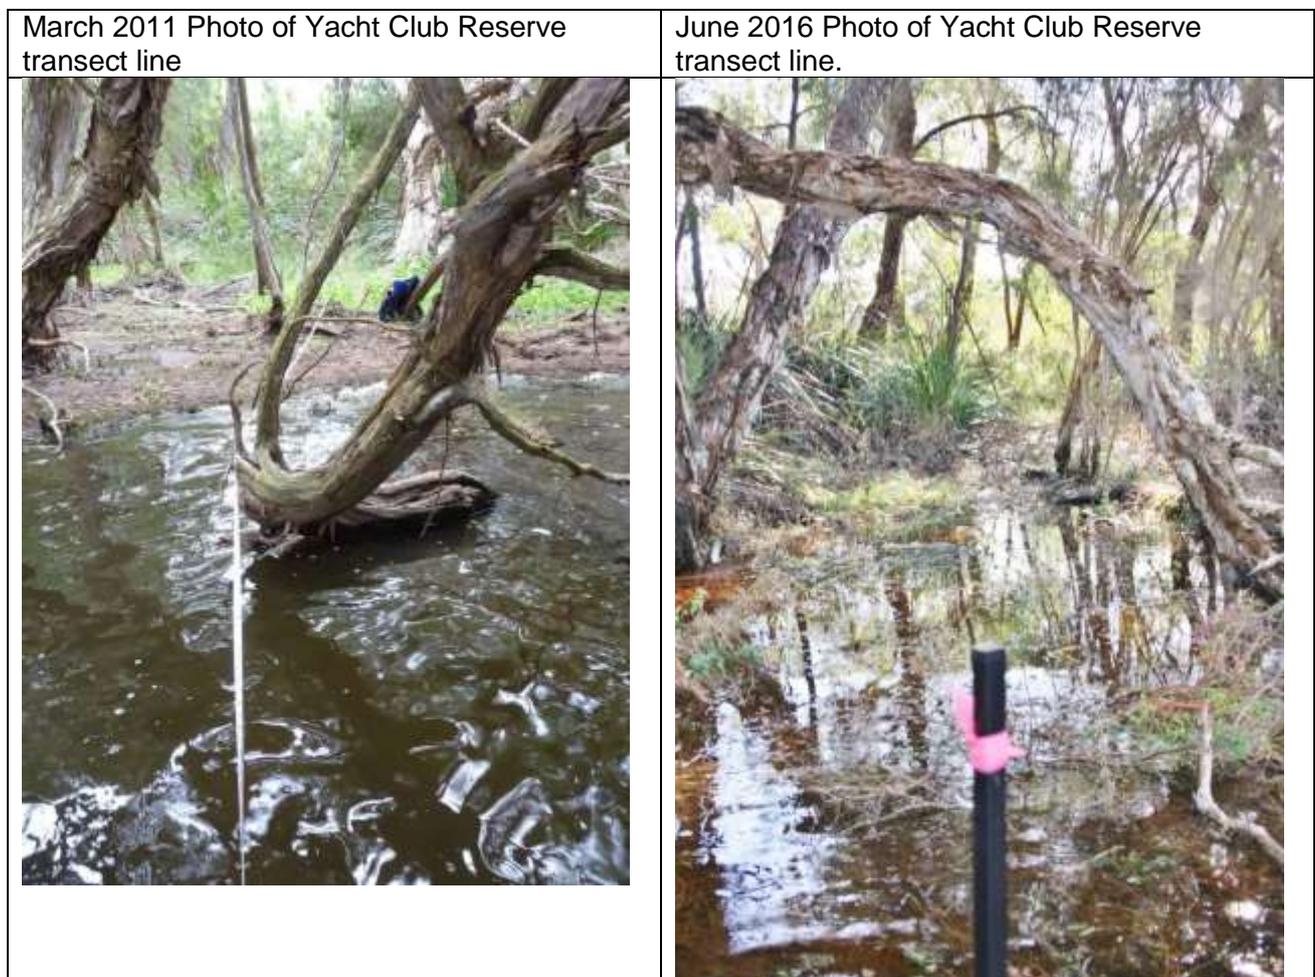
Comparative Photos

Native vegetation condition has declined, weeds are persisting.

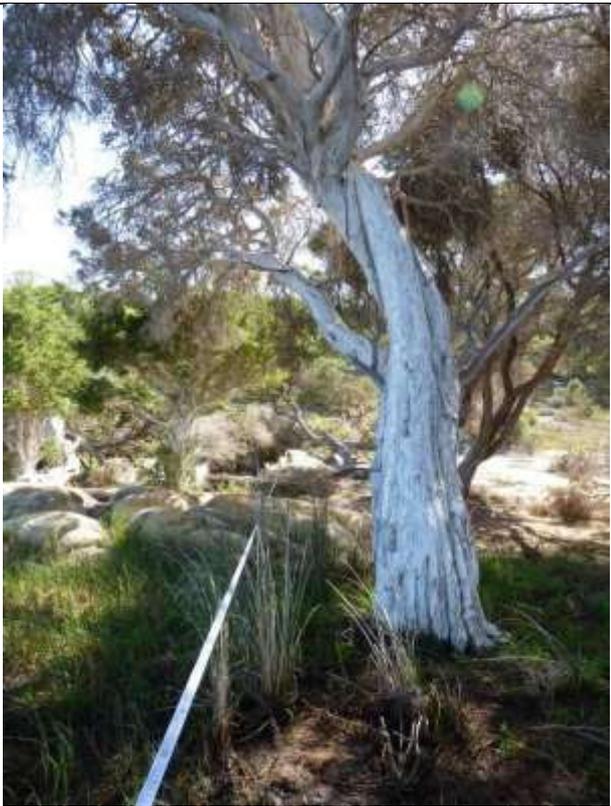
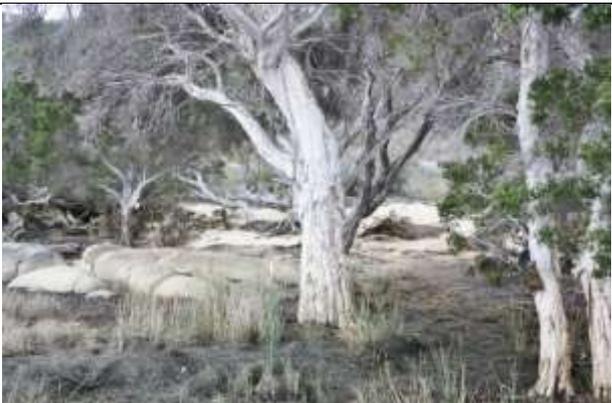
March 2011 Photo of Crusoe Beach transect line	June 2016 Photo of Crusoe Beach transect line.

There are some *Melaleuca* seedlings above the High water mark. The native vegetation appears to be in good condition. Comparing the 2011 photo to the present one of the same area it indicates the *Juncus kraussii* has declined.

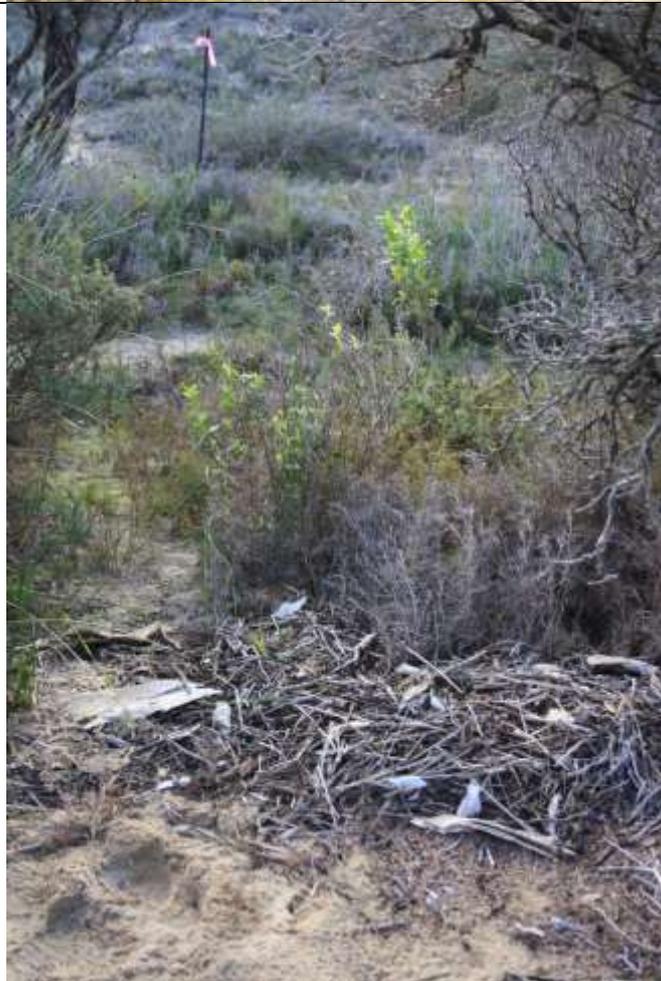
Crusoe Beach
Photo4 / 101.6845
At high water mark
looking towards land
peg showing
Desmocladius sp.
Dead and alive.

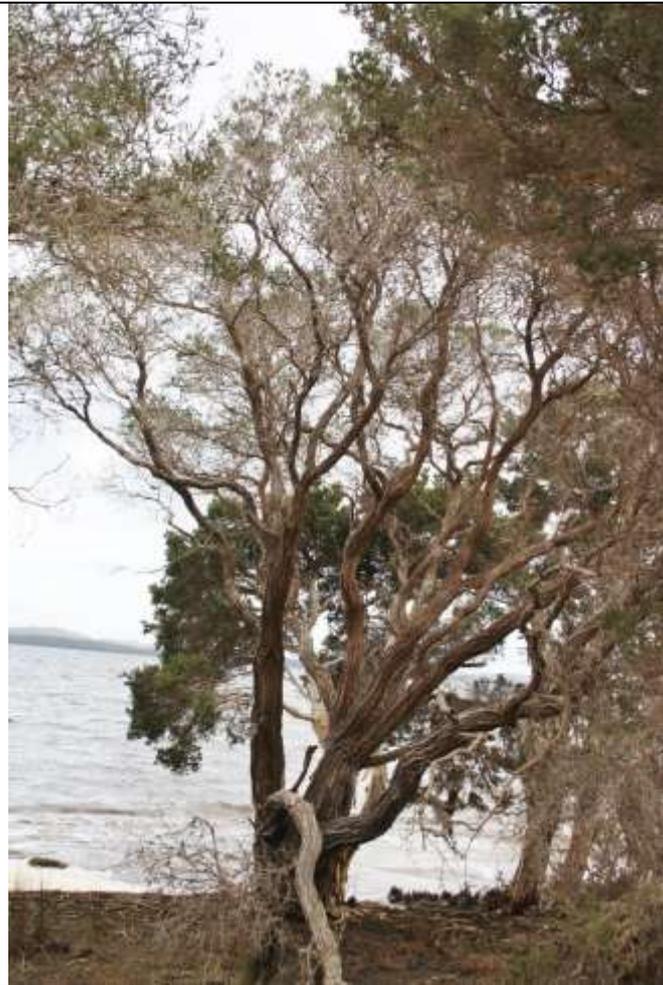
Photo9/ 101.6894

Taken to the East of
transect to show the
difference in canopy
density between
Melaleuca densa
and *Melaleuca*
cuticularis

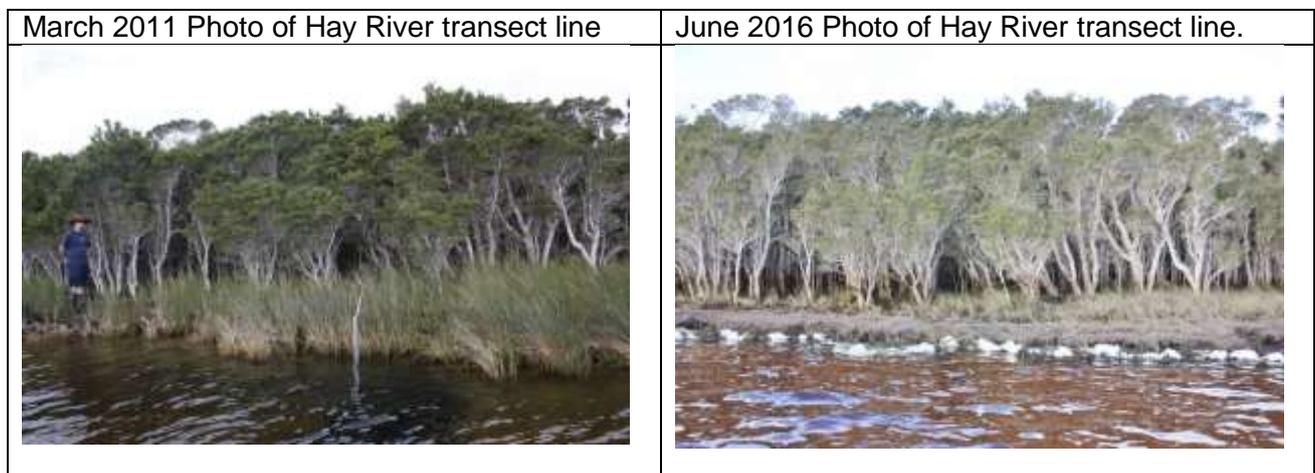
Comparative Photos

Rushes in decline

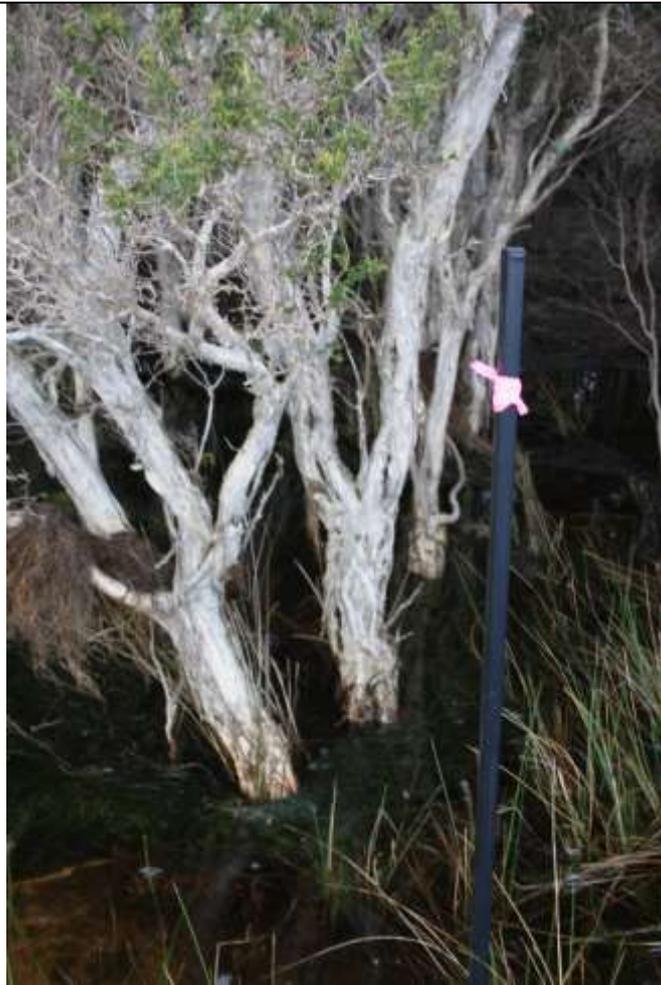
Photo2 / 101.6836

Taken from inlet peg looking towards land peg but focussing on *Juncus kraussii* at peg base and *Rupia megacarpa* hanging at last years inundation level.

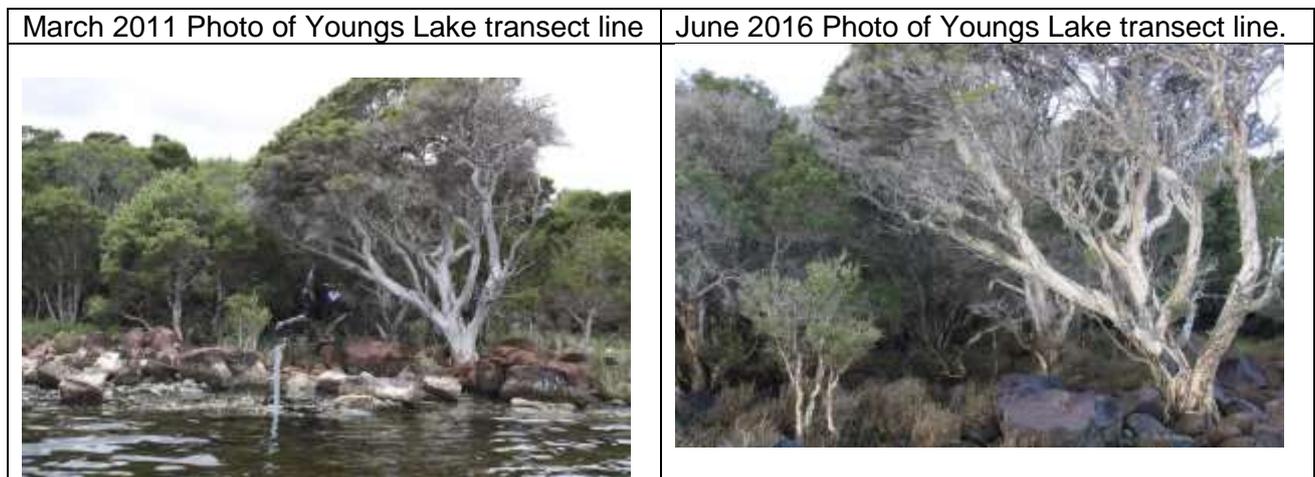
Comparative Photos

There is a small *Melaleuca densa* between 2 small *Melaleuca cuticularis* to the north of the large *Melaleuca cuticularis* in the 2011 report photo that is now dead.

Melaleuca densa is showing stress,

Melaleuca cuticularis is in good condition

Juncus kraussii is in decline

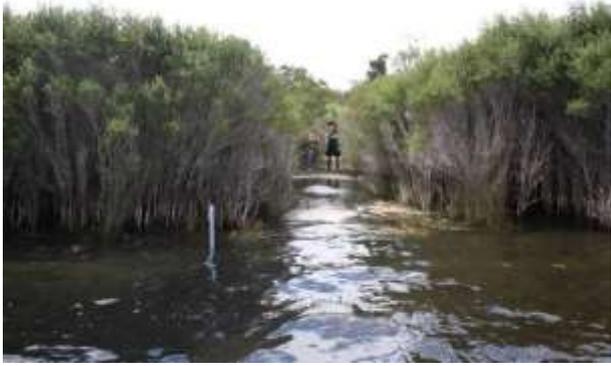
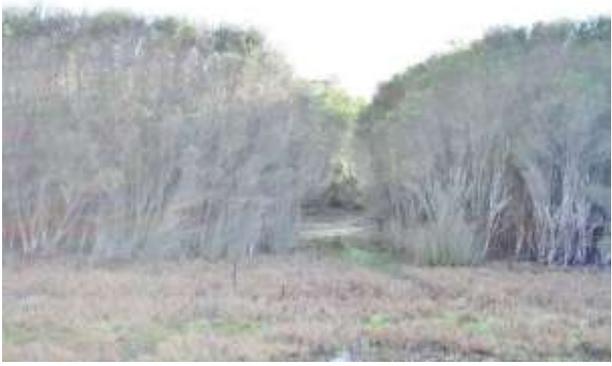
March 2011 Photo of Nenamup Inlet transect line	June 2016 Photo of Nenamup Inlet transect line.

Vegetation condition is little changed from the 2011 survey.

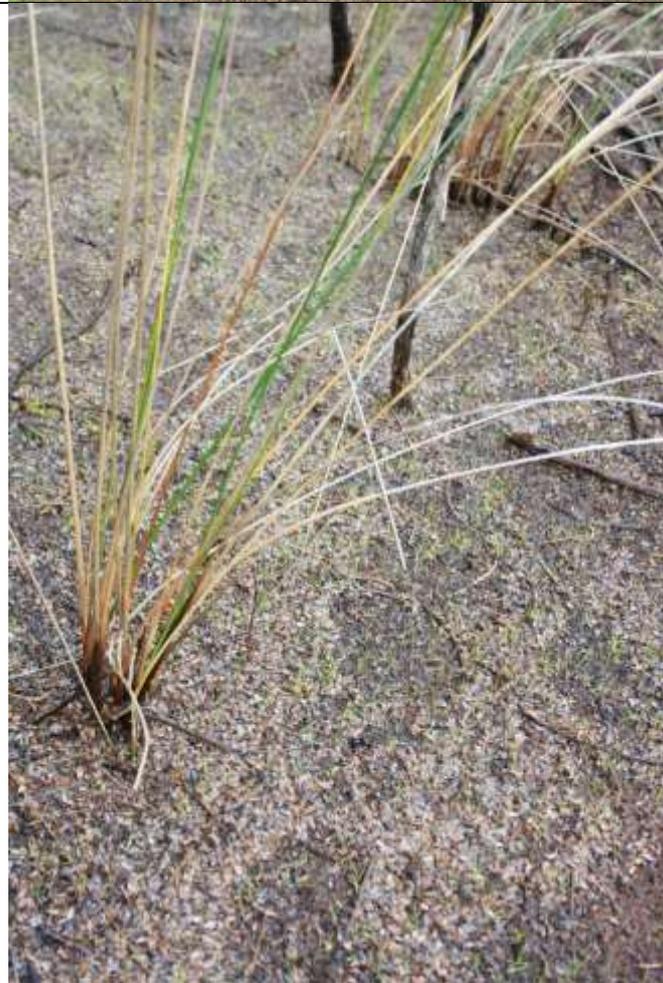
Photo4 / 101.6821
Juncus krausii
seedlings as many
as 40 per 10²cm.
S35.01981
E117.47768 . A
good point to
monitor survival.

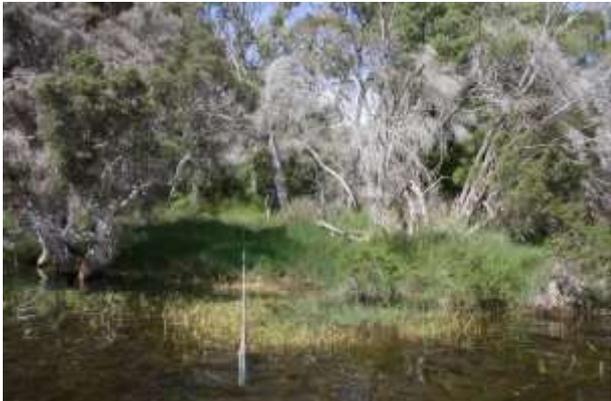
March 2011 Photo of Nullaki Gate transect line	June 2016 Photo of Nullaki Gate transect line.

Site conditions are much as they were for the 2011 survey.

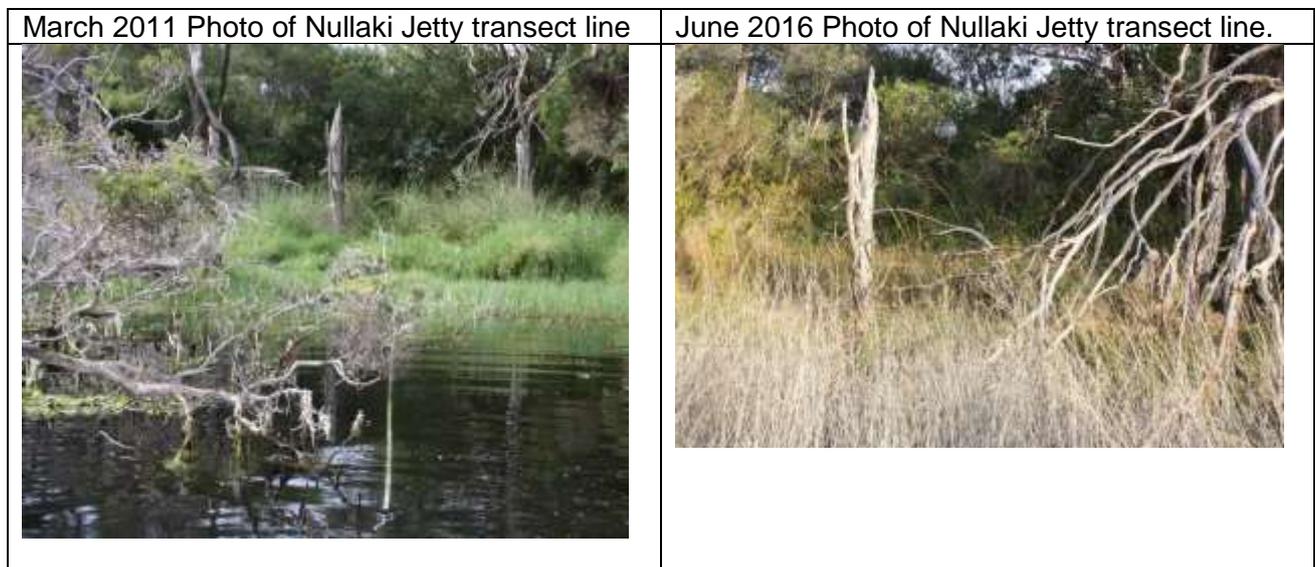
Comparative Photos

Melaleucas are recovering

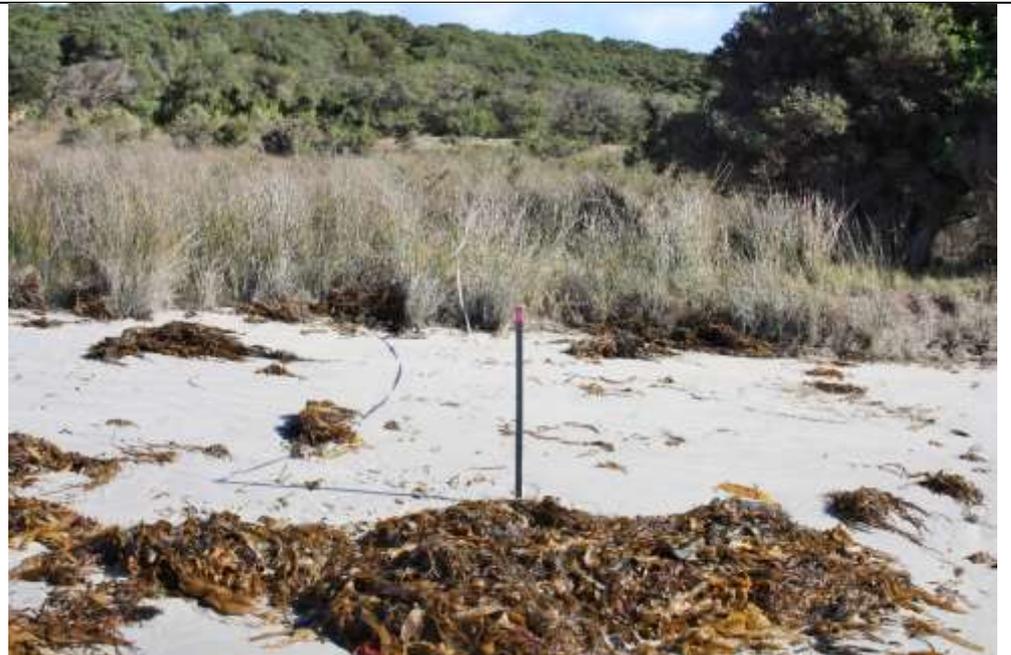
Photo1 /101.6866

The plants all looked stressed but as it is an exposed position, wind-blown salt is most likely the cause.

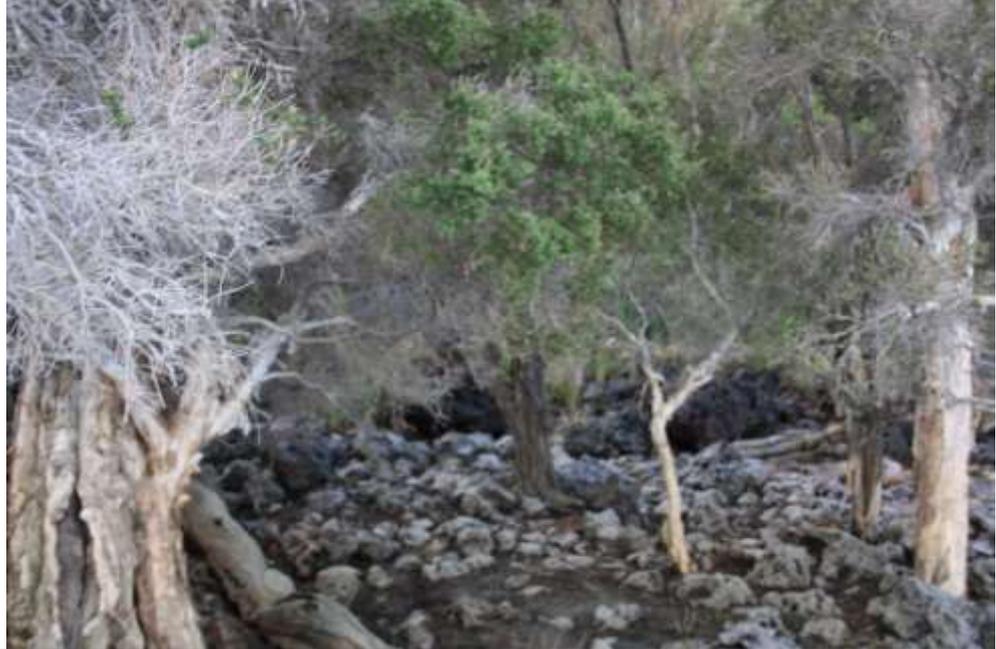
<p>Springdale Beach Inlet peg S34.97001 E117.38853</p> <p>Photo1 / 101.6883 At inlet peg looking to land peg</p>

Vegetation is in good condition however there are no *Melaleuca* seedlings in the zone of inundation.
