# PROPOSED YACHT CLUB AND MARINA FACILITIES **DENMARK**

# Preliminary report into development options and development costs

PJ0021-001, Rev. A

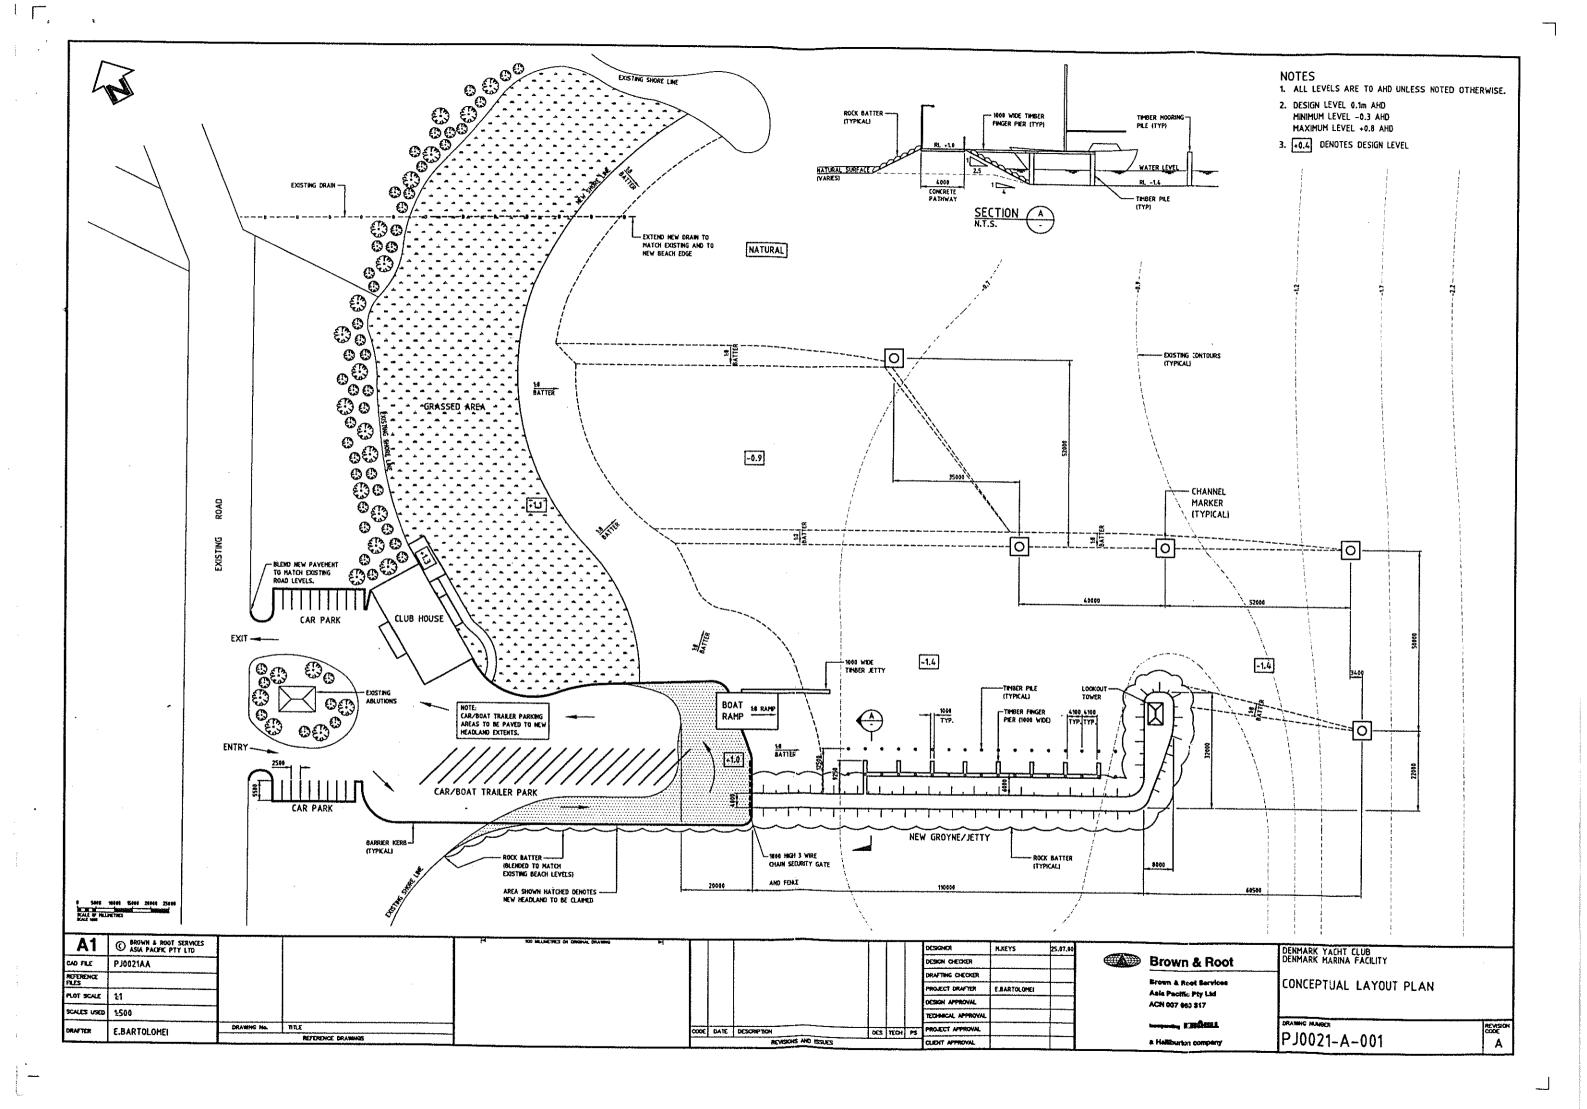
# CONCEPTUAL LAYOUT PLAN

The conceptual design layout plan developed by Brown & Root for The Denmark Yacht Club Marina facility is shown on Drawing No. PJ0021-A-001 (Attachment A).

As proposed in the concept plan, the marina facility would comprise the following main elements:

- an extended reclaimed headland that provides parking for cars and trailers and also provide access to a new boat ramp;
- a new boat ramp, complete with timber jetty to facilitate launching and retrieval of boats;
- a new groyne to provide protection from the prevailing south-east wind and to provide access to new boat pens;
- 16 new boat pens;
- a club house located so that it overlooks the grassed rigging area;
- a grassed rigging area backing onto a beach;
- dredged basin and access channel with the dredged spoil utilised to form the grassed rigging area and beach;
- parking area adjacent to the new club house.

The conceptual layout plan developed by Brown & Root is largely based on the concept plans developed by the Yacht Club. The following summarises the variations between the two concept plans:

- the club house location has been moved in order to provide access and parking for cars and trailers. The new location promotes a greater relationship between the club house, club and social activities that would occur on the grassed rigging area;
- the boat ramp orientation has been altered in order to access deeper water. The ramp is also provided with a narrow jetty to facilitate boat launching and retrieval;
- the number of boat pens has been reduced to 16 in order to accommodate clearance requirements of current Australian Standards. The boat pens have also been provided with a lower level timber finger pier in order to improve access from the rock groyne.

- The dredged basin has been divided into two design levels, a deeper area for the boat ramp and pens and a shallower area adjacent to the grassed rigging area. This design reduces the quality and cost of dredging;
- The grassed rigging area and beach have been shaped into a stable concave profile with the level and extent of the fill area matched to the dredged volume;
- channel markers have been provided in order to mark the extent of the dredged basin.

The purpose of the conceptual layout plan is to provide a spatial arrangement of the various components requested by the Yacht Club so that quantities can be determined for the purpose of developing a cost estimate. Changes to the conceptual layout plan can be made without significant change to the cost estimate, providing the changes do not result in significant changes to the quantities. For example, the cost estimate is not sensitive to the location of the club house, but a change to the size of these facilities could have a significant effect on the cost estimate.

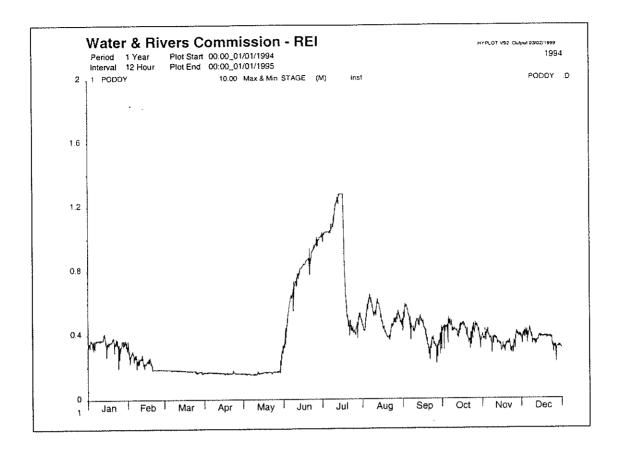
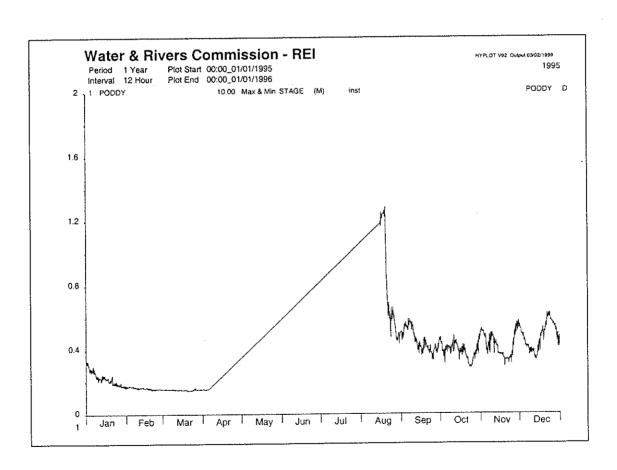
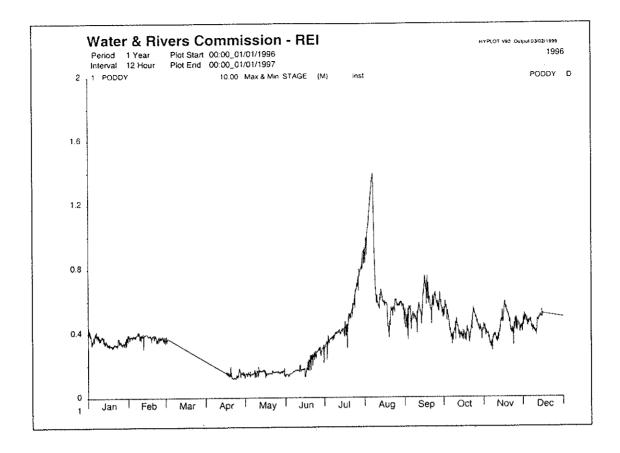
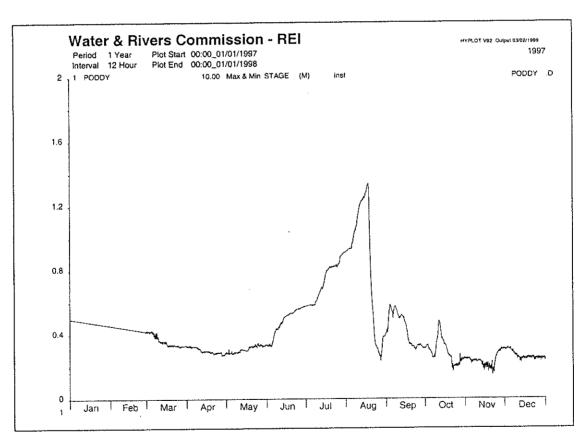
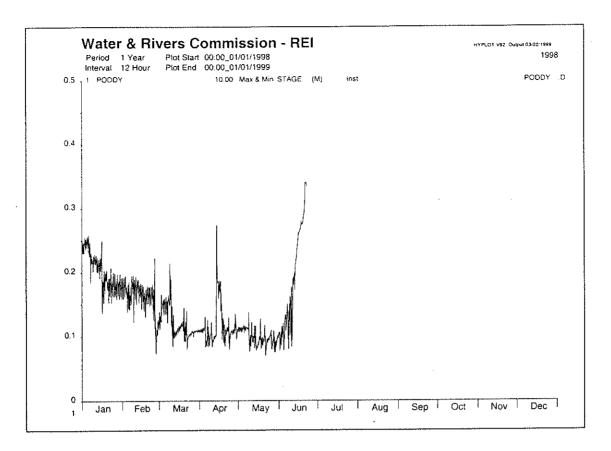
The data presented in these plots is raw data and has not been fully verified. Inparticular the datum changes several times, so the absolute levels recorded in each year may not be directly comparable. Until the data is processed using recommended methods it should be used with caution.

Water levels in Wilson Inlet vary considerably with seasonal conditions. Appendix B contains water level information for the Inlet from January 1994 to June 1998 that was kindly supplied by the Water and Rivers Commission. Although these water levels have not been adjusted to a recognised datum they do show a maximum variation over this time of approximately 1.3 metres. Maximum water levels in Wilson Inlet are artificially controlled through management of the sandbar at the Inlet's mouth.

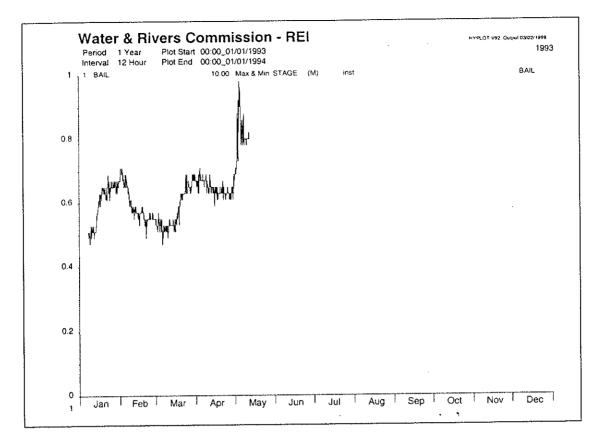
Note different datum and instrument.

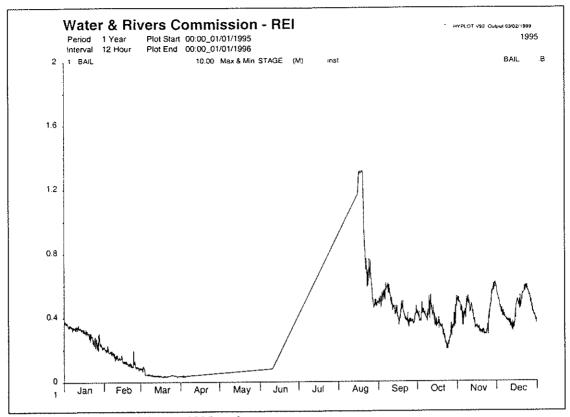
Note March 1195 - mid August 1995 no data.

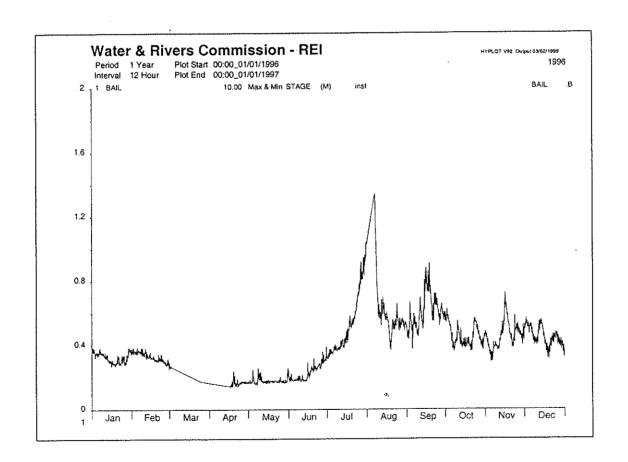
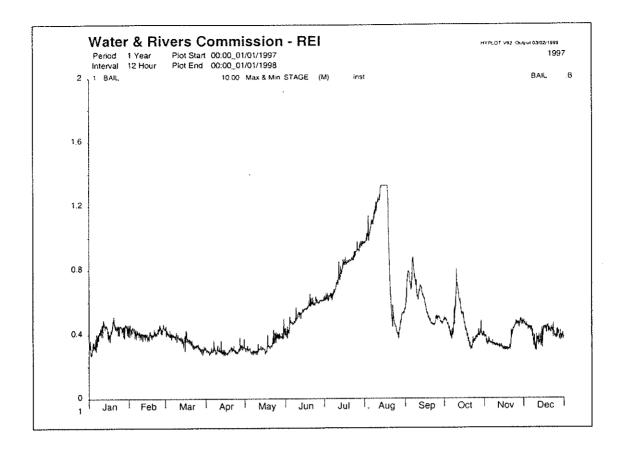
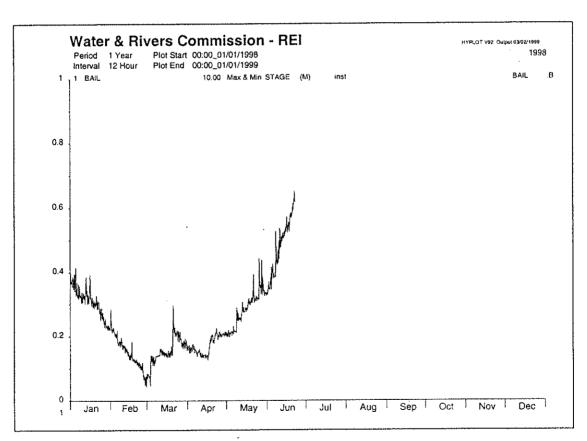
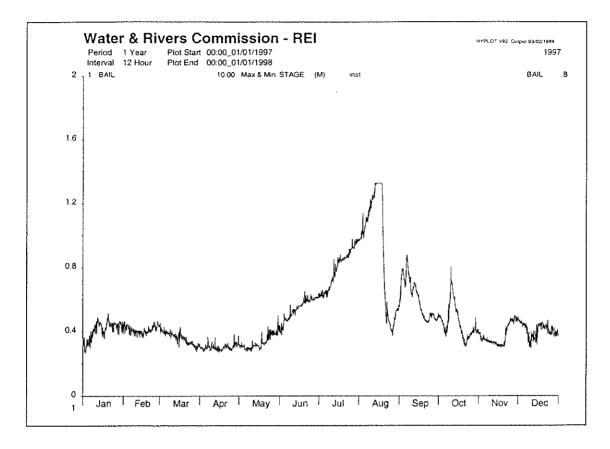
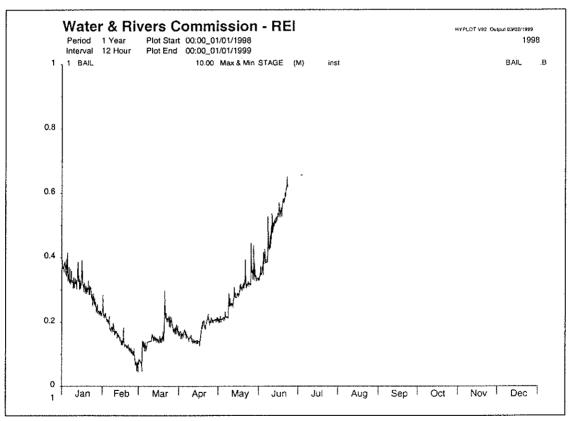
The data presented in these plots is raw data and has not been fully verified. Inparticular the datum changes several times, so the absolute levels recorded in each year may not be directly comparable. Until the data is processed using recommended methods it should be used with caution.
