Subject: Safety Inspection of Wentworth Road Dam, Plantagenat Lot 303

DENMARK SHIRE COUNCIL BRIEFING

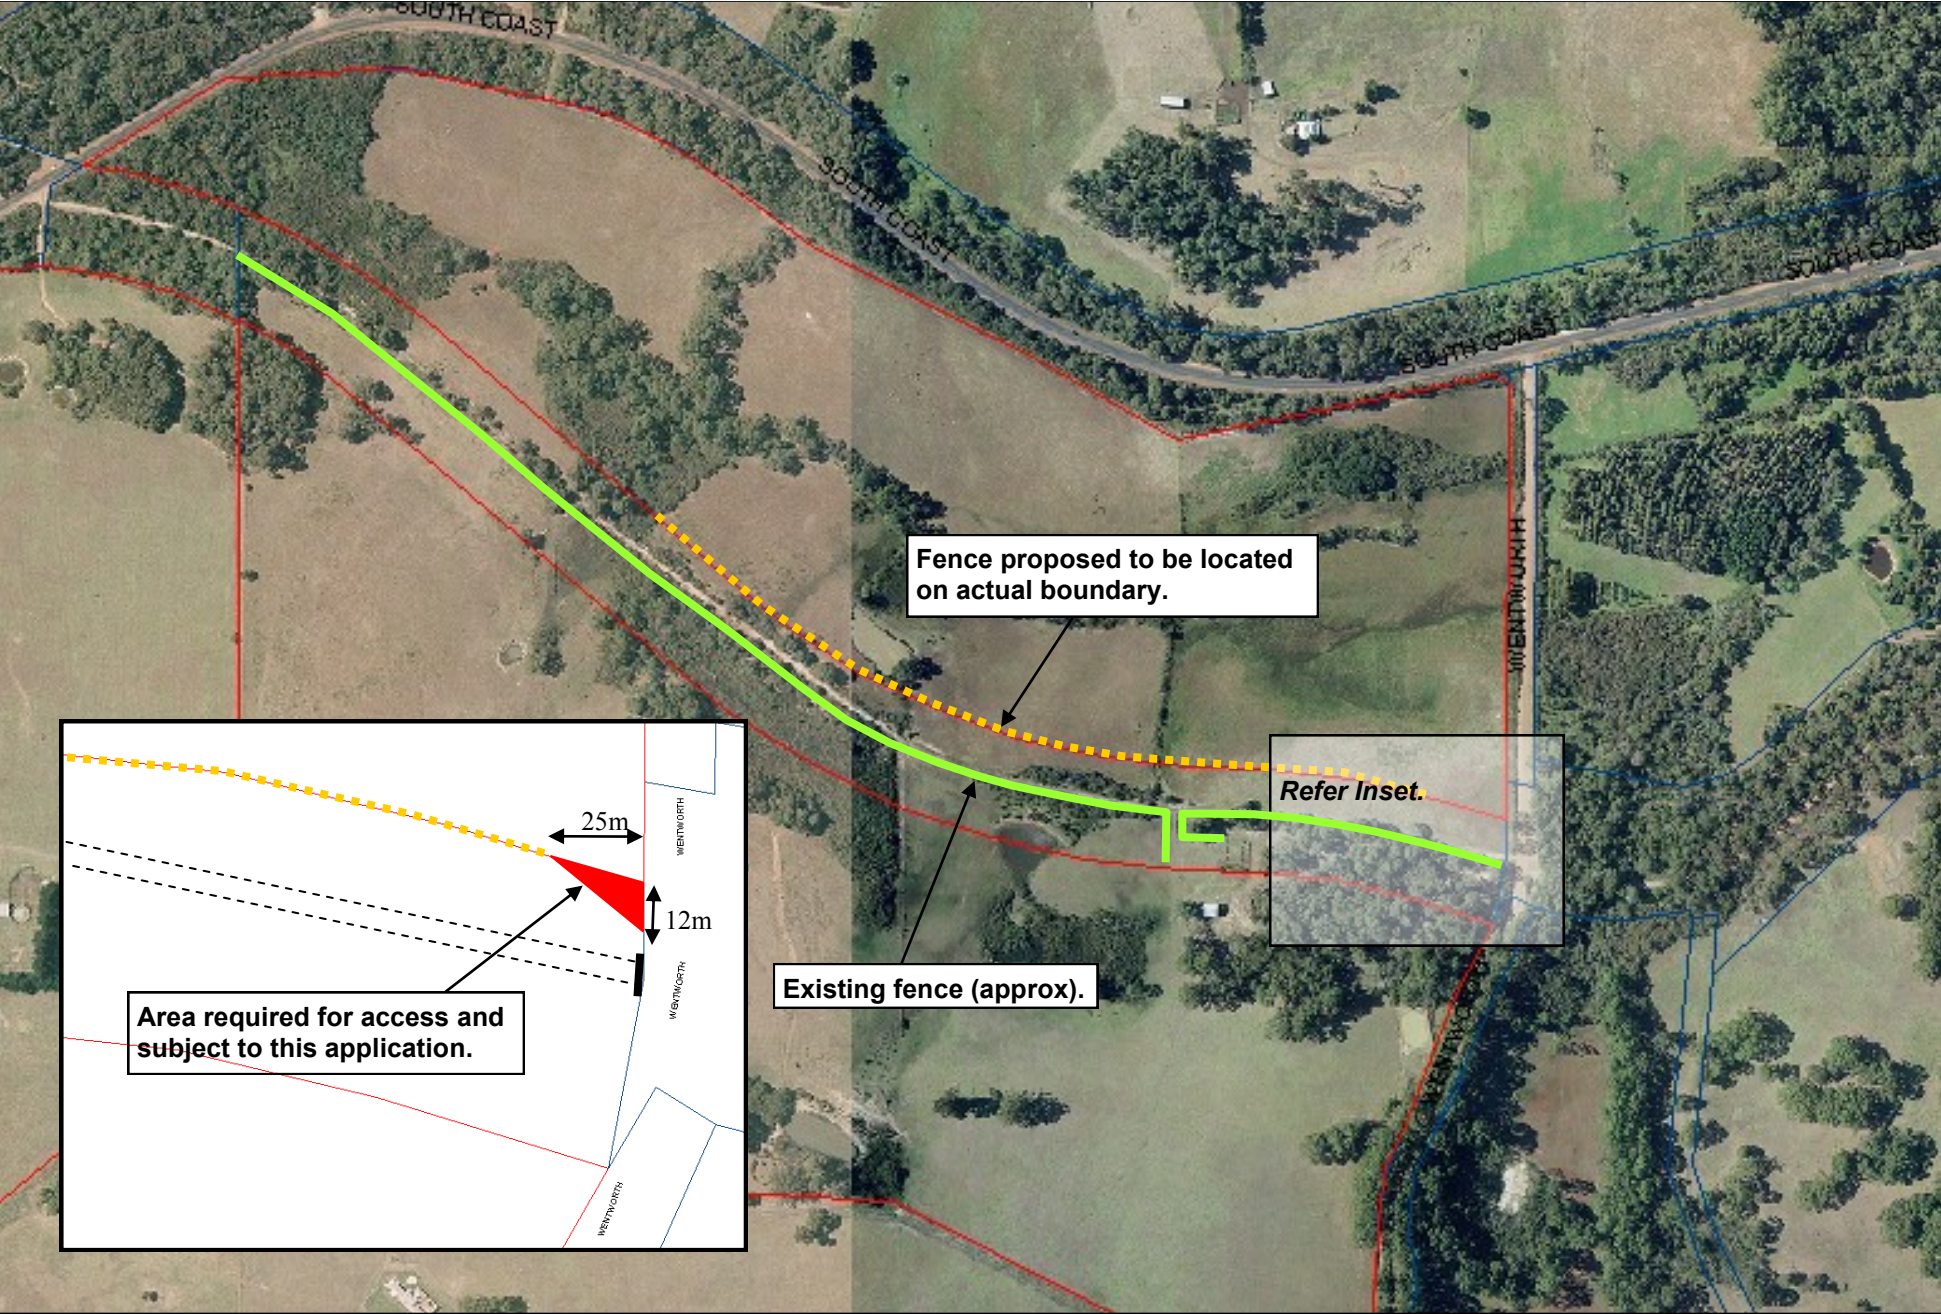
Fence proposed to be located on actual boundary.

Refer Inset.

Existing fence (approx).
