Foreshore Management Plan

**Springdale Beach Estate
Denmark**

Prepared for LWP Denmark Pty Ltd

Reference: W-A1207.00/004AN/ZA
Status: DRAFT5

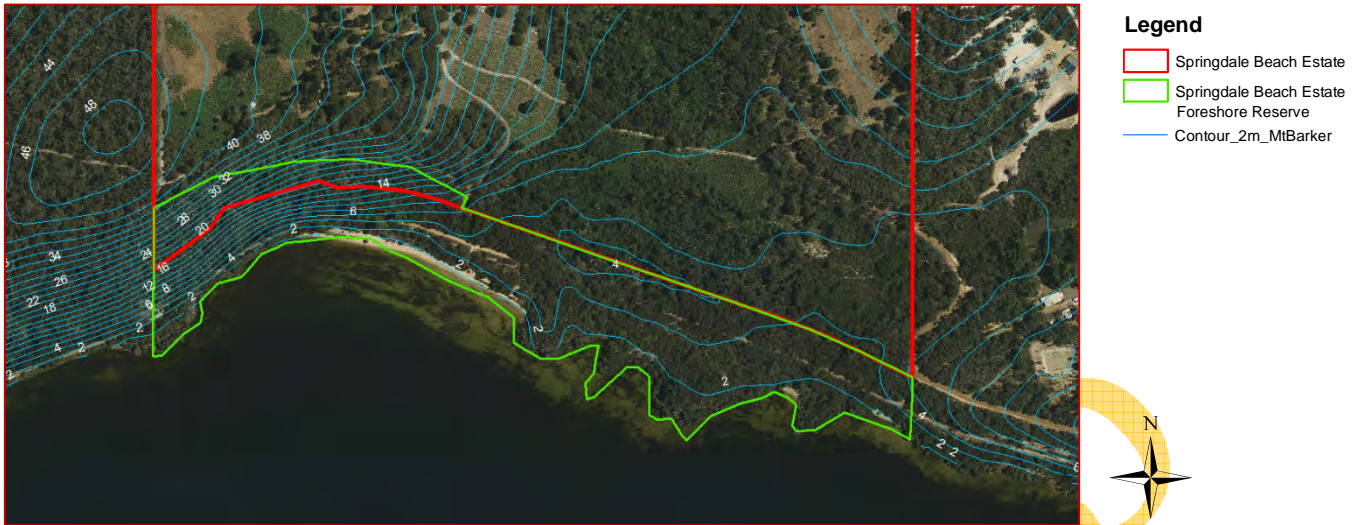
Figure 5 Topography within Springdale Beach Estate Foreshore Reserve (DAFWA 2 m contour dataset)

The highest elevation within the foreshore is located at approximately 38 m AHD on the western boundary. The lowest point is approximately 2 m AHD in the eastern boundary and water's edge (Figure 5).

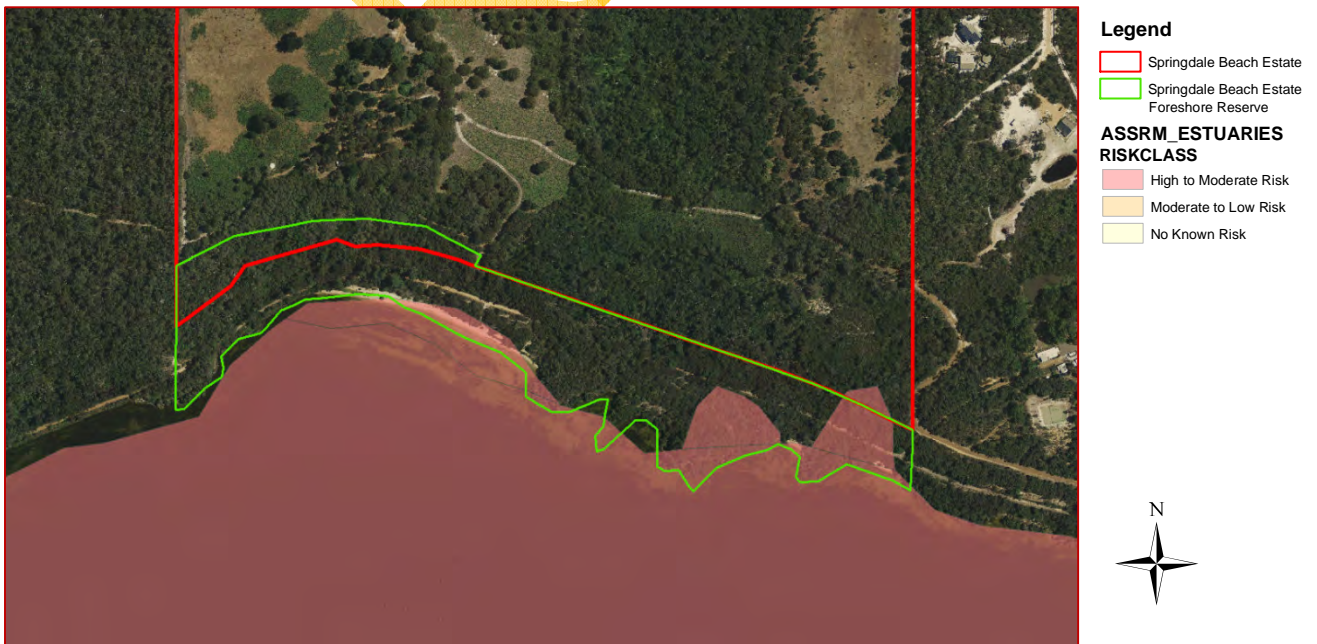
Figure 6 Desktop Assessment of Acid Sulfate Soil Risk of the Springdale Beach Estate Foreshore Reserve (DEC, 2006)

Limited Acid Sulphate Soil (ASS) Risk Mapping (WAPC, 2009) is available for the Denmark area however mapping has been undertaken for estuaries within this locality. Existing mapping indicates that Wilson Inlet, directly to the south of the site, has a high to moderate risk of ASS occurring <3m from the soil surface. There is some encroachment of this risk mapping into the foreshore area and the southeast corner of Springdale Beach Estate (Figure 6).

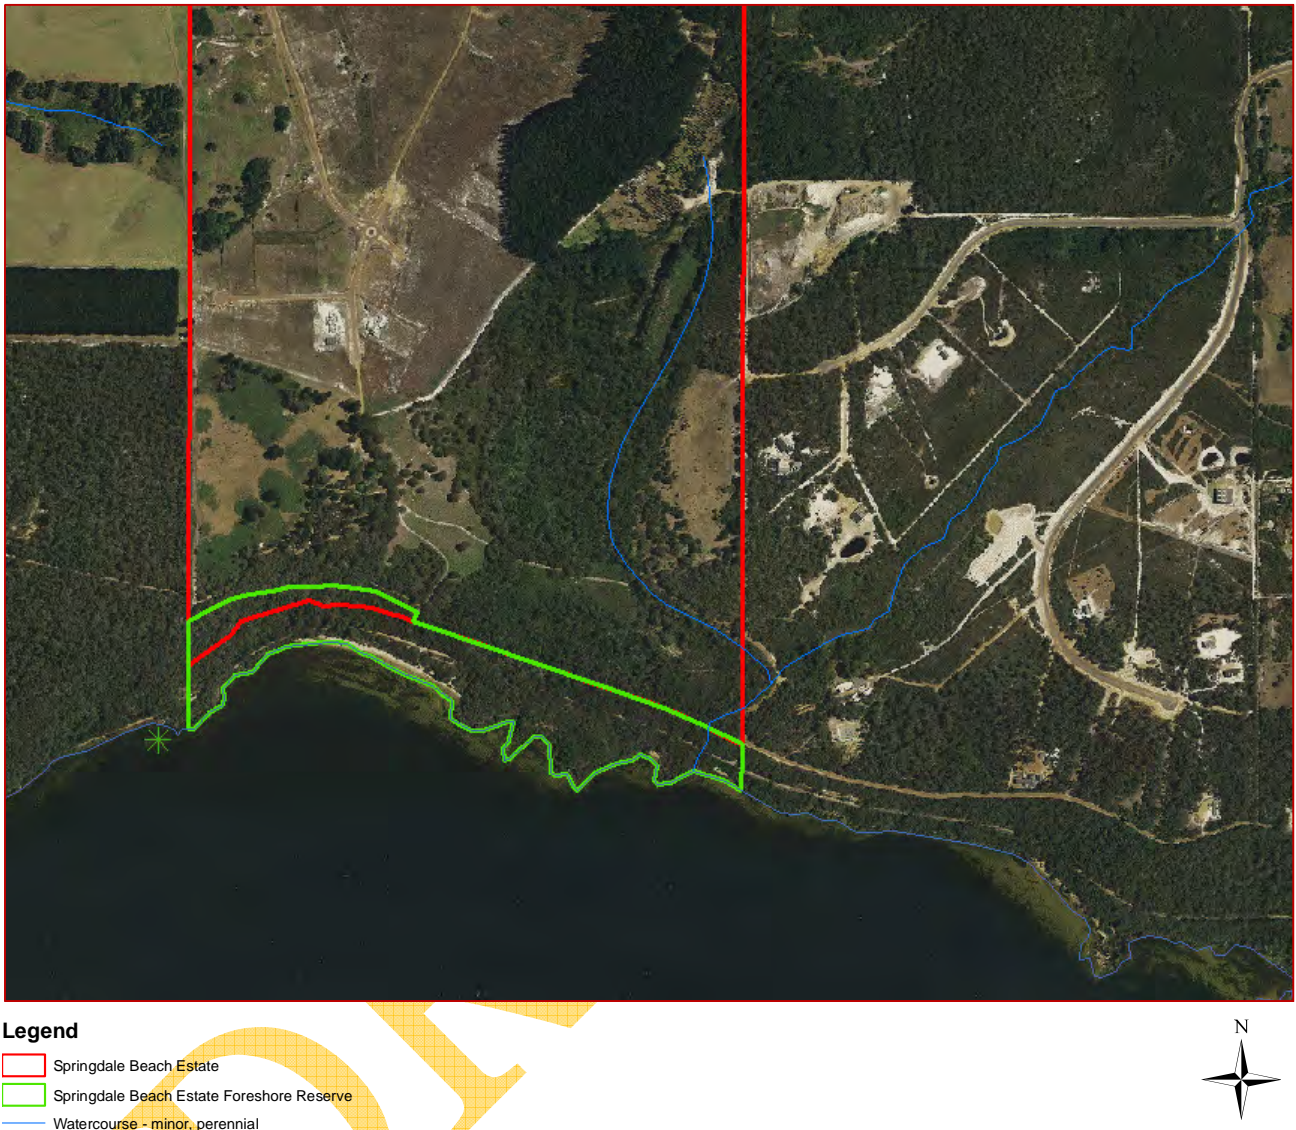
Figure 7 Desktop Assessment of Catchments (DoW, 2008)

The foreshore reserve is located within the Wilson Inlet Catchment in the Denmark Coast Basin, in the South West Division (DoW, 2008). Two natural drainage lines (perennial minor water courses) flow to and converge at the eastern end of the foreshore reserve (Figure 7).

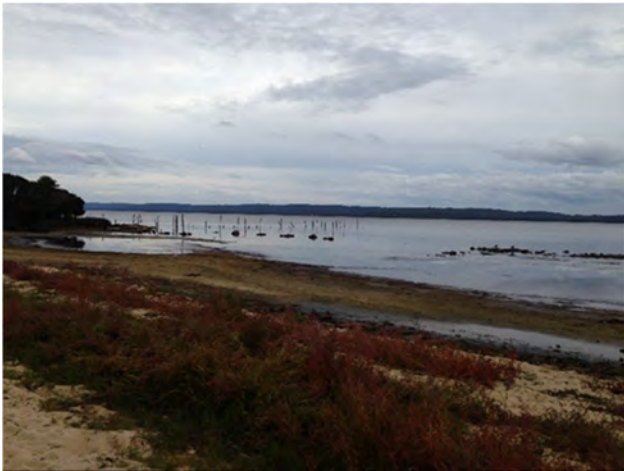
Plate 1 Weed invasion on Springdale Beach – view east to historical jetty

Further site inspection by Diane Harwood (Denmark Weed Action Group - DWAG) and Albert Adams (Ecologic Tree Services) in June 2014 noted that there are scattered seedlings of *Asparagus scandens*, *Phytolacca octandra* (Inkweed), *Watsonia* sp. and *Solanum laciniatum* (Kangaroo Apple) present. These species will require hand weeding in September / October following spring germination (Plate 1 to Plate 4).

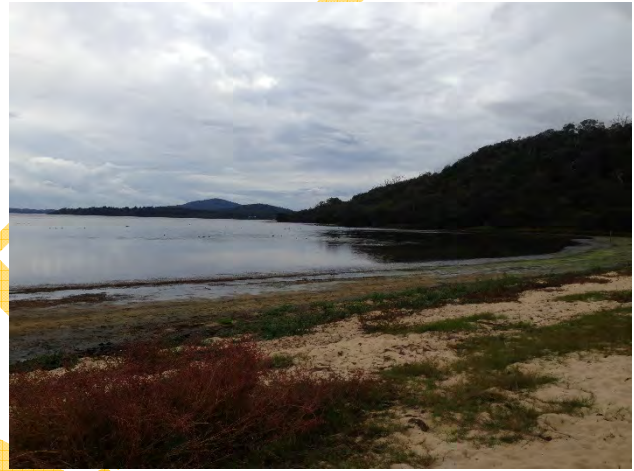
Plate 2 Weed invasion on Springdale Beach – view to western end of beach

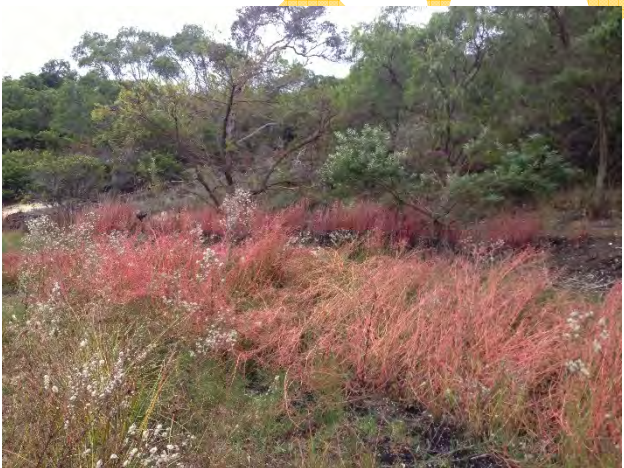
Plate 3 Weed invasion on Springdale Beach – view north

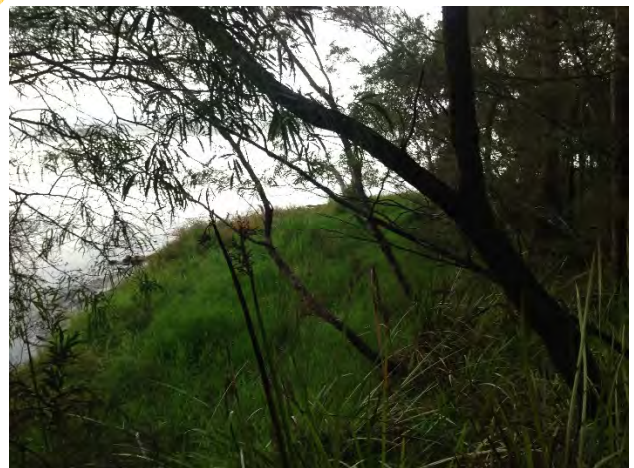
Plate 4 Weed invasion at western end of Springdale Beach – view south

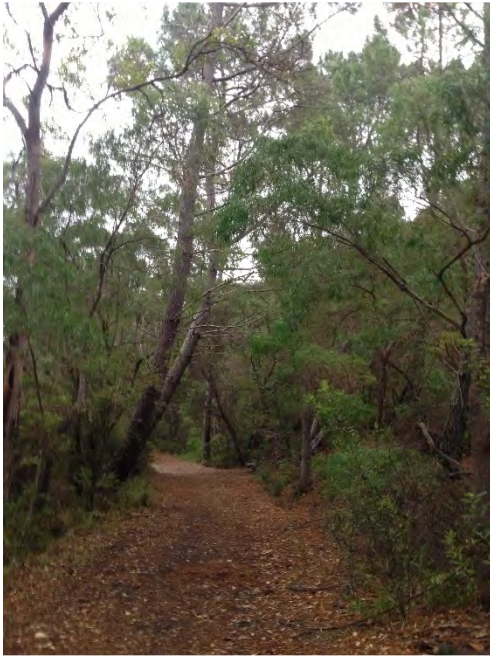
Plate 5 Pine trees on either side of the Heritage Trail view west

Specimens of the pine tree species *Pinus radiata* are located throughout the Springdale Beach Estate (due to previous land use as a pine plantation) and in a relatively localised area within the foreshore reserve. Pine trees have wind driven seed dispersal, which contributes to the large distances pine trees can invade into native vegetation. Approximately 20 pine trees of varying maturity are present adjacent to the Heritage Trail (Appendix C and Plate 6). At this location smothering of native vegetation by pine needles has occurred which may have resulted in erosion and land slip (Plates 5 and 6). It is recommended that all individuals are removed from the foreshore area to prevent further spread of pines and erosion.

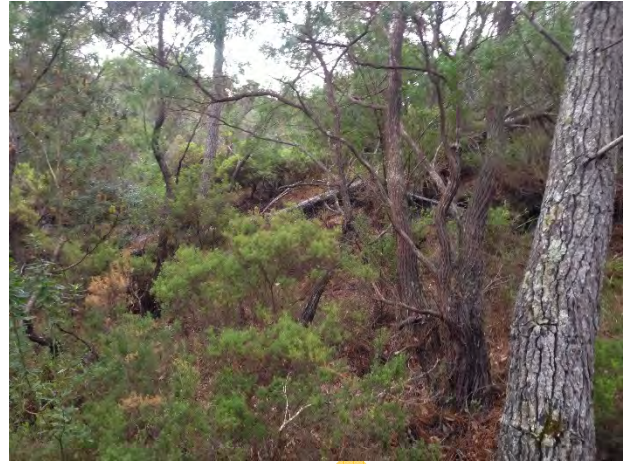
Plate 6 Land slip likely due to presence of pines on northern side of Heritage Trail

- Approximately 15-20 existing well established pine trees are causing a land slip of the upslope vegetation likely due to loss of native vegetation which stabilises soils as they have been smothered by pine needles. The Shire recommends the pine trees are removed.

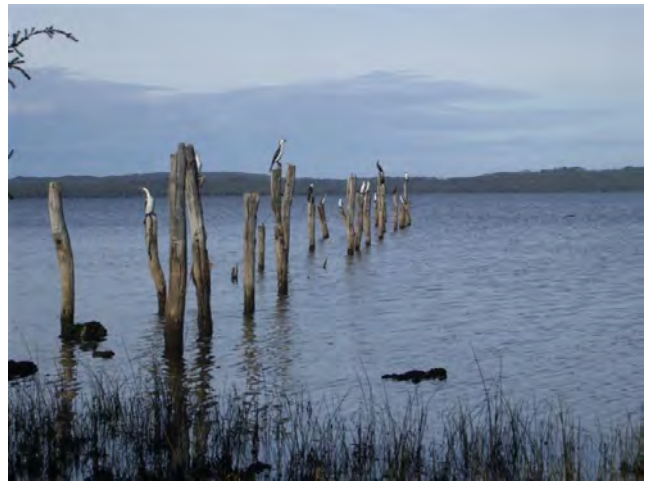
Plate 10 Remnants of the historical jetty

Springdale beach historically housed a jetty, which may have been used for Wilson Inlet fishermen and for people to visit the Springdale Beach from the water. This structure has not been maintained and now sits as a remnant in the foreshore area (Plate 10).

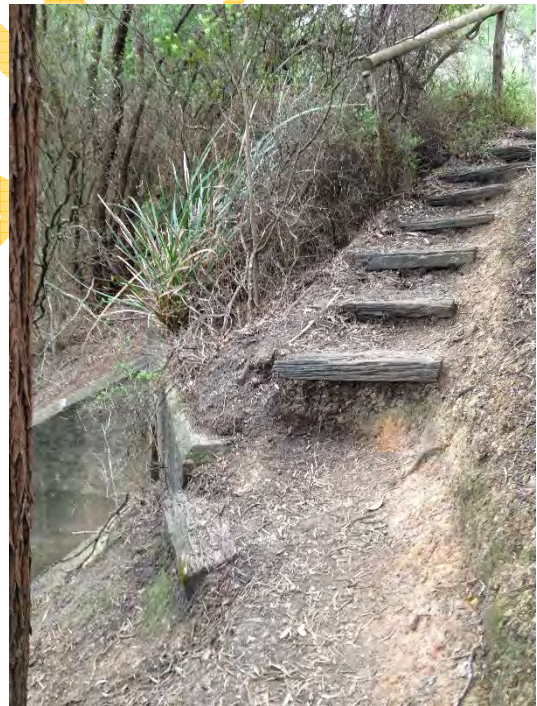
Plate 12 Access to the Springdale Tunnel to the south of the Heritage Trail requires upgrade of steps and handrail

The Springdale Tunnel is located at the eastern end of the Springdale Beach Estate foreshore reserve. Access to the Springdale Tunnel and adjacent beach, on the southern side of the Heritage Trail, is via a set of wooden steps with a partial handrail. These steps are in a degraded state and require refurbishment of the steps and handrail with similar materials.

15. Upgrade stairs and handrail at the Springdale Tunnel with similar materials.

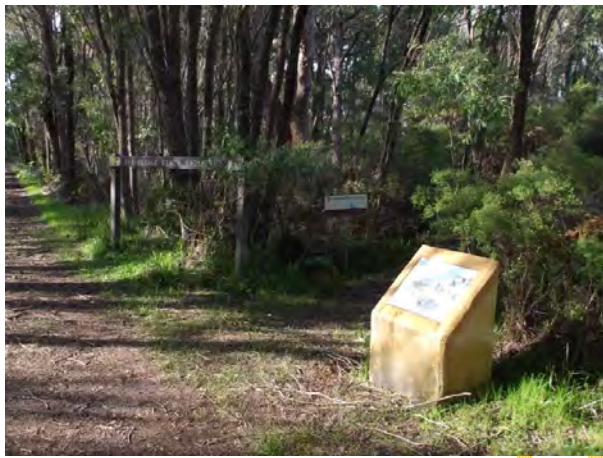
Plate 13 Access entrance to Heritage Trail shelter at Springdale Beach

A semi-formal access path leads from the Heritage Trail to the beach and Heritage Trail Shelter at the eastern end of the Springdale Beach (Plate 13). This trail is partially stepped towards the beach. Where the steps are in place the trail is in good order however towards the beach the trail widens with no formal direction and has become degraded at this location (Plate 14).

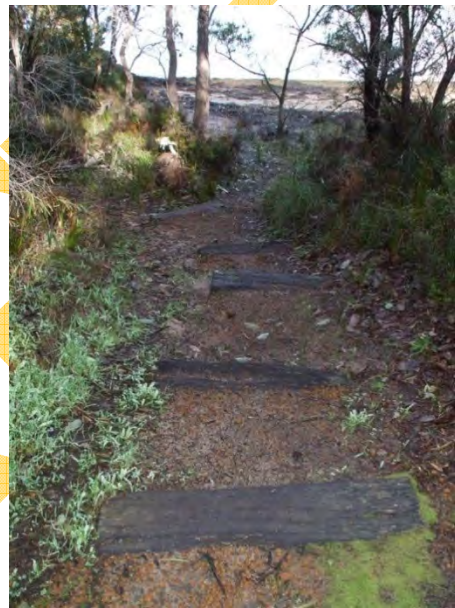
Plate 14 Stairs to the Heritage Trail shelter

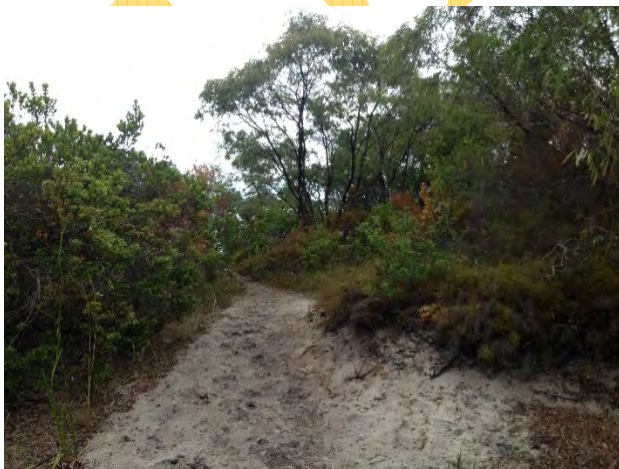
Plate 15 Well utilised but informal access trail to eastern end of Springdale Beach

Two well utilised, but informal, access tracks exist at both the eastern and western ends of the beach (Plate 15 and 16). Three of the other tracks are minor informal tracks and a well-established track at the eastern end of the foreshore leads to private property to the north of the Heritage Trail and is gated.

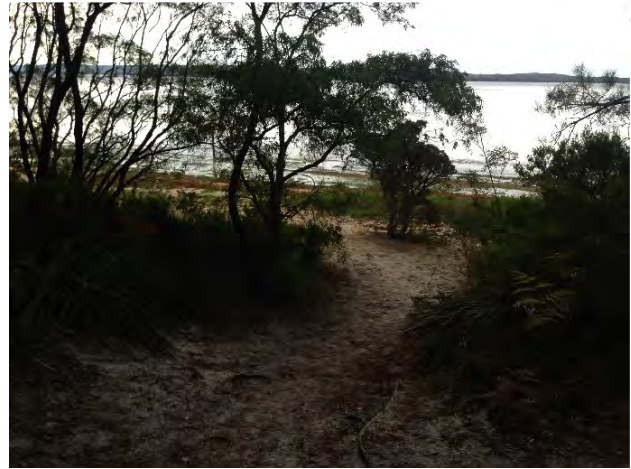
Plate 16 Well utilised but informal access trail to western end of Springdale Beach

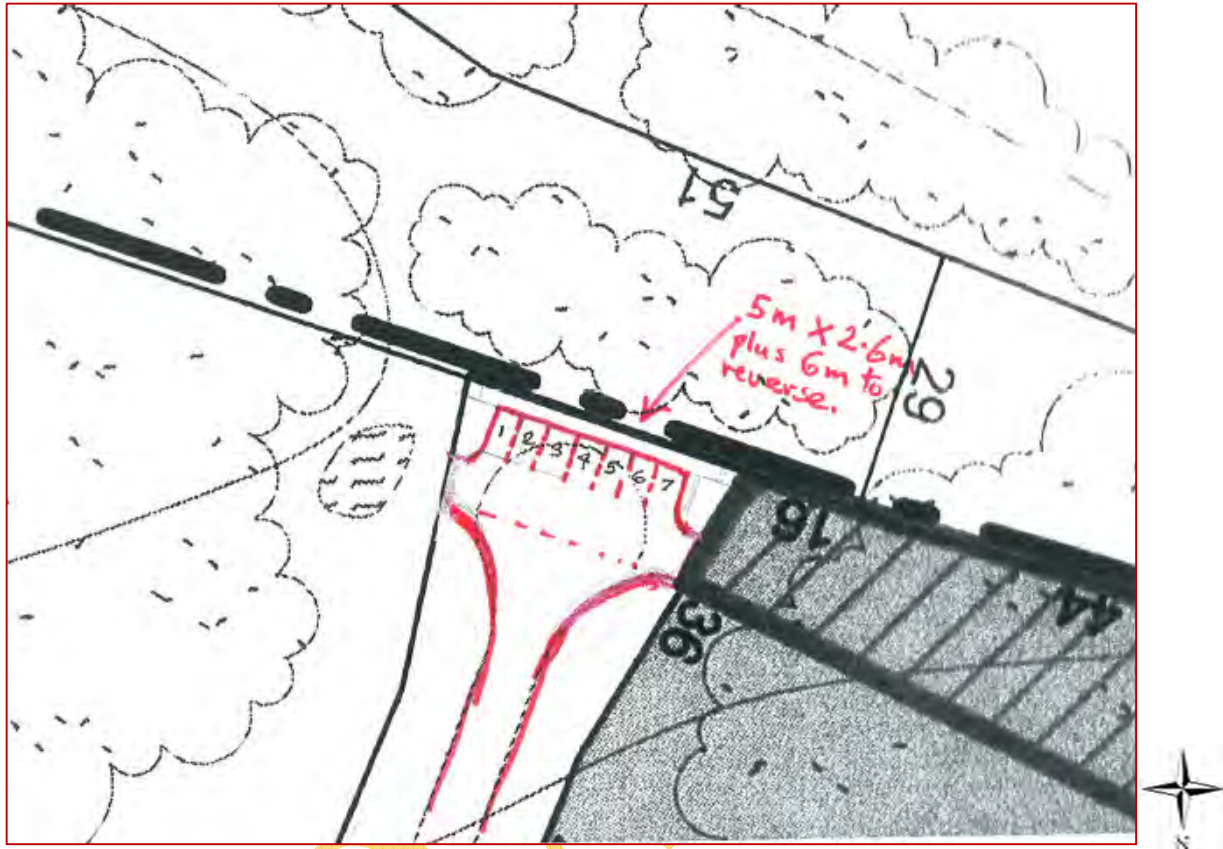
Figure 8 Indicative Location of Parking Bays at Cul-de-sac End of Beaufortia Gardens Road Reserve

Formal construction (i.e. sealed) of Beaufortia Gardens and footpath within the road reserve to the foreshore will be undertaken at the time of creation of the Tourist Site, Lots 181-183 or the balance of 5 years from the adoption of the FMP (whichever is earlier). At this time the cul-de-sac and parking bays will be sealed with provision of 6 - 7 bays (Figure 8). Until the Beaufortia Gardens road is sealed public access to the foreshore reserve will be provided via the current gravel road.
