SHIRE OF DENMARK REVEGETATION SITES

INFORMATION SHEET

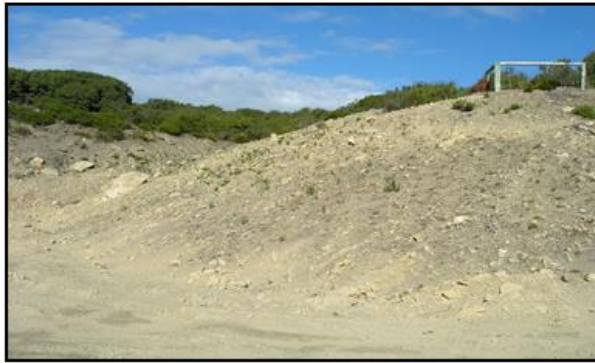
Ocean Beach Limepit upper slope
planted 2001, mid slope 2005

Good survival of seedlings

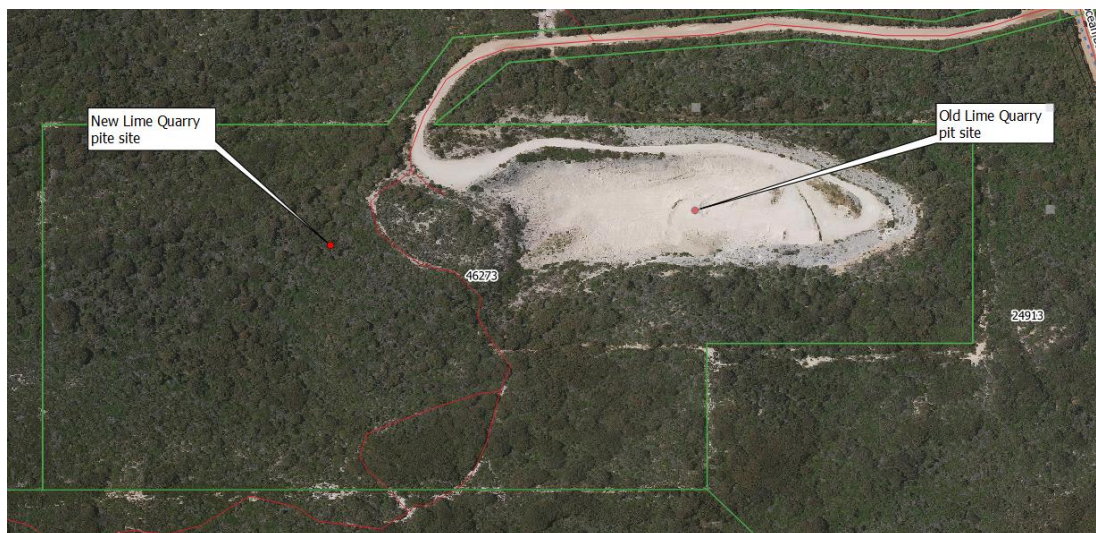
Lime Pit Quarry site showing old pit site - aerial 2014.

A total of seven sites have been revegetated in stages in the old lime quarry pit from 2000-2021, with two staged revegetation sites in the new lime quarry pit site from 2016-current. The old quarry pit site revegetated area totals 18,192 square metres, with the number of plants installed at the old quarry pit site totalling 20,814. The new quarry pit site revegetated area comprises 2300 sq metres with the total number of plants revegetated at the new quarry site totalling 1846. The total amount of seeds direct-sown at the lime quarry pit sites (old and new) totals 11.025kg.

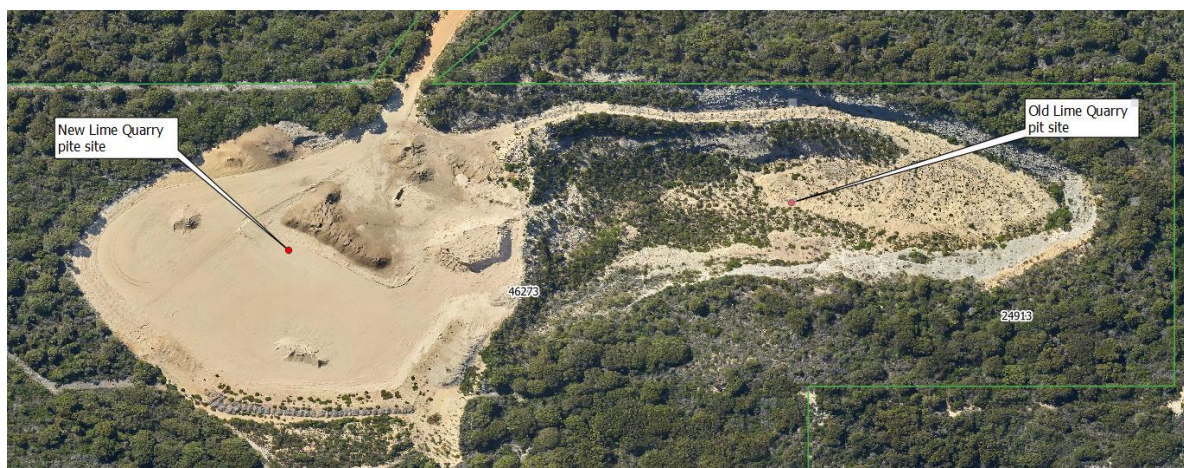
Lime Pit Quarry site showing new and old revegetated areas – aerial 2020.

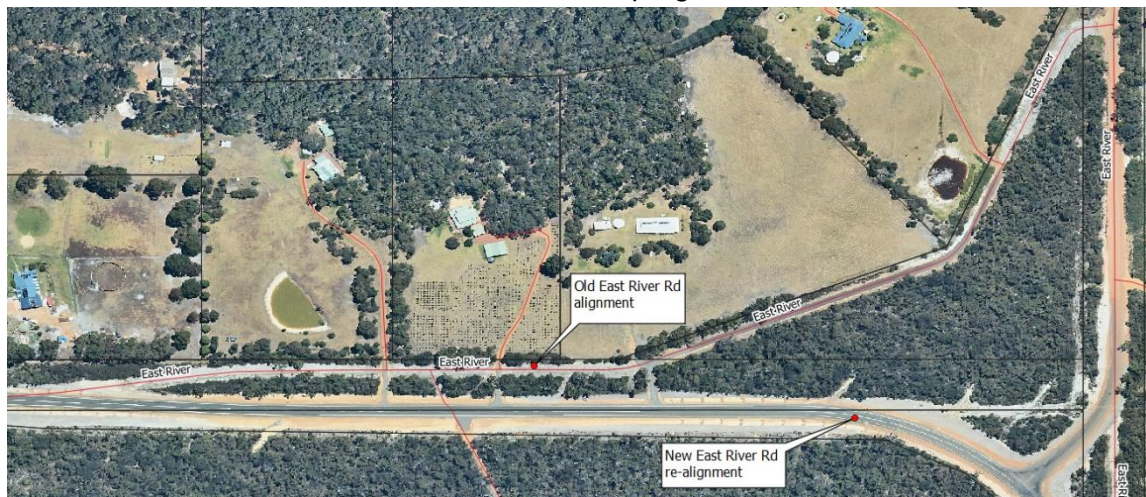
East River Rd re-alignment revegetation site – aerial 2021.

The total area to be revegetated totals 5600 square metres over four sections. 2.683kg of seed were sown by direct seeding in the first year with a total of 6877 seedlings planted over 2020-2021. WA College of Agriculture, Denmark, students were involved in the direct seeding in 2019 and planting in 2020.

The main issues at this site include poor sub-soil site preparation due to compaction by machinery, burial of rocks and sub-standard top-soil being spread. This was due to the stock-pile of top-soil being mixed with the McIntosh Rd top-soil which had a higher incidence of weed seeds. This was in part due to a contractor working on the site and the Shire had limited access and control of how the work was conducted and progressed.
