Ocean Beach and Peaceful Bay Shire of Denmark

Coastal Hazard Risk Management and Adaptation Plan

Seashore Engineering Pty Ltd
June 2018

Report SE050-01-Rev0

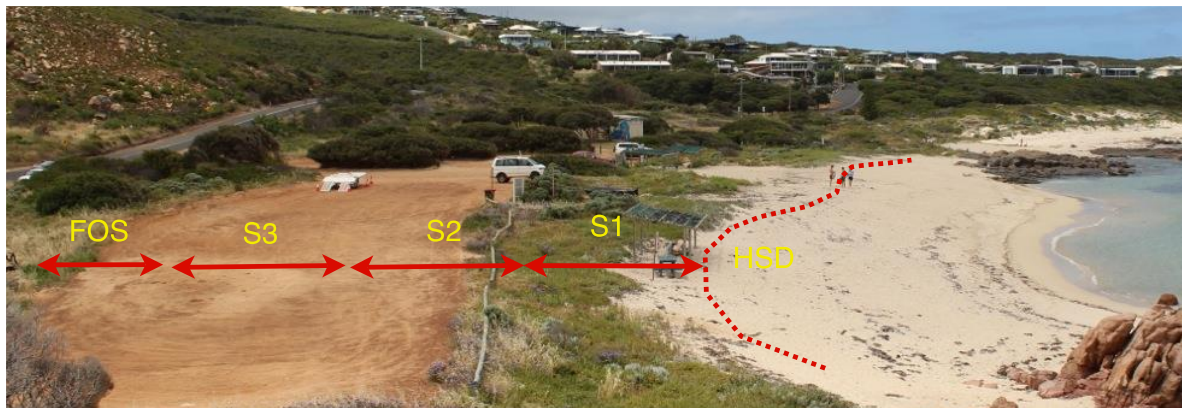
Figure 2.1 Representing Allowance for Erosion on Sandy Coast (incl HSD) S1 + S2 + S3 + FOS

The assumption underlying the mapping for the 10, 50 & 100 year are provided in Attachment B. The method and assumed coastal processes allowances for sandy coasts (S1 + S2 + S3) for the 10, 50 and 100 year planning periods for the project sites are shown in Figure 2.1 and detailed below.

Note: HSD – Horizontal Setback Datum, S1 – Allowance for Current Risk of Storm Erosion, S2 – Allowance for Historic Shoreline Movement Trends, S3 – Allowance for Erosion Caused by Future Sea Level Rise, FoS – Factor of Safety (Allowance for Uncertainty)

For sandy coastlines, SPP2.6 specifies allowance for erosion on sandy coastlines as outlined in Figure 2.1. For rocky coastlines, SPP2.6 recommends a geotechnical stability assessment be completed for assessing erosion risk, which is not within the scope of the current report, however, allowances have been made for slumping of vertical erosion scarps.

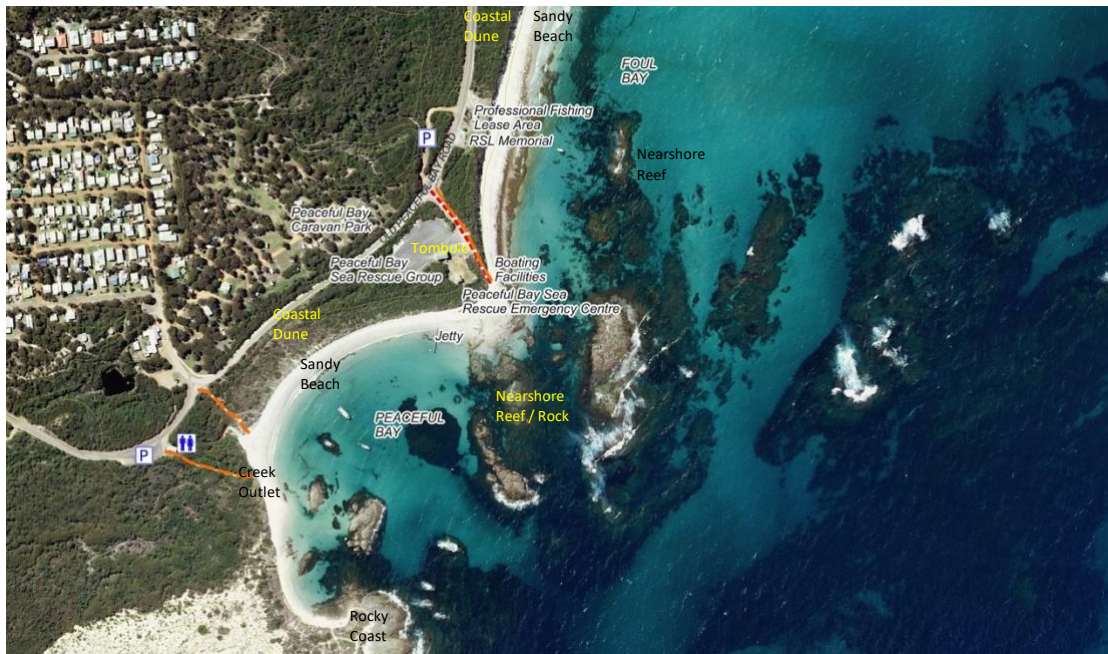
Figure 2.3 Peaceful Bay Coastal Landforms

- Sandy beach of Peaceful Bay, with a crescent shaped planform. Sand at Peaceful Bay and Foul Bay is predominantly fine white marine sand with a median grain diameter of 0.2mm (see Figure 2.4).
- Rocky coastline to the south, which provides a local control.
- Coastal dunes including:
 - Incipient foredunes along Peaceful Bay subject to cycles of erosion and recovery, and primary dunes up to 5m in height.
 - Eroding primary dune along Foul Bay. The height of the dunes is ~6m AHD, which is 4m above the level of the beach.
- Nearshore rock and reef and an associated large salient or tombolo¹ in the vicinity of the boating facilities, which separates Peaceful and Foul Bays.
- Nearshore reefs which provide sheltering and localised wave refraction, including the shoreline planform locally.

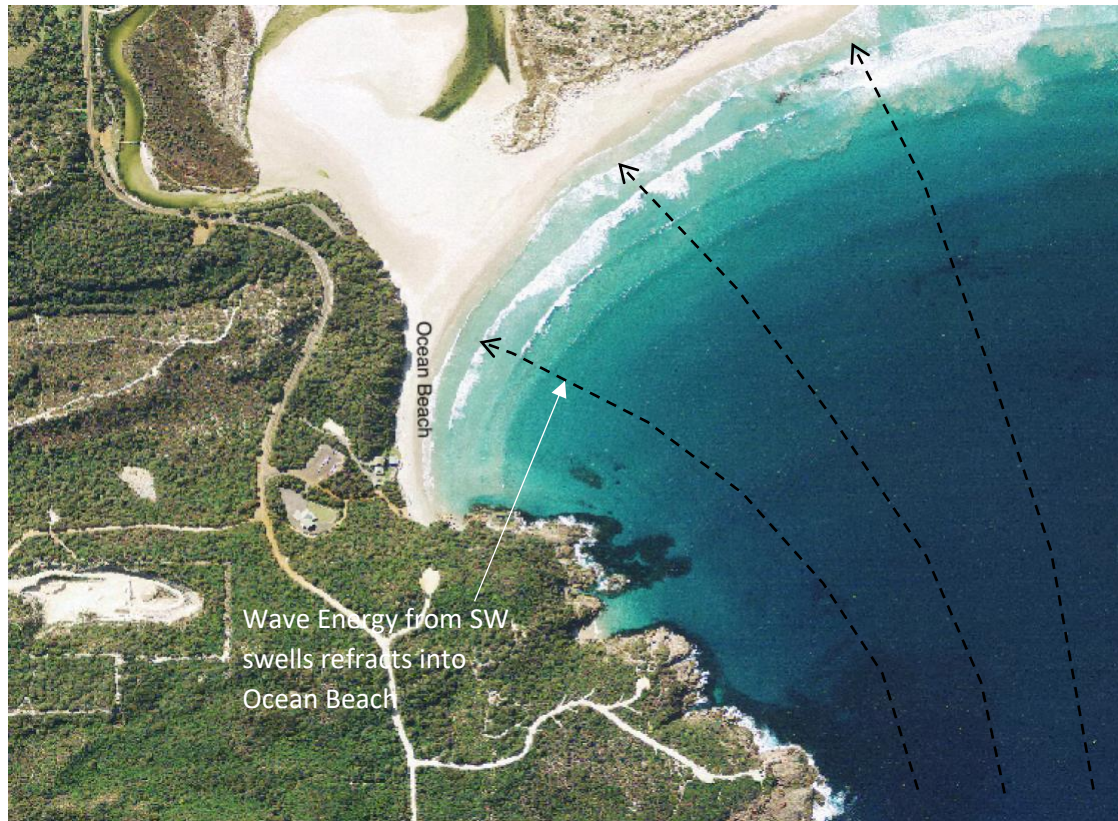
Figure 2.9 Refraction of Waves into Ocean Beach (September 2010)

Ocean Beach is an east facing beach at the western end of an exposed high wave energy beach. Some sheltering is afforded Ocean Beach through dissipation of wave energy from SW and SSW swell energy as it refracts around Wilson Head, which was illustrated by modelling undertaken for the Ocean Beach Alternate Boat Launching Facility Study [7]. However, the beach is exposed to sea waves produced by local winds from the E to S. Figure 2.9 Illustrates the refraction of waves into Ocean Beach.

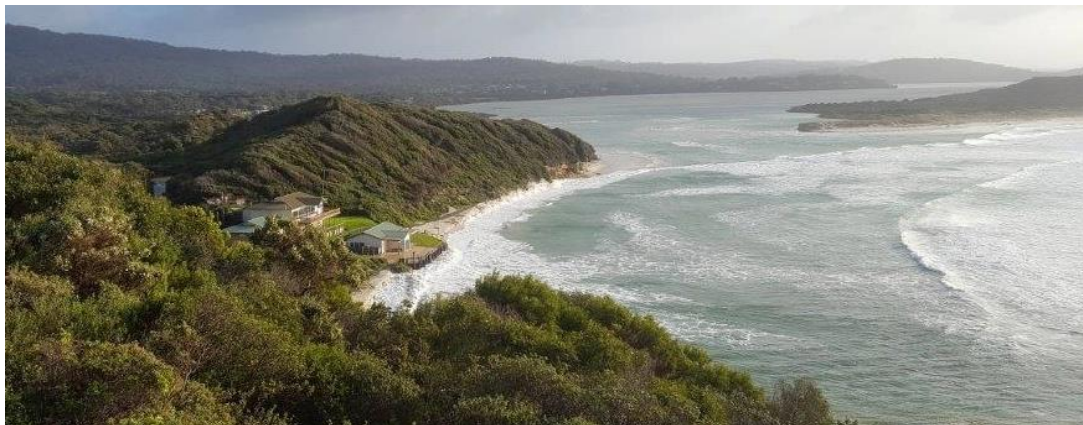
Figure 2.12 Ocean Beach During Storm (Sep 2016) – Supplied by Shire of Denmark.

The focus of the coastal hazard assessment at Ocean Beach is on the 400m stretch of coastline between the granite rock outcrops and the entrance to the seasonally open Wilson Inlet where the majority of the coastal assets are located. As outlined in Section 2.2.1.2 this section of Ocean Beach is east facing and is exposed to locally generated easterly seas and refracted swell energy, which is predominantly from the SW and SSW. This makes this stretch of beach vulnerable to periodic erosion events associated with large storms, as was the case in the late 1990’s, 2013 and 2016.

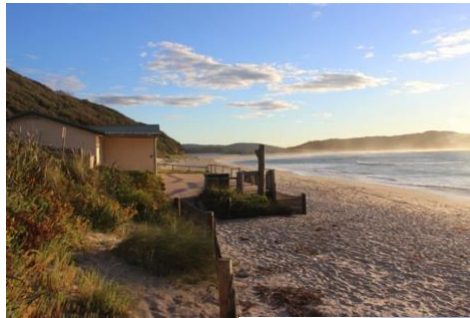
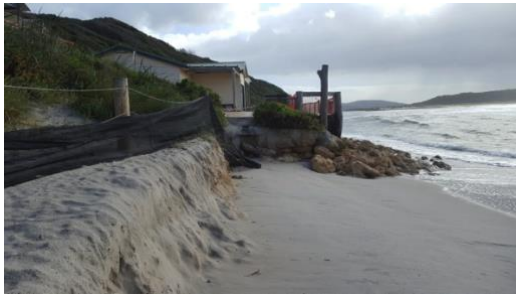
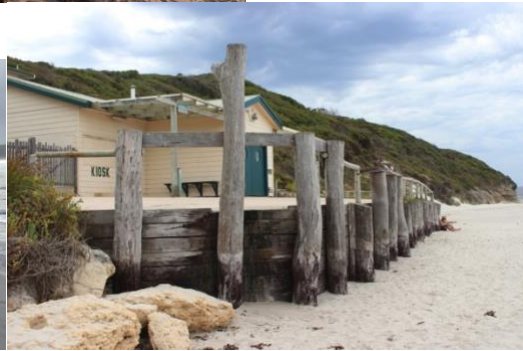
Figure 2.13 Erosion Event at Ocean Beach Timber Retaining Wall Pre (SE top June 2016) During (August 2016) and Recovered (March 2017)

The Shire provided site photos from a storm erosion event in August 2016 that damaged beach access ramps and stairs. Meteorological records indicate the storm was associated with a low-pressure system passing directly over the site. Storm erosion of beaches often occurs during elevated water levels (high tide coincident with storm surge). Water level records from Albany identified a moderate storm surge that may have coincided with high tide as it passed over Denmark. Wave heights and directions were not recorded in this event. Based on site photos, near vertical erosion scarps larger than 2 meters in height were observed (Figure 2.13). This provided some local context to the modelling of the current risk of storm erosion, although survey was not available to verify the model for this event.

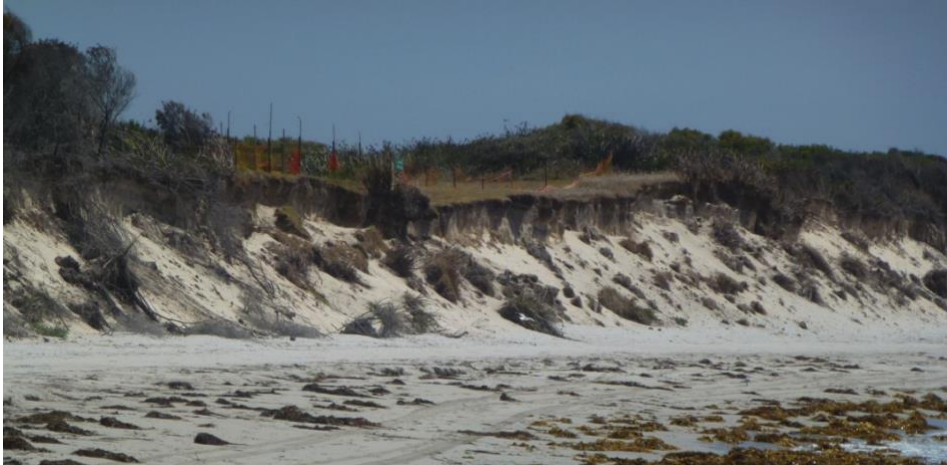
Figure 2.16 Peaceful Bay (Foul Bay) – Erosion Near Fisherman’s Lease Area (SoD)

Peaceful Bay is a small coastal settlement in the west of the Shire. A small sheltered pocket beach provides a relatively calm swimming beach and beach launching for recreational vessels, and there is a longer eroding sandy beach to the north. There appears to be significant gaps between erosion events as incipient vegetation is evident at the toe of the dune in many site photos.

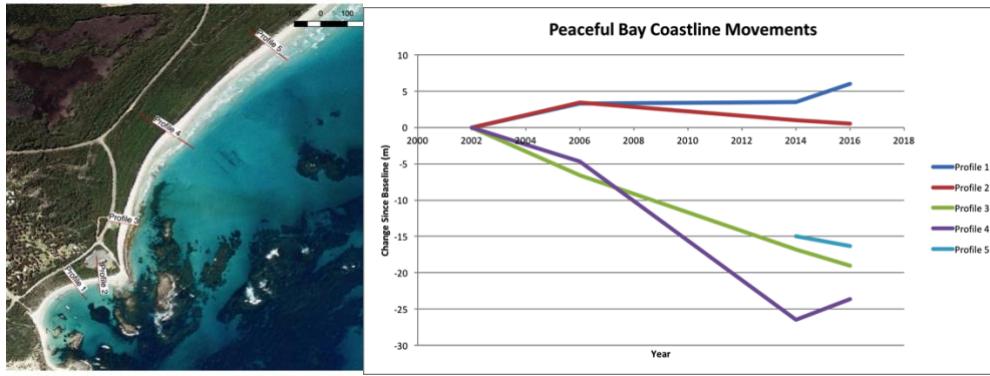
Figure 2.17 Peaceful Bay – Historic Shoreline Movement Trends

The historic shoreline movement trends have been assessed based on aerial imagery provided by the Shire from 2002, 2006, 2014 & 2016. The following was noted based on the assessment of 5 profiles:

- The jetty/swimming beach has been relatively stable since 2002 due to rock headlands providing a stable shoreline.
- The vegetation line has eroded between 16 and 24 meters north of the boat ramp within Foul Bay since 2002. Erosion and/or removal of a number of structures is evident in the aerial photography. Whilst erosion is expected to be associated with storms, and there is capacity for the dunes to recover between events, a net erosion trend in the order of 1.4m/yr. was observed.

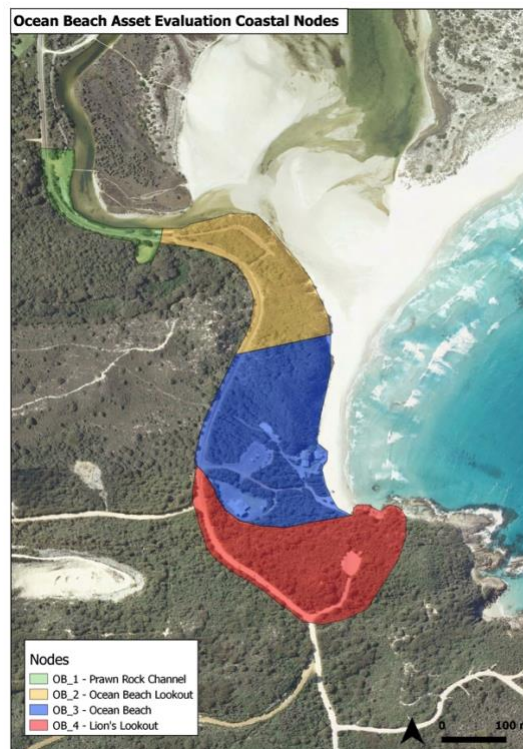
Figure 3.1 Ocean Beach Coastal Nodes

Four coastal nodes were identified at Ocean Beach based on coastal type and the location of public infrastructure. These coastal nodes are Prawn Rock in the north, Ocean Beach Lookout, Ocean Beach and Lion's Lookout in the south. The delineation of the coastal nodes is shown in Figure 3.1.

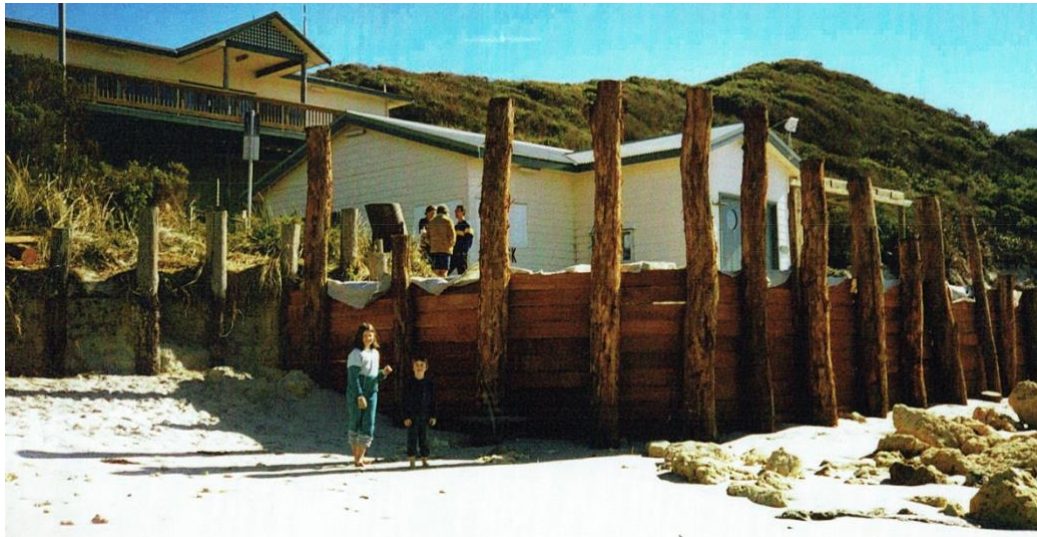
It is acknowledged that work has been undertaken by the club over many years to stabilise the grassed area in front of the original club building with the installation of a timber retaining wall constructed from timber piles, horizontal boards and rock spalls at the toe. From initial inspection and review of historic photographs this structure appears to be in reasonable condition. However, further engineering consideration is required to determine longevity of this solution, with this type of vertical structure generally being dependent upon the adjacent beach levels for its stability. An engineering inspection and maintenance regime is required for this structure going forward.

Figure 5.3 Timber Retaining Wall in front of the Ocean Beach SLSC Buildings (date unknown, courtesy of the Denmark SLSC)

- Inspection and maintenance of the timber retaining wall is required to provide COASTAL PROTECTION to the SLSC boat shed and adjacent landscape areas, and allow the Shire to provide beach access either side of the wall. Whilst the relocation of buildings reduces the value of assets exposed to coastal processes, PROTECTION in some form is likely to be required in the longer term. In particular:

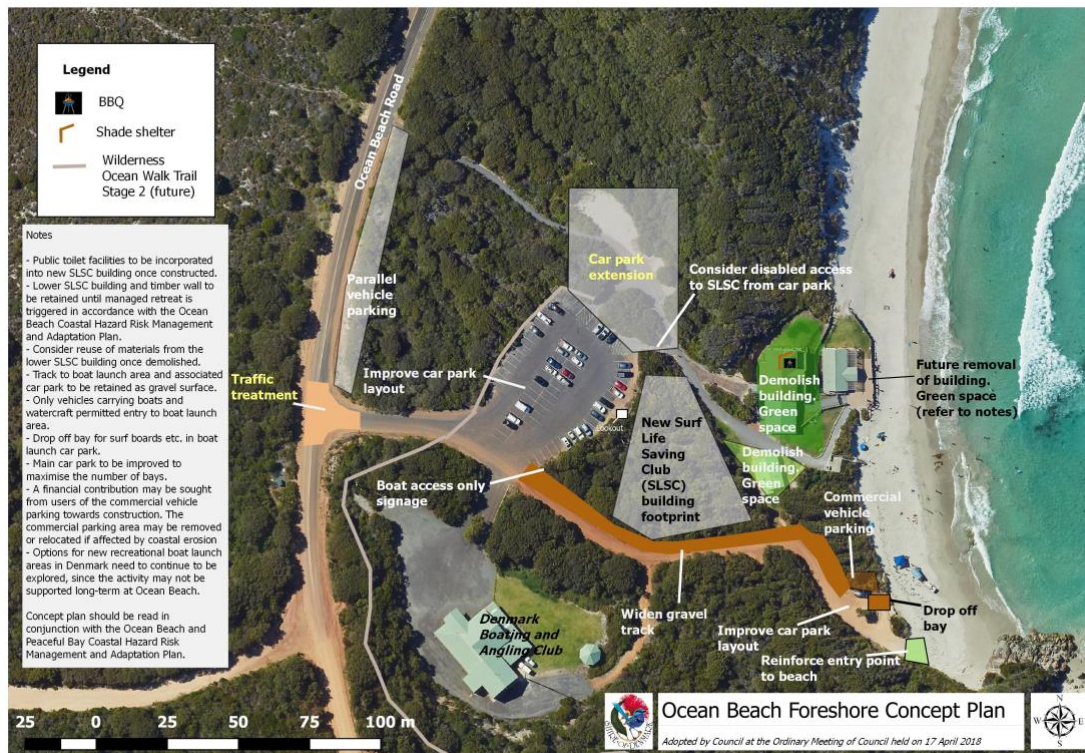
In general, the principles of the State Coastal Planning Policy should guide future development. The future provision of *public recreational facilities with a finite lifespan* is accepted under SPP2.6 provided adequate hazard risk planning has been undertaken and that new structures are removed or modified if threatened by erosion. The general principle would be to, where practicable, avoid the potential future impact of coastal processes for the design life of the asset. This would generally preference siting of assets in the areas with lower exposure to coastal process where practicable. However, the suitable design and monitoring of beach access will continue to be required.

Figure 5.5 Ocean Beach 10 year Foreshore Concept Plan

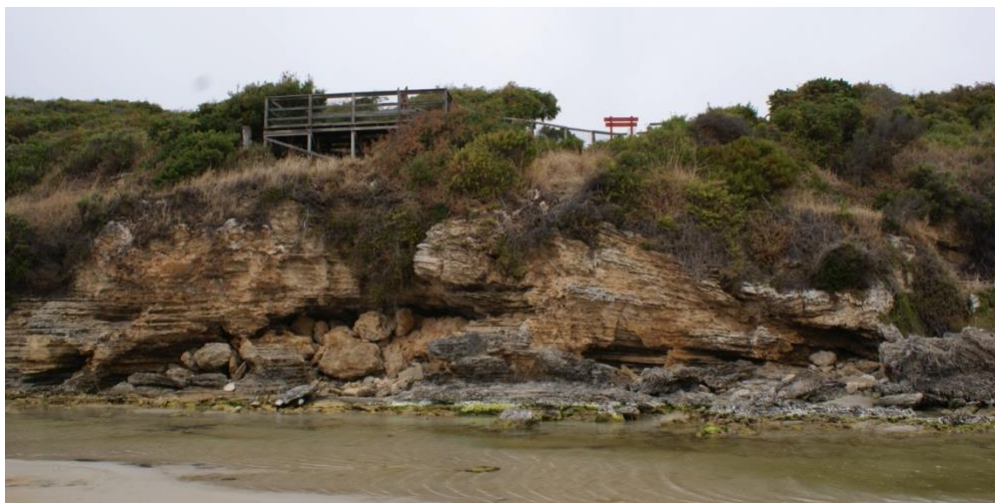
- Lookout Beach Access – The Shire planned to install stairs to provide access to the beach from the Ocean Beach Lookout car park. This will require consideration of the stability of the limestone cliffs and appropriate siting of the access stairs to reduce the risk of failure of the stairs due to cliff collapse or beach erosion.

Figure 5.8 Weakly Lithified Sedimentary Rock Coast adjacent to Ocean Beach Lookout

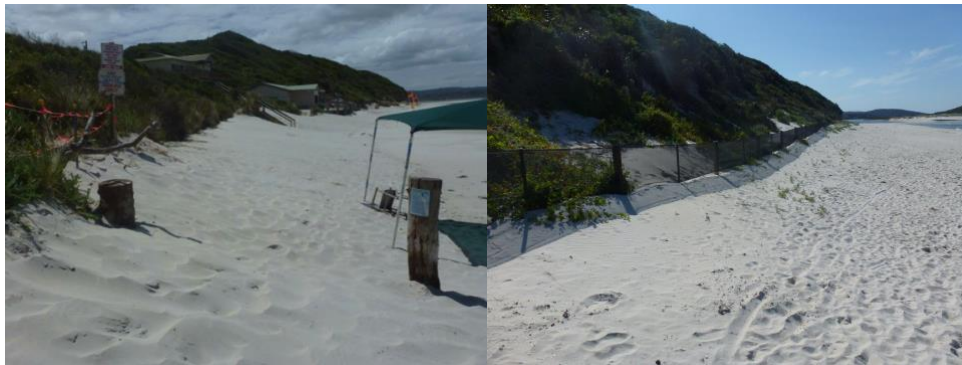
There are also a range of short-term adaptation options that can be considered by the Shire. These include beach nourishment as has occurred previously at Ocean Beach to reinstate foredunes at the back of the beach. Management of pedestrian access of coastal dunes also ensures existing dune buffers are maintained or enhanced prior to coastal storms. Existing voluntary dune revegetation and rehabilitation should continue to be supported, to assist foredune protection and post-storm recovery

Figure 5.9 Coastal Adaptation Responses including Sand Nourishment and Dune Rehabilitation
