# PEACEFUL BAY HERITAGE PRECINCT

## CONSERVATION PLAN

PREPARED BY DAVID HEAVER AND ASSOCIATES ARCHITECTS  
FOR THE SHIRE OF DENMARK

DECEMBER 2003

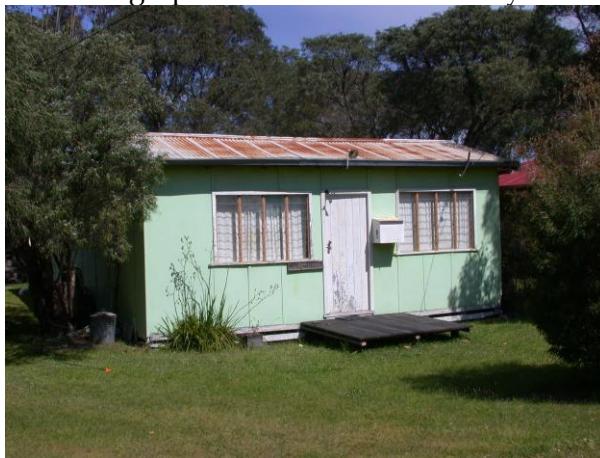
**Photo 3** Typical gable cottage

The simple platform outside the front door has been introduced and is in keeping with the minimal detailing in the precinct.

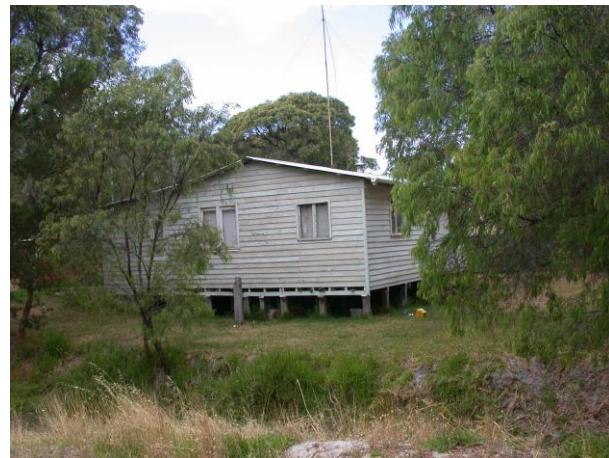
**Photo 4** Timber clad gable without verandah

The skillion addition to the rear has been added. This house is located on East Avenue—note the native vegetation behind the house.

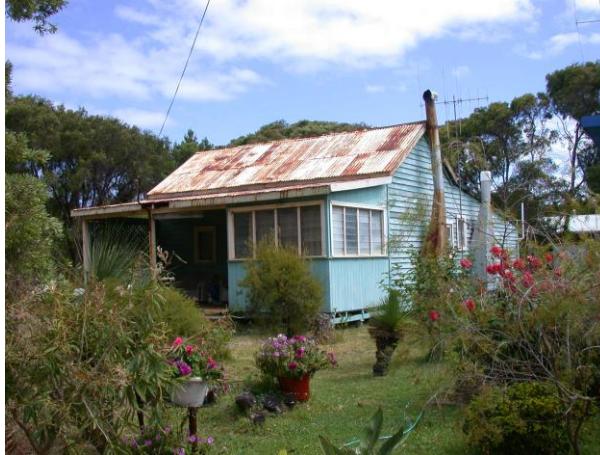
**Photo 5** Jarrah clad mill cottage

The sleepout is considered to be an authentic element.

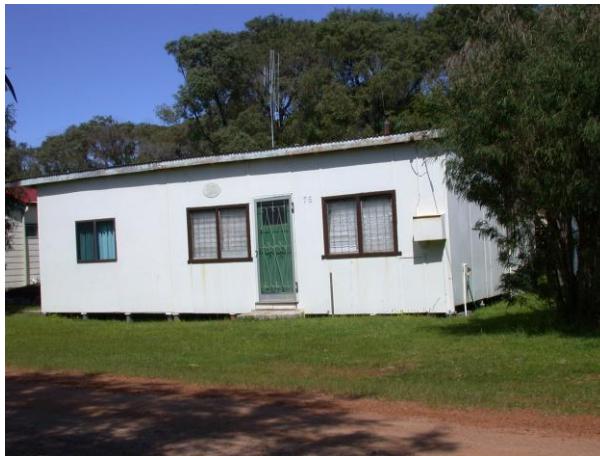
**Photo 7** Shallow pitched skillion

The room to the left is an addition.

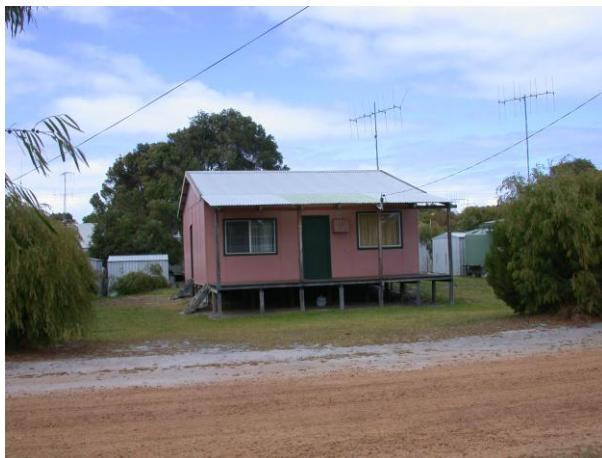
**Photo 9** Typical fibro clad gable cottage  
The verandah has been added.

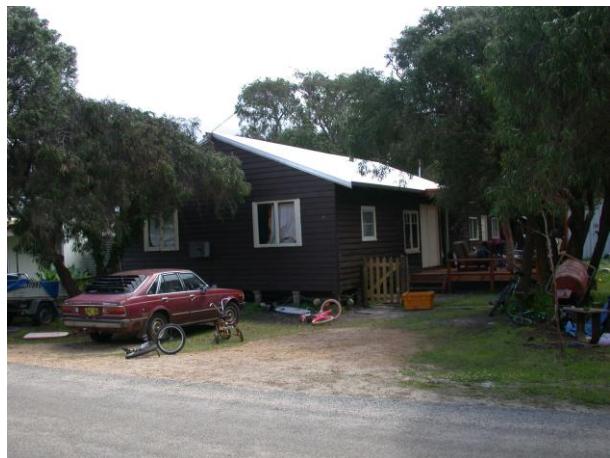
**Photo 10** Typical jarrah mill house  
Appropriately maintained and refurbished.  
The introduced platform deck is simple and  
has no decorative elements or balustrading.

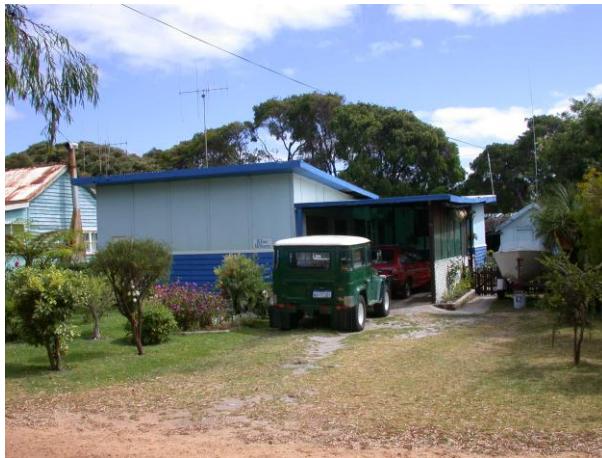
**Photo 11** Skillion roofed jarrah and fibro house  
The simple carport is in keeping with the aesthetic of the precinct.

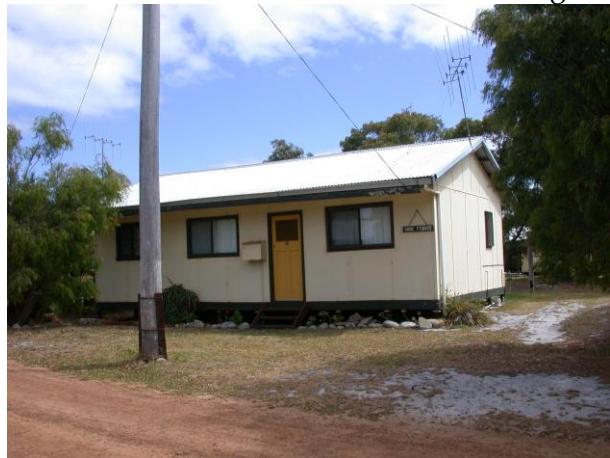
**Photo 12** Typical fibro gable

This form is very common in the precinct. This is a three bay example. The room to the left is probably an addition.

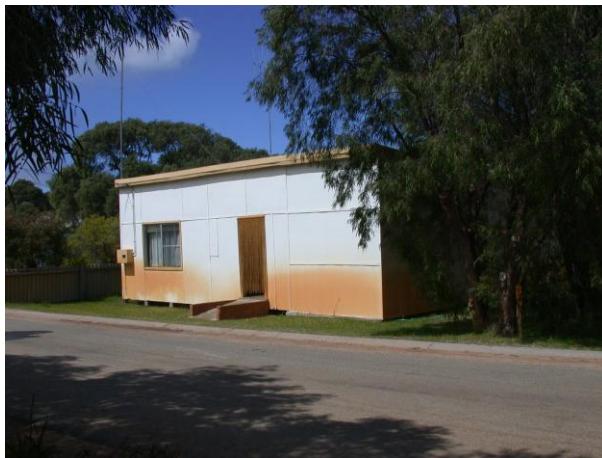
**Photo 13** Typical fibro skillion in authentic condition

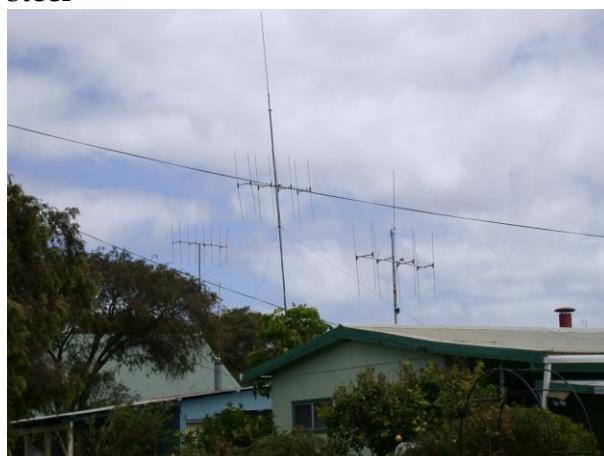
**Photo 21** TV and radio aerials

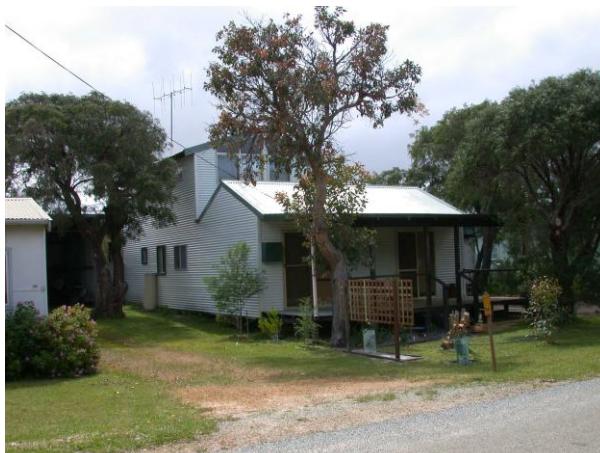
**Photo 25** Two storey construction is not authentic to the precinct

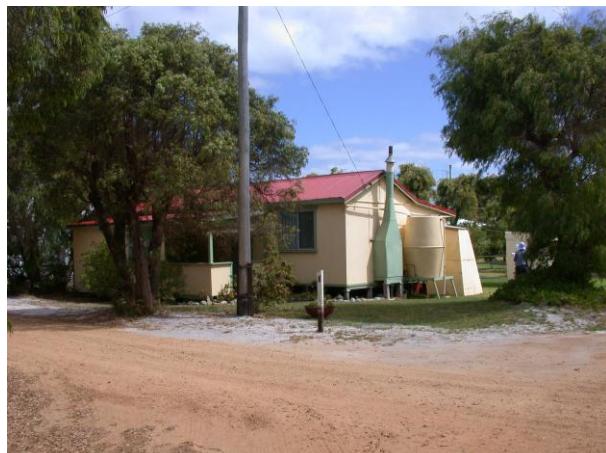
**Photo 26** Fibreglass water tank and toilet extension

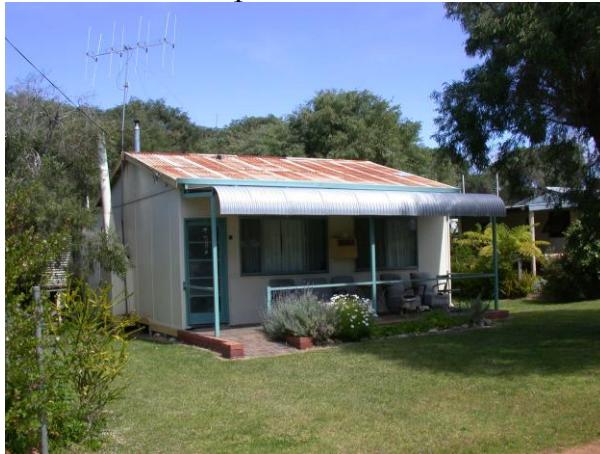
**Photo 27** Bullnose verandah is not an authentic detail

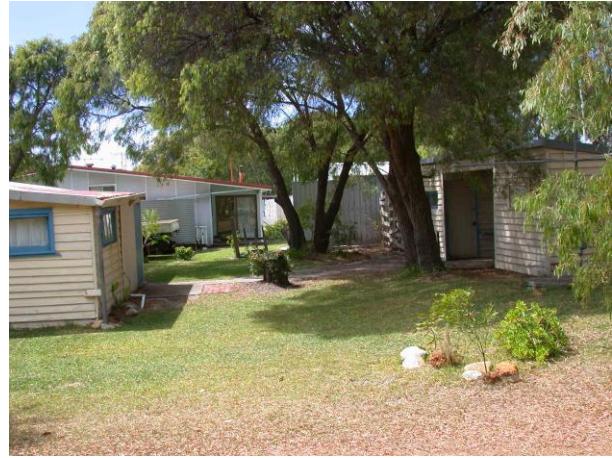
**Photo 34** Garages are usually set at the rear of the lots where they have little visual impact

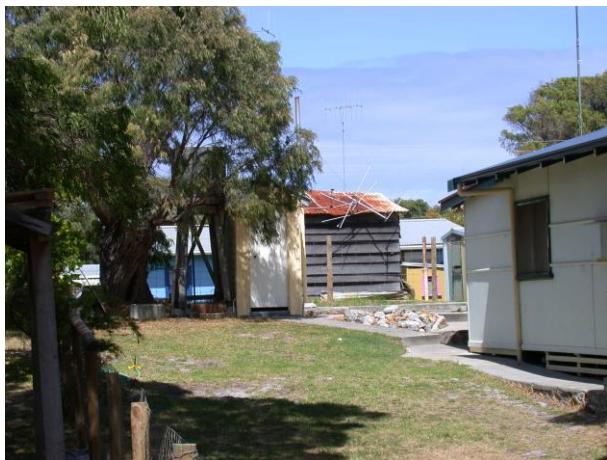
**Photo 35** Timber outbuildings

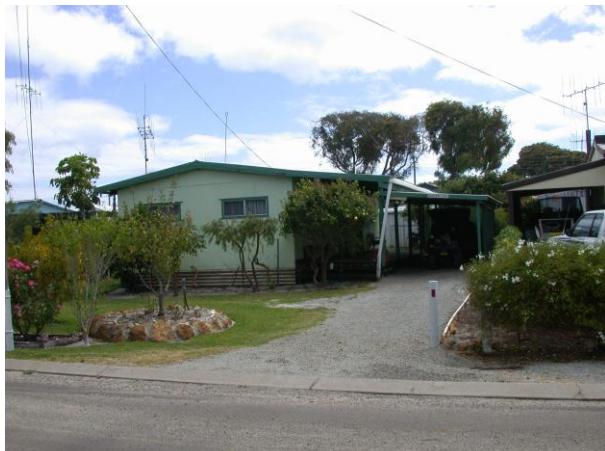
**Photo 41** One of the few driveways in the precinct

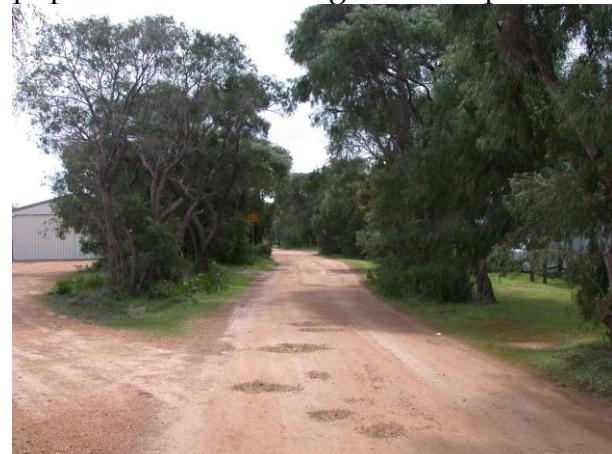
**Photo 44** Large areas of gravelled surfaces around the Fire Brigade building

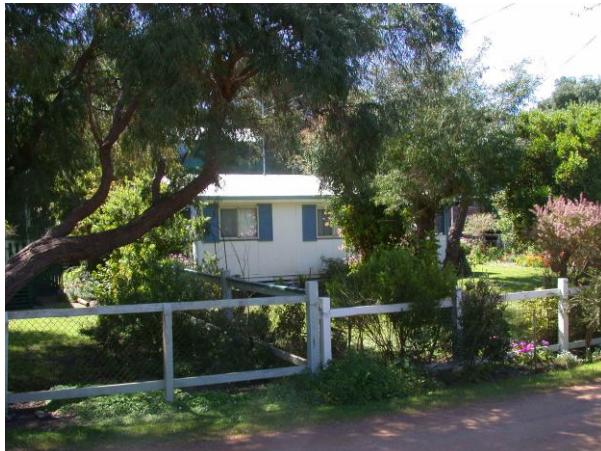
**Photo 47** Light post and rail fence with mesh insert has low visual intrusion

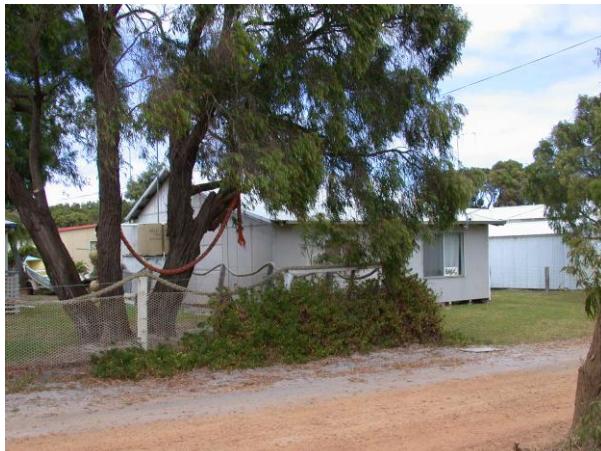
**Photo 49** light post with mesh infil and rope balustrade has little visual impact

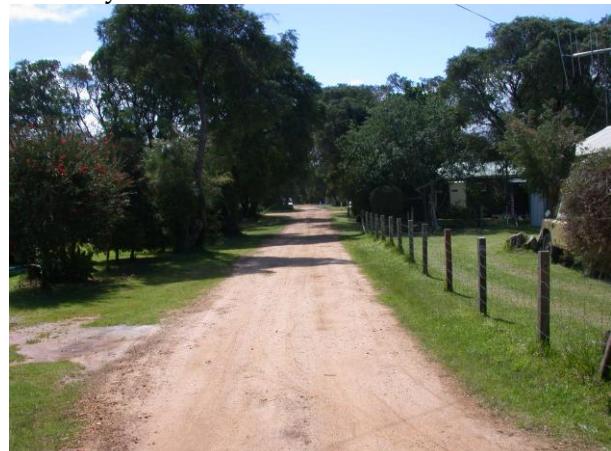
**Photo 50** Light posts with mesh infil has little visual impact

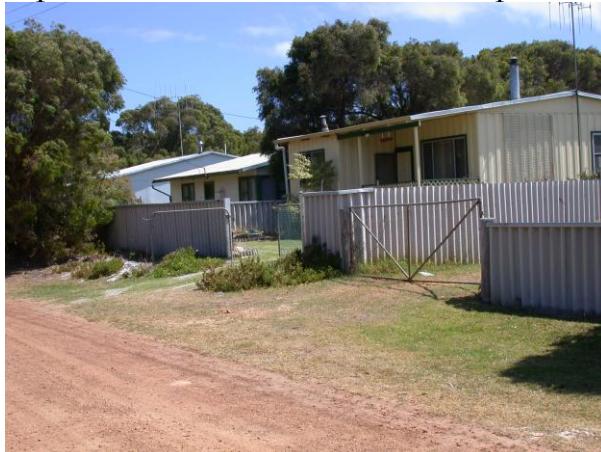
**Photo 51** Solid super six fence on Fourth Avenue is visually intrusive

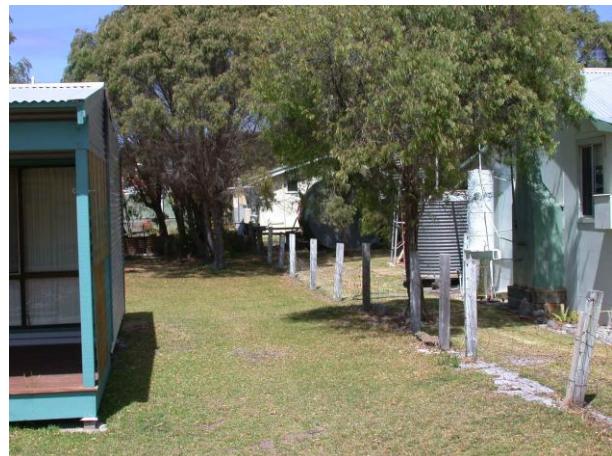
**Photo 56** Simple dressed posts with mesh or wire infil have little visual impact
